# EARTHQUAKE REPAIR

## 425 & 427 ARMAGH STREET

**IN RESPECT OF:** Structural Design of Foundation Repair for 425 & 427, Internal Alterations at Nr. 425 only  
(Description of Building Work)

## TR001: Technical Report – Desktop Technical Review & Structural Inspection

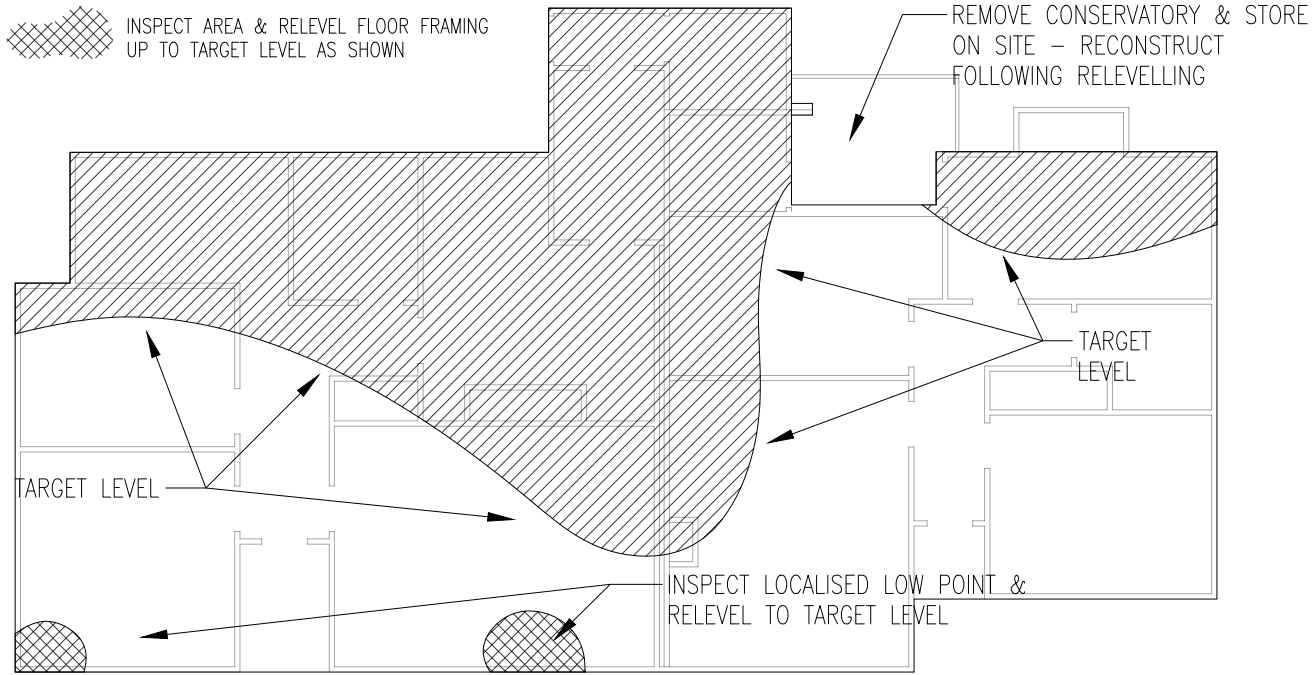
PROPOSED REPAIR ARRANGEMENT

- RELEVEL PERIMETER FOUNDATION & INTERNAL PILES UP TO TARGET LEVEL AS SHOWN
- INSPECT AREA & RELEVEL FLOOR FRAMING UP TO TARGET LEVEL AS SHOWN

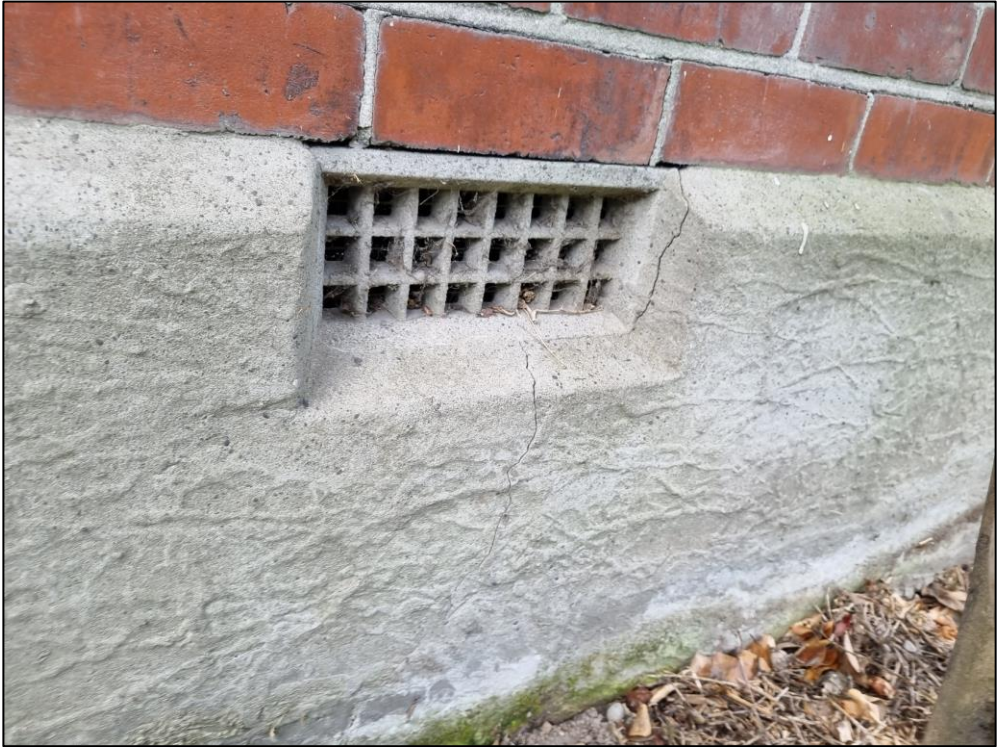
Photo 3A –350mm Perimeter Foundation embedment depth along the west elevation.

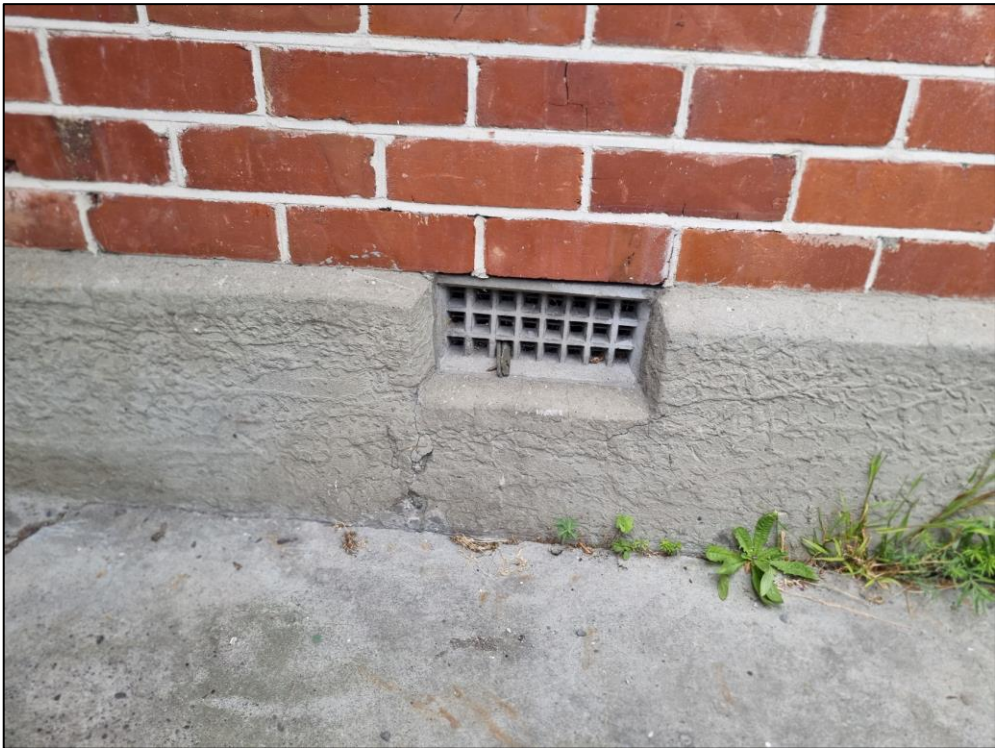
Photo 3B – Foundation crack at vent along the south elevation.

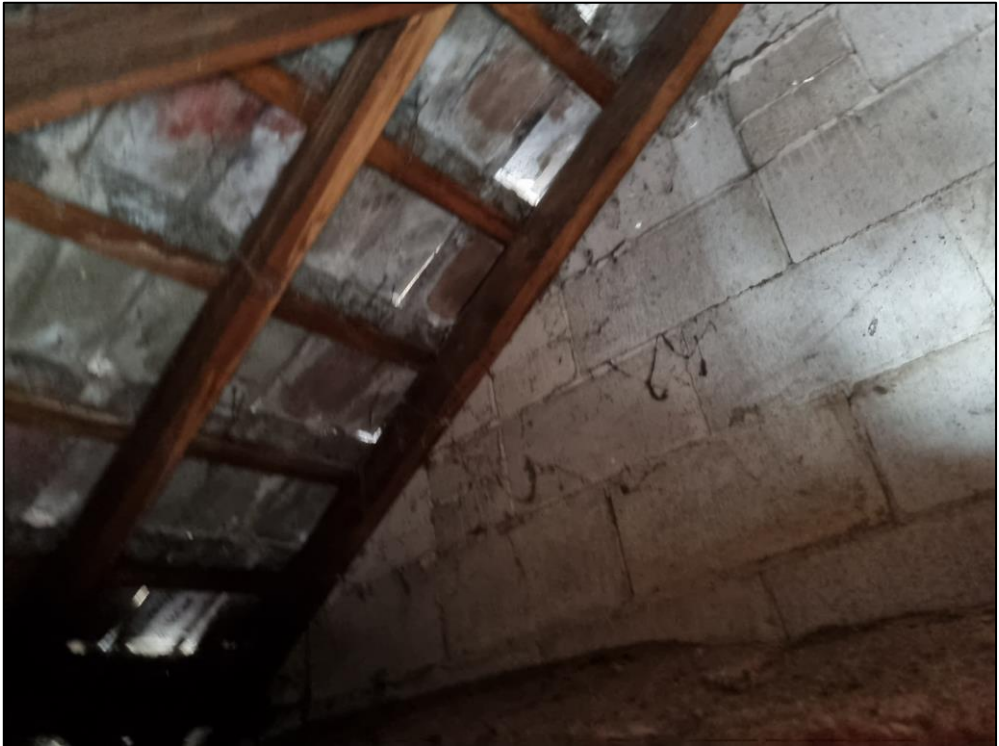
Photo 6B – Partition block wall. No cracking damaged observed. Gaps evident between the roof tiles and the partition wall.

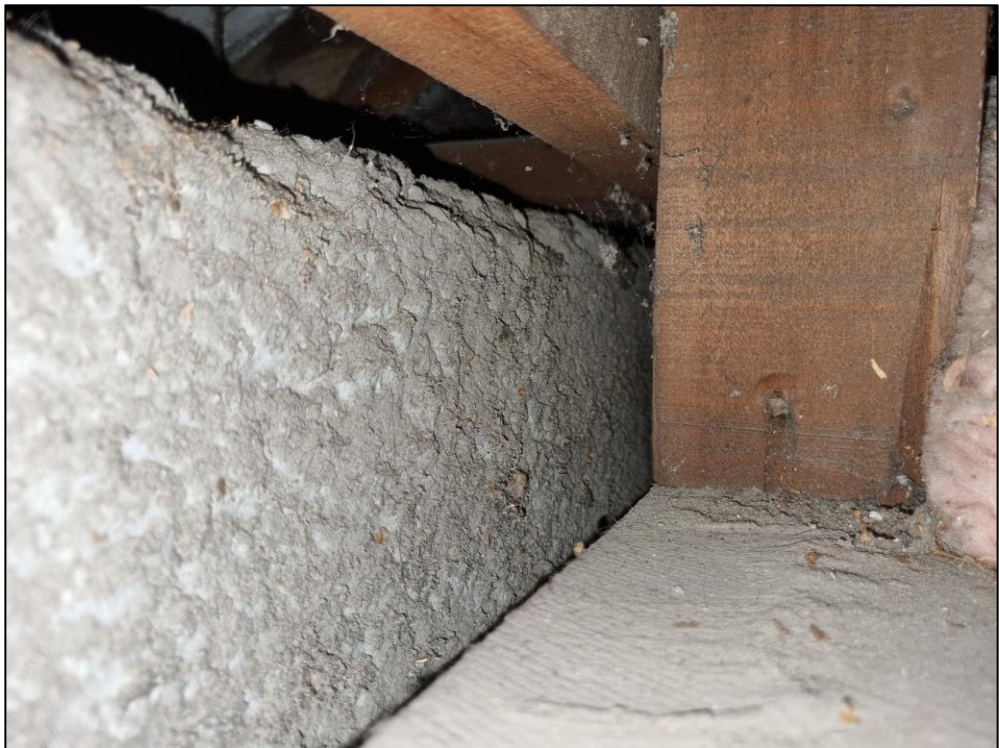
Photo 6D – Internal view of the precast concrete beams running above the external brick veneer.

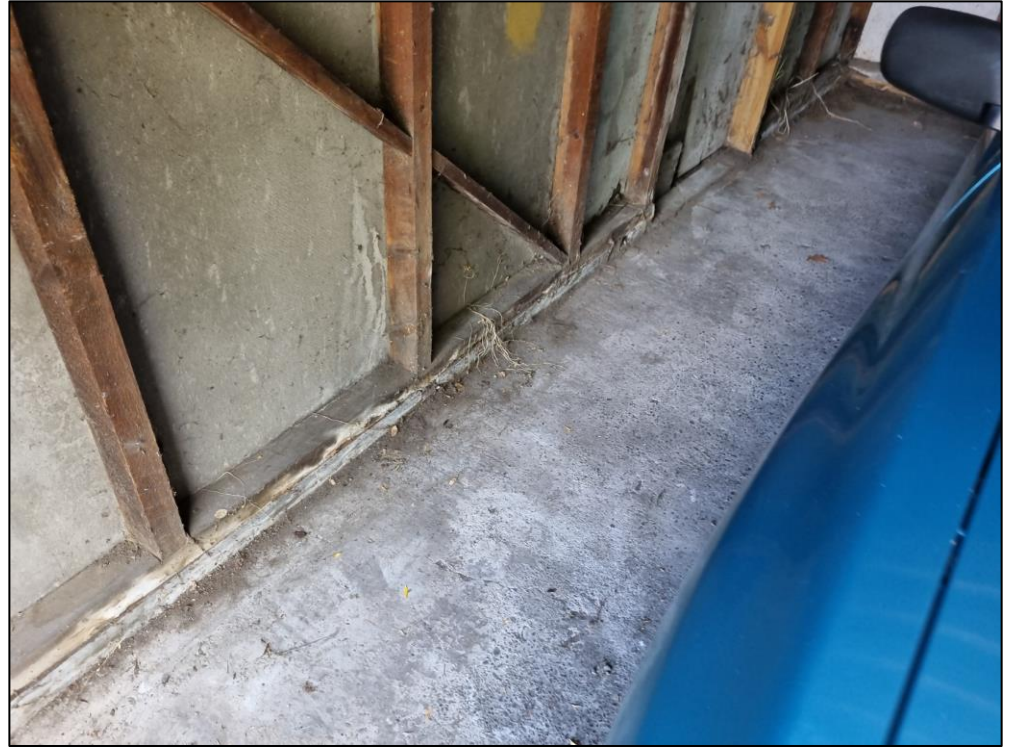
Photo 7B – Garage slab and upstand was undamaged with no signs of previous repairs or settlement cracking.

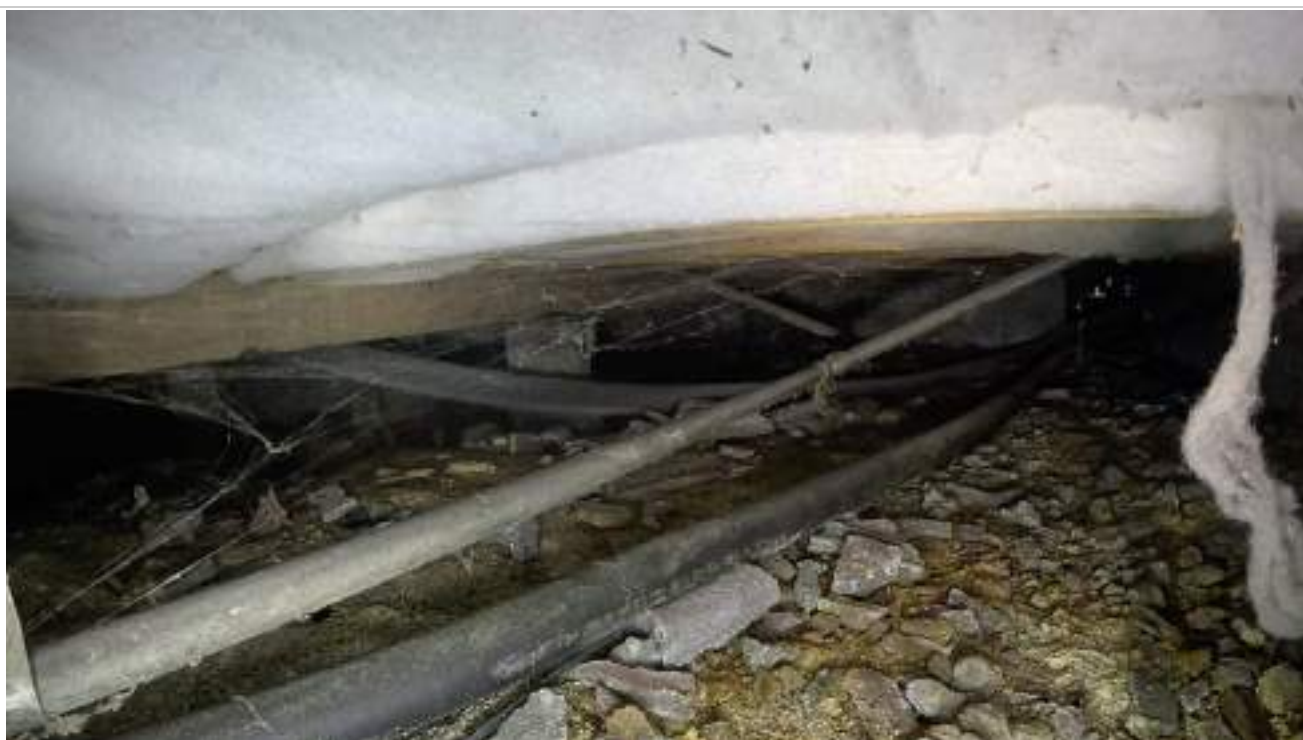
11: The home has precast concrete piles. These are concreted into the ground but not connected to the bearers. We do see one cracked pile.

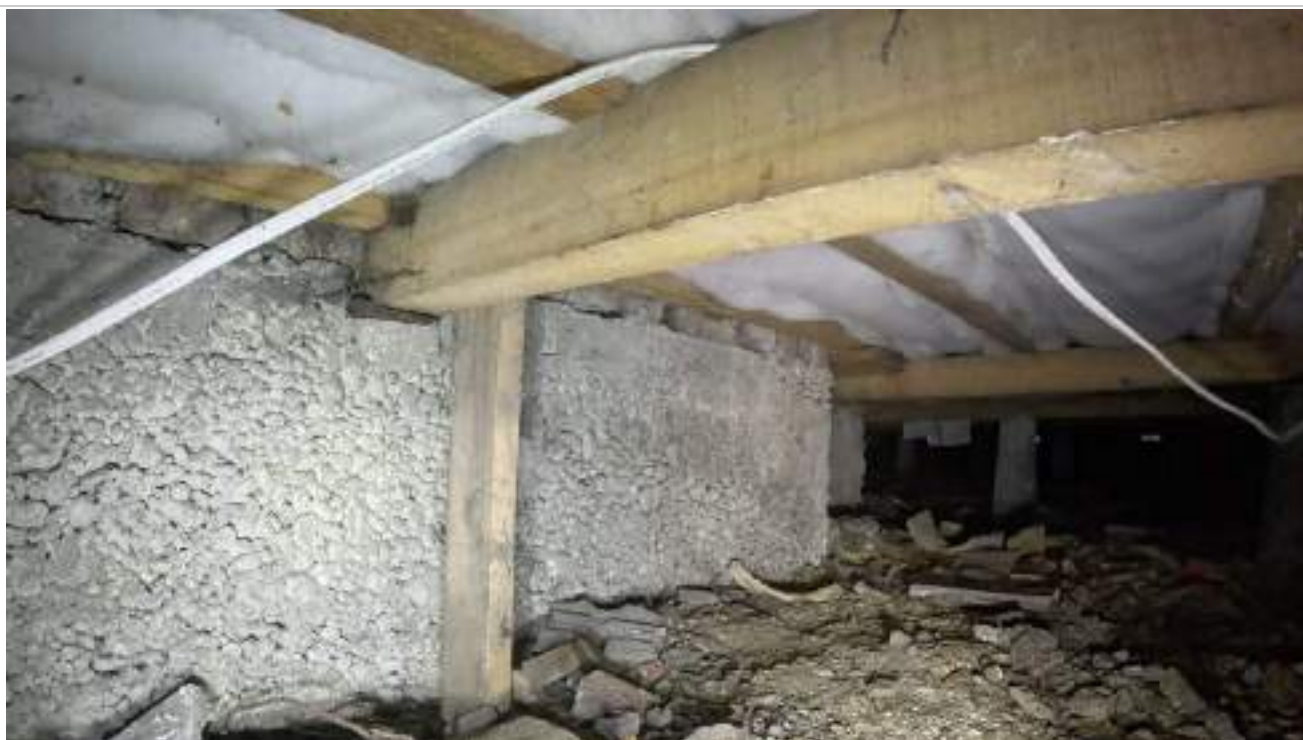
13: View of bearer meeting chimney breast. There are some non-compliant issues with the wiring seen in this home. They could also be a significant hazard to anybody operating under the floor. This relates specifically to unclipped wires. An electrical inspector could be consulted regarding this.

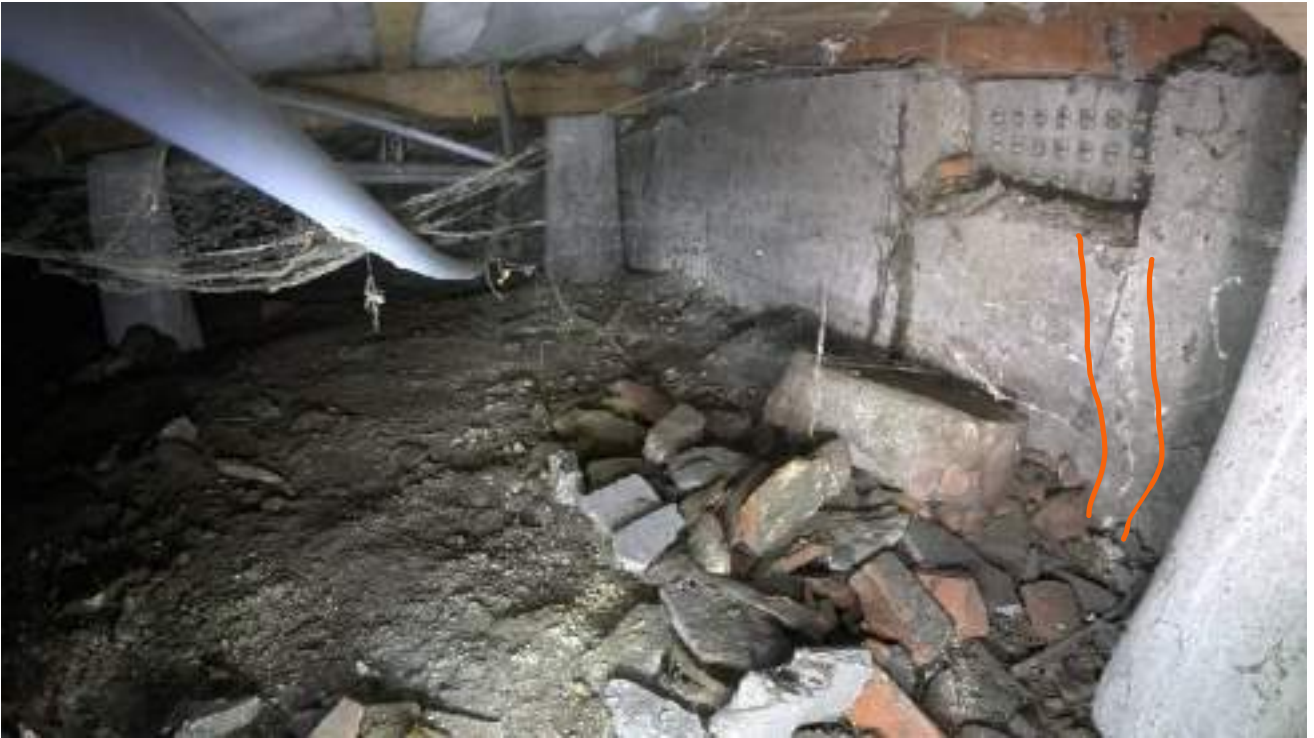
17: View of foundation with what may be a crack.

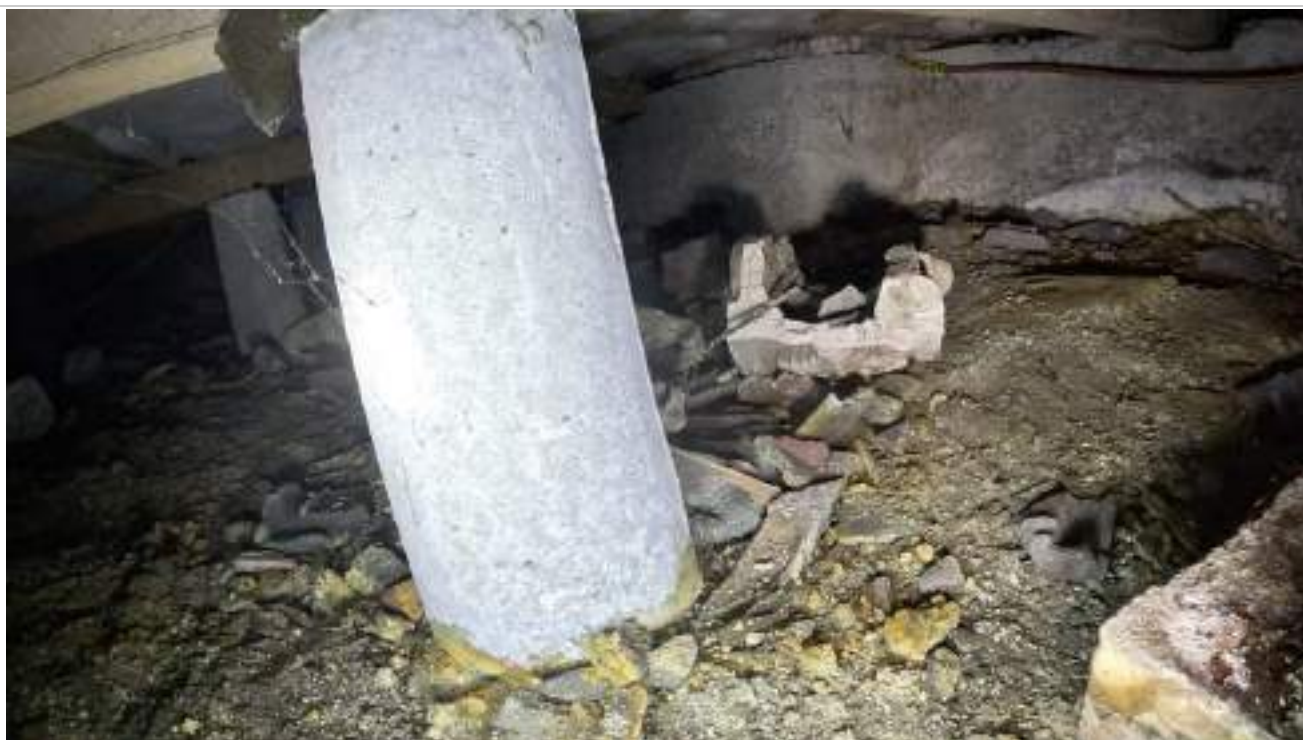
28: Precast concrete pile with crack in the foundation.

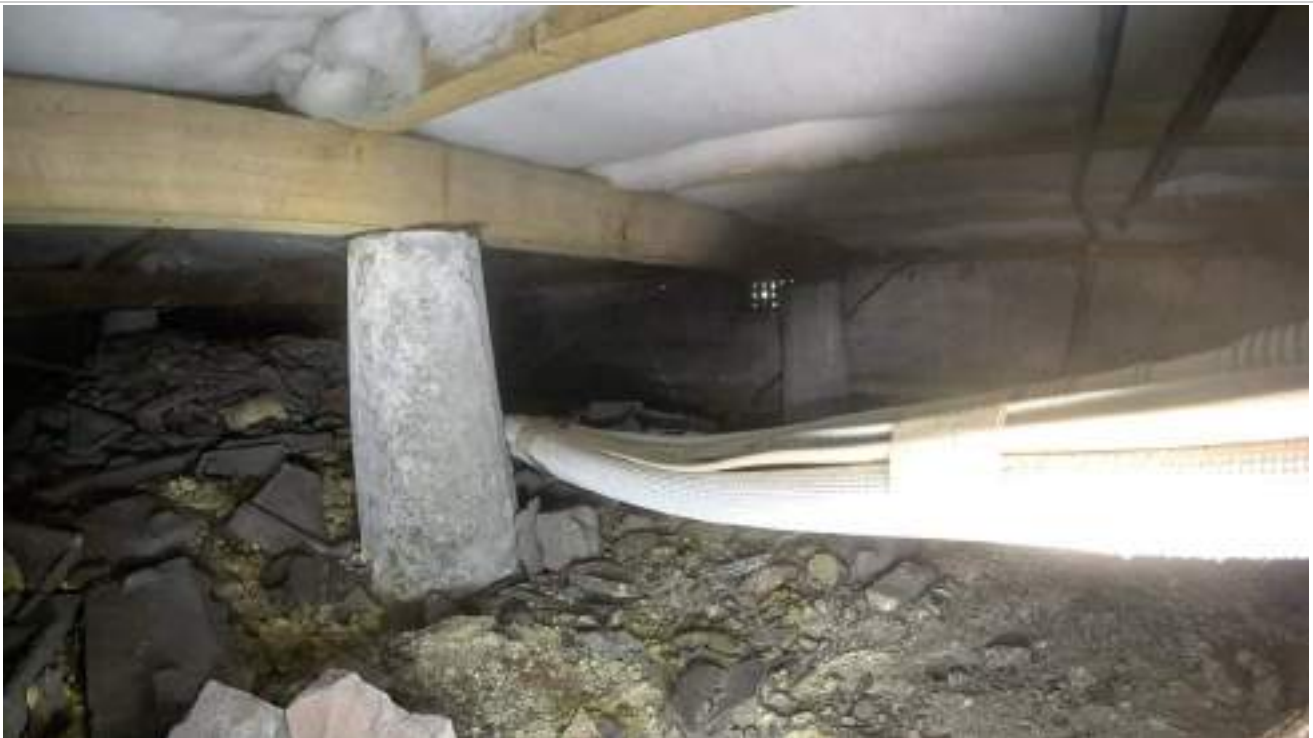
35: View of ring foundation with main water pipe into the home and there are indications that the pipe is heavily corroded in ground and may be either leaking, or close to leaking.

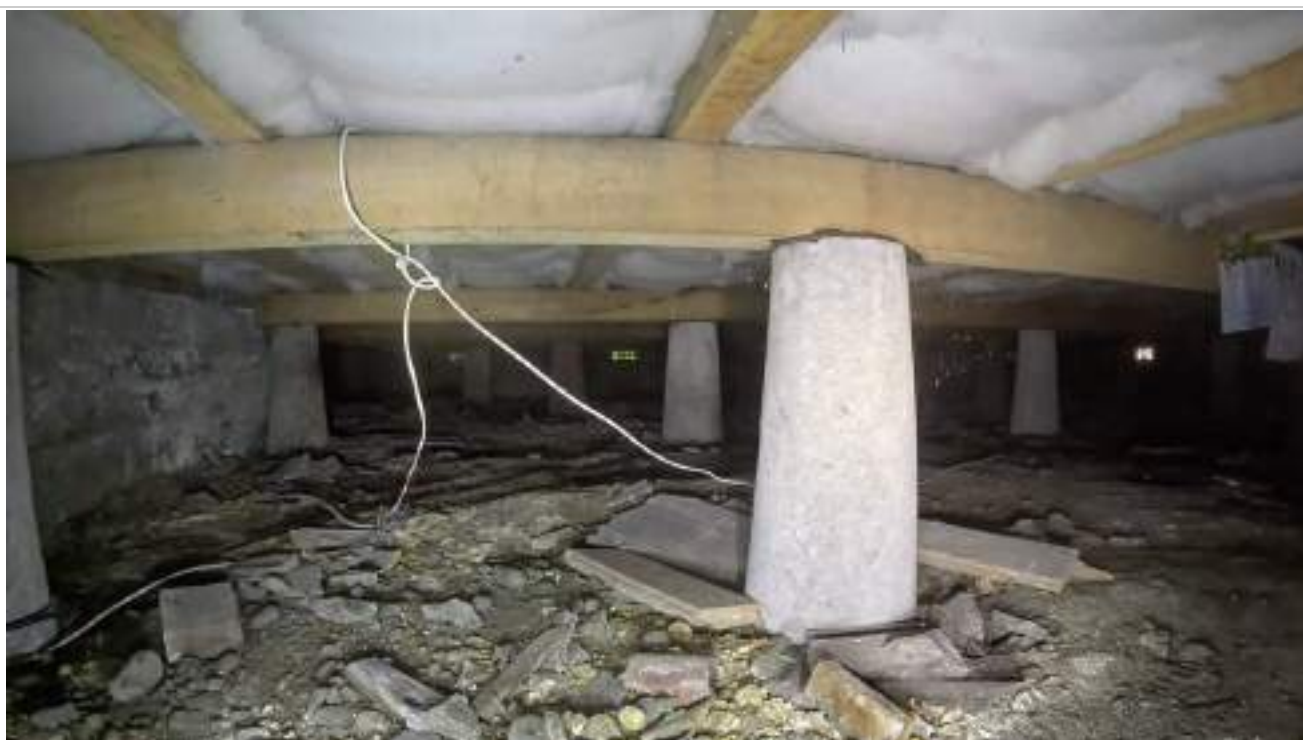
38: Precast concrete pile with no connection. The communication cable has not been laid in a compliant manner and would easily be damaged by people accessing the subfloor.

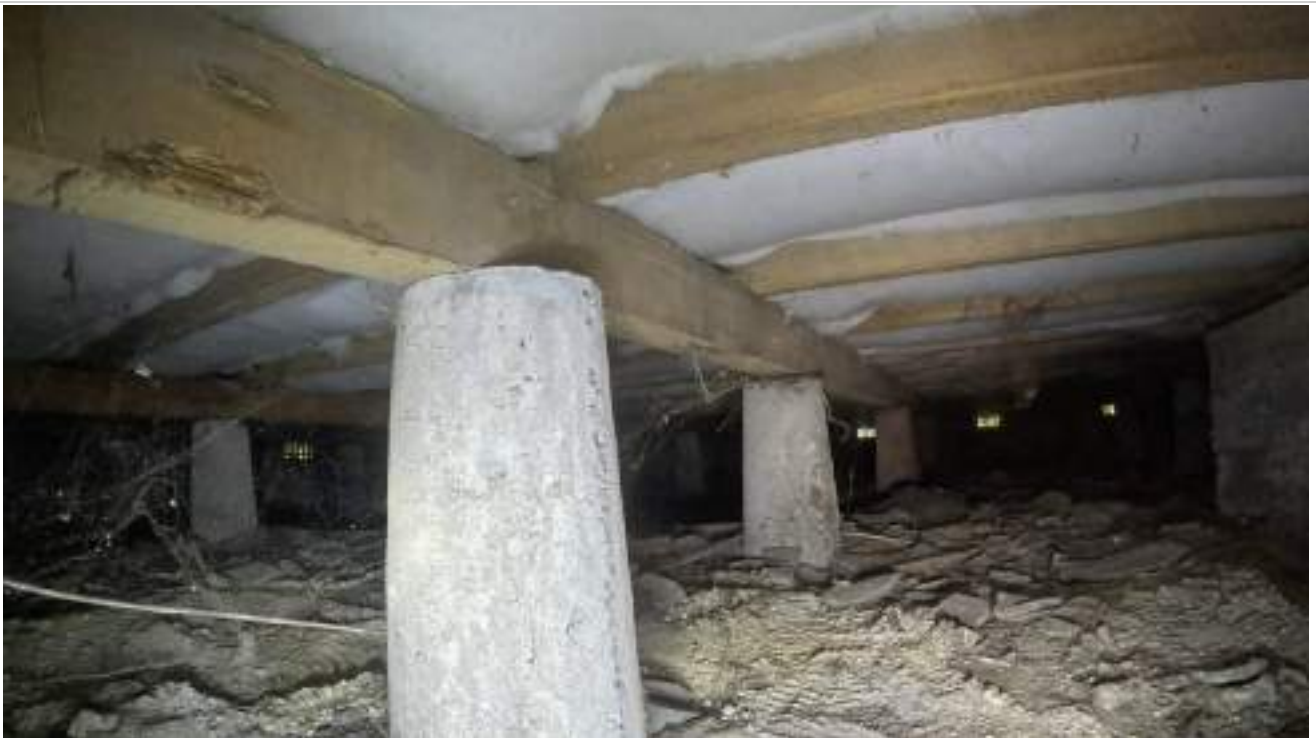
55: This pile is cracked.

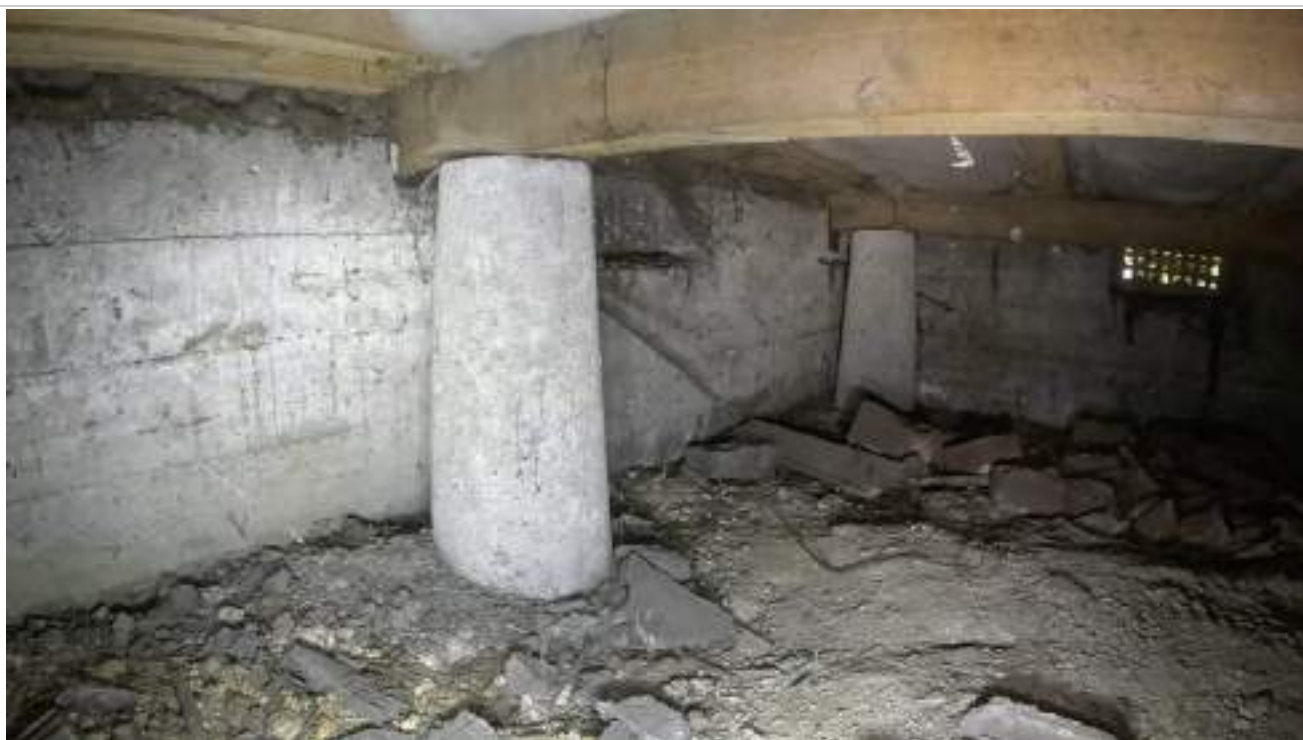
70: View of ring foundation with cracking.

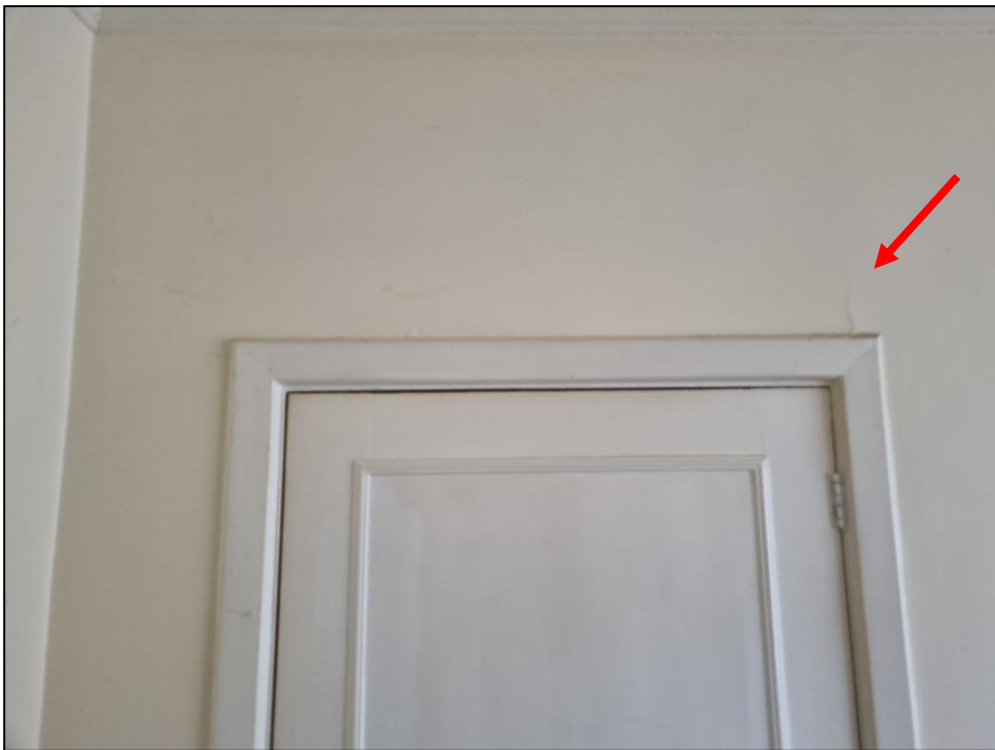
Photo 4E –Minor wall lining damage above the lounge door indication of foundation settlement and racking of the internal wall framing.
