# Cavity Critter

Roof Inspection **Internal**

**Property address: 427 Armagah Street. Linwood**

**Date: 2 June 2025**

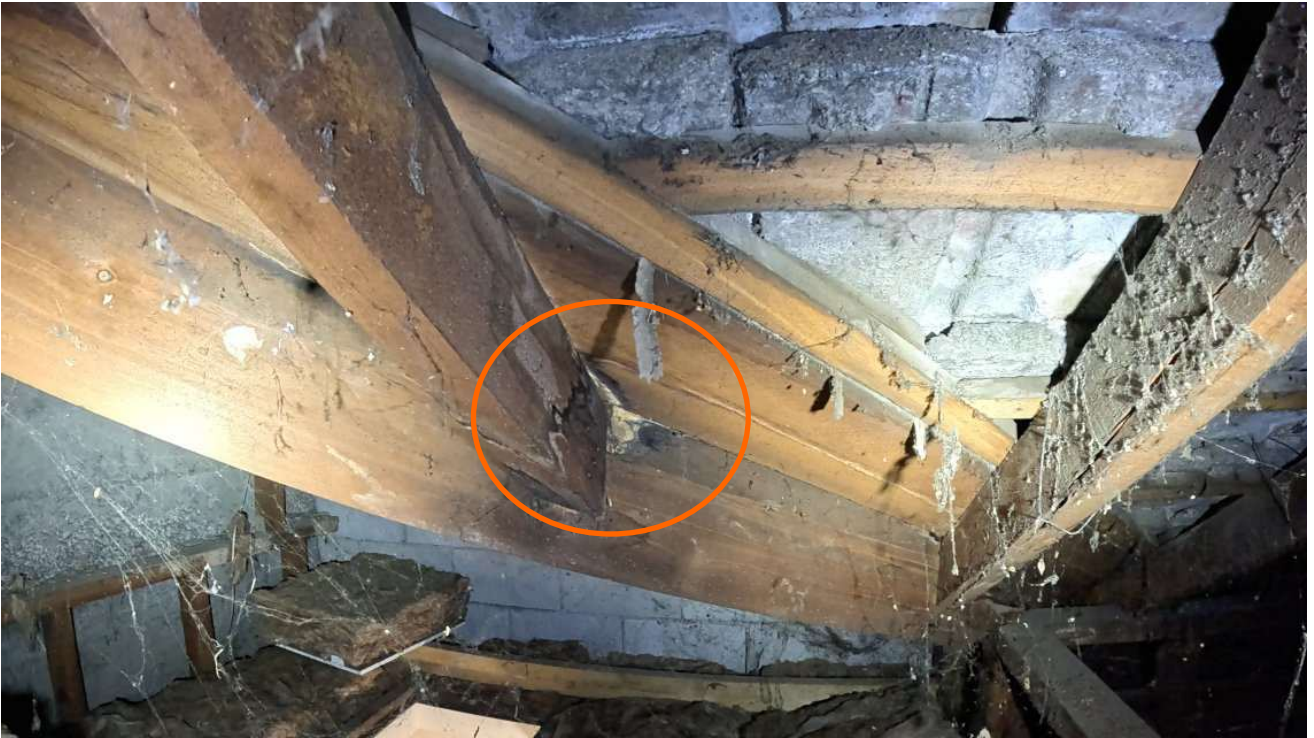
12: The support structure we see in this roof is fairly typical of a roof of this period but does leave some areas vulnerable to sagging.

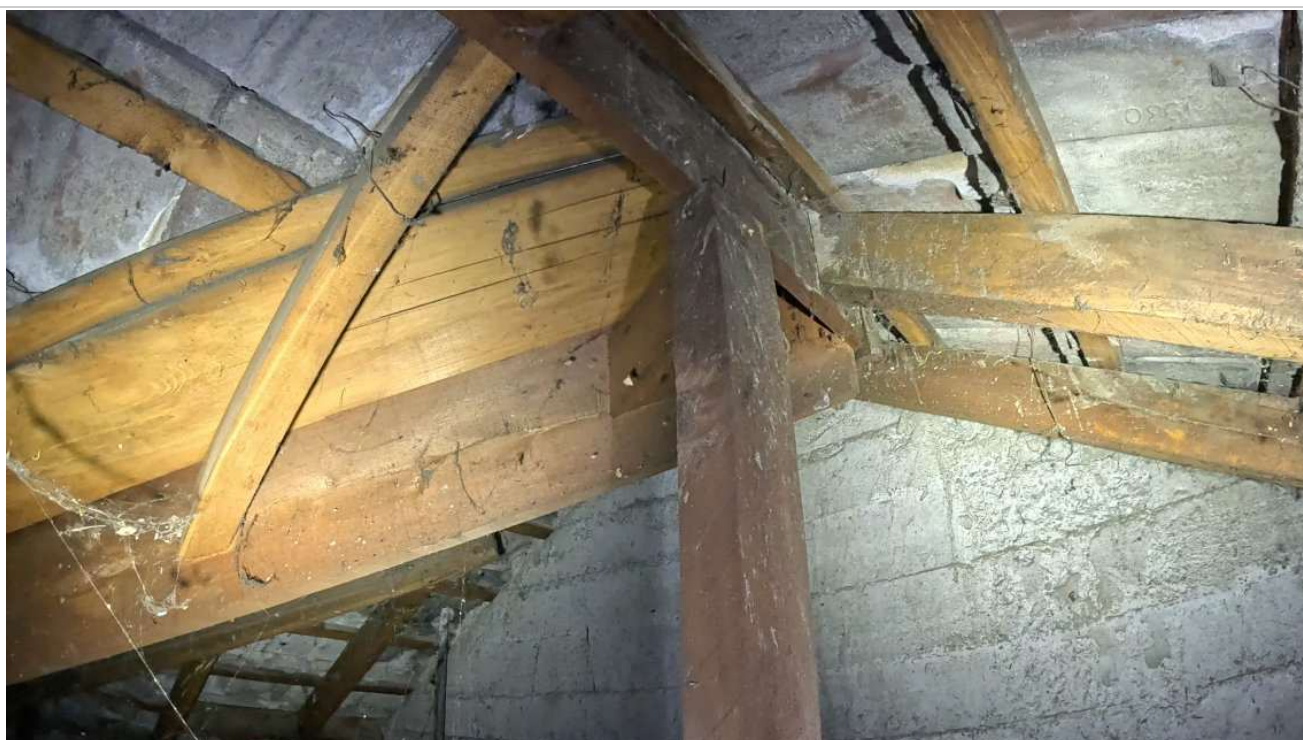
17: There are indications that the left side rafters may have moved around 7mm away from the ridge. Most of them appear to have this gap.

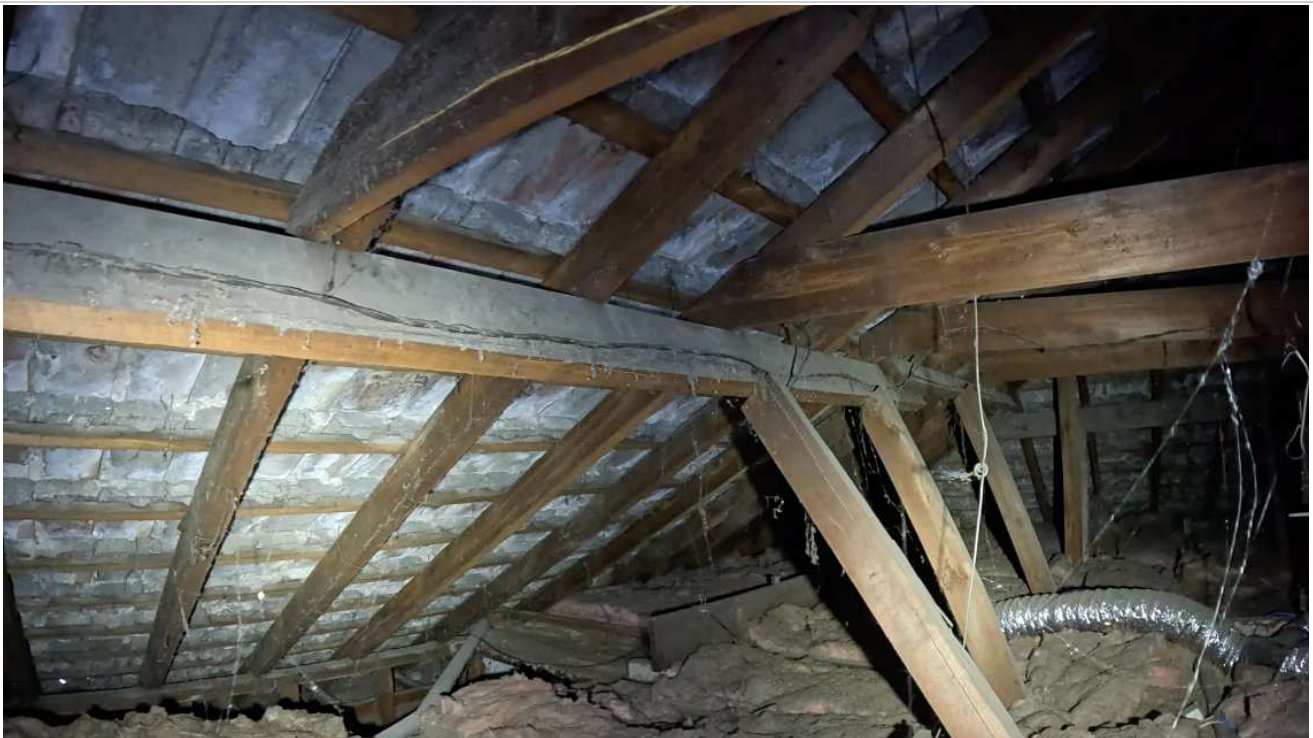
19: We do see some dislodged and broken tiles, as we see here.

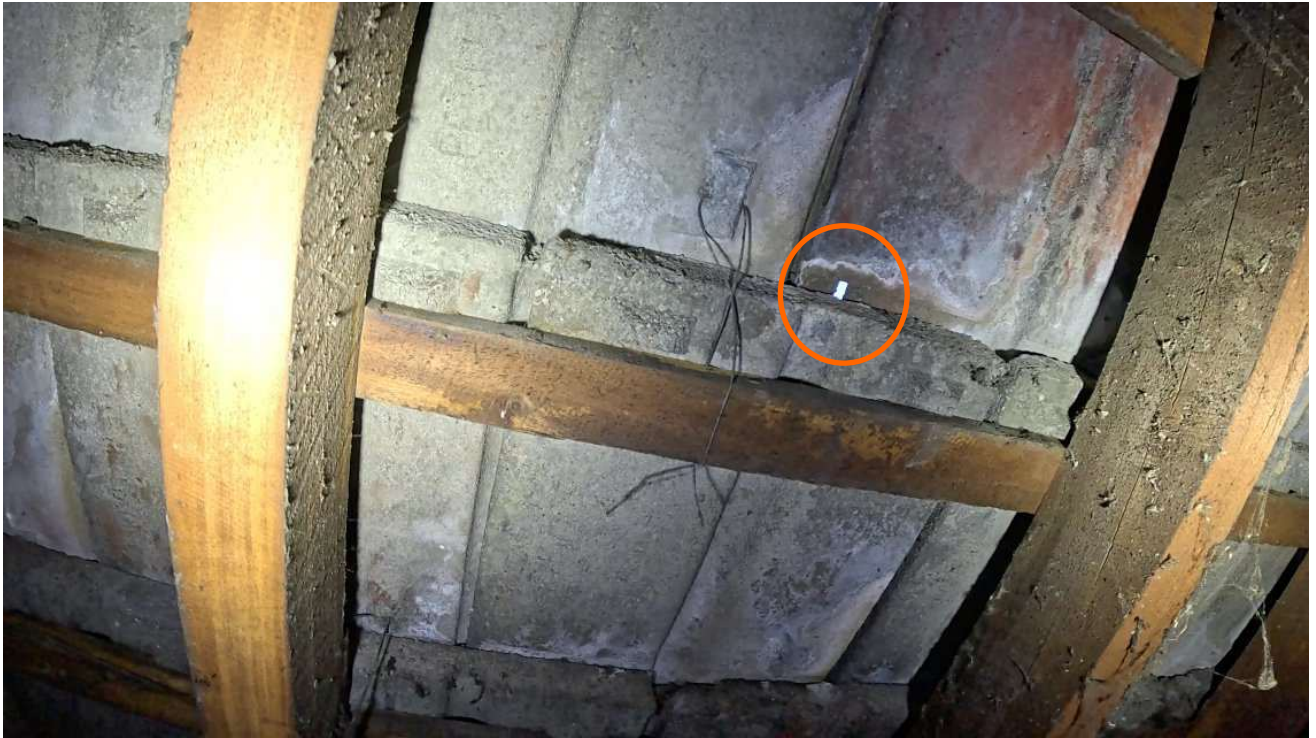
20: There are two broken tiles here.

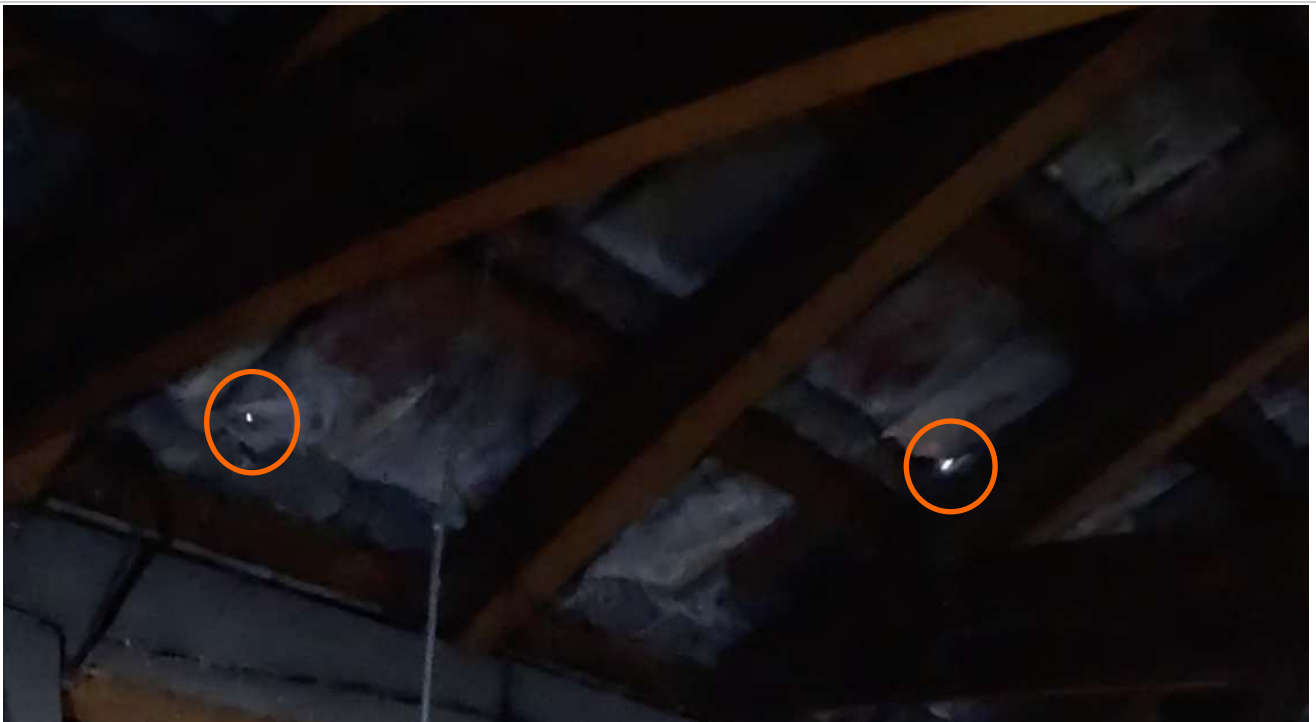
21: Generally, every second or third tile is wired off to a batten or rafter although there appears to be a few missing here.

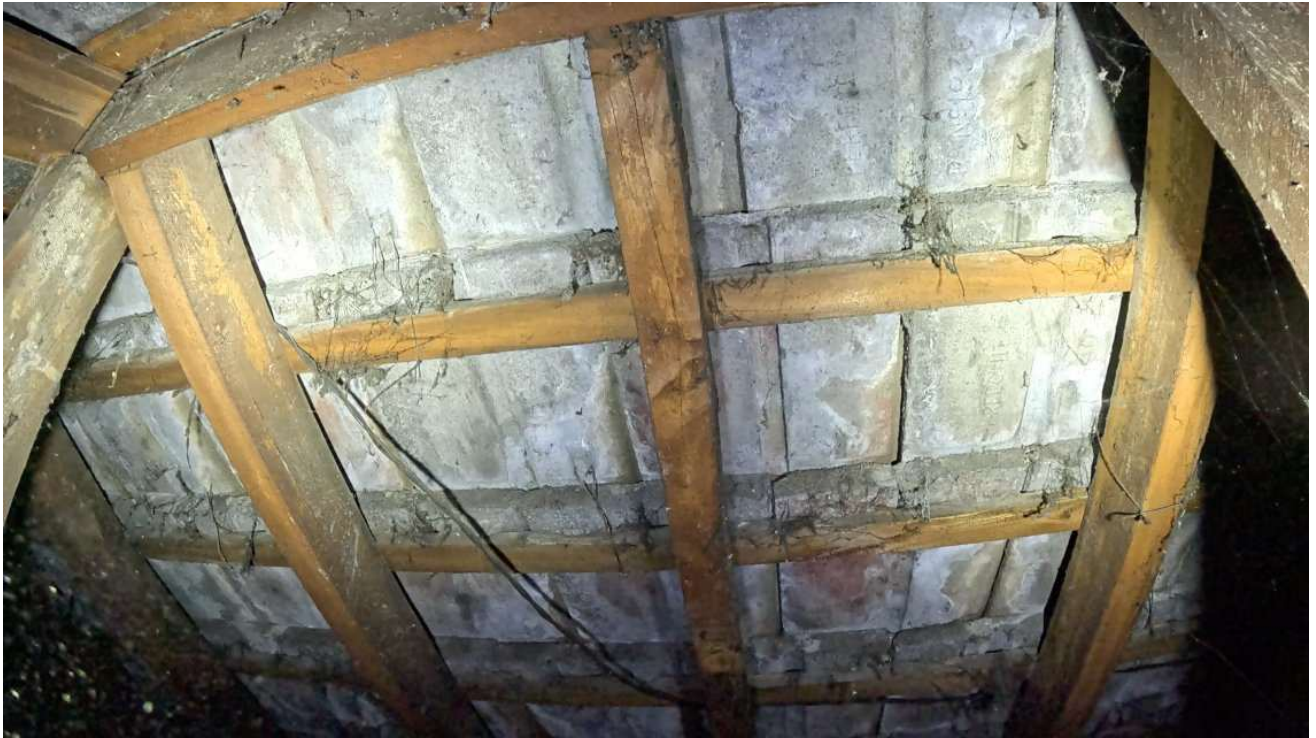
22: Here we see the gap between the rafters on both sides of the ridge.

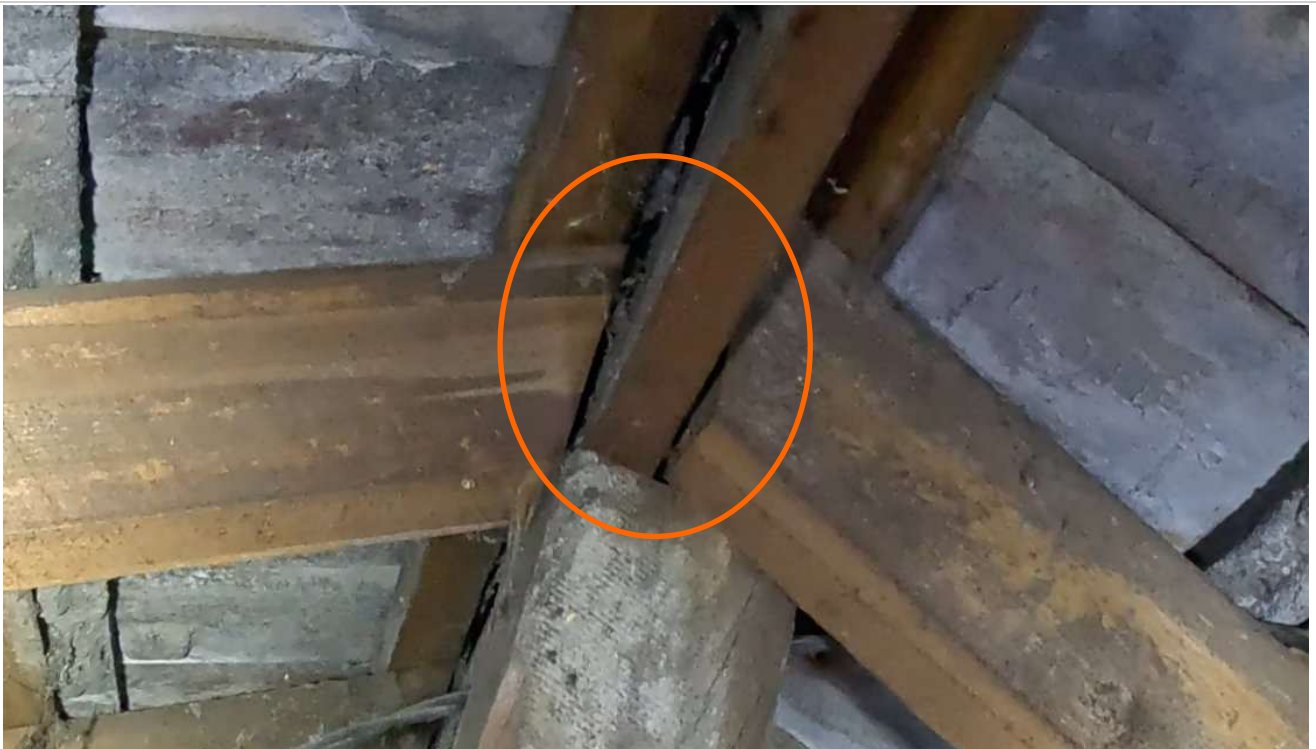
23: Here we see a broken tile and another that has dropped down.

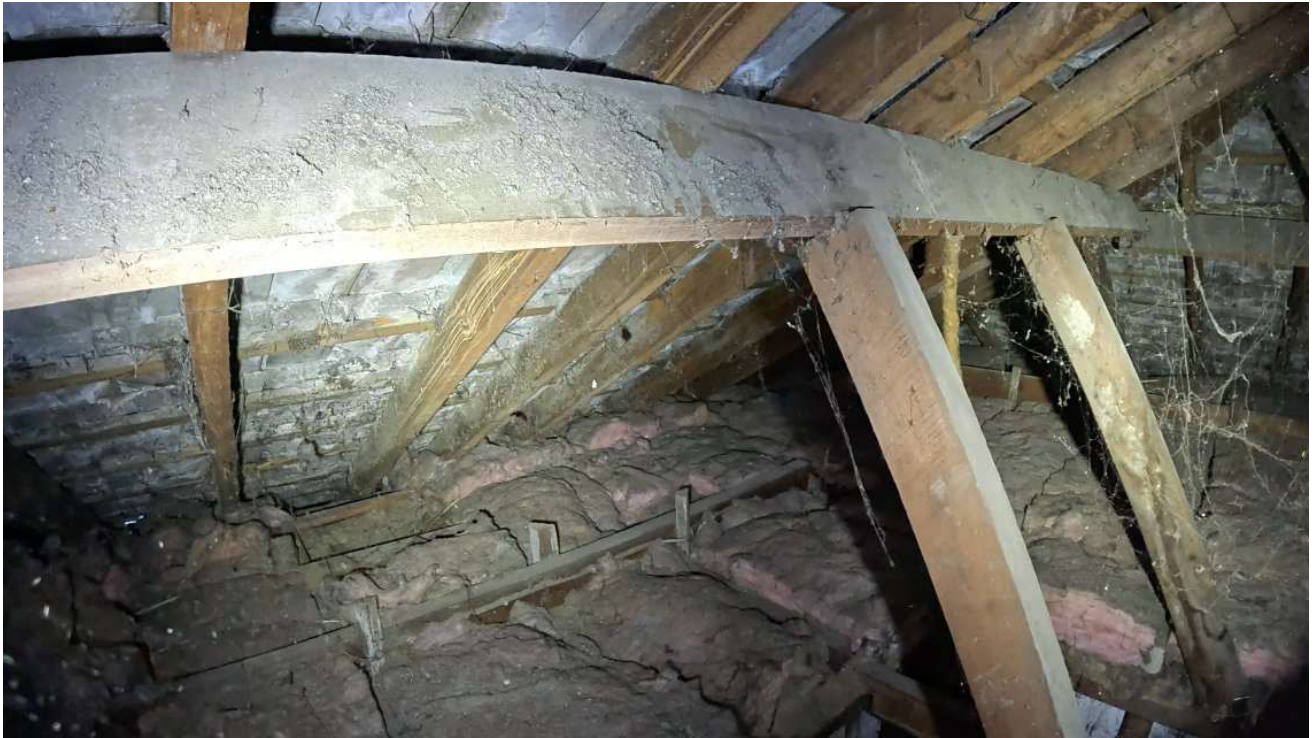
26: View along under purlin and note the lack of support.

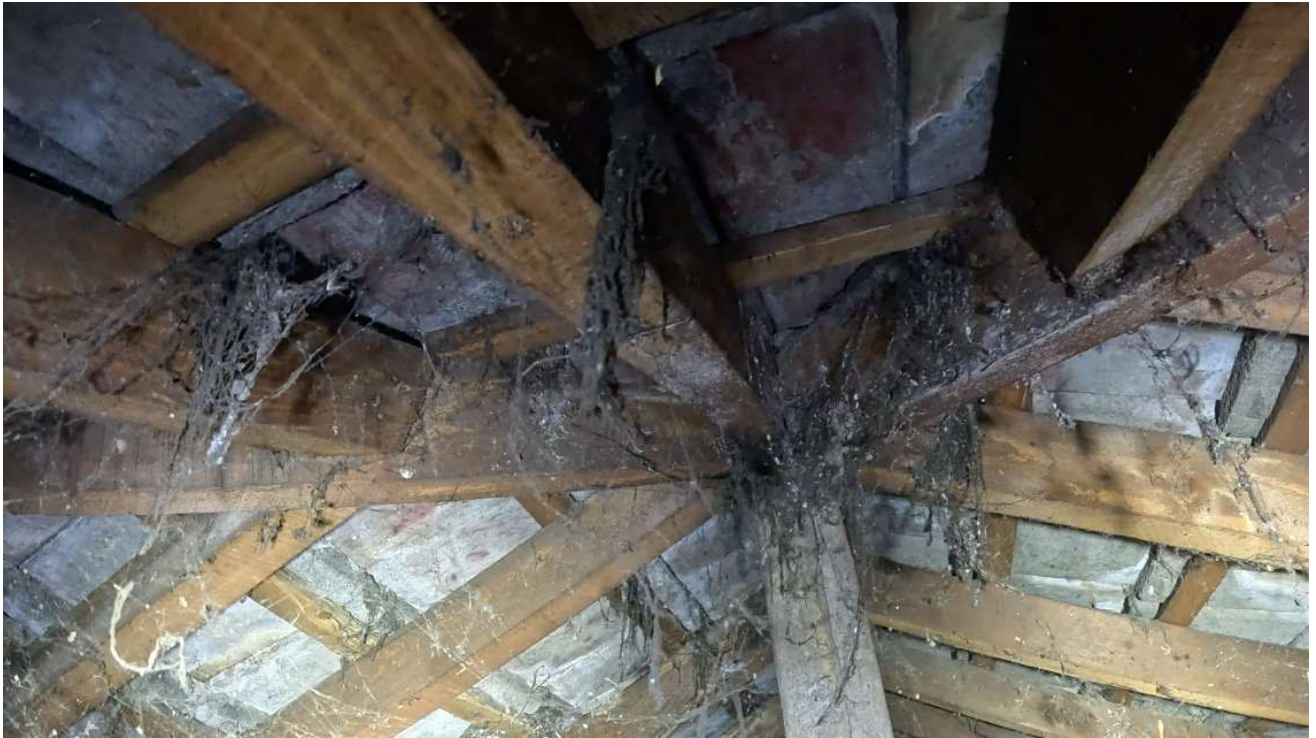
28: There is a broken tile.

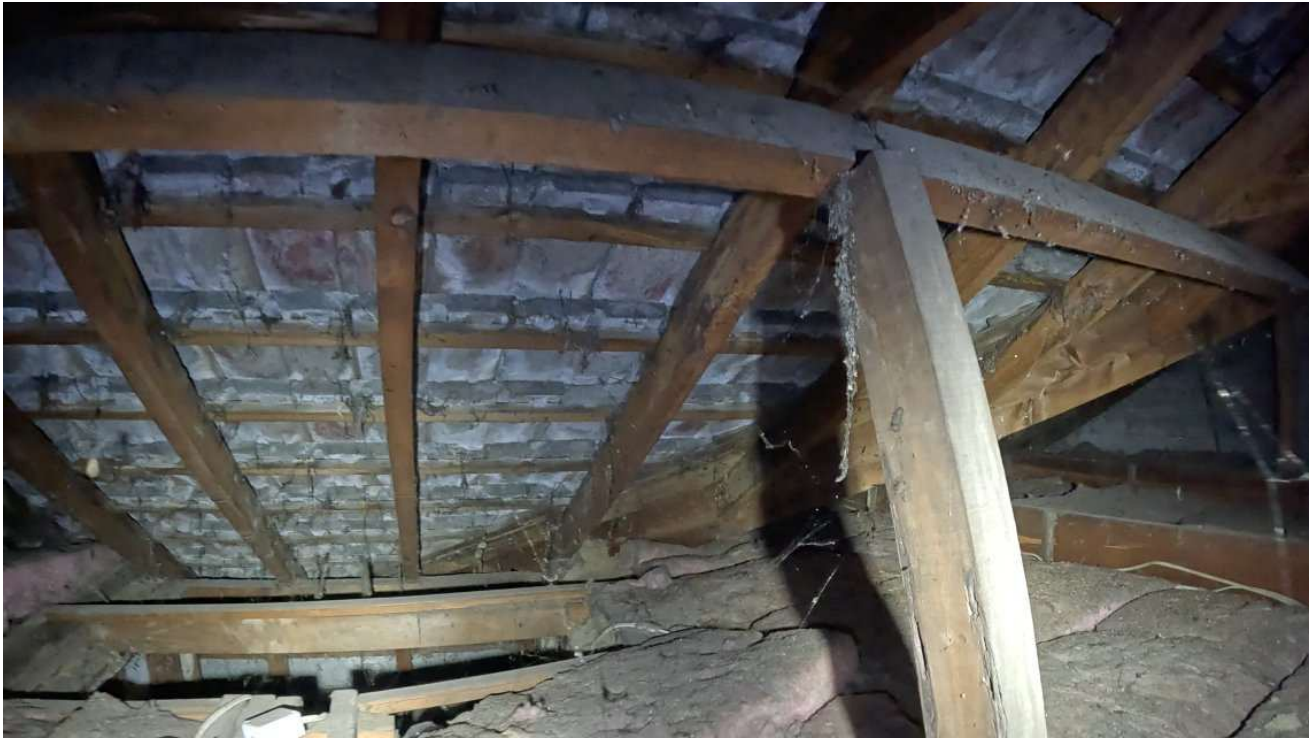
32: Here we see damage to the ridge join and the right side has moved towards the back of the home

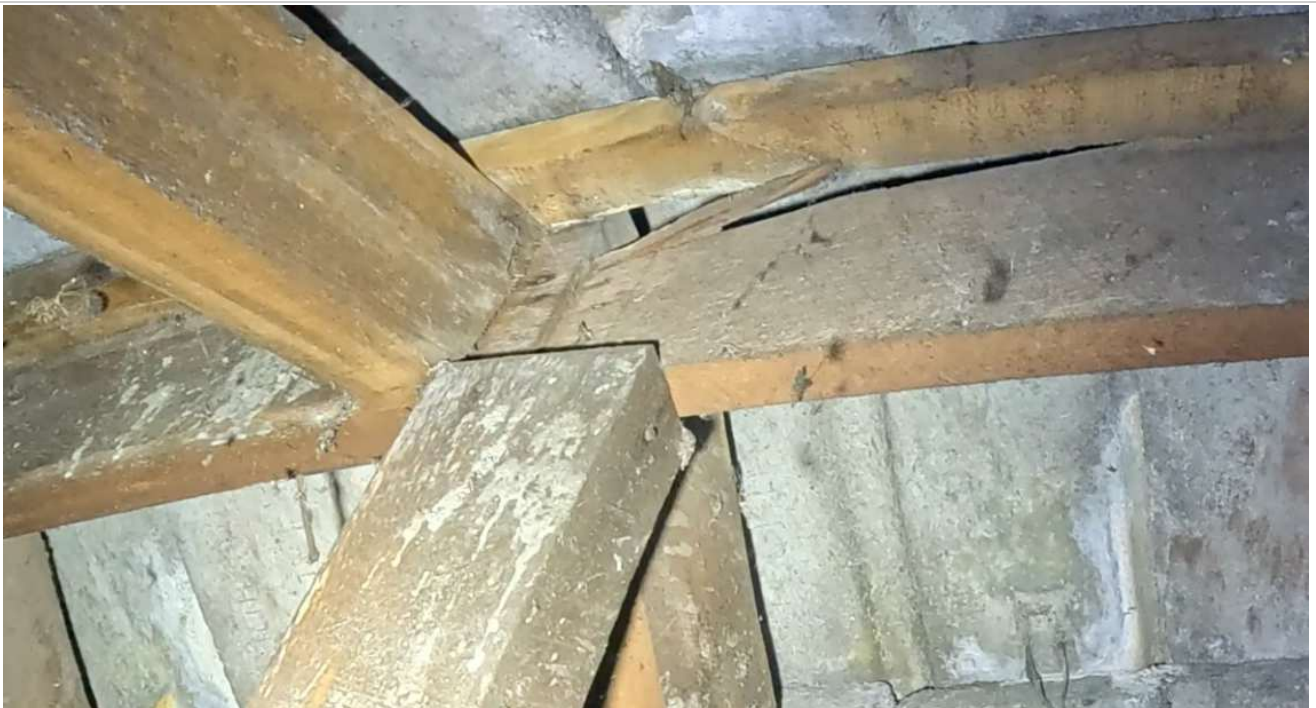
33: The ridge has moved at the bottom here.

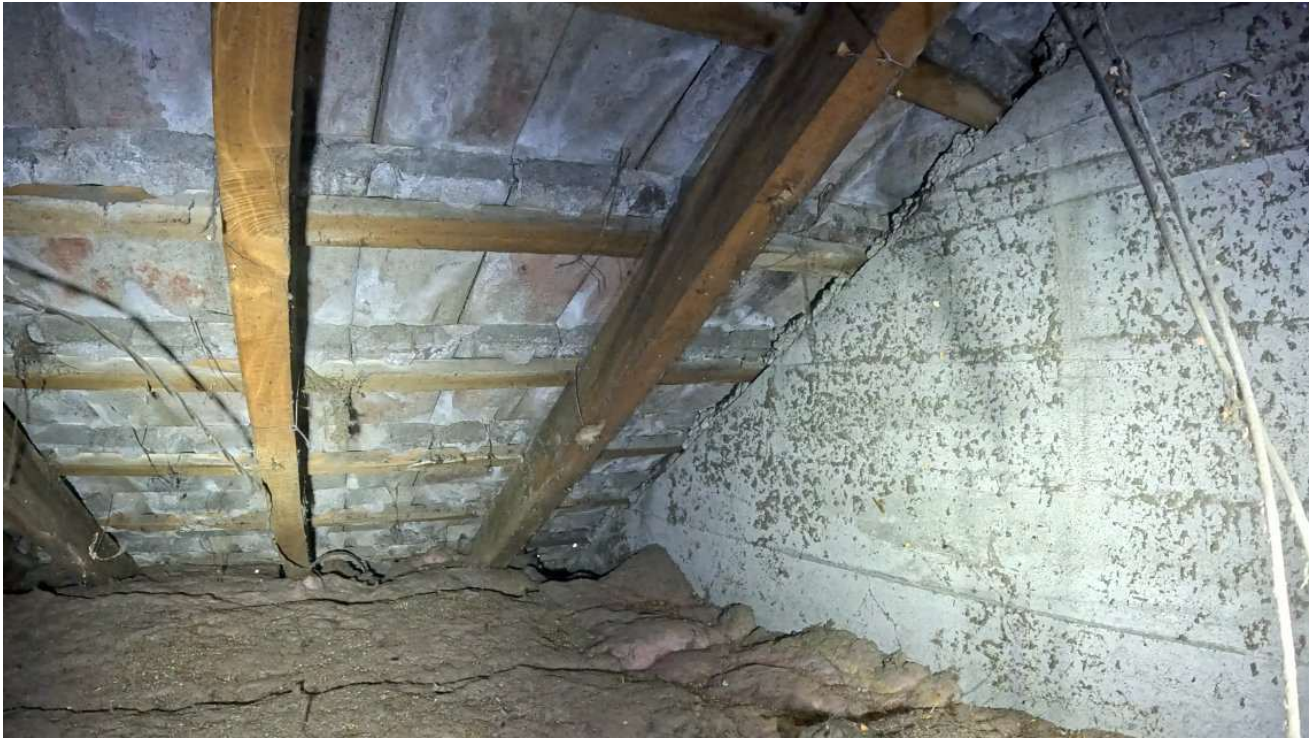
38: This is a chimney has been reduced to rafter height and it has cracked down all sides.

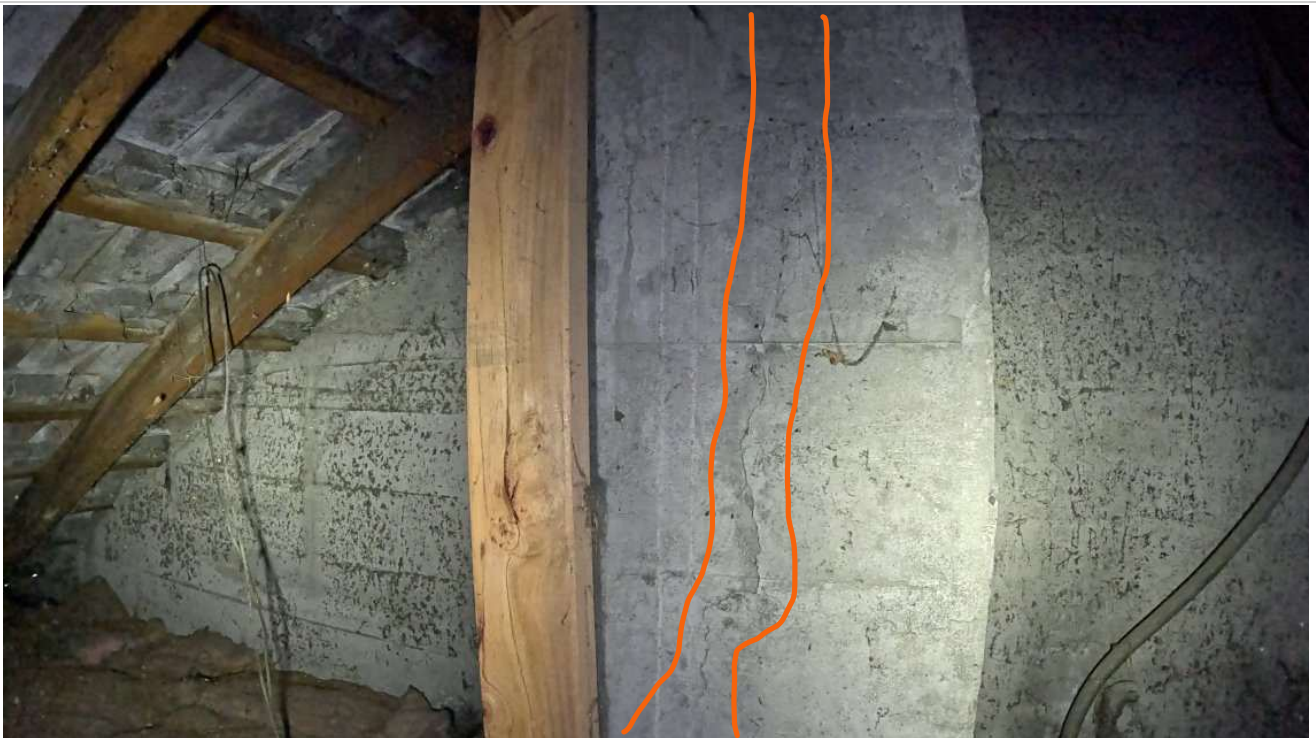
39: View of chimney with cracking. The prop is a latter addition.

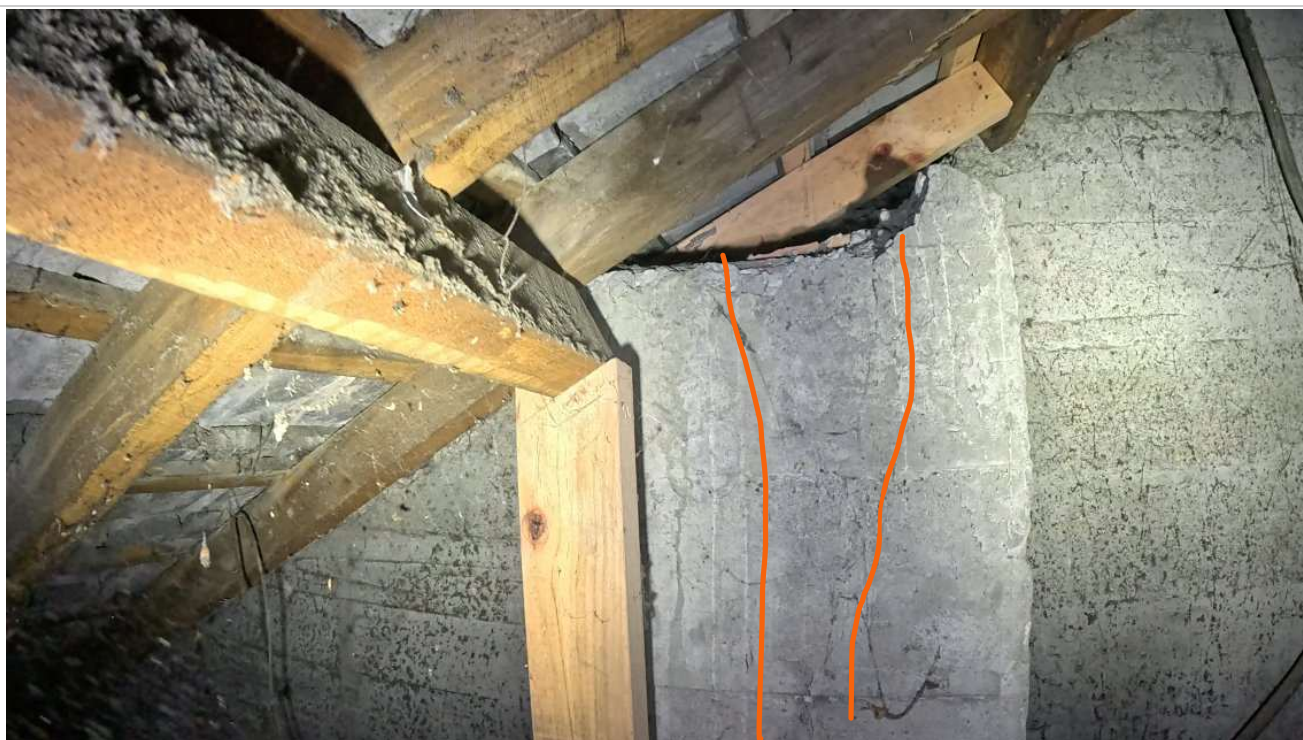
40: View of chimney with cracking.
