| <b>Date</b> | 26 March 2025 | <b>Job Ref.</b> | CLM/2011/122912 |
| <b>Address</b> | 427 Armagh Street, Linwood, Christchurch 8011 | <b>Author</b> | J McCloskey |

## TR001: Technical Report – Desktop Technical Review & Structural Inspection

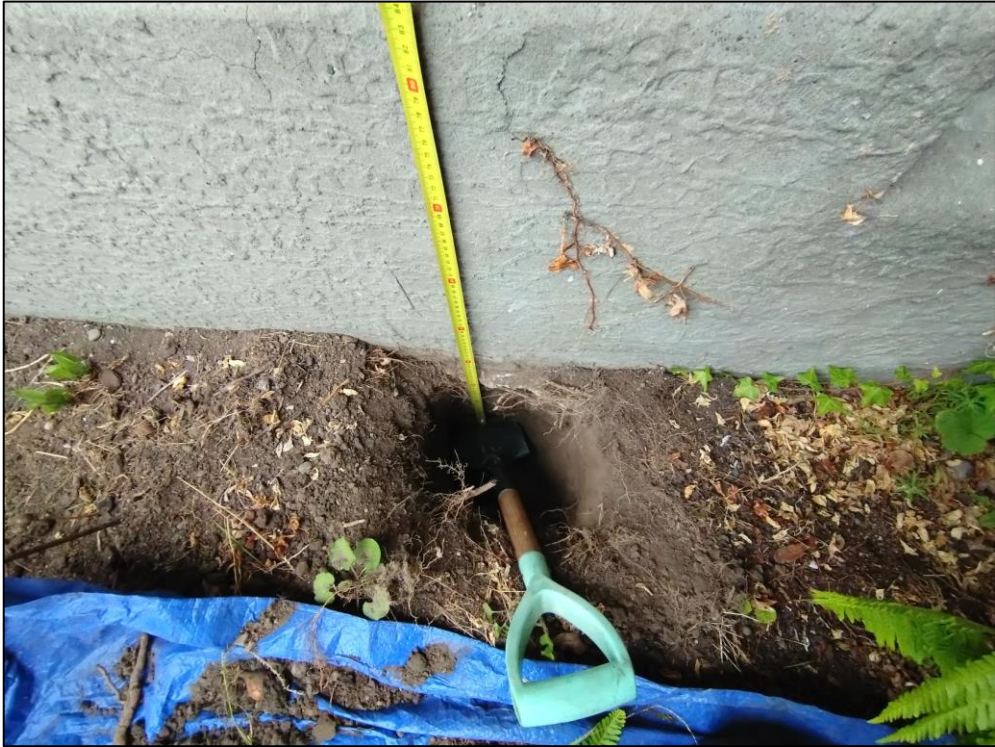
- Foundations of the multi-unit building are categorised as Type B2 (timber-framed superstructure with heavyweight cladding supported by concrete perimeter foundation wall and internal piles) in accordance with Table 2.1 of MBIE Guidance Document (Photo Set 3).
  - A perimeter foundation excavation was carried out along the west elevation of 425 Armagh Street that shares the same foundation construction as 427 Armagh Street. The embedment depth was found to be embedded approximately 350mm below ground level (BGL) (Photo 3A).

Photo 3A –350mm Perimeter Foundation embedment depth along the west elevation.

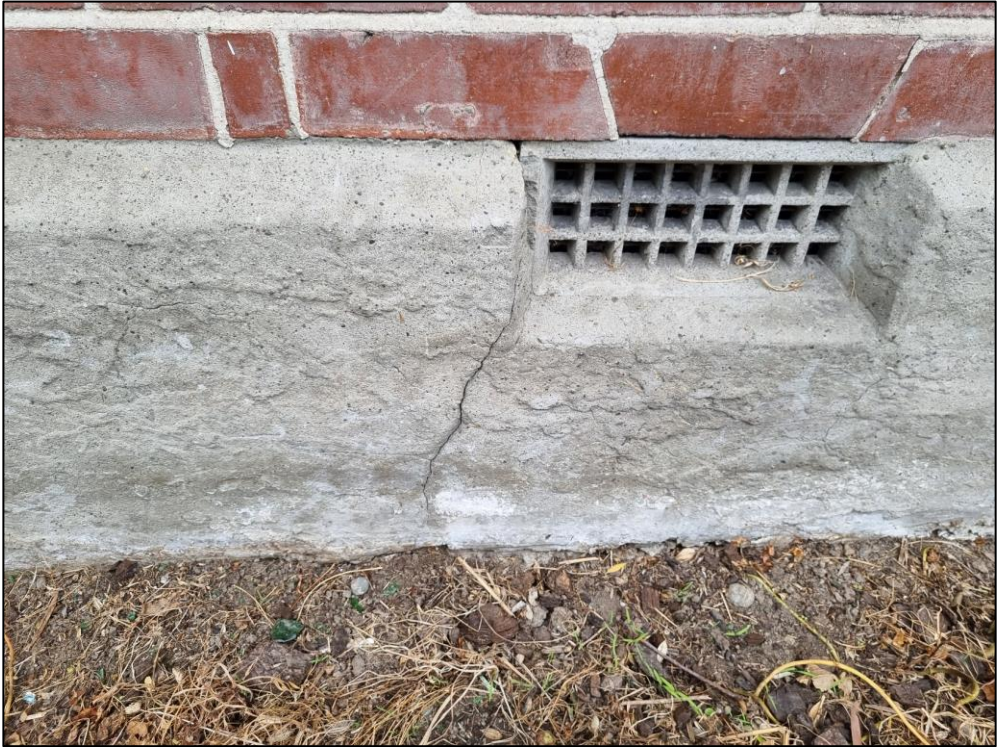
- Most of the foundation cracks identified on the exterior were found along the south and east perimeter foundation. We note that the perimeter foundation cracks have not been previously repaired or infilled as shown in Photo Set 3. However, the post-earthquake scopes allowed for 2.8m<sup>2</sup> of perimeter foundation plaster repairs.

- Externally, NZCSE has observed several cracks to the perimeter foundation of 427 Armagh Street along the southeast and eastern elevation coinciding with the floor falling from south to north along the eastern elevation.

Photo 3B – Foundation crack at vent along the east elevation.

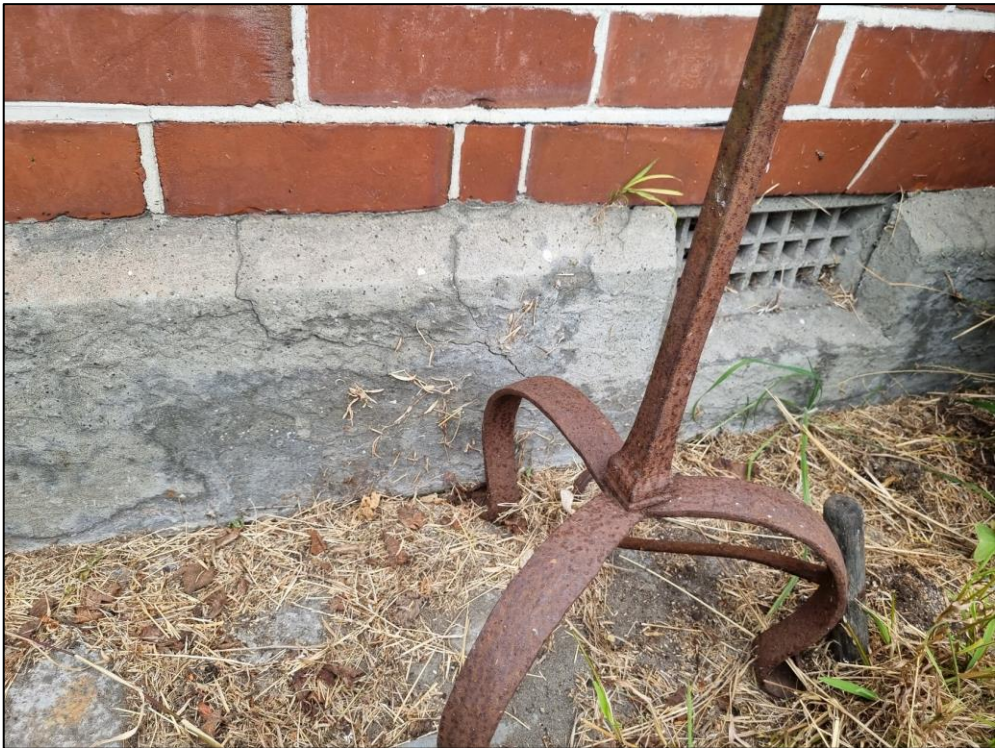
Photo 3C – Plaster and foundation cracks along the north elevation

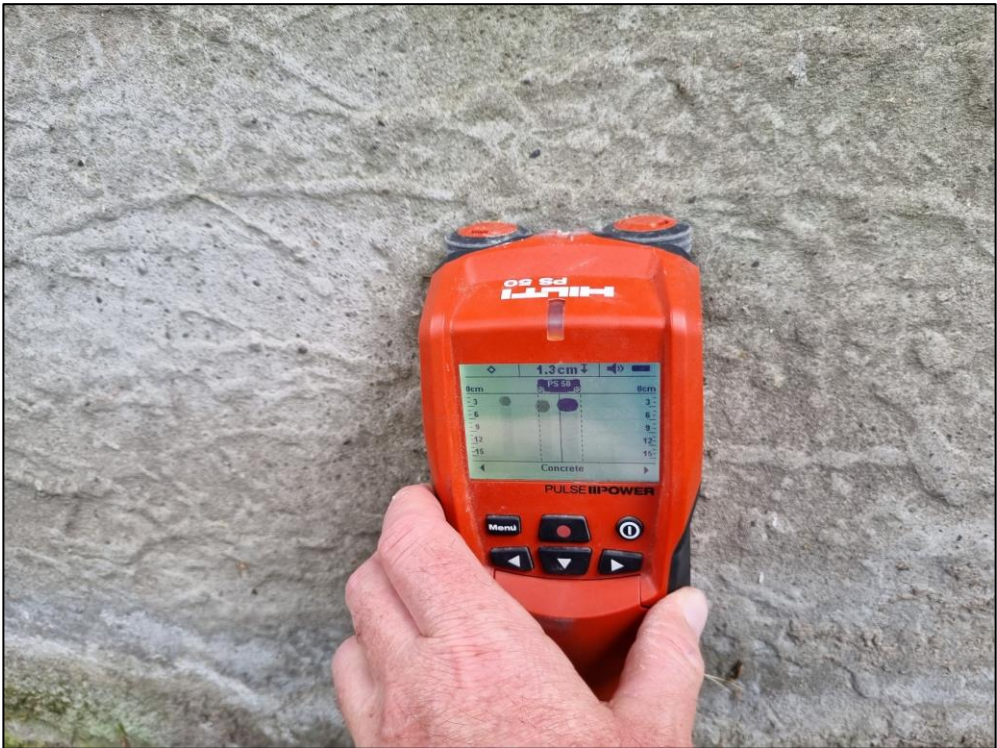
- The perimeter foundation was scanned for reinforcing using a Hilti PS50 Multidetector which did not confirm the presence of steel reinforcing. Given the age of construction and absence of cracks, it is likely that the foundation does contain some reinforcing steel, refer to Photo 3D.

Photo 3D – No reinforcing was detected in the perimeter foundation wall.

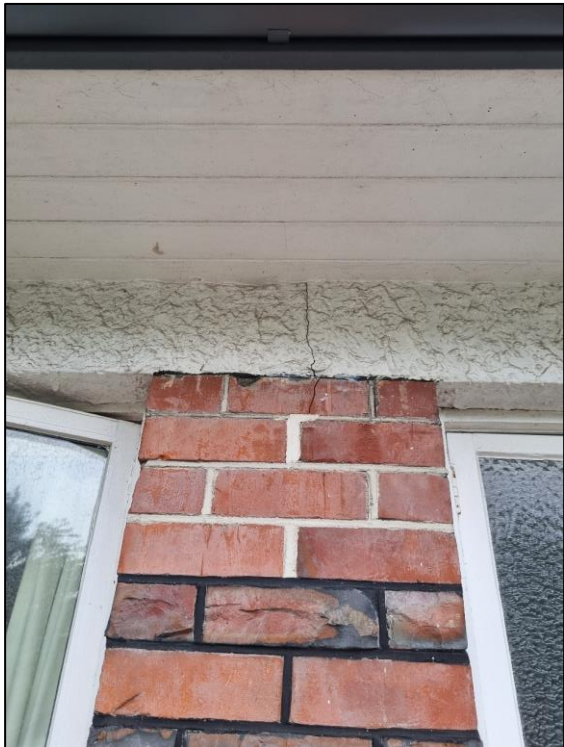
Photo 3E – Separation of the concrete beam above the cladding panel and cracking through the top brick. New mortar suggest recent cladding settlement cracks repairs along the east elevation.

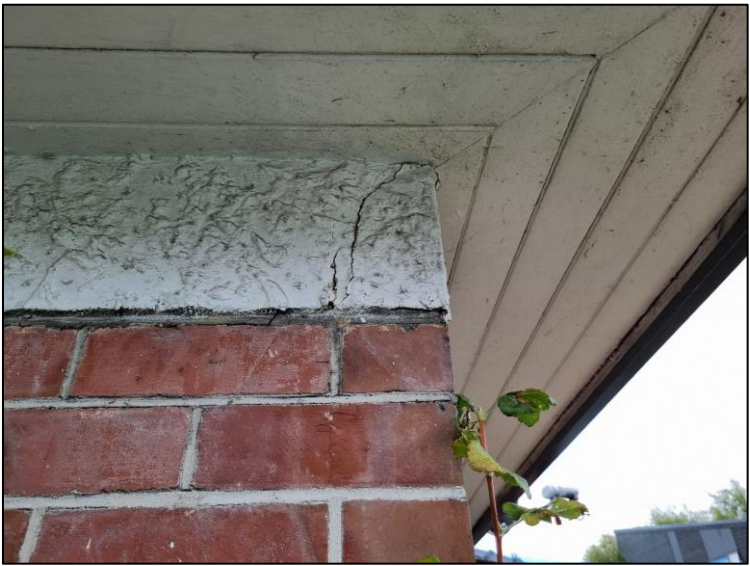
Photo 3F –Separation at the corner joints of the precast concrete beam above the veneer panels at the exterior north east corner of the kitchen.

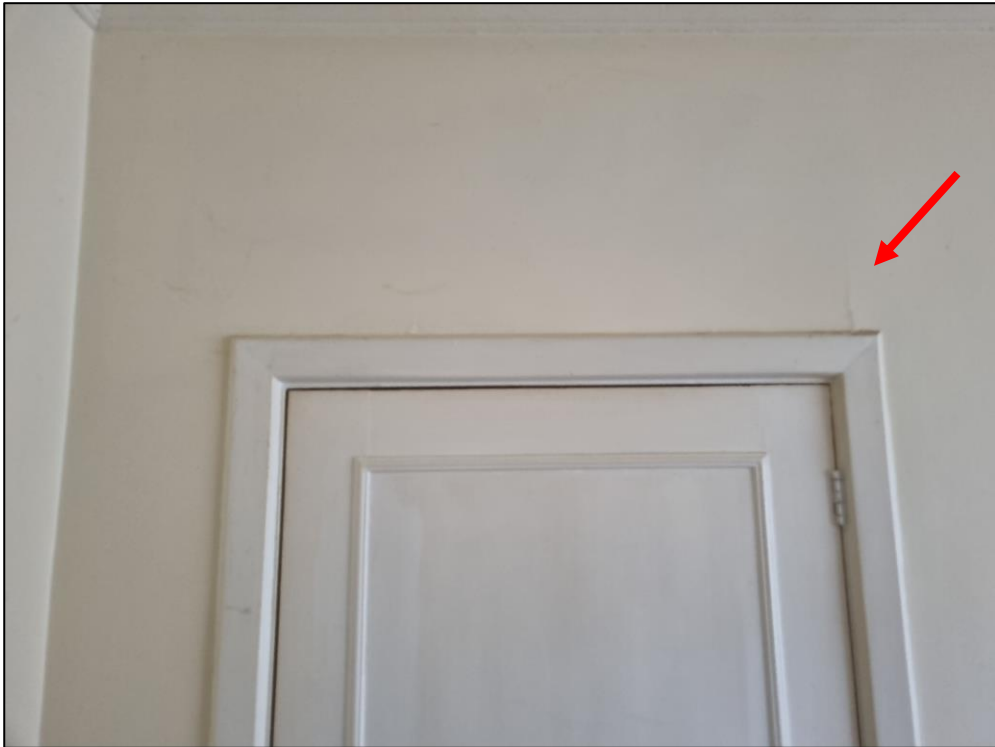
- No damage to the functionality of the windows or doors in this room was recorded in the post-earthquake scopes. We noted the presence of lining creasing damage above the door which is indicative of differential settlement across the door opening (photo 4E) The floors across the door opening vary by 10mm on the inside of the room.

- Minor wall lining cracks was identified above the lounge door indicating some settlement has occurred in this area.
  - The partition wall was scanned using a rebar scanner and reinforcing was detected.

Photo 4E –Minor wall lining damage above the lounge door indication of foundation settlement and racking of the internal wall framing.

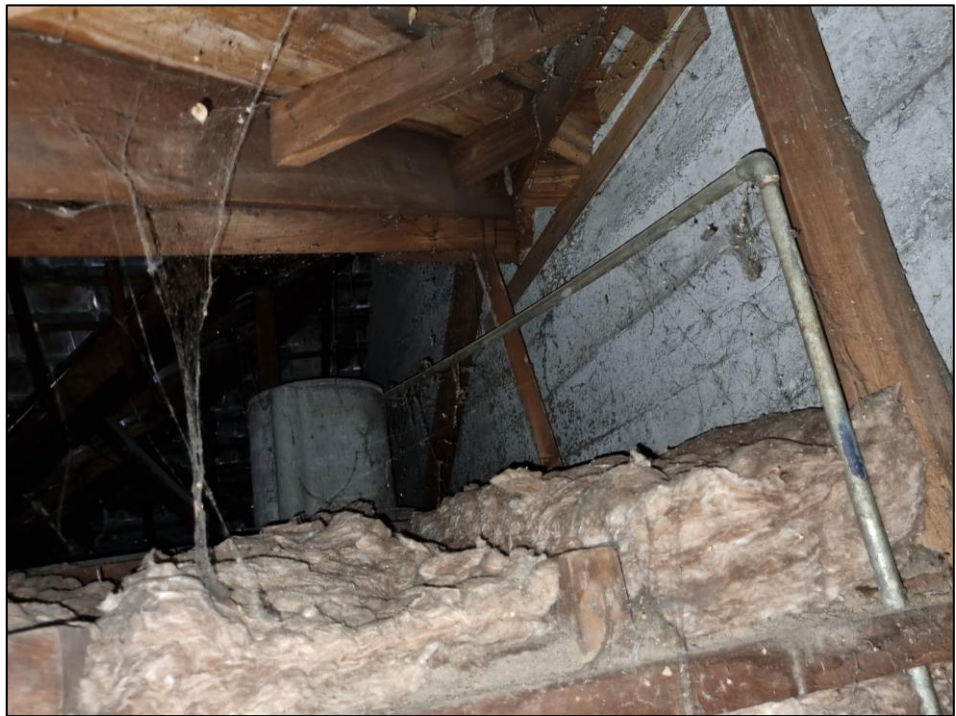
Photo 6A – Unrestrained Concrete water tank in the roof space .

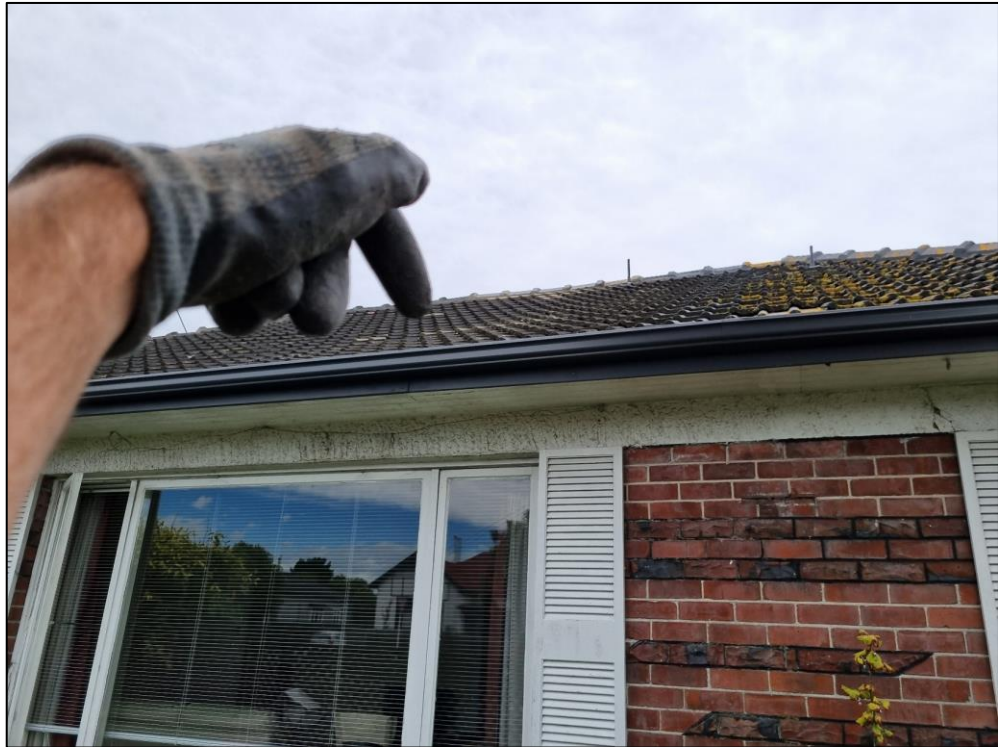
Photo 6C – Roof plane sagging towards the middle due to inadequate roof framing underpurlin support .

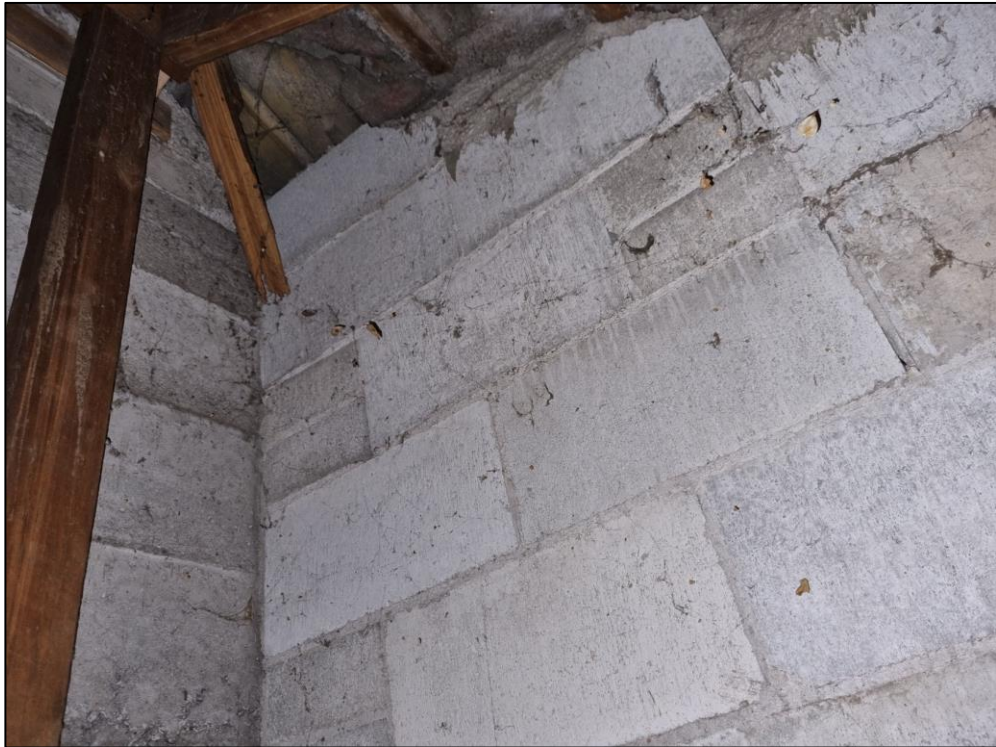
Photo 6D – Newer masonry block wall ( Partition wall extension) above the Laundry extending to the rooftiles constructed circa 1987.

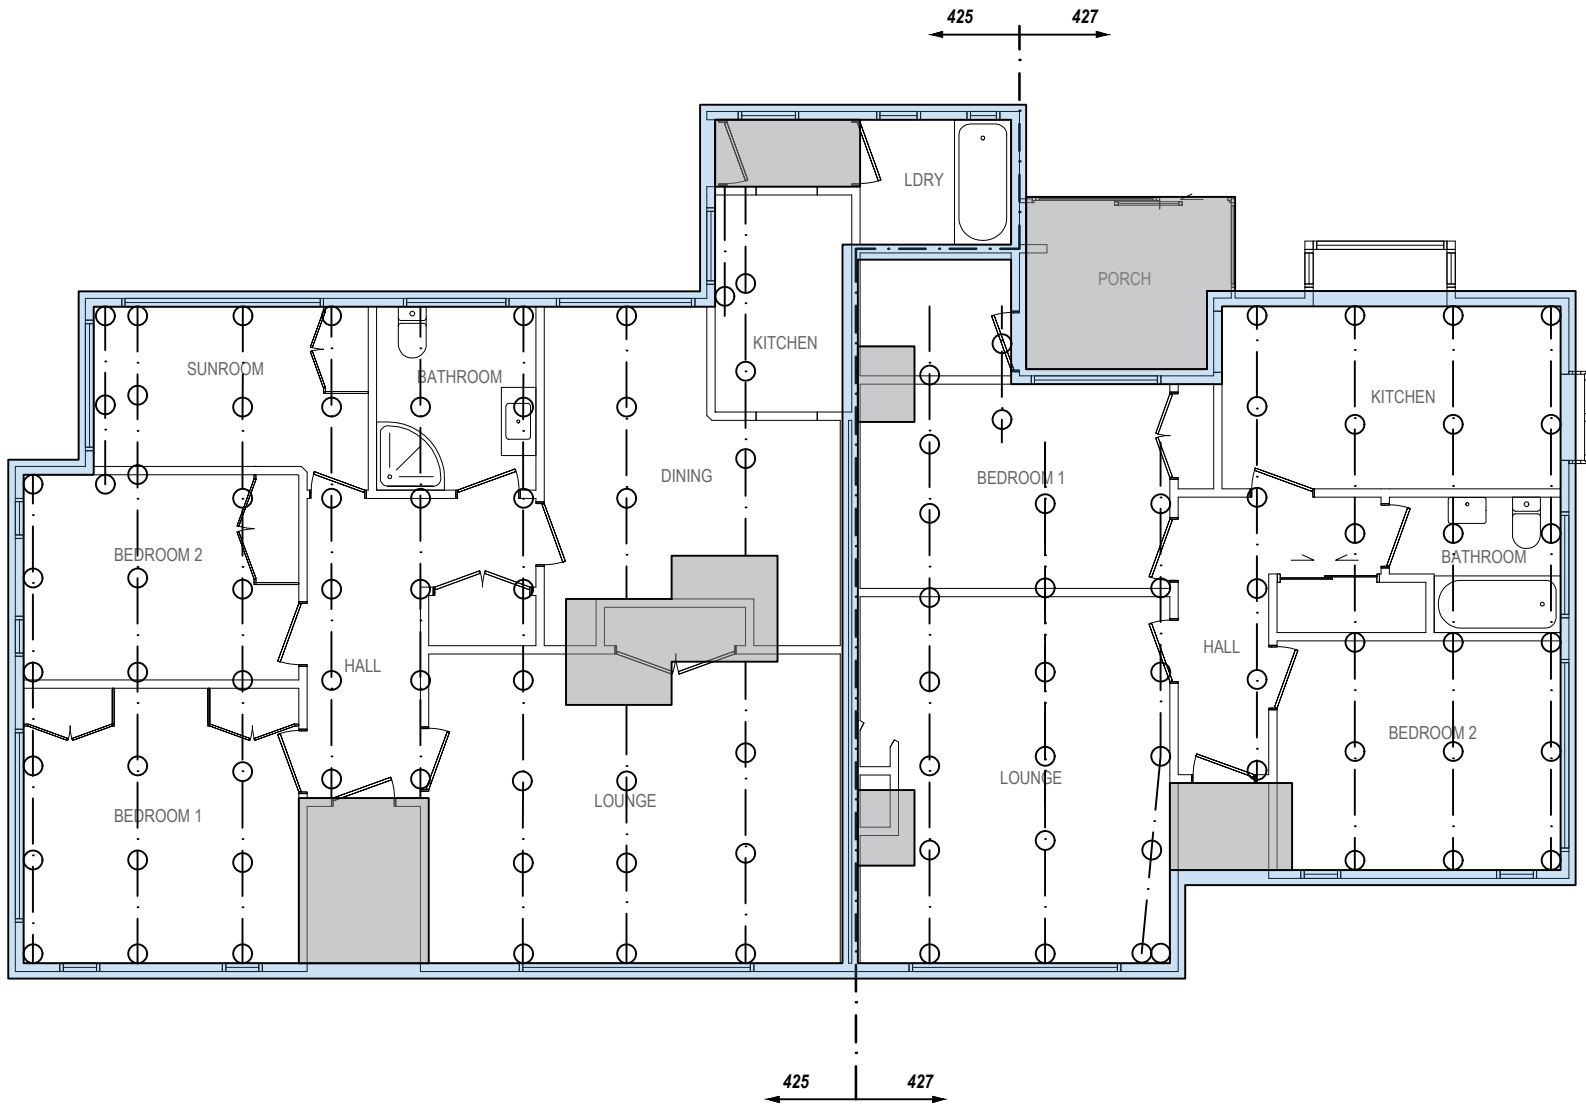
**DWELLING FOUNDATION PLAN**  
SCALE 1:100

- Based upon the contents of the *Cavity Critter Underfloor Inspection Report*, the following observations have been made (Refer to SK4 Foundation Plan):

- 427 Armagh Street is supported by a perimeter concrete foundation with a suspended timber floor supported on 47x precast concrete piles. Most of the internal piles have a damp-proof membrane (DPM) of varying thicknesses and have no structural fixings between the pile and bearer. None of the piles appear to have been packed and none of the bearers appear to have been notched in the past.

- The bearer ends are supported on the perimeter foundation wall.
  - The subfloor report shows areas of broken concrete roof tiles spread across the subfloor between the piles, likely remaining from the when the multi-unit building was constructed.

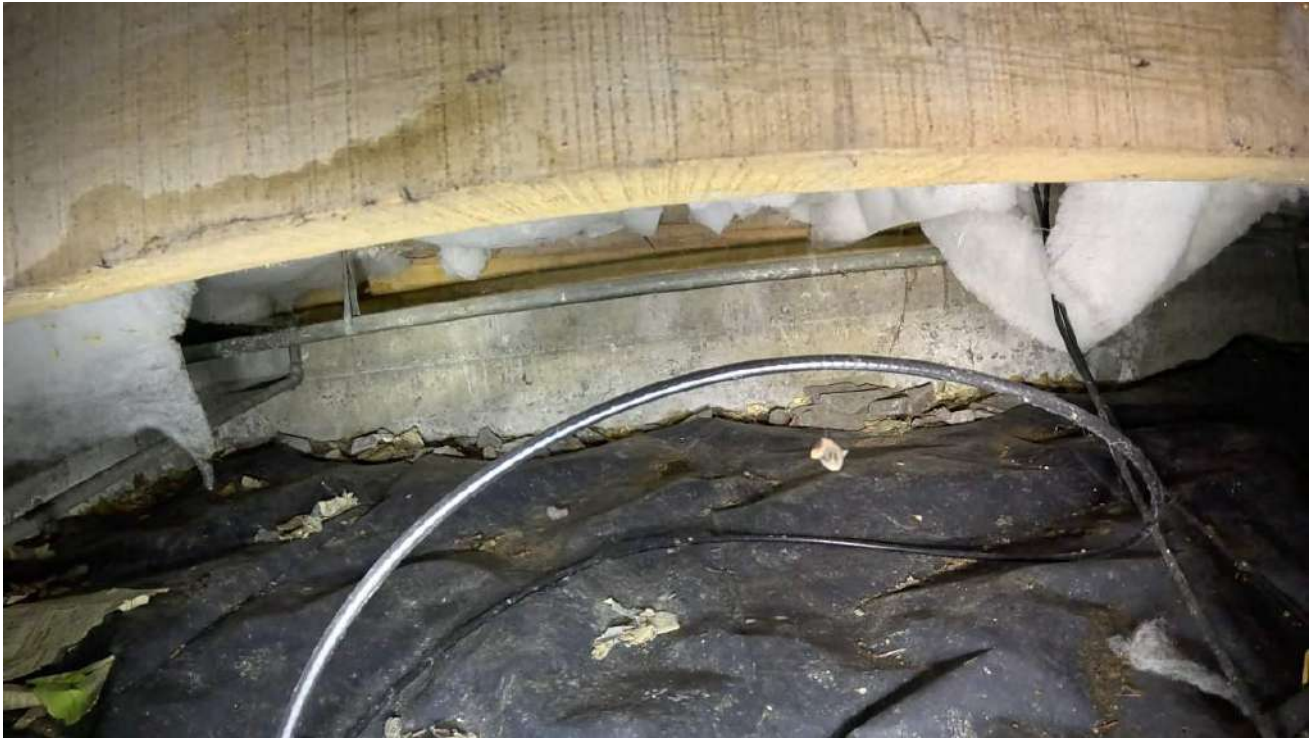
6: The home has precast concrete piles. These maybe concreted into the ground but the polythene obscures this. They are not connected to the bearers. None appear damaged or to have moved from their original positions although this does not preclude changes in height.

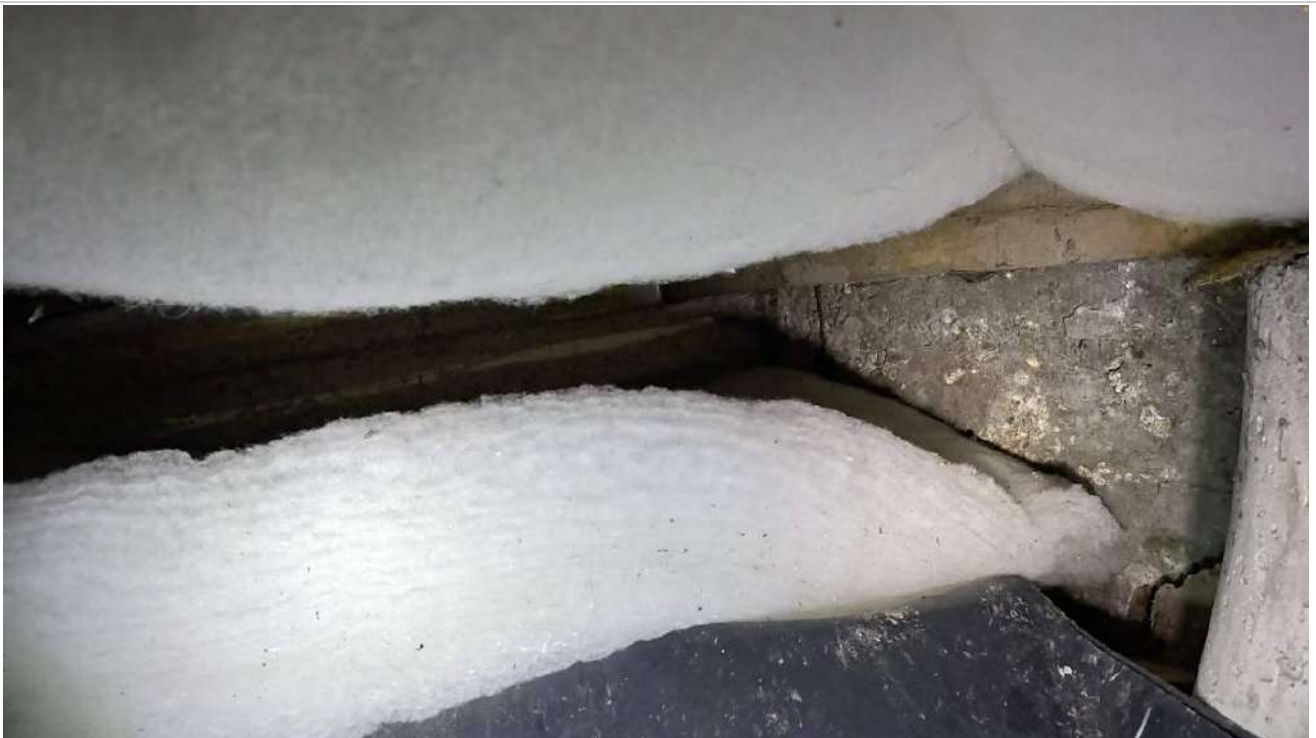
13: Precast concrete pile with no connection. It is important to note that rodents have been using the insulation for nesting. The yellow marks represent their urine, and they have also caused many of the batts to fall down.

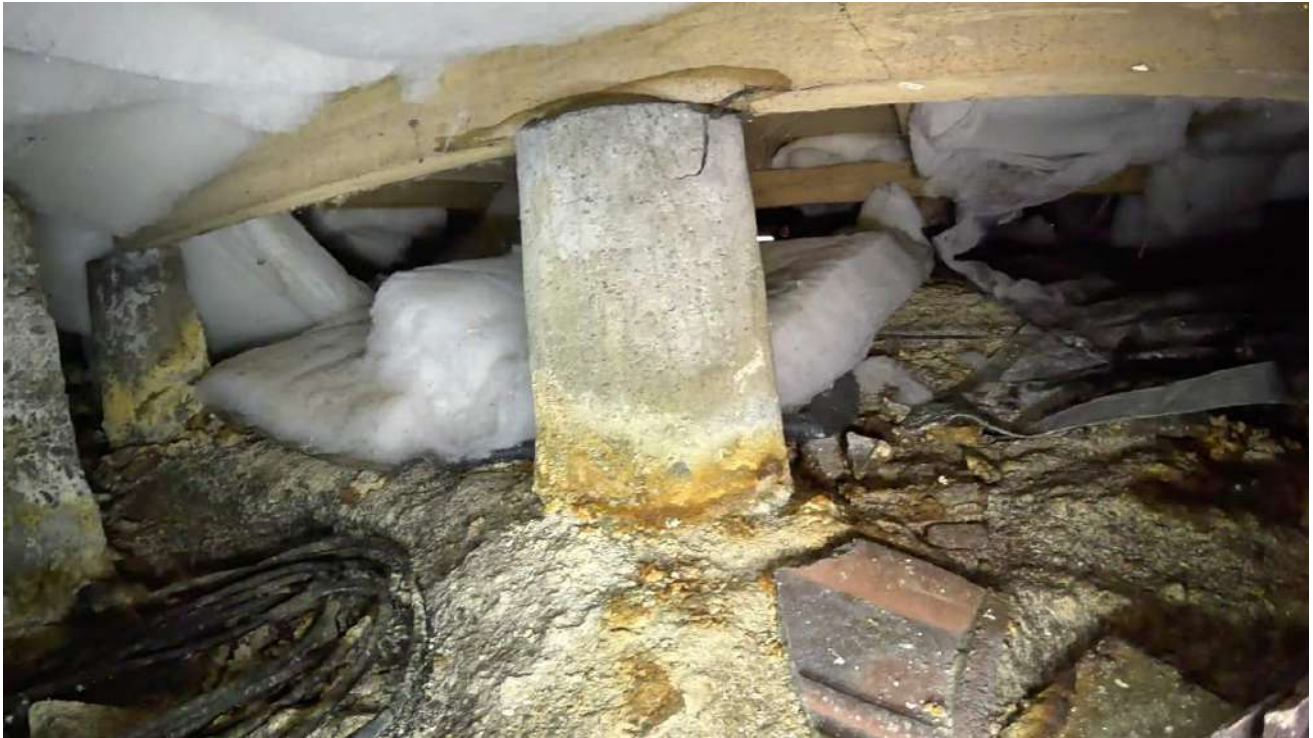
32: There are some non-compliant issues with the wiring seen in this home. They could also be a significant hazard to anybody operating under the floor. This relates specifically to unclipped wires. An electrical inspector could be consulted regarding this. The communication cables have also not been laid in a compliant manner and would easily be damaged by people accessing the subfloor.

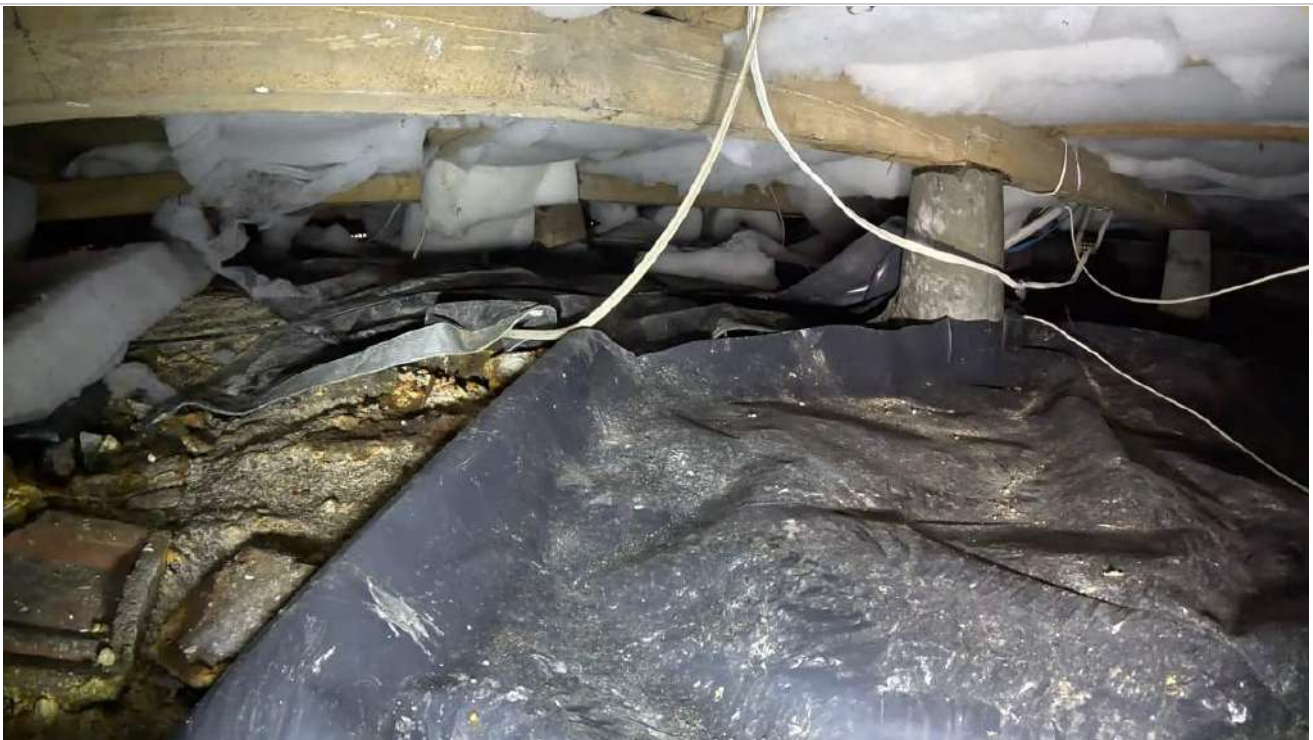
33: Precast concrete pile with no connection. Here we see a heat pump drain. It is discharging to ground but should be vented to the outside.

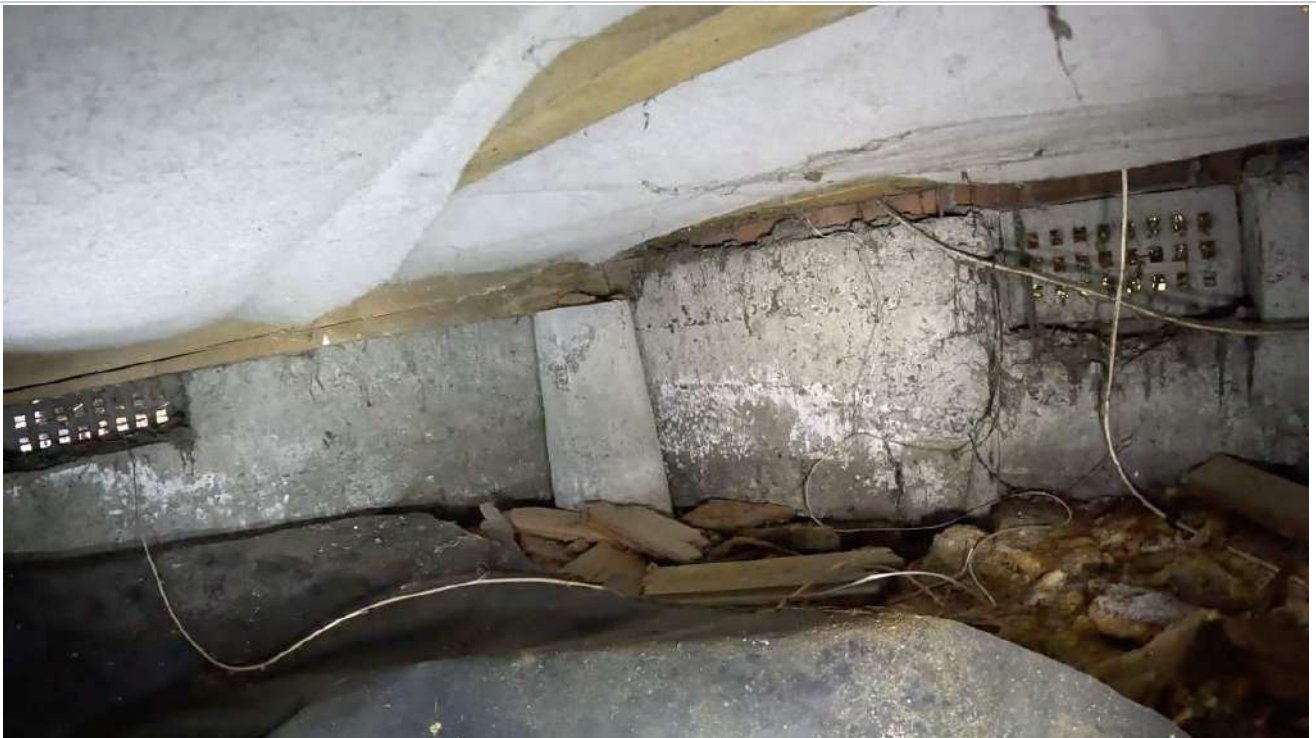
43: Precast concrete pile with no connection and the pile leans to the right.

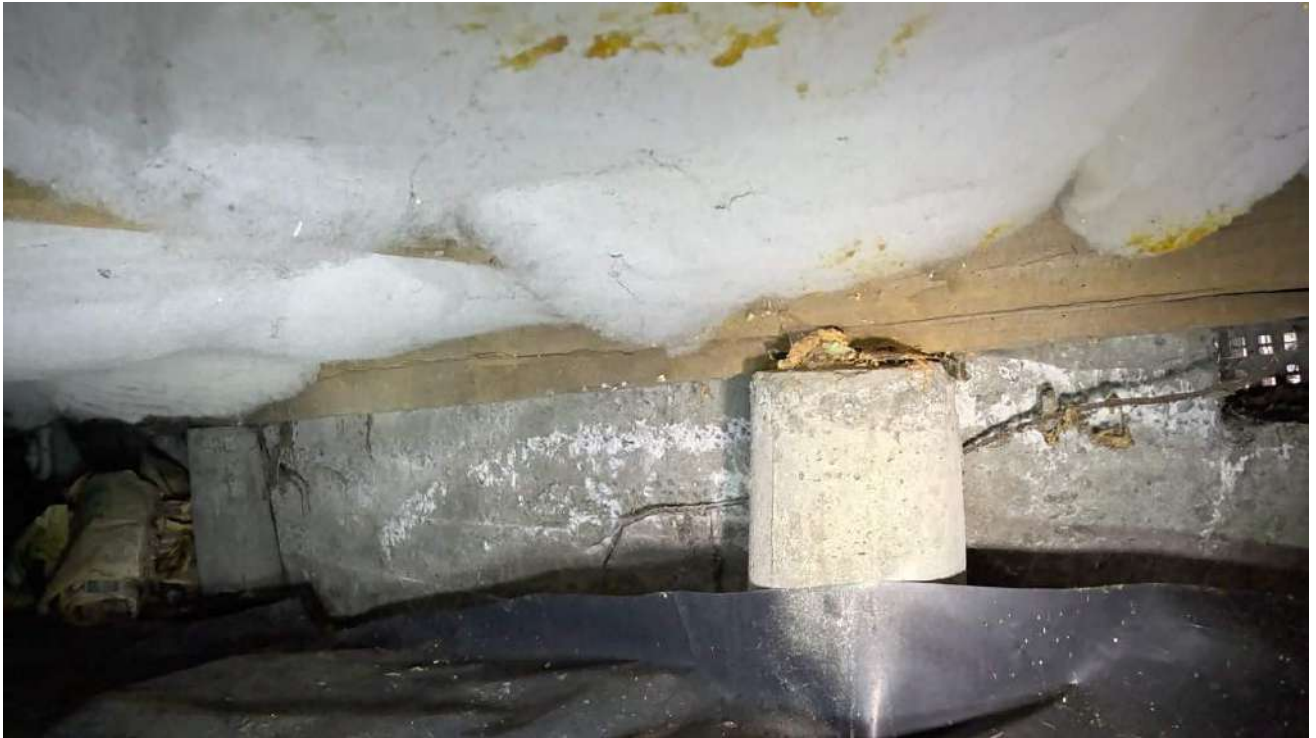
44: The ground level appears to drop in this area.

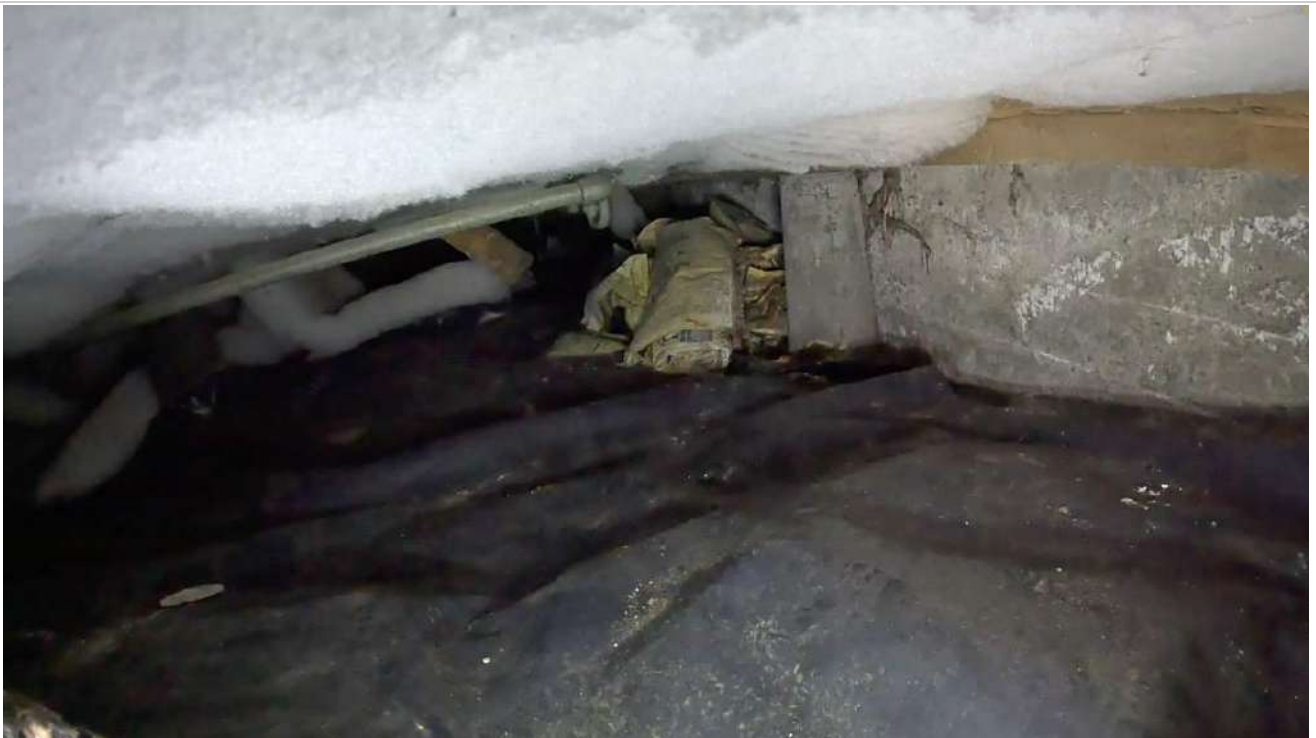
45: Precast concrete pile with no connection and the pile leans to the right.
