# Cavity Critter

## Under floor Inspections

**Report prepared for: NZCSE**

**Property address: 427 Armagh Street, Linwood**

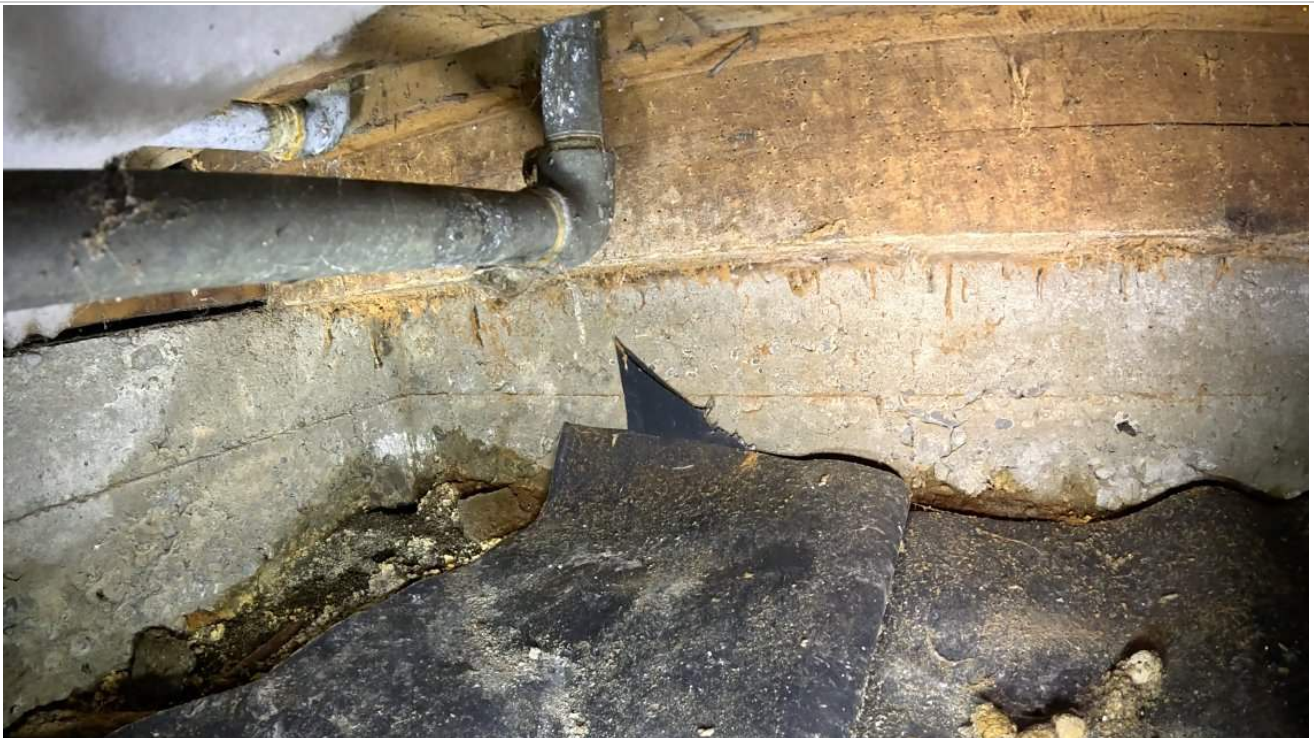
2: The foundations are average quality type “B” foundations. There is a lack of fine sand and cement along with spider webs in some areas, making it hard to discern finer cracks, if they exist. There is also a high level of borer in some of the subfloor timber, as seen here.

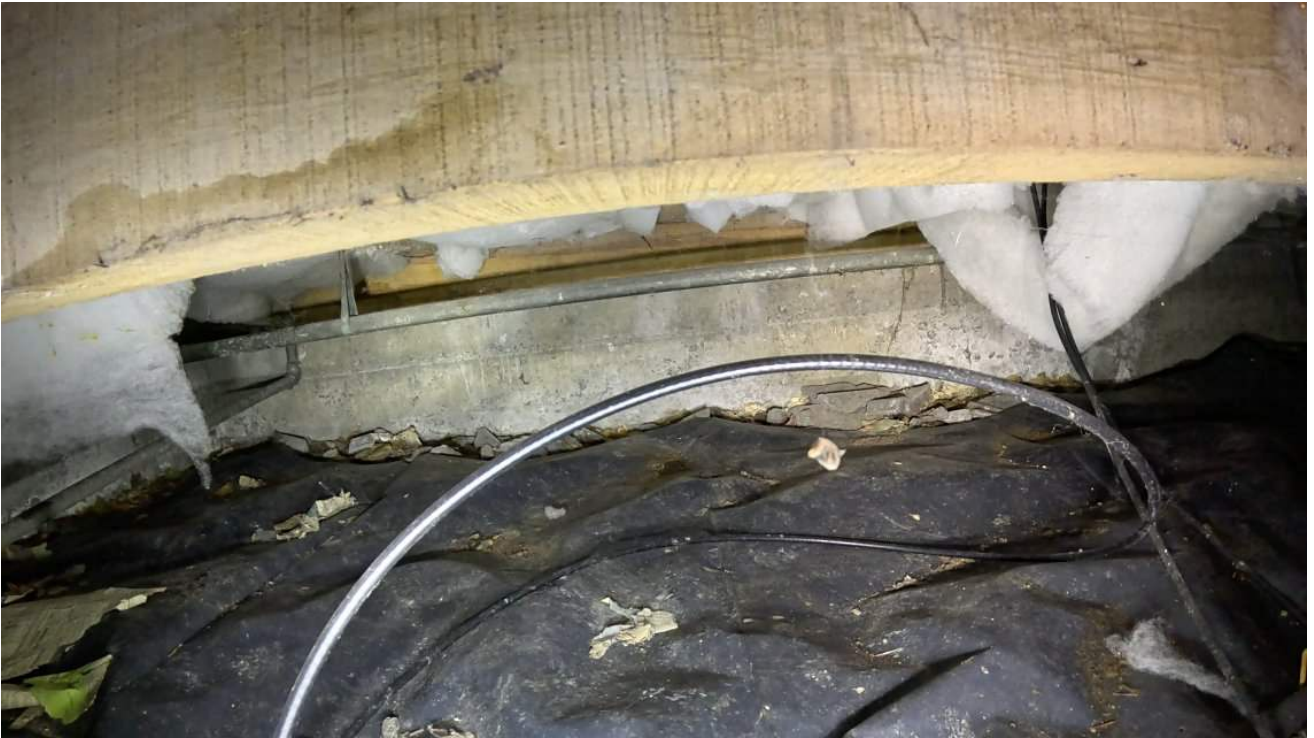
5: There are a lot of services and batts that have been pulled down that obstructed our access.

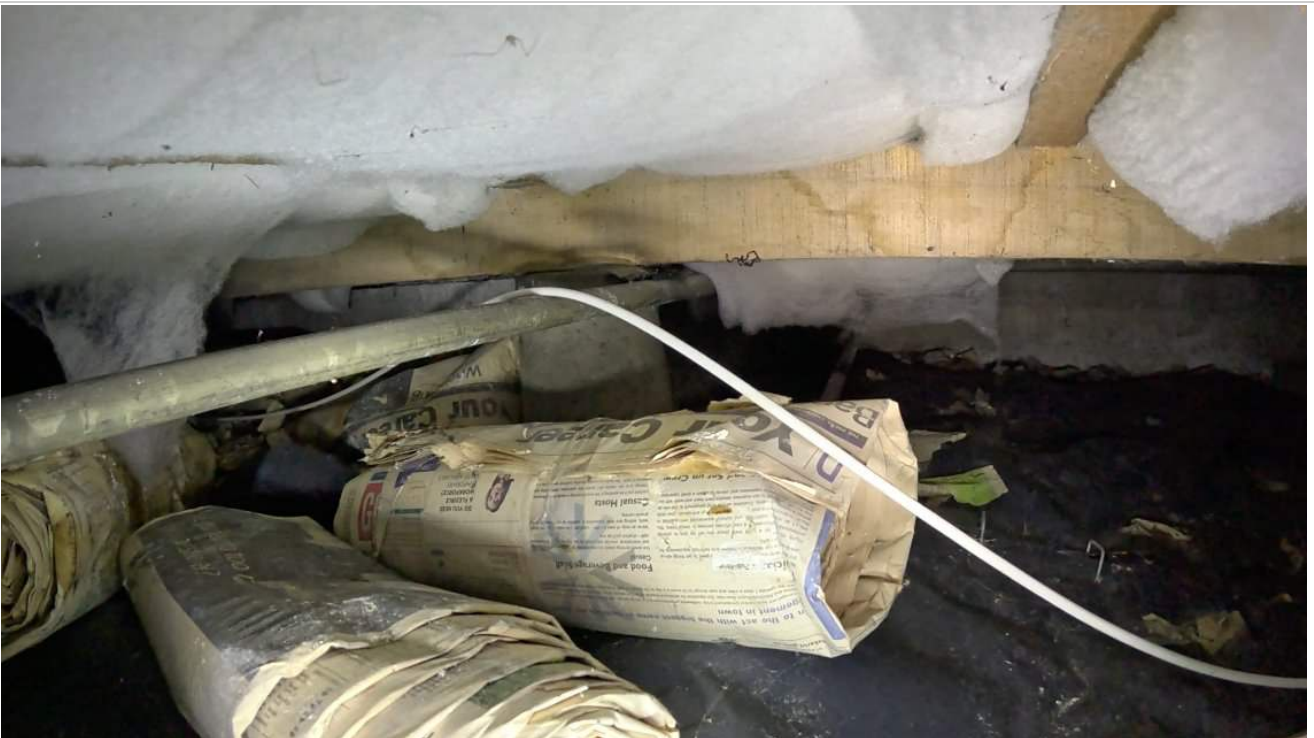
6: The home has precast concrete piles. These maybe concreted into the ground but the polythene obscures this. They are not connected to the bearers. None appear damaged or to have moved from their original positions although this does not preclude changes in height.

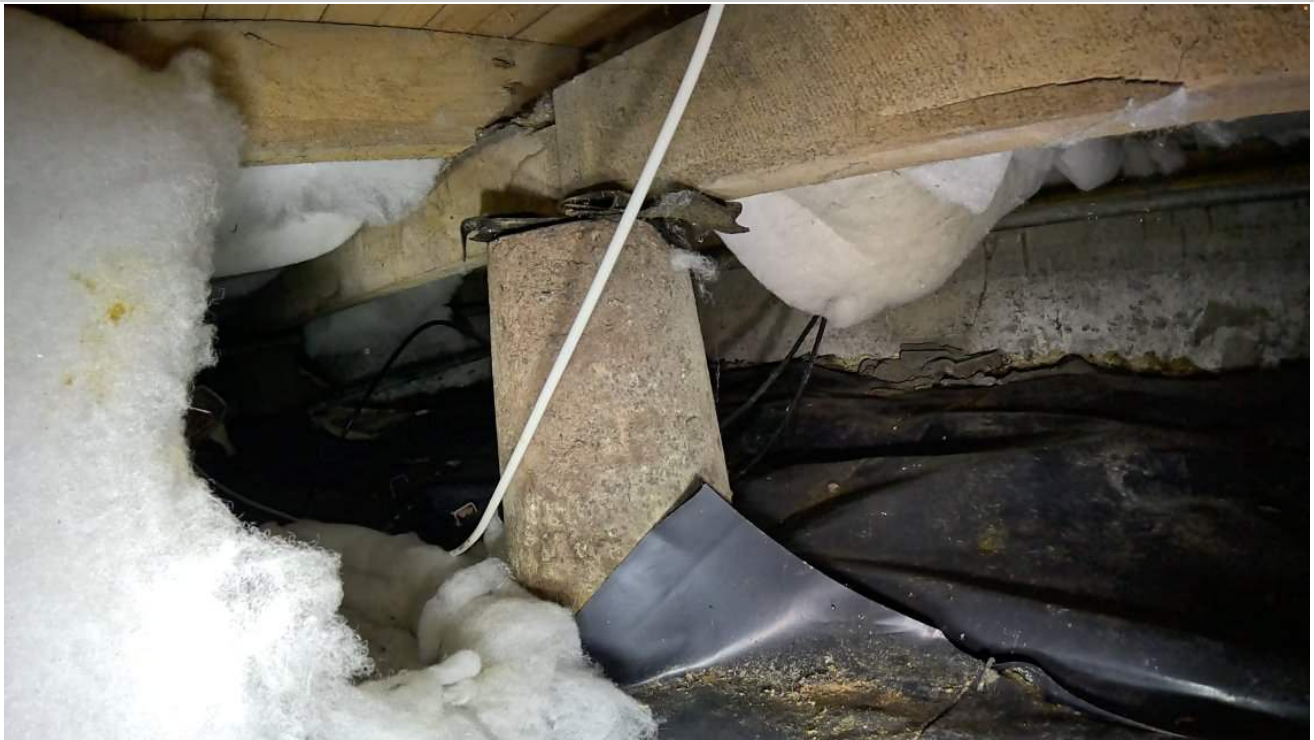
7: Precast concrete pile with no connection.

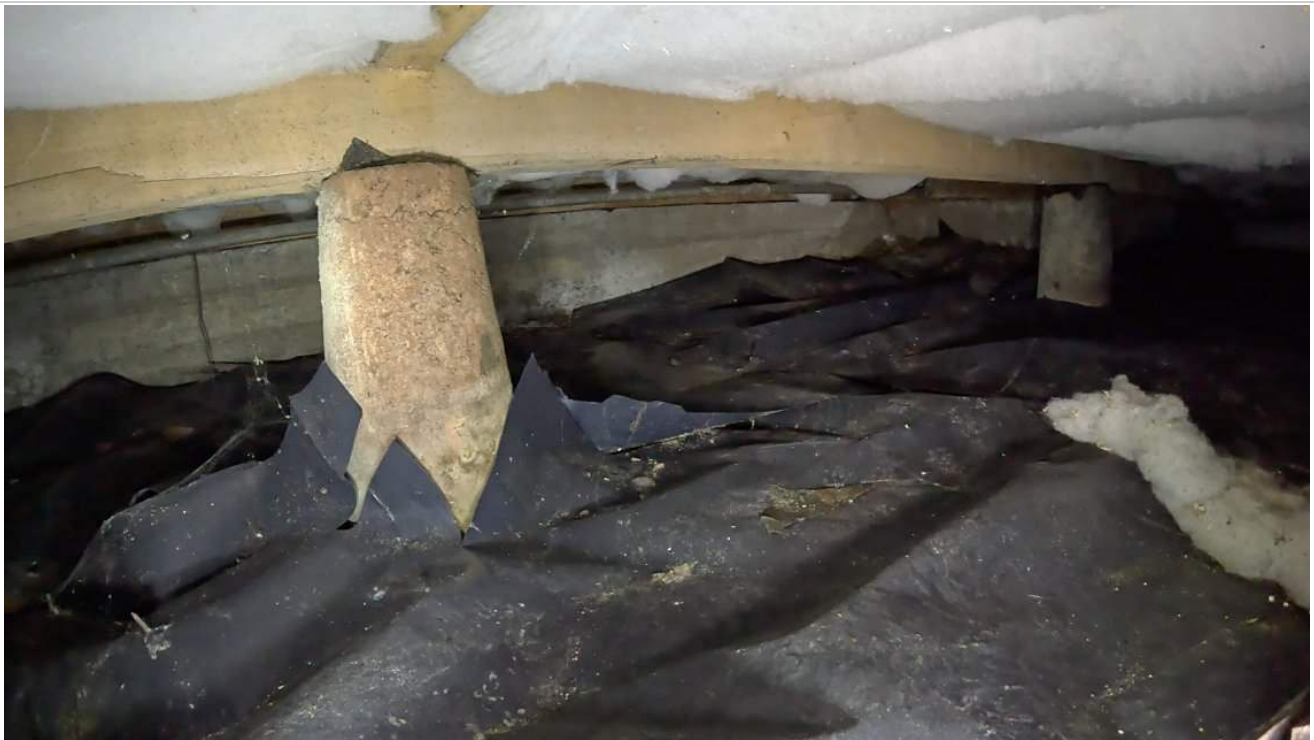
8: Precast concrete pile with no connection.

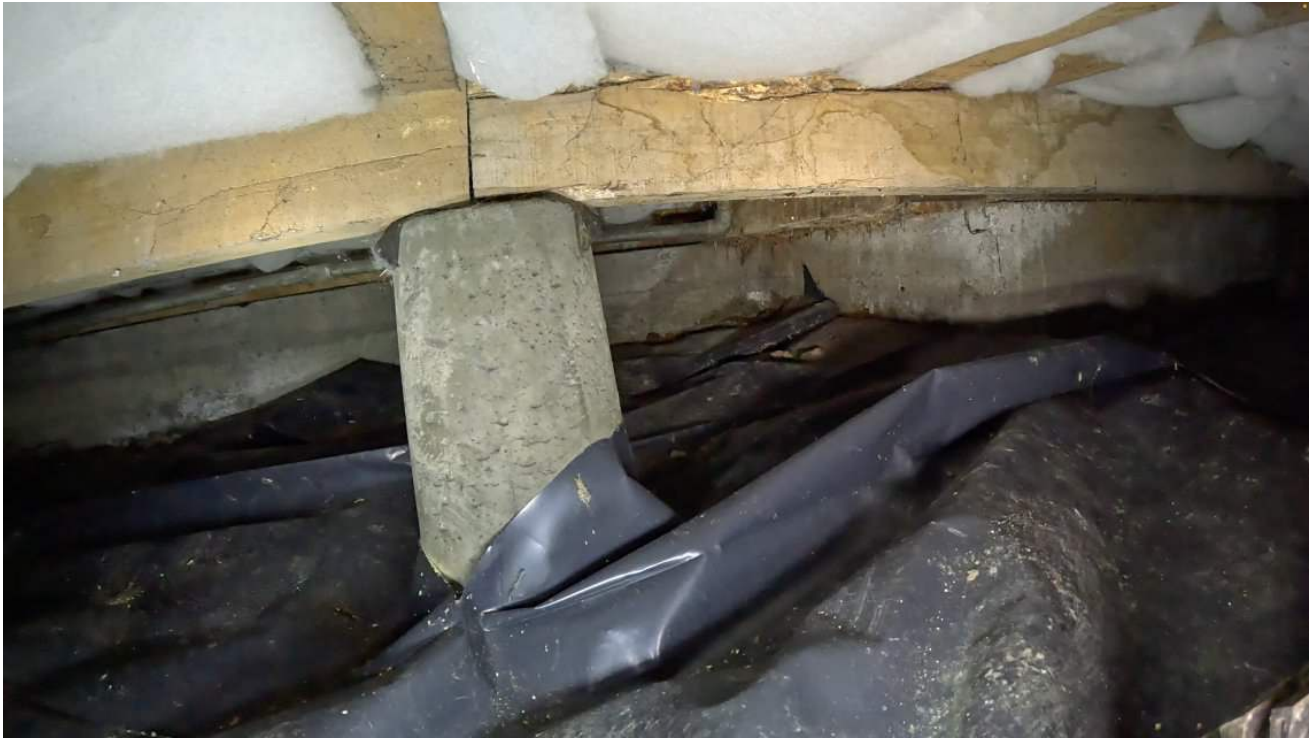
9: Precast concrete pile with no connection.

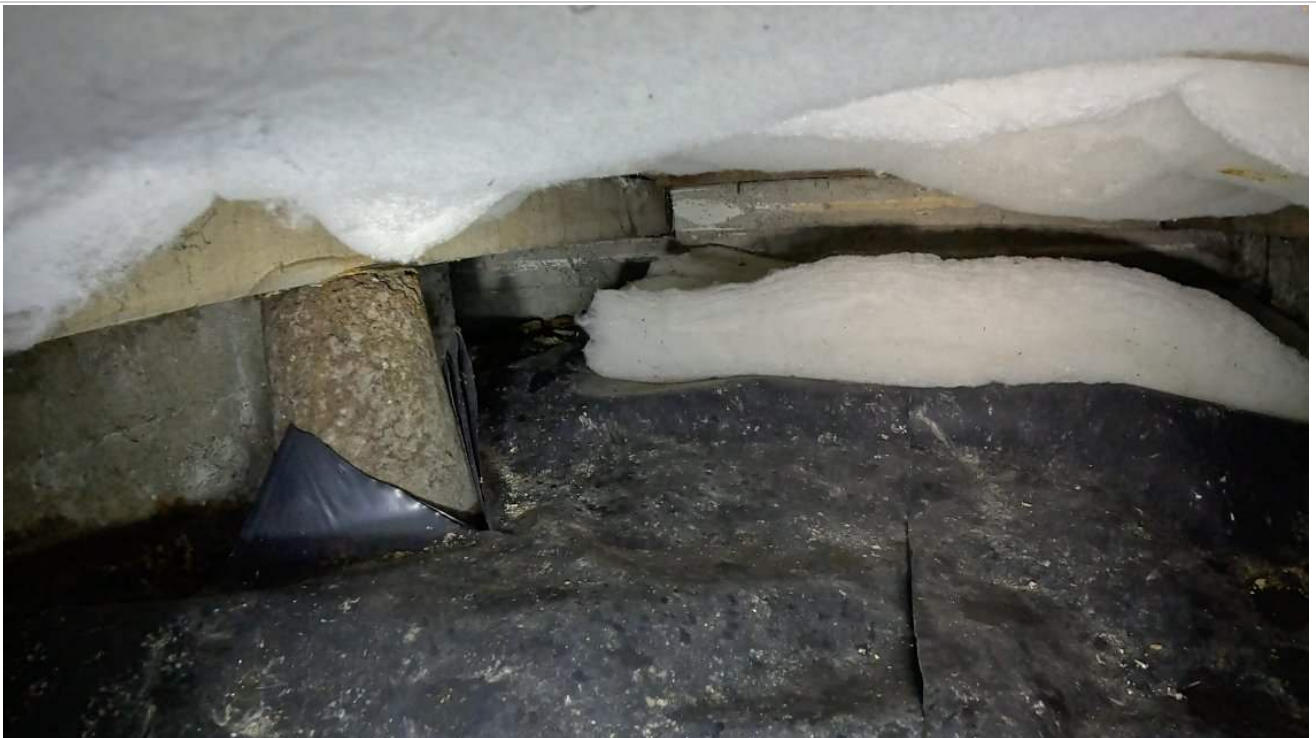
10: Precast concrete pile with no connection.

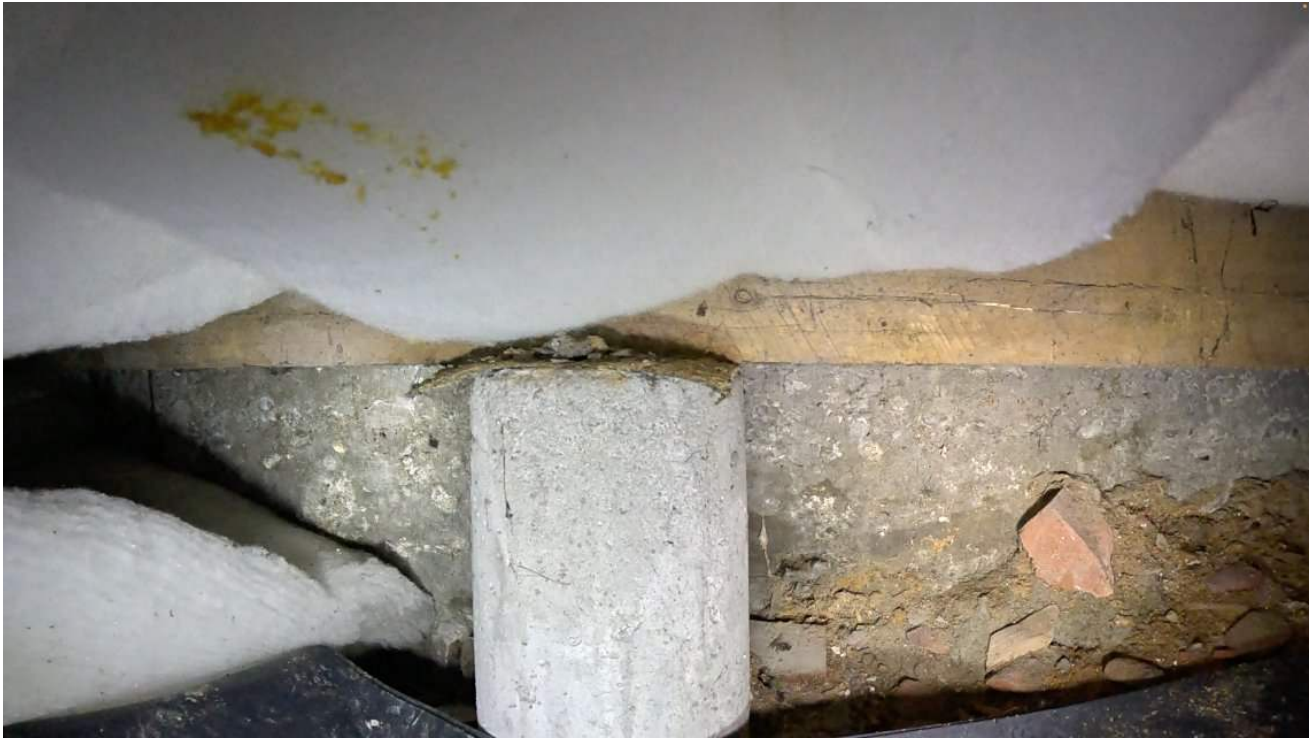
13: Precast concrete pile with no connection. It is important to note that rodents have been using the insulation for nesting. The yellow marks represent their urine, and they have also caused many of the batts to fall down.

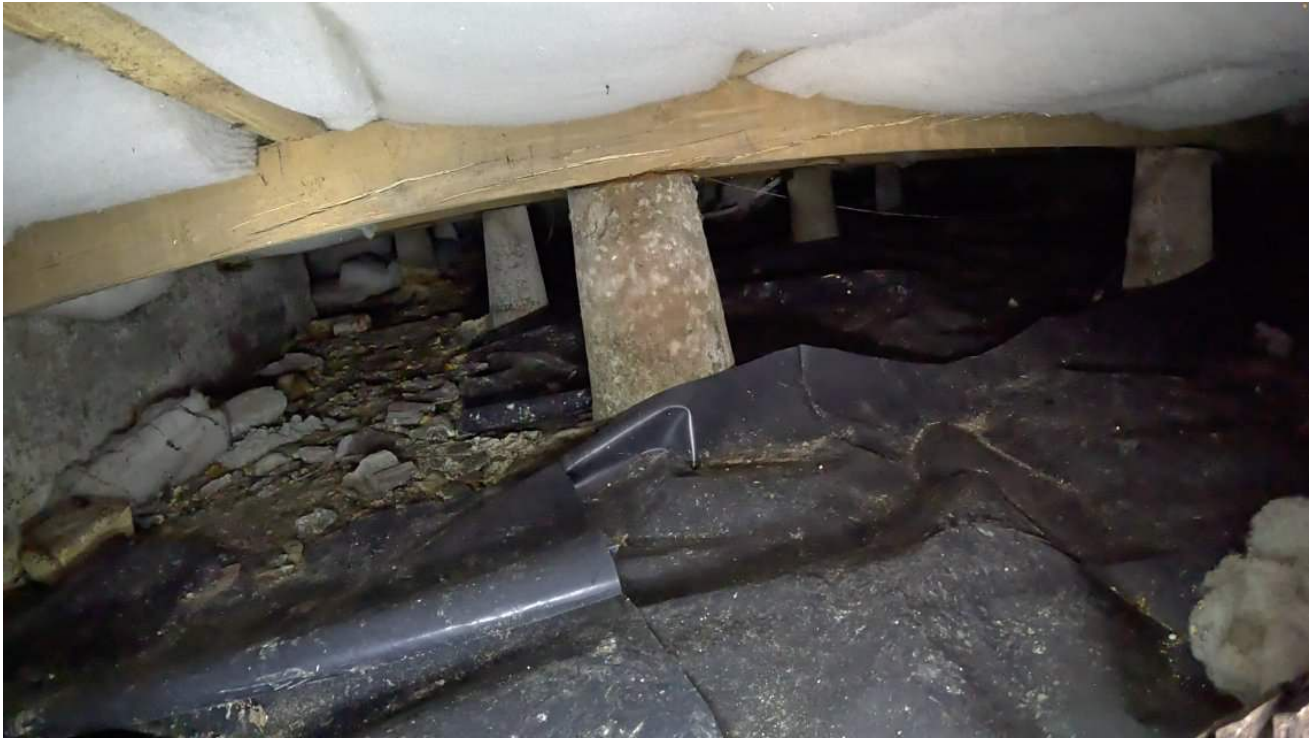
15: Precast concrete pile with no connection.

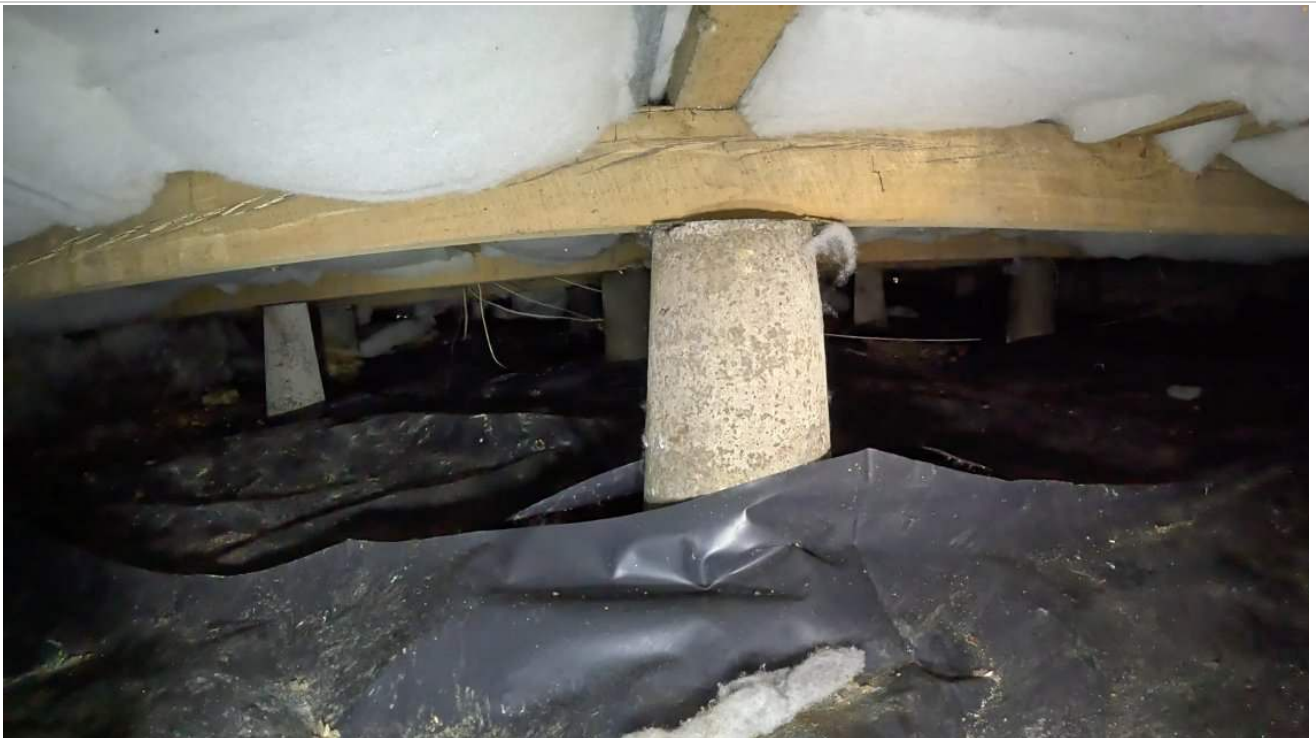
16: Precast concrete pile with no connection.

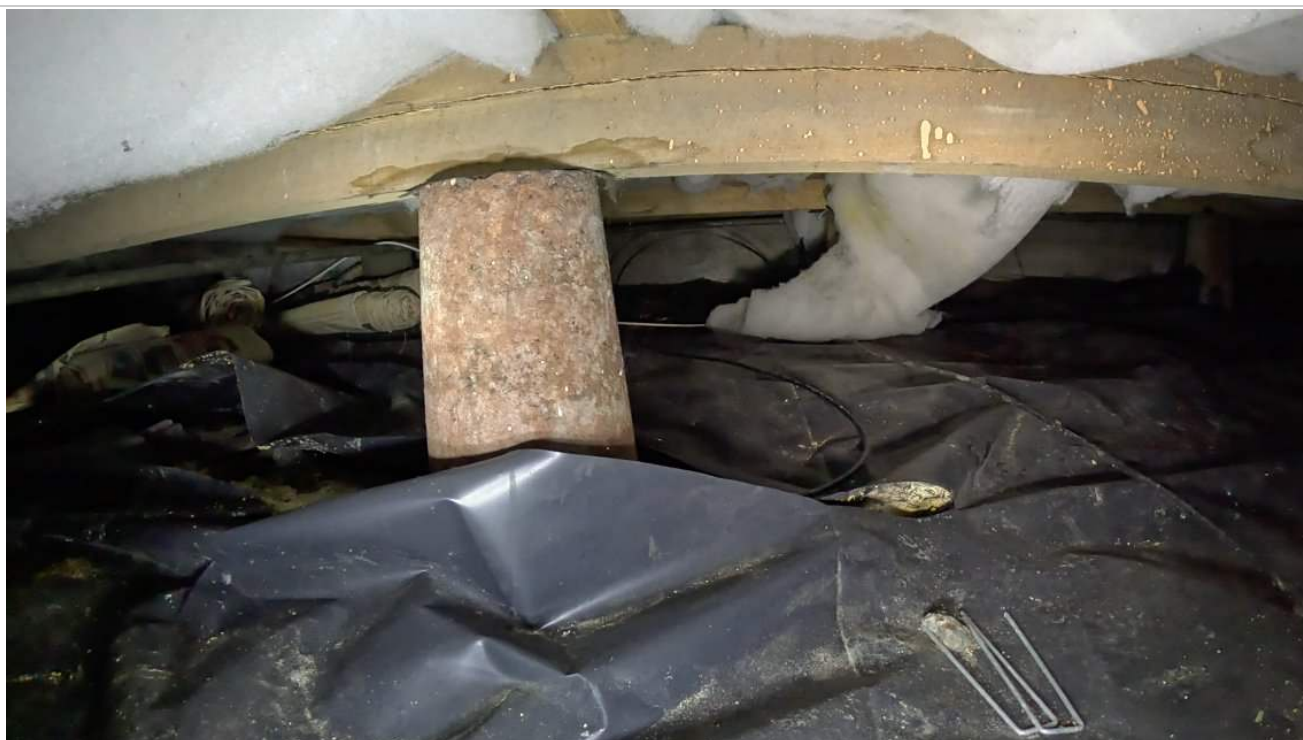
17: Precast concrete pile with no connection.

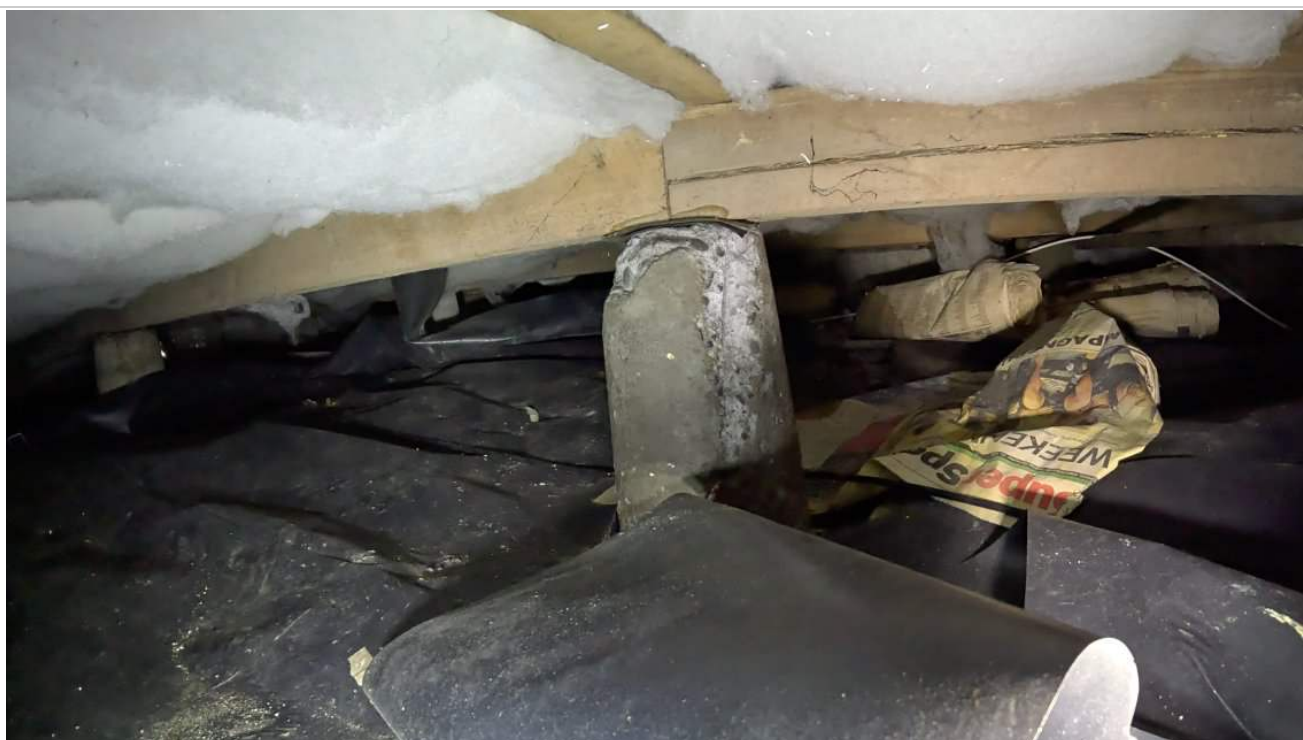
18: Precast concrete pile with no connection.

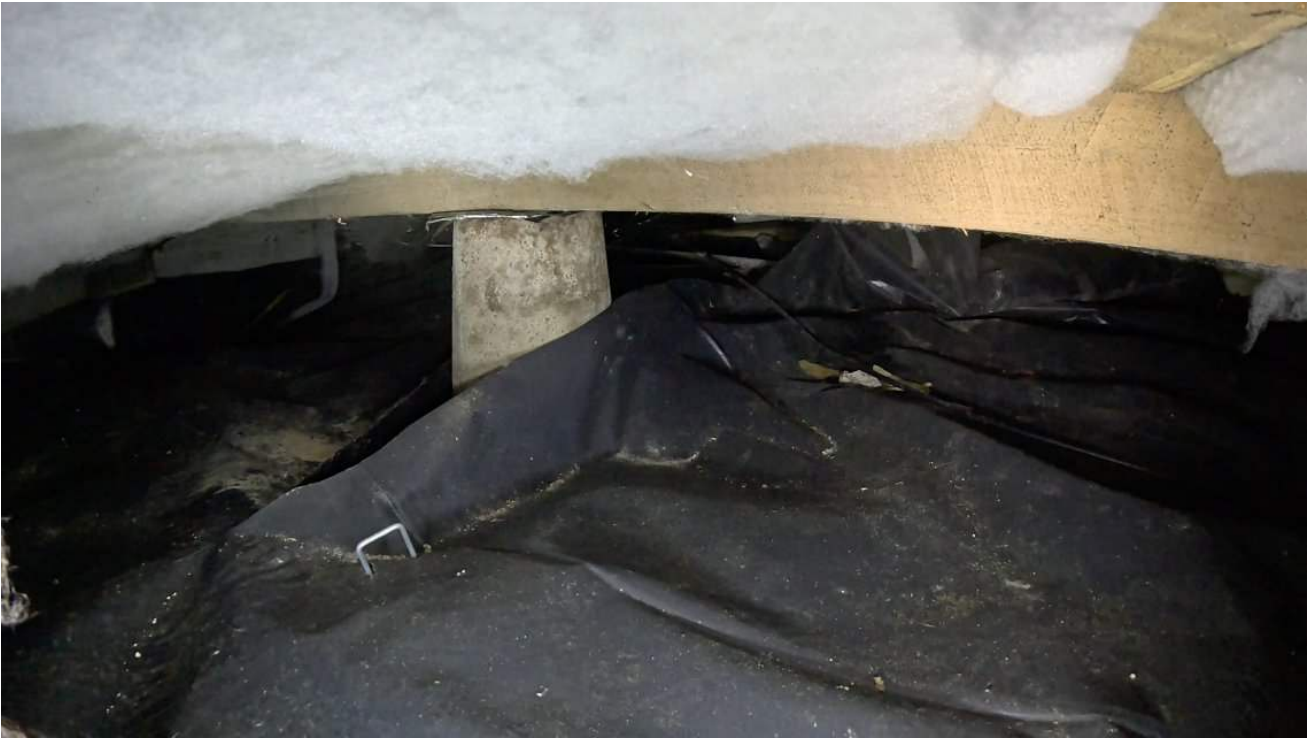
19: Precast concrete pile with no connection.

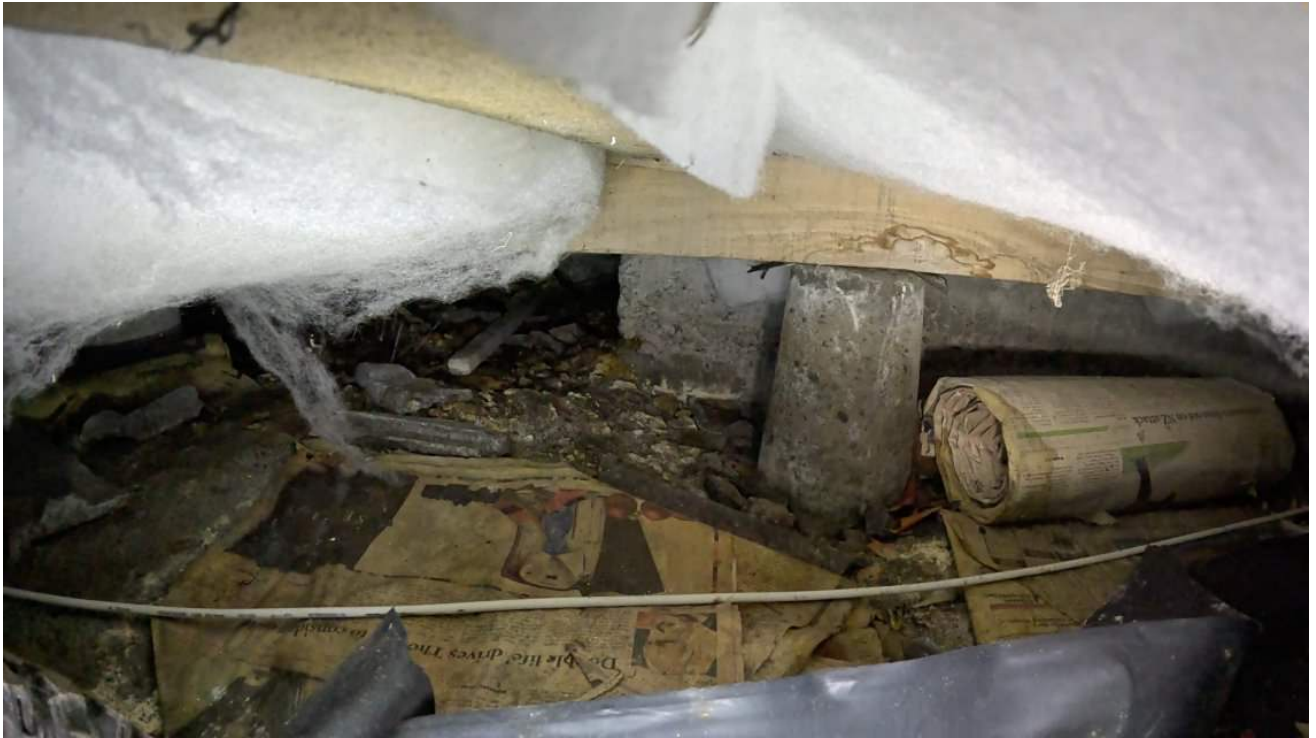
21: Precast concrete pile with no connection.

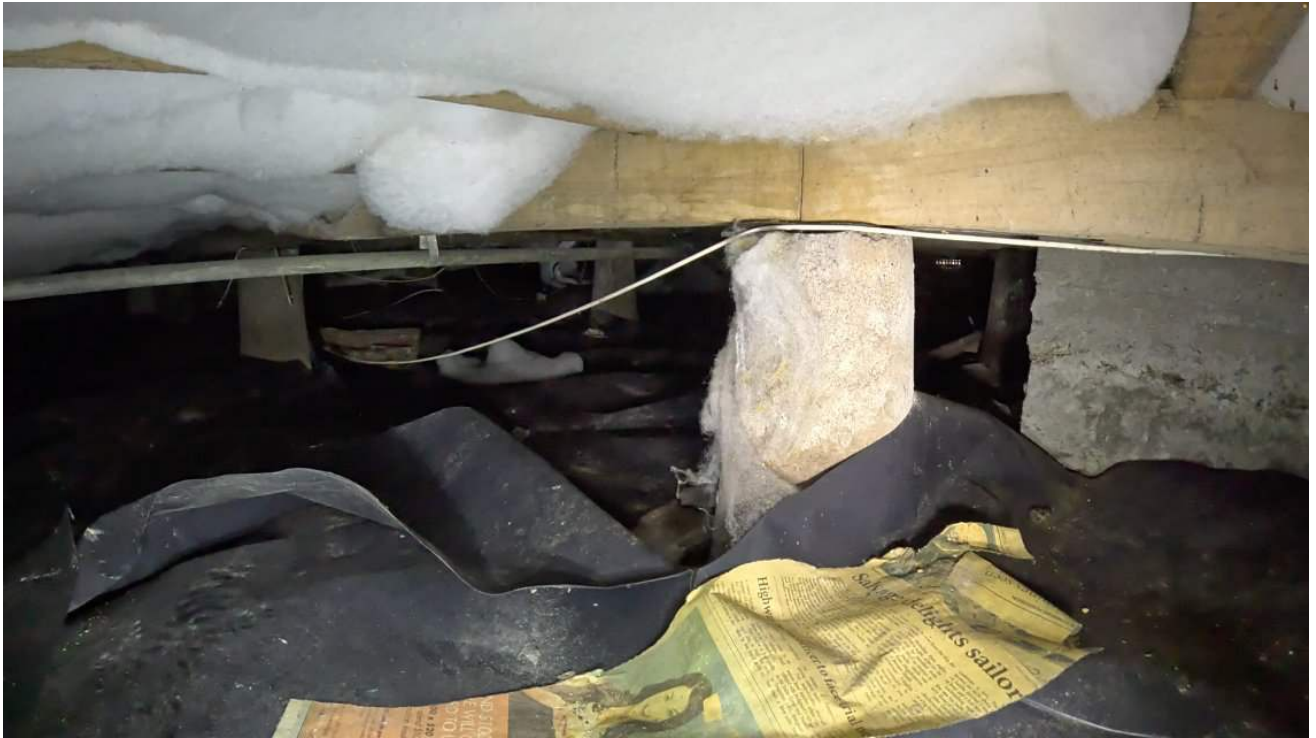
25: Precast concrete pile with no connection.

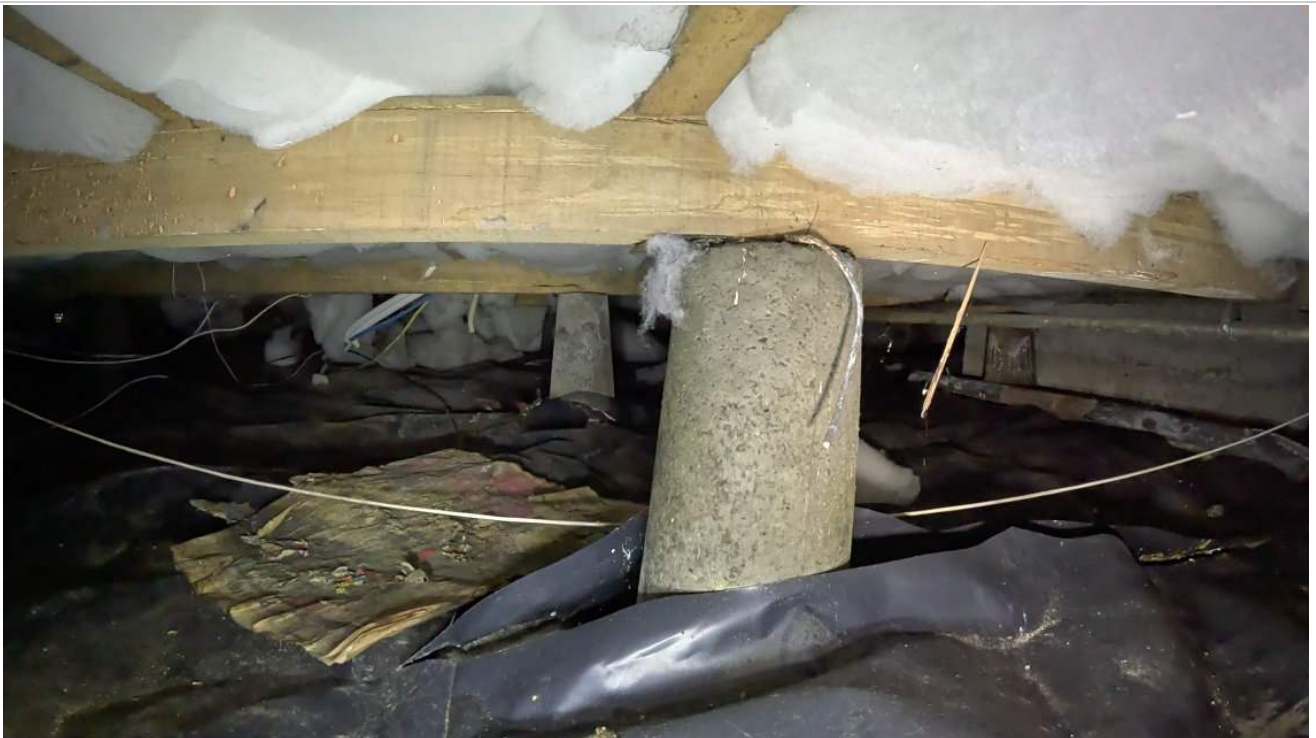
26: Precast concrete pile with no connection.

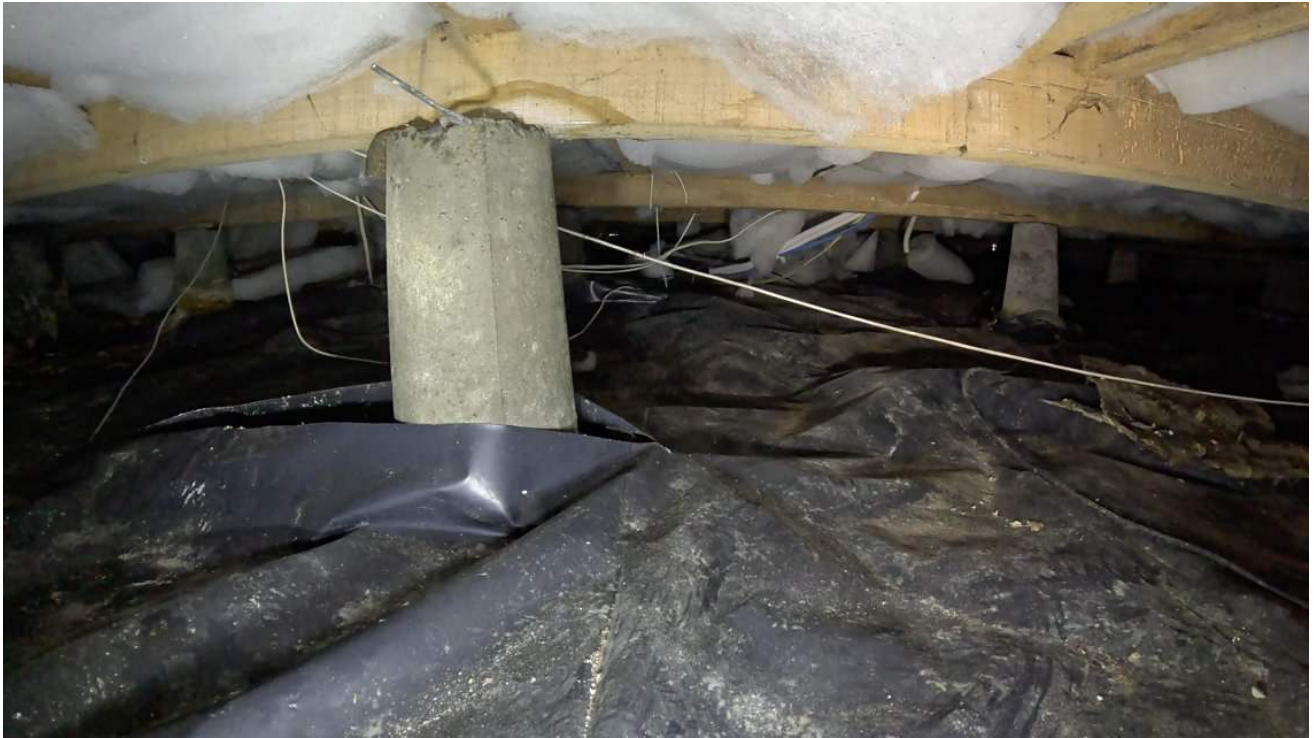
27: Precast concrete pile with no connection.

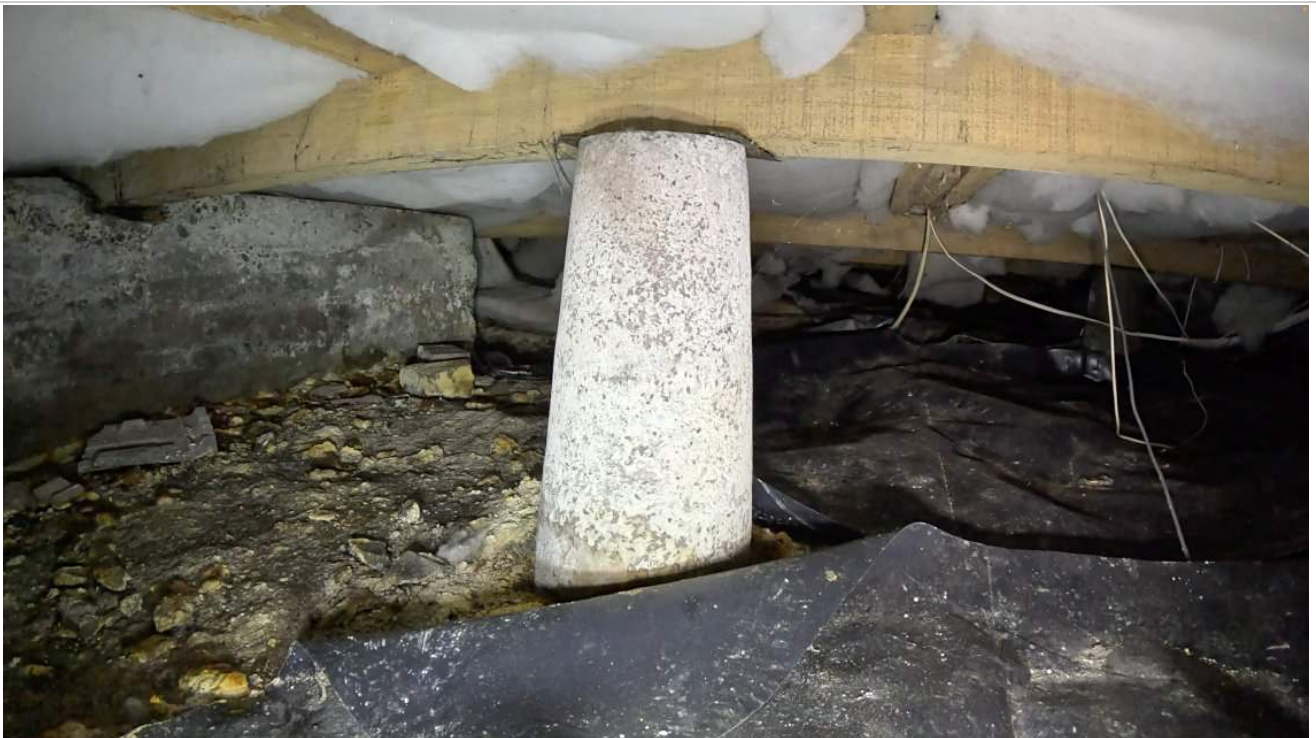
28: Precast concrete pile with no connection.

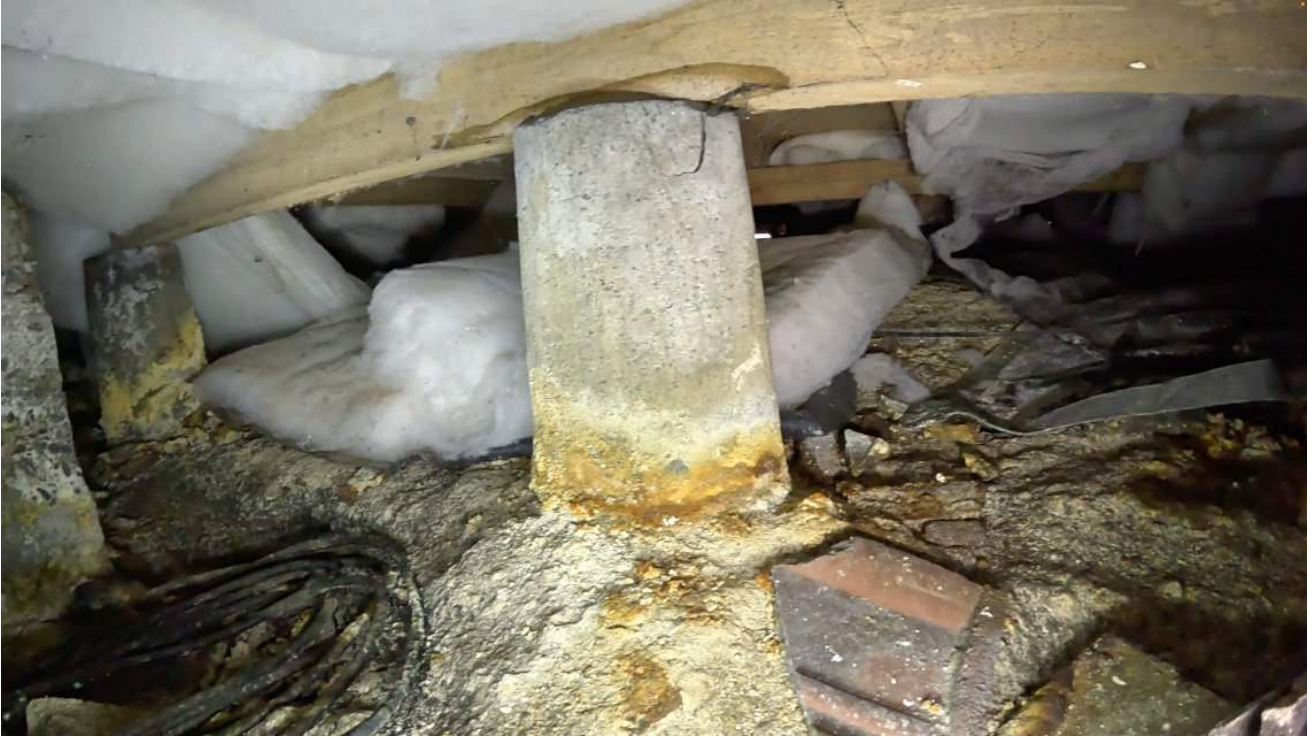
31: Precast concrete pile with no connection.

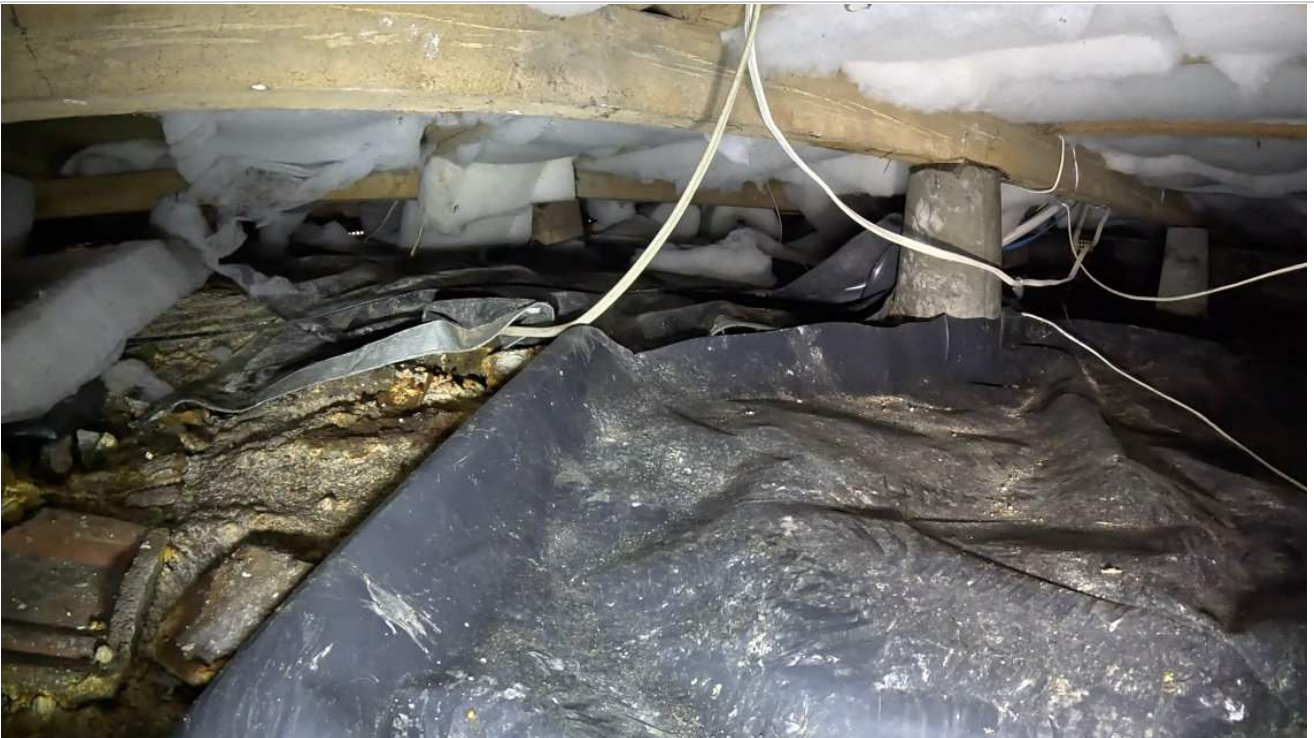
32: There are some non-compliant issues with the wiring seen in this home. They could also be a significant hazard to anybody operating under the floor. This relates specifically to unclipped wires. An electrical inspector could be consulted regarding this. The communication cables have also not been laid in a compliant manner and would easily be damaged by people accessing the subfloor.

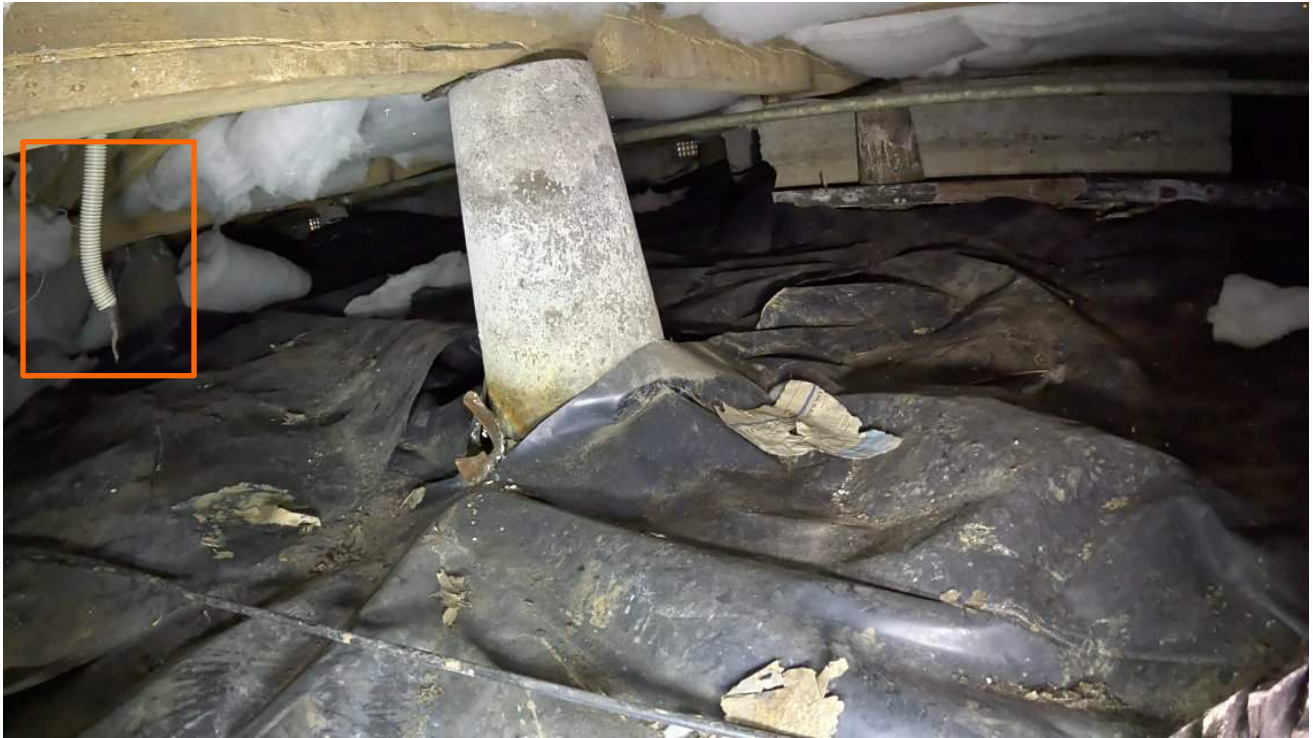
33: Precast concrete pile with no connection. Here we see a heat pump drain. It is discharging to ground but should be vented to the outside.

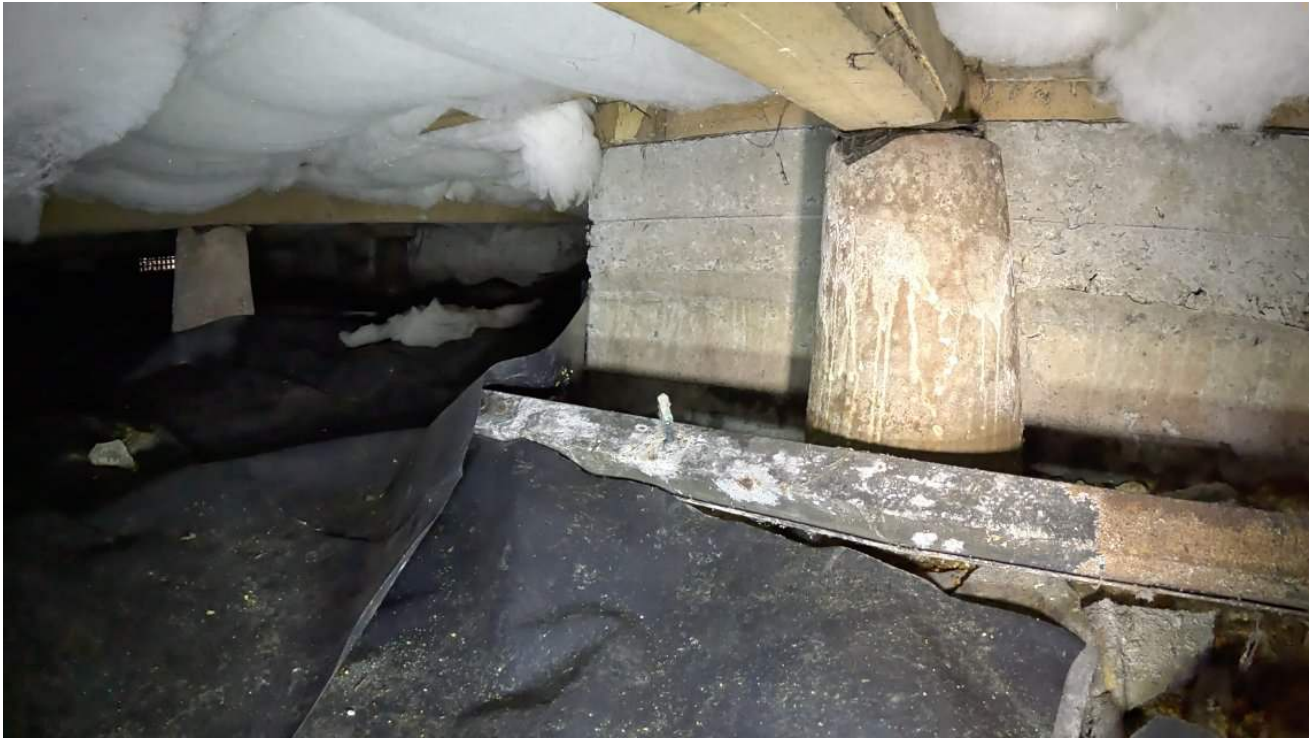
35: Precast concrete pile with no connection.

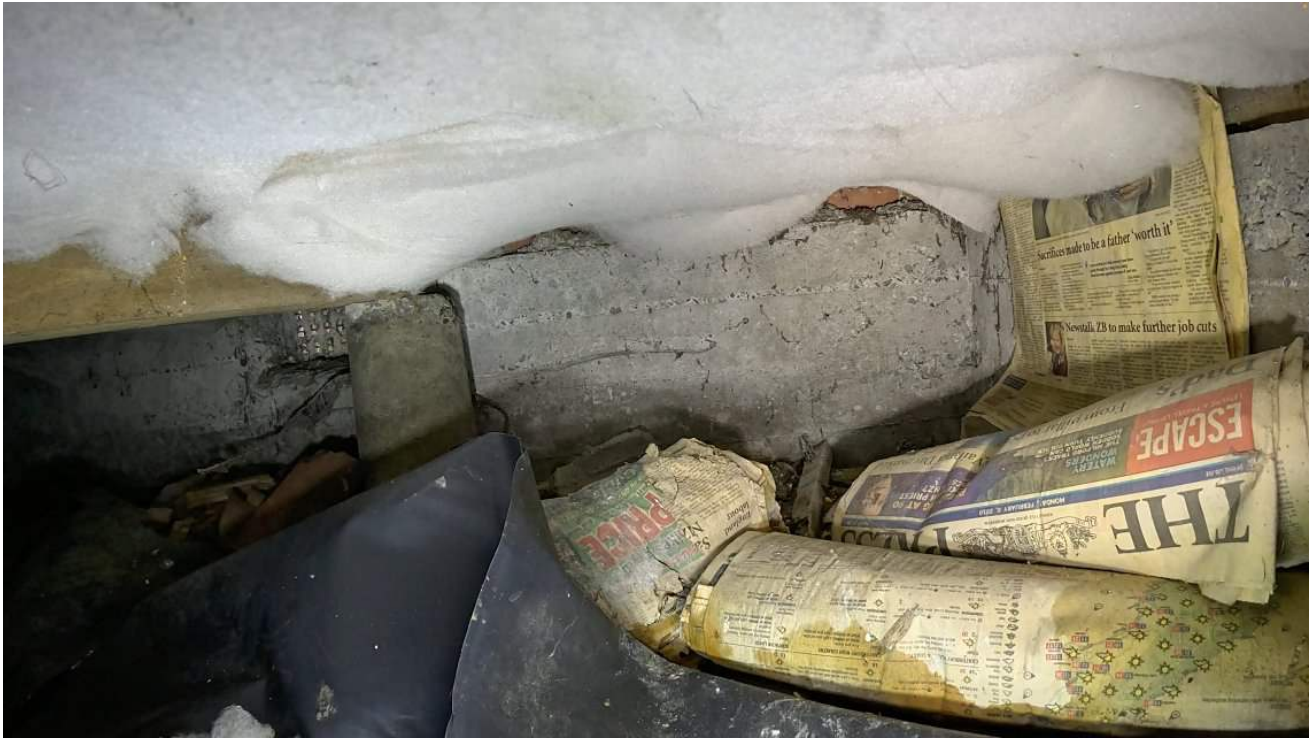
37: Precast concrete pile with no connection.
