# Cavity Critter

## Under floor Inspections

**Report prepared for: NZCSE**

**Property address: 427 Armagh Street, Linwood**

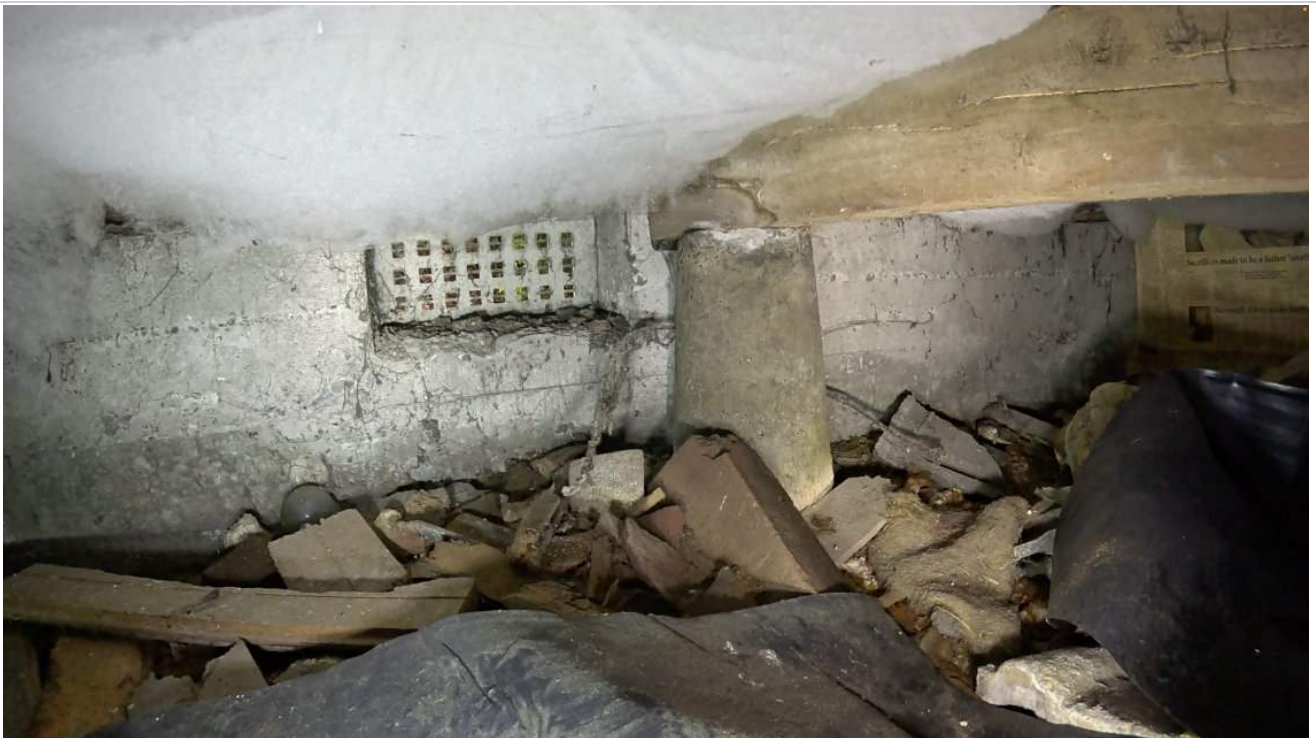
38: Precast concrete pile with no connection.

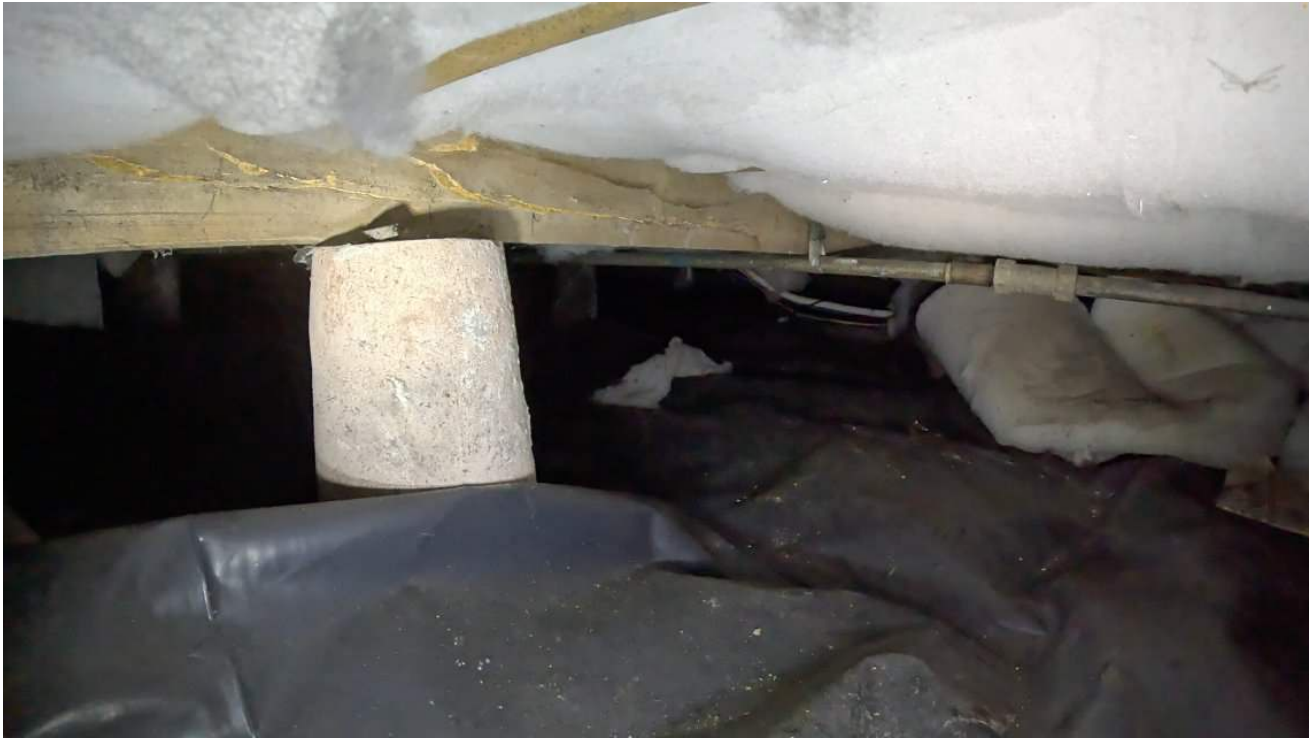
39: Precast concrete pile with no connection.

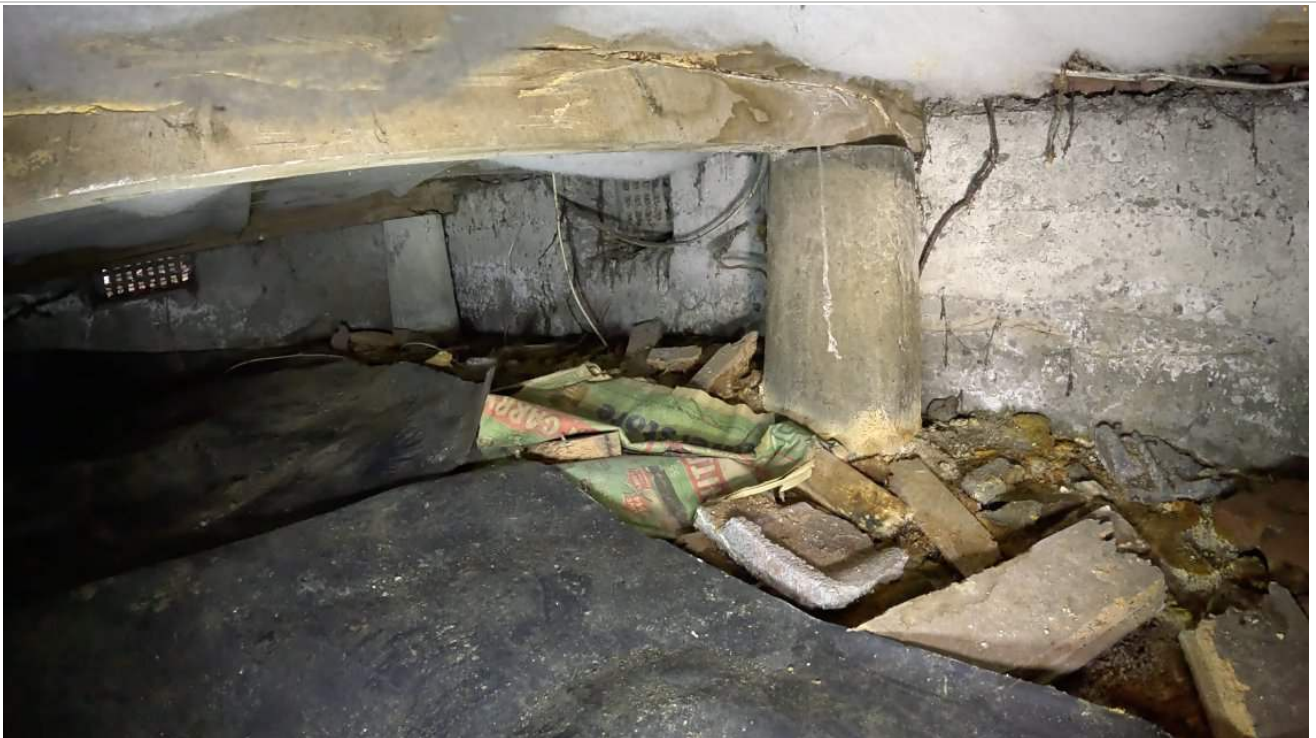
40: Precast concrete pile with no connection.

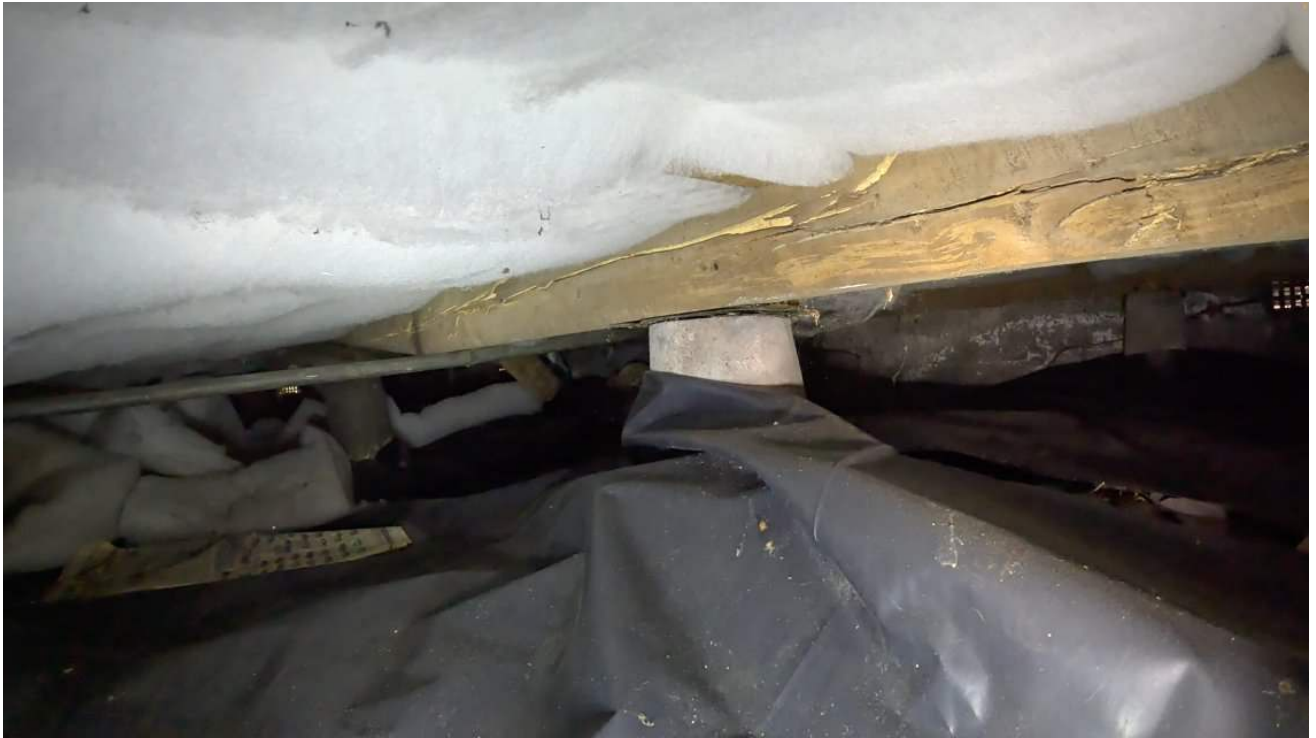
41: Precast concrete pile with no connection.

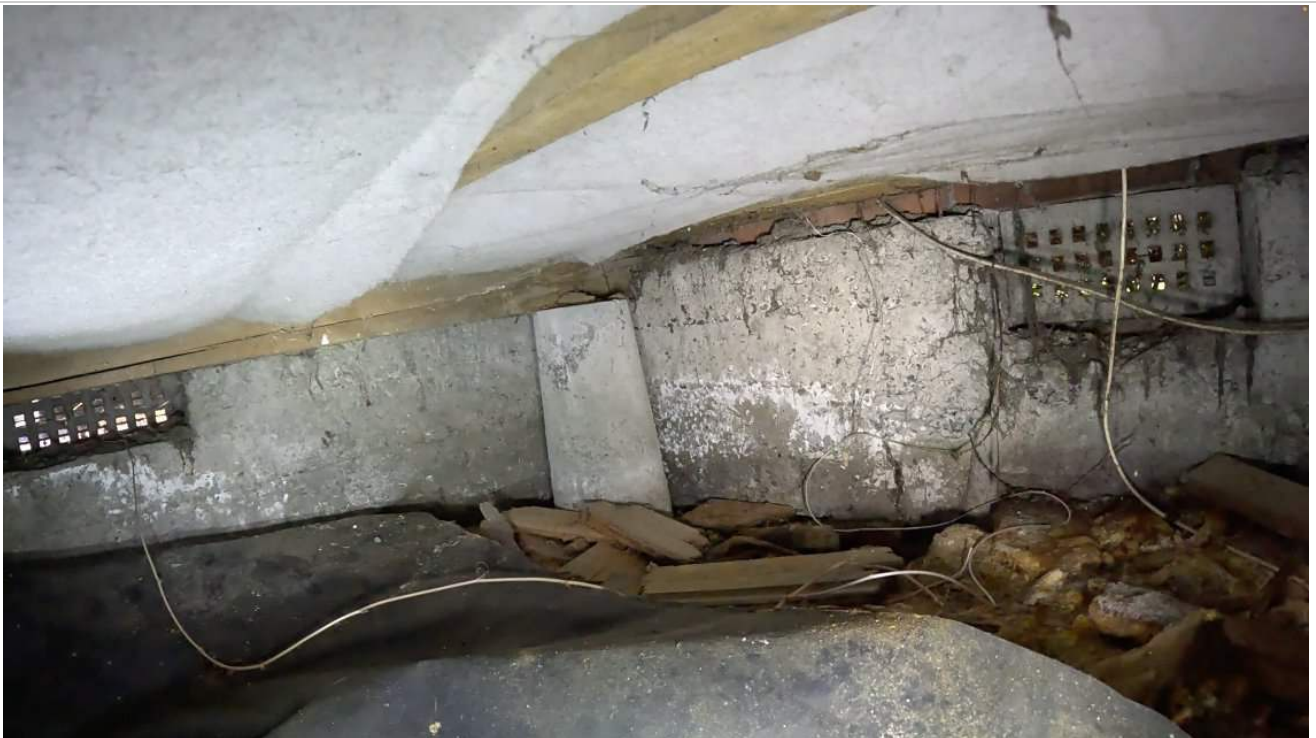
42: Precast concrete pile with no connection.

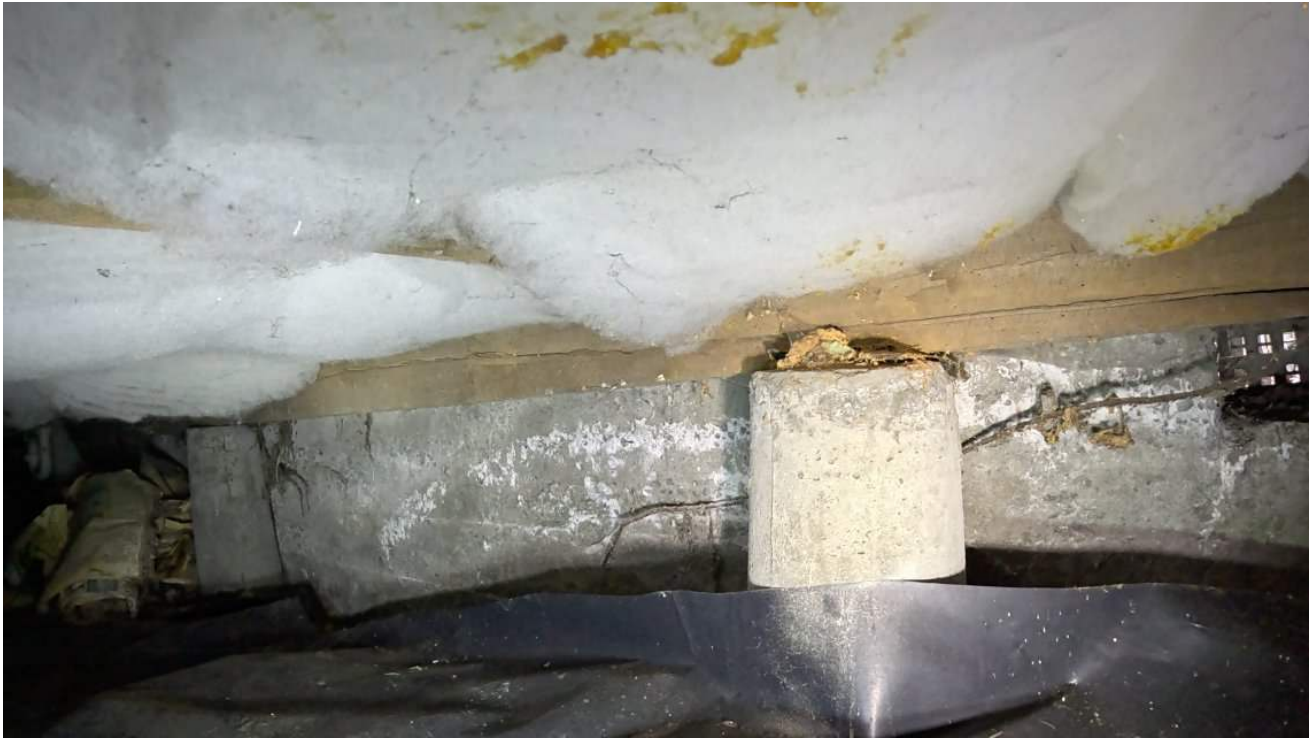
43: Precast concrete pile with no connection and the pile leans to the right.

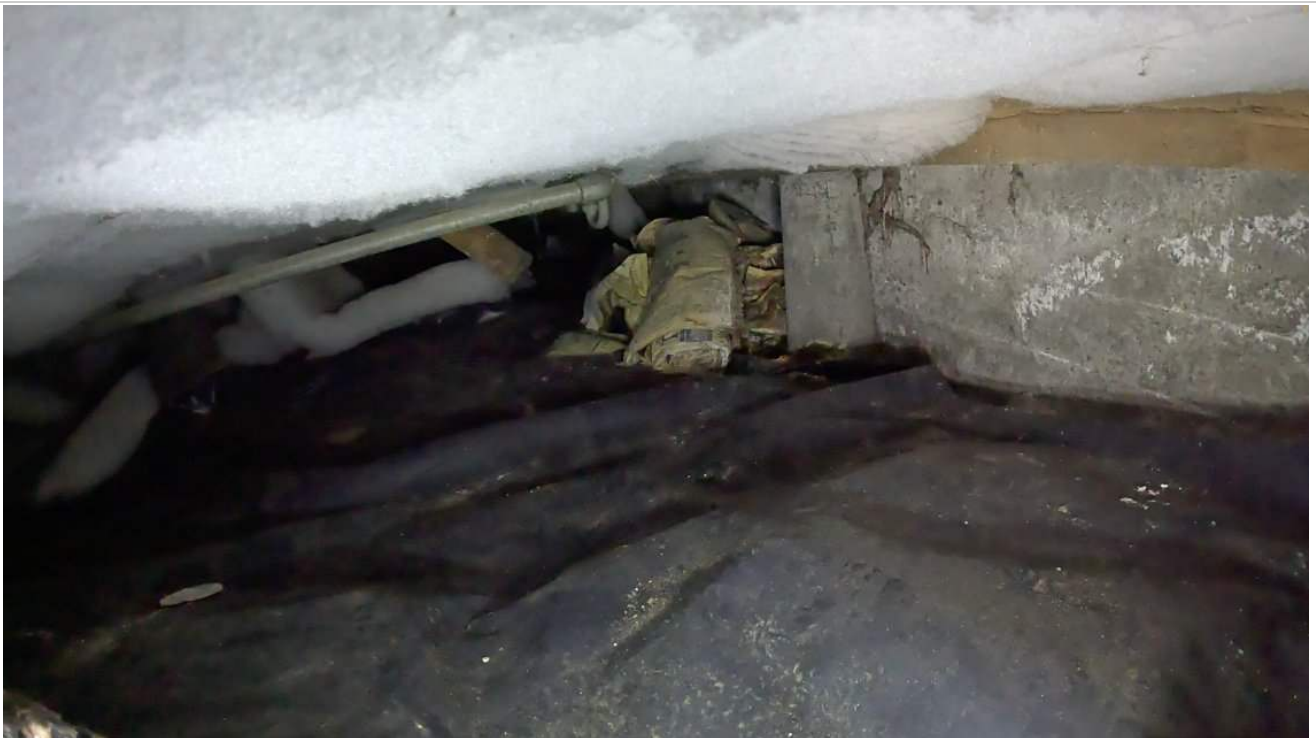
44: The ground level appears to drop in this area.

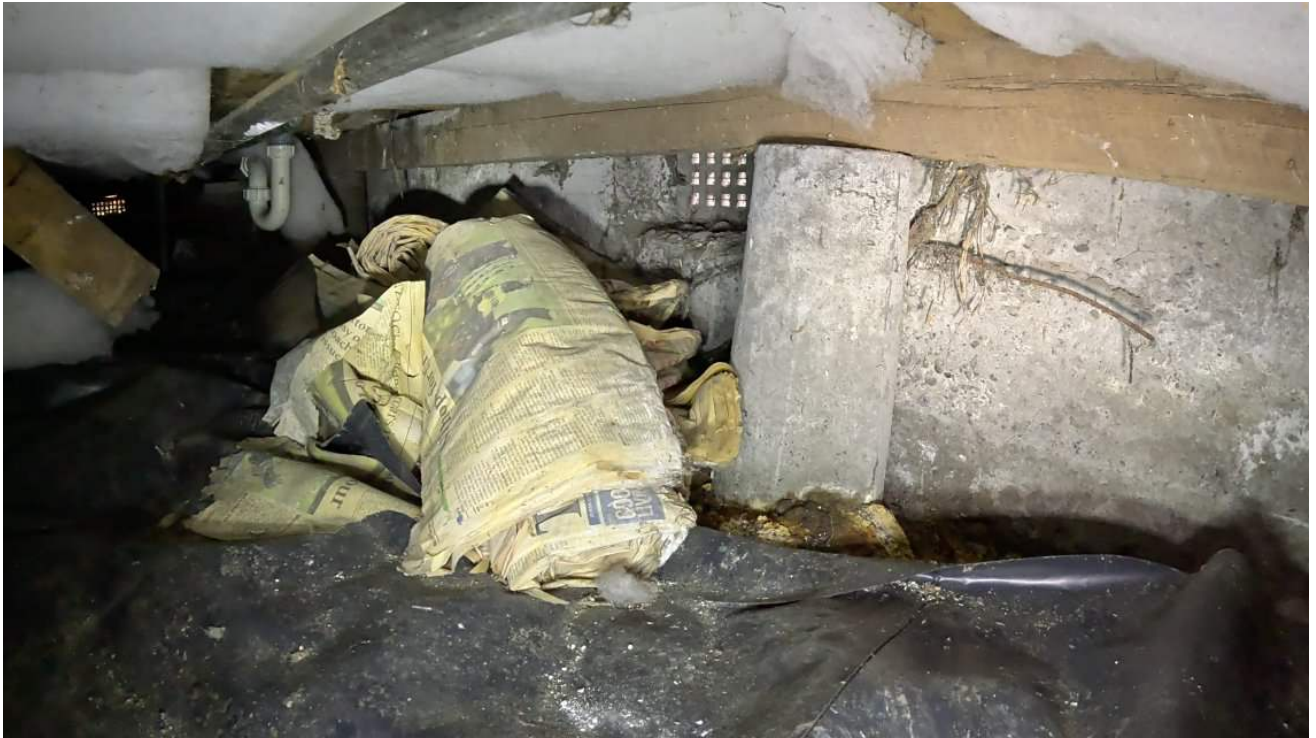
45: Precast concrete pile with no connection and the pile leans to the right.

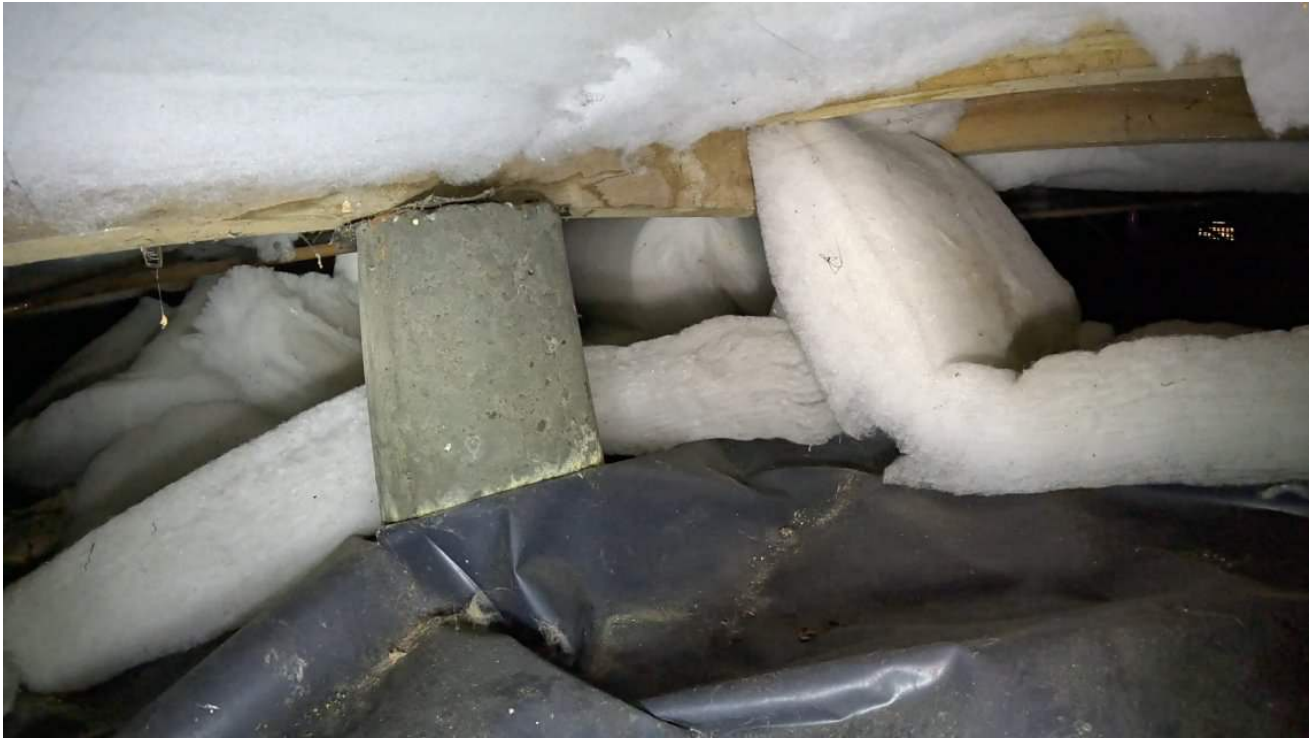
47: Precast concrete pile with no connection.

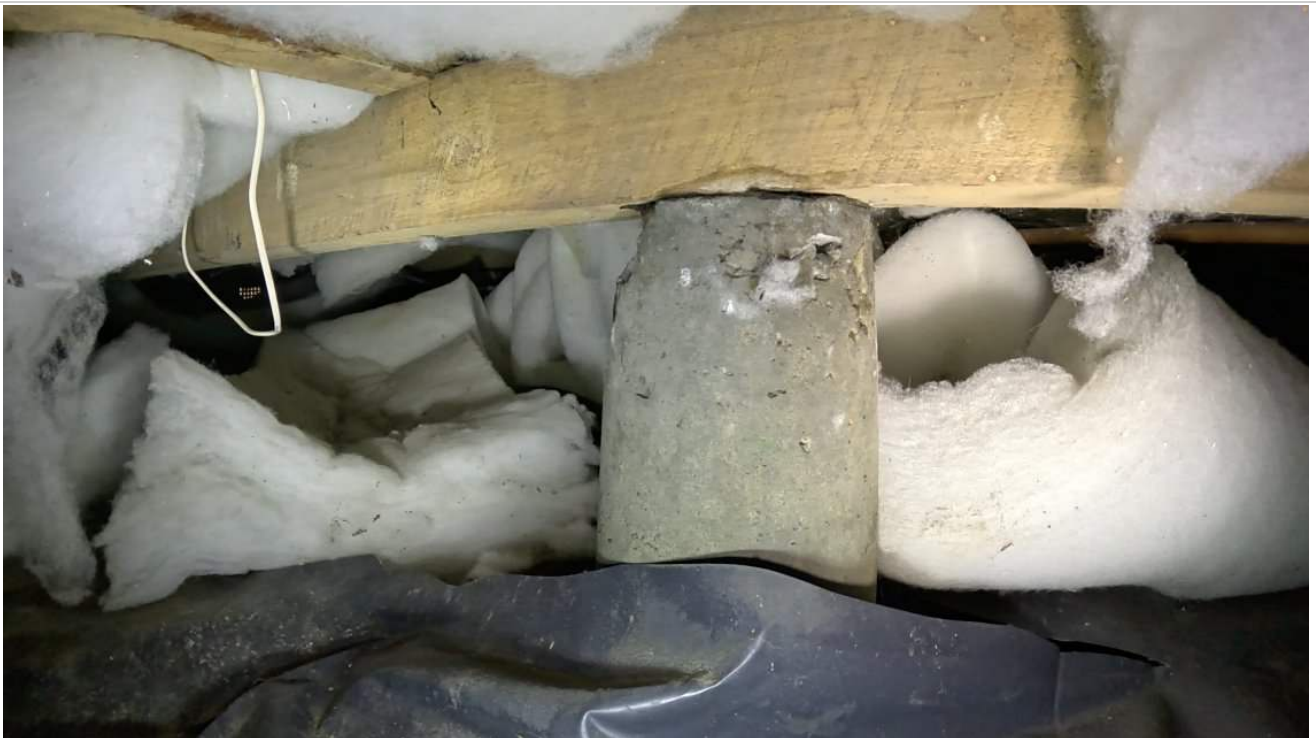
48: Precast concrete pile with no connection.

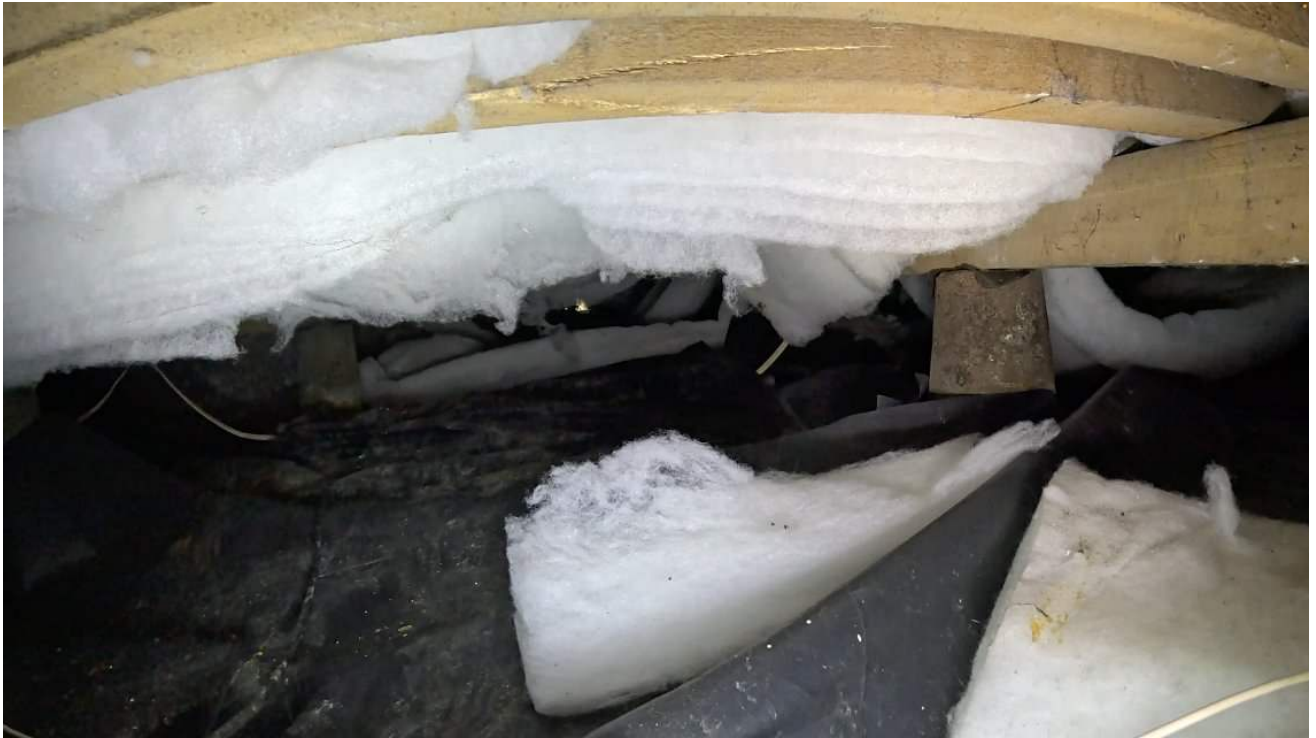
49: Precast concrete pile with no connection.
