# KIWI HOUSE INSPECTIONS

## Independent Building Inspection Report on 21 Devon Street, Mangawhai

INDEPENDENT BUILDING INSPECTION  
21 Devon Street

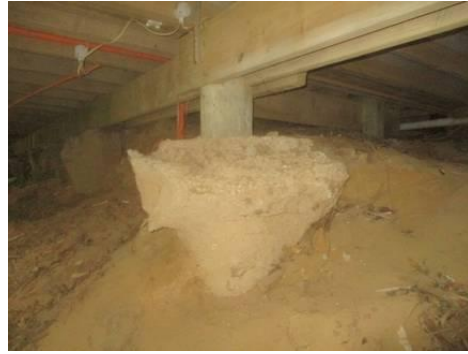
Note: The dwelling is built on a sand base. There has been some erosion around the footings – this will need to be monitored.

**Erosion**

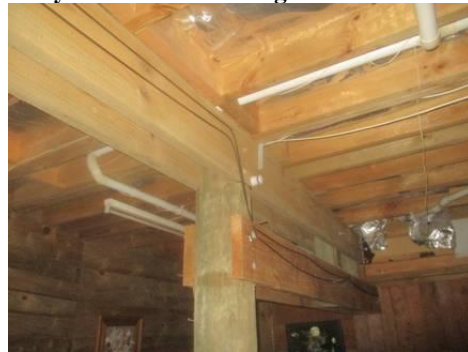
Expol type underfloor insulation has been installed (excluding the storage areas). NOTE: The insulation has been installed directly over the sisalation (foil). Best practice is to remove the foil prior to ensure moisture does not become trapped.

**Insulation over foil**

**Only insulation to storage areas**

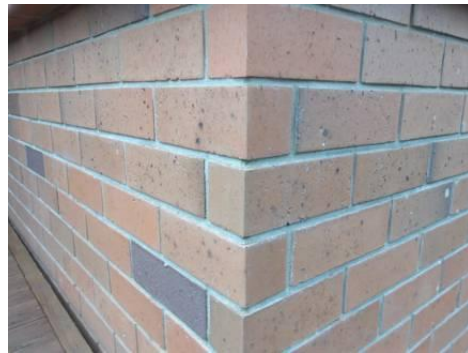
**Cavity system**

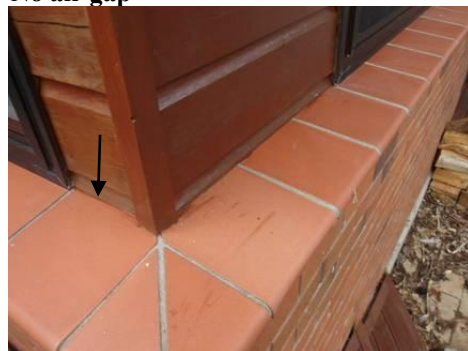
Note: There is no air gap between the bottom of the timber cladding and the brick cladding (this is consistent with methods used at the time of construction); therefore, there is potential for moisture to be drawn in via capillary action.

**No air gap**

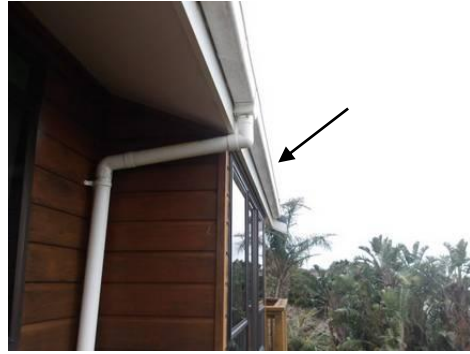
**No eaves in areas**

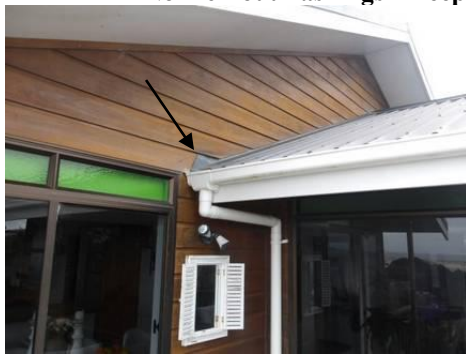
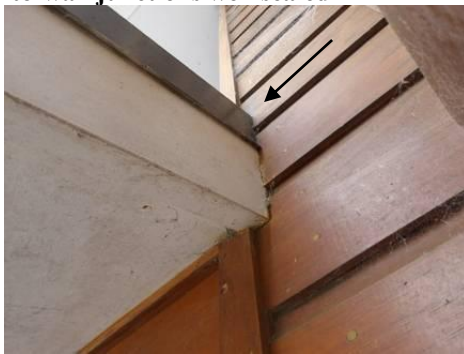
Roof flashings appear to be well installed, suitably fixed and sealed appropriately in accordance with good trade practice. NOTE: Kick-out flashings have not been installed – this was not a requirement at the time of construction. Please ensure roof-to-wall junctions remain well sealed as this is a critical junction.

**No kick-out flashings - Keep roof-to-wall junctions well sealed**

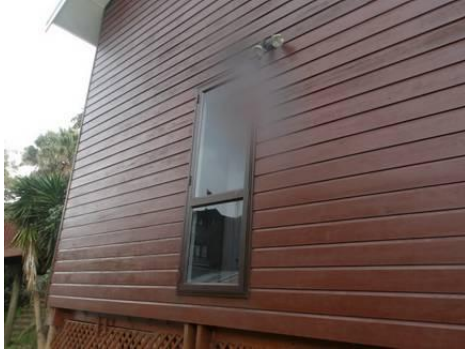
Note: There is a door off the lower bedroom on the southern elevation which opens from a height – this must be kept permanently and securely closed.

**Door from a height**

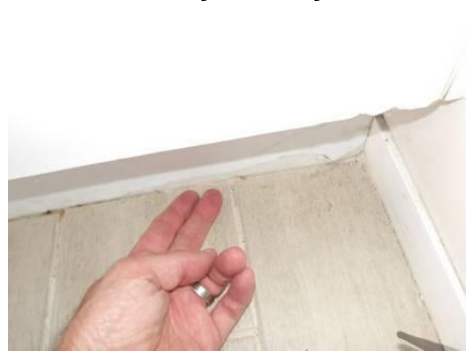
**Swollen cabinetry - laundry**

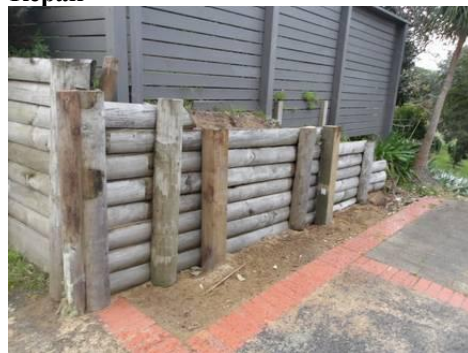
Note: There has been a repair to the retaining wall by the front of the dwelling – the works appear to have completed to a satisfactory standard.

**Repair**

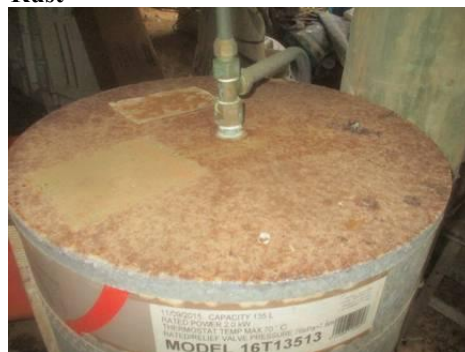
Area to Note: The smaller, Low pressure unit has rust developing – please monitor.

**Rust**

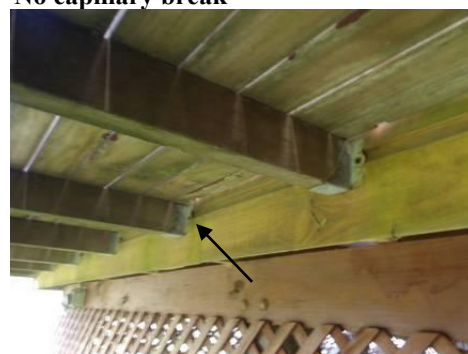
NOTE: The decking has been built up against the cladding with no moisture break – this is consistent with methods used at the time of construction – current building code requires a 12mm gap to ensure moisture cannot become trapped.

**No capillary break**
