## Class A Clearance Inspection

| Address | 30 Garden Heights Avenue, Glenview, Hamilton 3206 |
| Issue Date | May 13, 2026 |
| Job Number | CLA36 |

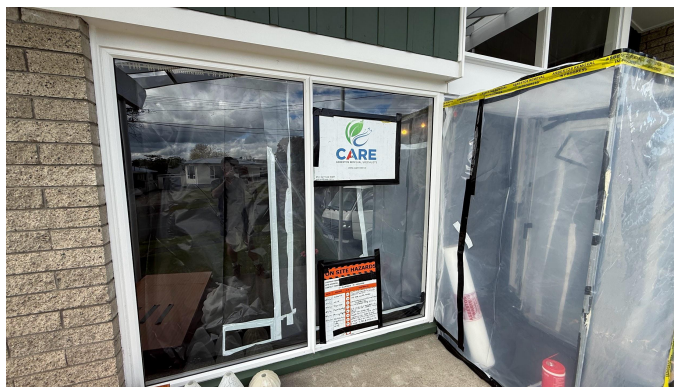
Stage 1 - Site Set-up

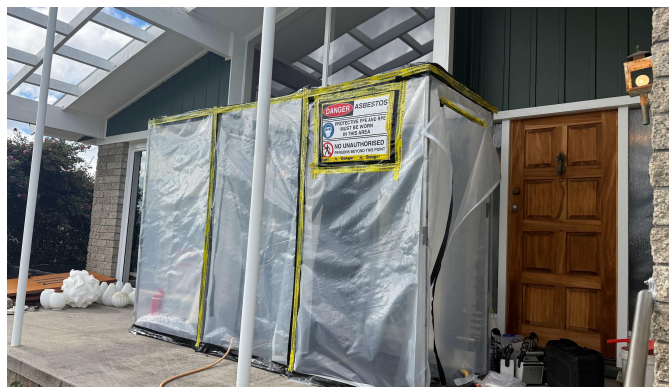
Stage 1 - Decontamination Unit/Area

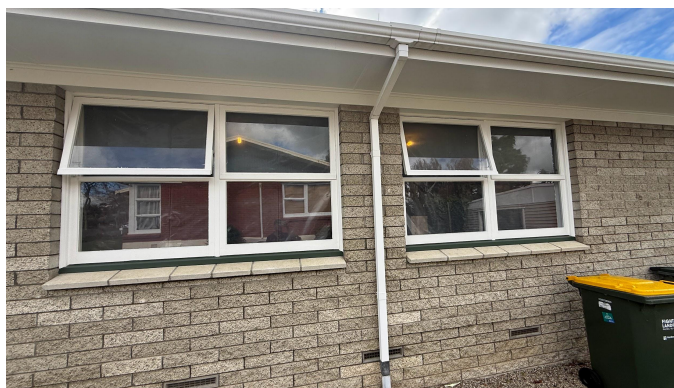
Stage 1 - Enclosure Integrity

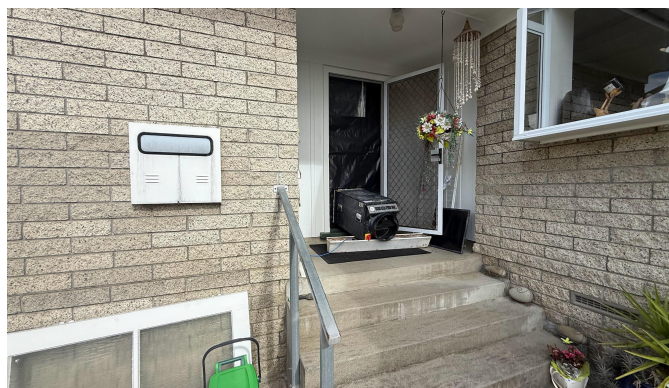
Stage 1 - NPU in situ

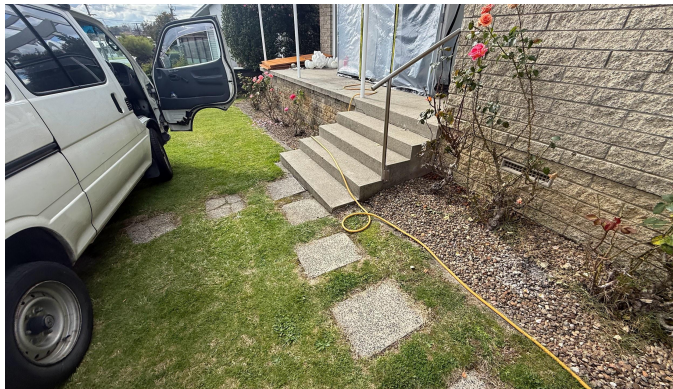
Stage 1 - Waste Route

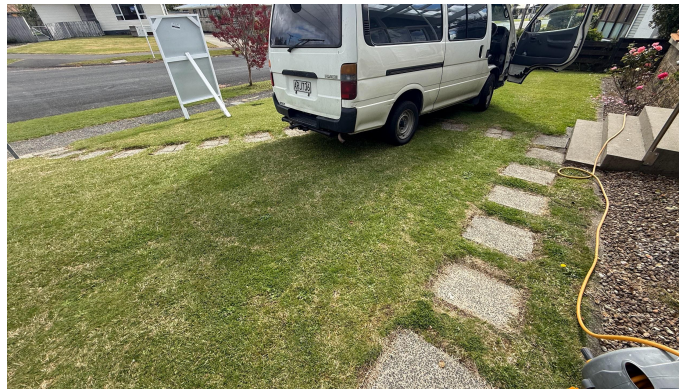
Stage 1 - Waste Route

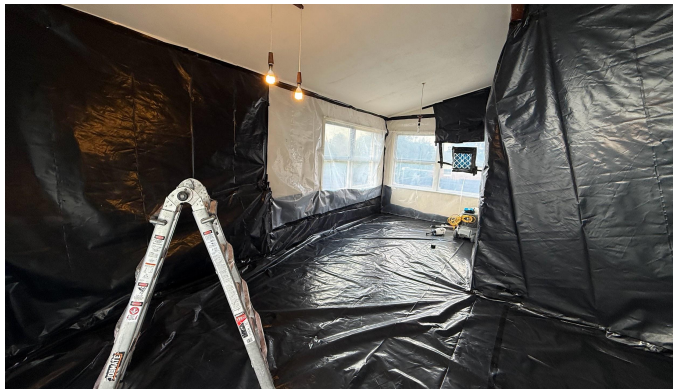
Stage 2 - Overview of enclosure - Living Room

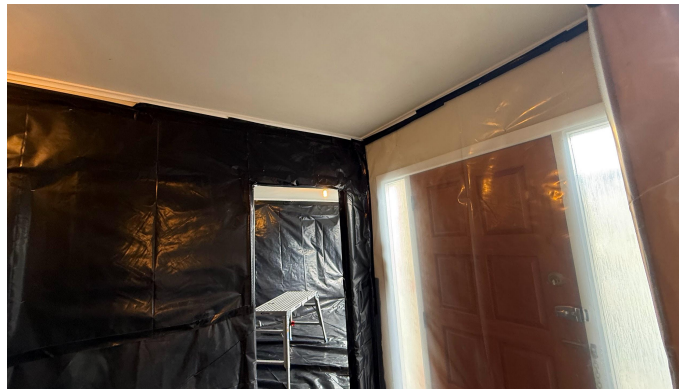
Stage 2 - Overview of enclosure - Hallway

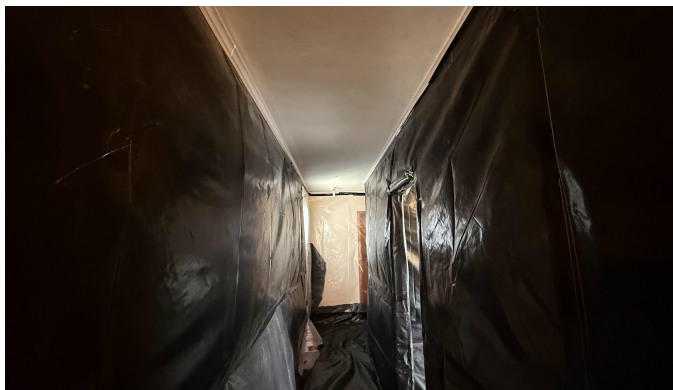
Stage 2 - Overview of enclosure - Hallway

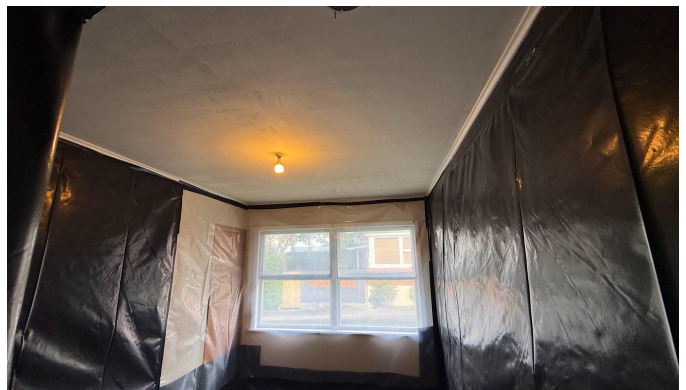
Stage 2 - Overview of enclosure - Bedrooms

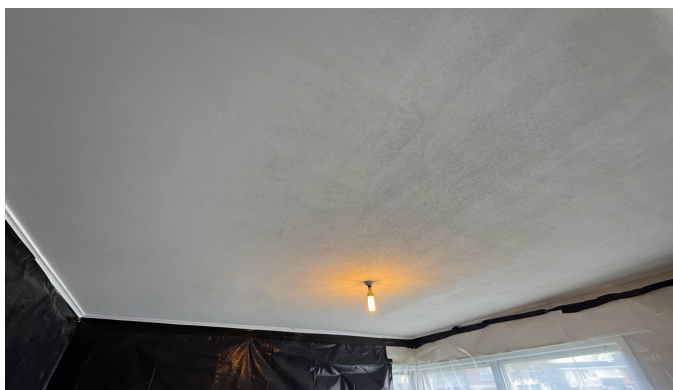
Stage 2 - Textured coating removed from bedroom ceiling

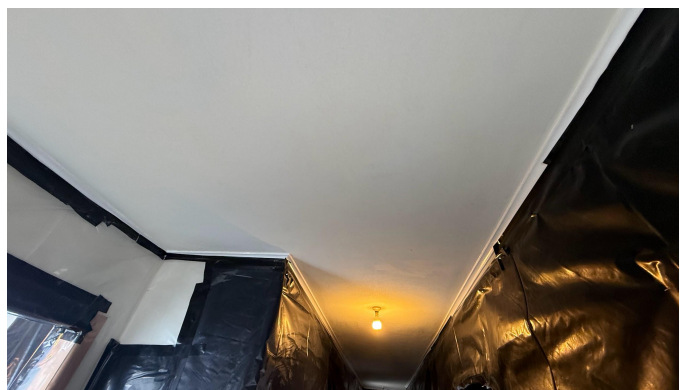
Stage 2 - Textured coating removed from Hallway ceiling

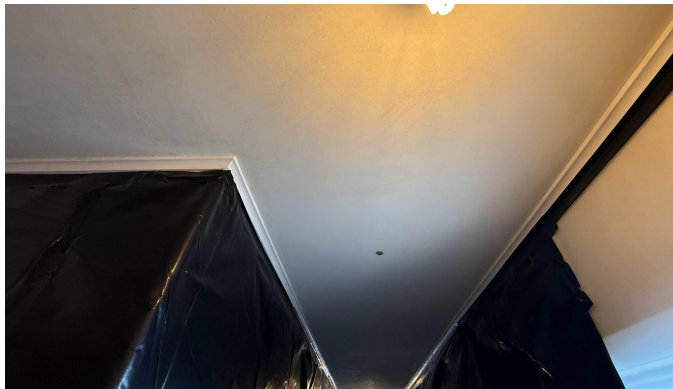
Stage 2 - Textured coating removed from hallway ceiling

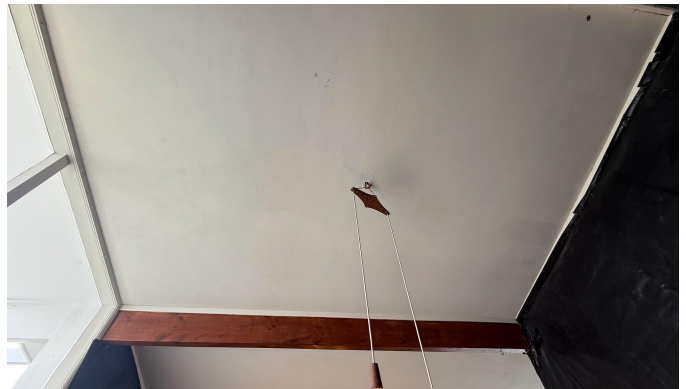
Stage 2 - Textured coating removed from living room ceiling

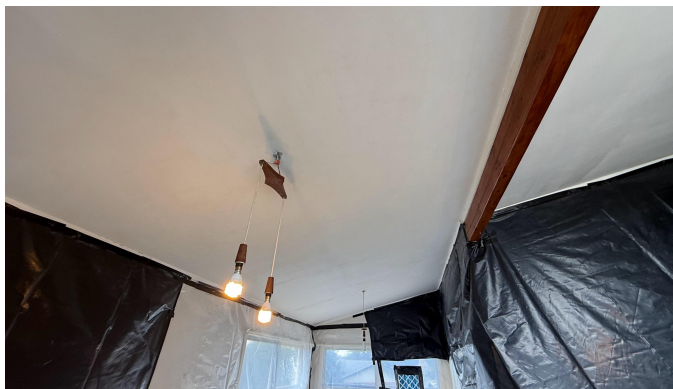
Stage 2 - Textured coating removed from living room ceiling

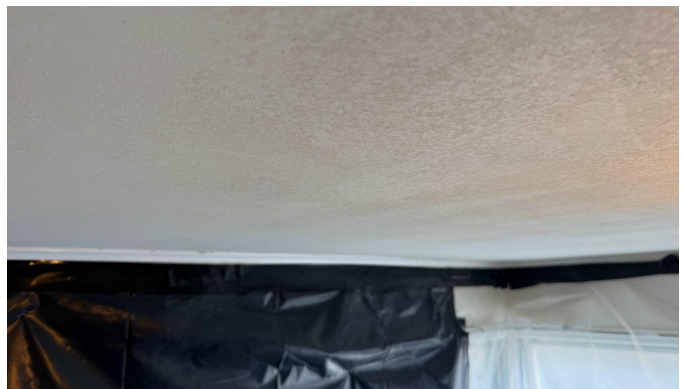
It was the sole decision of the home owner to keep the plasterboard in situ, the home owner was advised of potential ACM fibres remaining on the paper layer of the plasterboard.

Stage 2 - Plasterboard in situ visually clear.

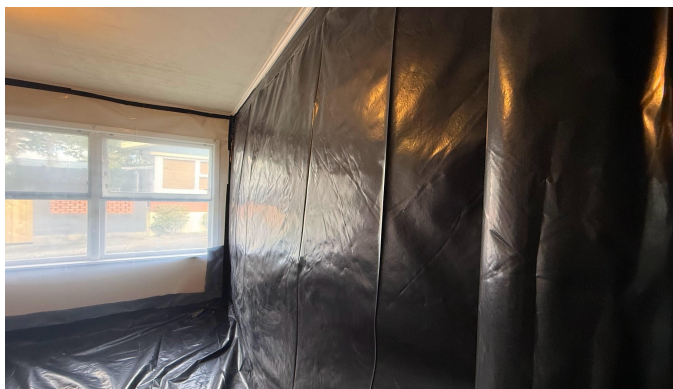
Stage 2 - Sheeted walls visually clear

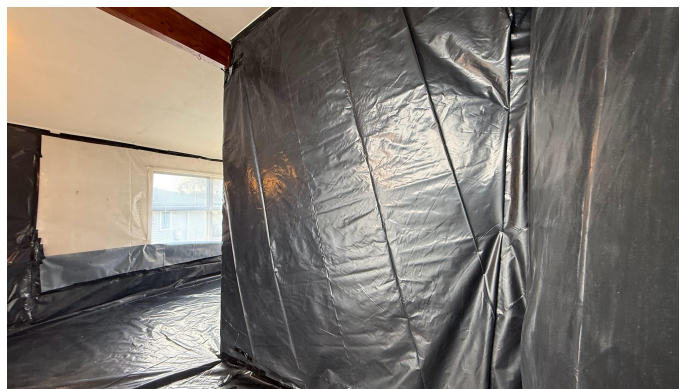
Stage 2 - Sheeted walls visually clear

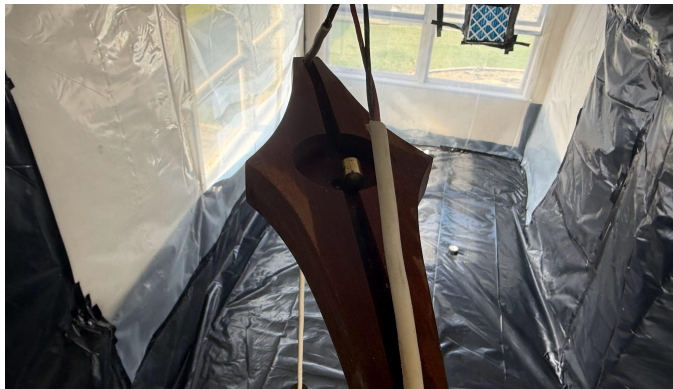
Stage 2 - Light fittings visually clear.

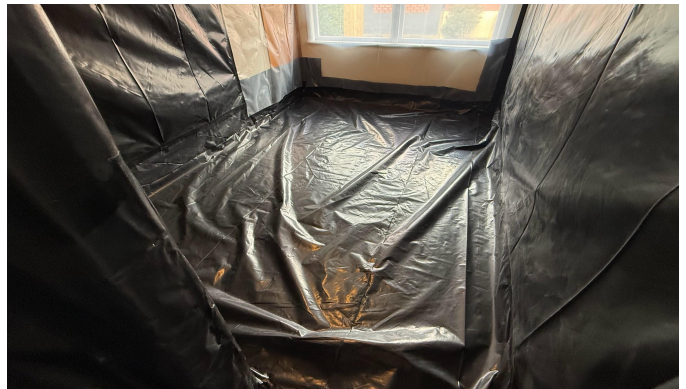
Stage 2 - Floors visually clear.

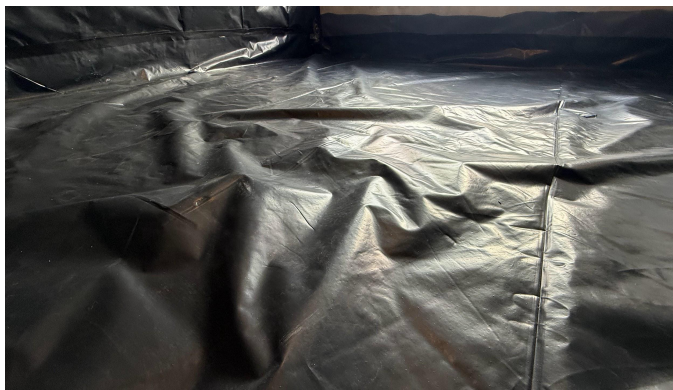
Stage 2 - Floors visually clear.

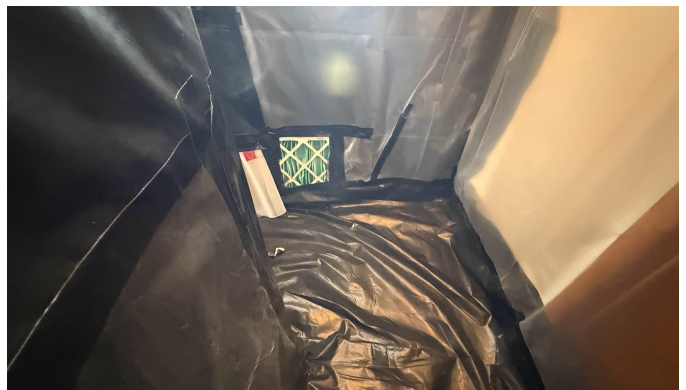
Stage 2 - Npu filter clean.

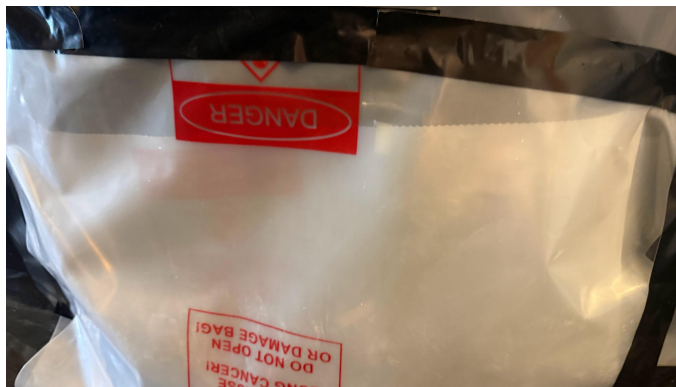
Stage 3 - NPU sealed.

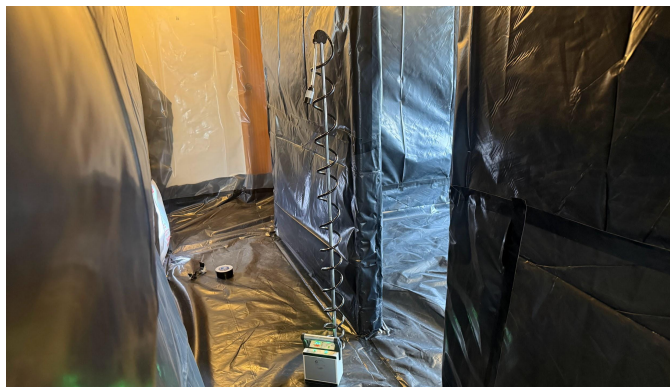
| Location | Sample No | Pump No. | Start time | End time | Average Flow | Volume | Fibre Count (Fibres/Field) | Result (Fibres/mL) |
|---|---|---|---|---|---|---|---|---|
| Hallway | 360 | P1 | 13:00 | 13:50 | 10 | 500 | 0 | <0.01 |

Stage 3 - Air Monitoring - Pump 1 - 360 - Pass

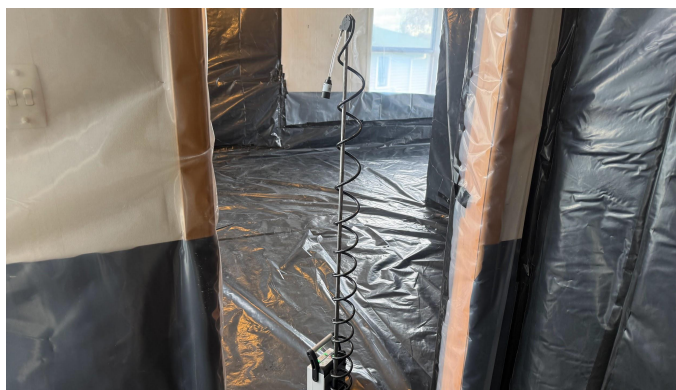
| Location | Sample No | Pump No. | Start time | End time | Average Flow | Volume | Fibre Count (Fibres/Field) | Result (Fibres/mL) |
|---|---|---|---|---|---|---|---|---|
| Living Room | 006 | P2 | 13:00 | 13:50 | 10 | 500 | 2 | <0.01 |

Stage 3 - Air Monitoring - Pump 2 - 006- Pass

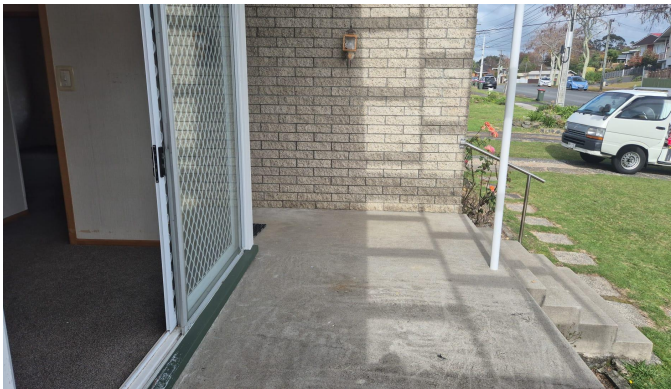
Stage 4 - Former Work Area removed.

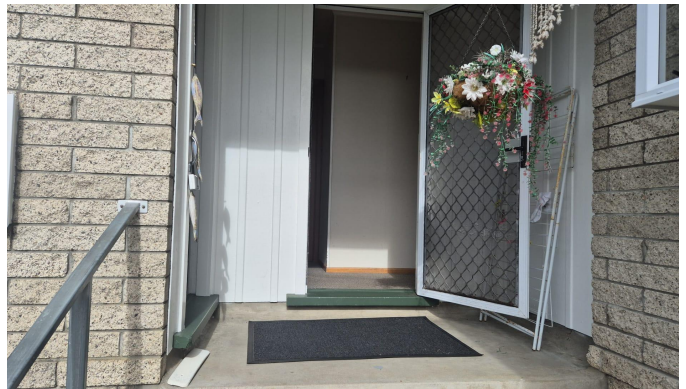
Stage 4 - NPU 1 fully removed.

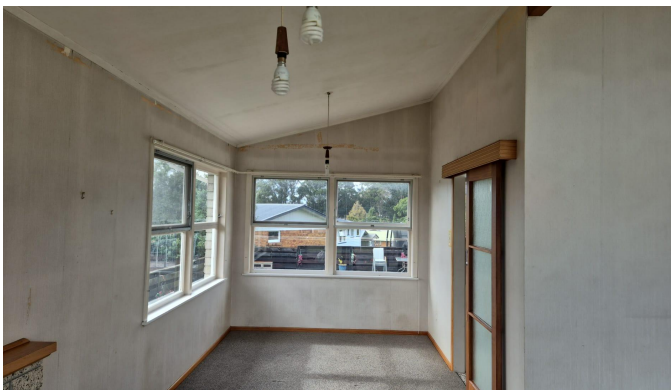
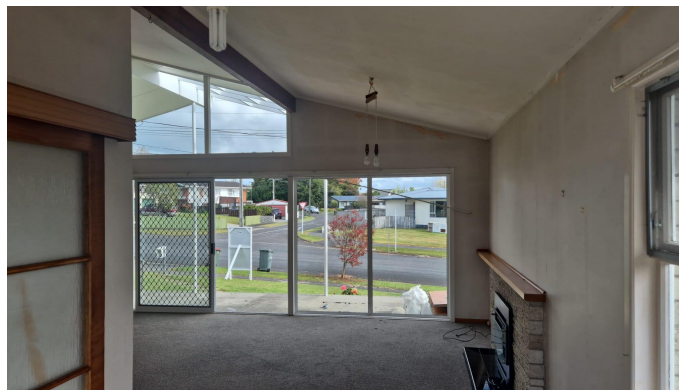
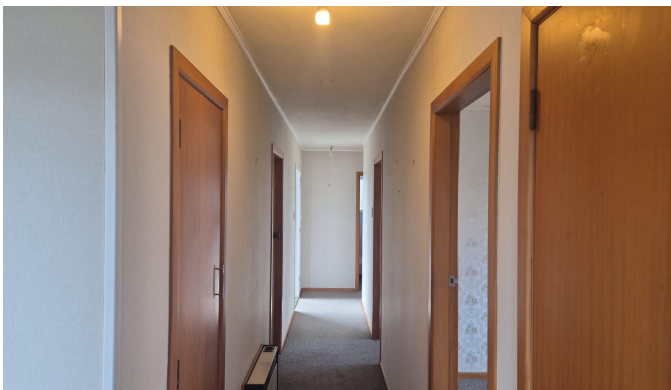
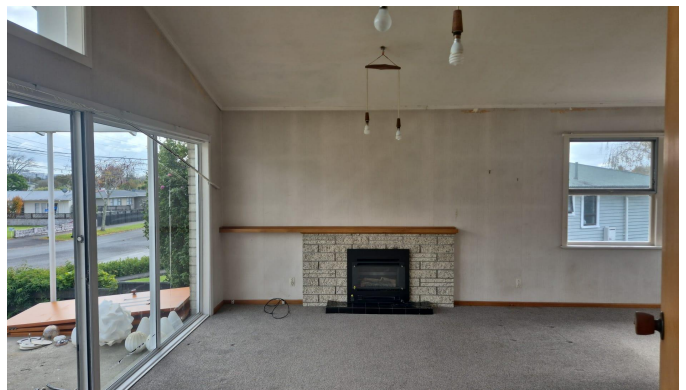
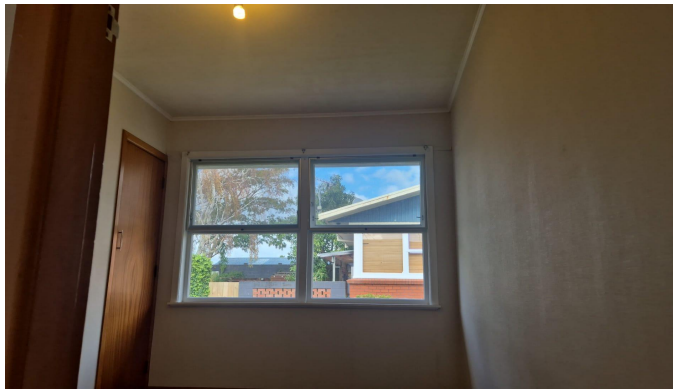
Stage 4 - Sheeting fully removed

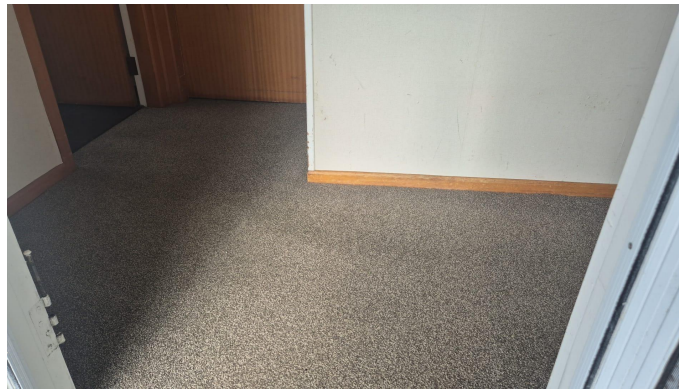
Stage 4 - Sheeting removed from floors.

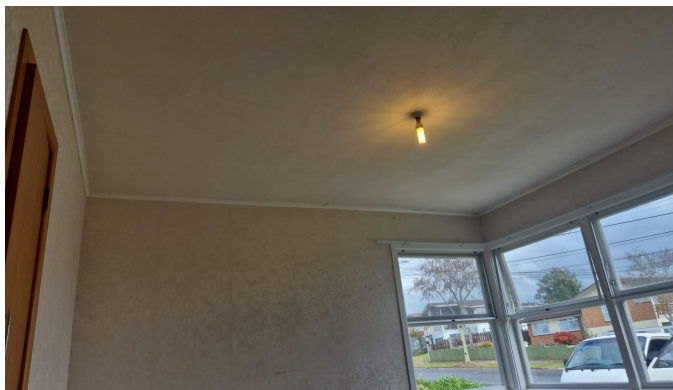
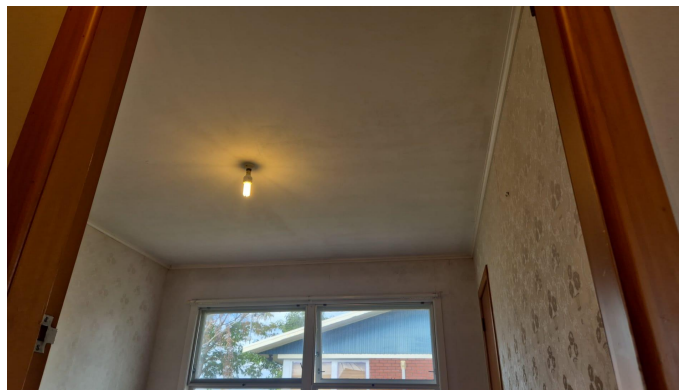
Stage 4 - Ceilings encapsulated.

| Inspect and Review | Y/N | Comments |
|---|---|---|
| Comments: | <p>The final inspection and evaluation to confirm that all asbestos-containing materials have been properly removed and that the worksite meets safety standards for reoccupation. The inspection revealed that the area was clean and free from any visible debris or contamination.</p> <p>The plasterboard ceiling has been encapsulated, no cutting, drilling or sanding on the ceiling can occur without additional controls in place to reduce potential fibres being released. The ceiling can be painted or plastered without disturbance occurring.</p> | |

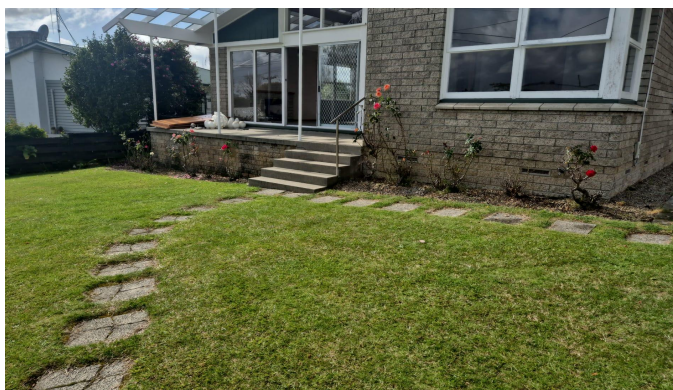
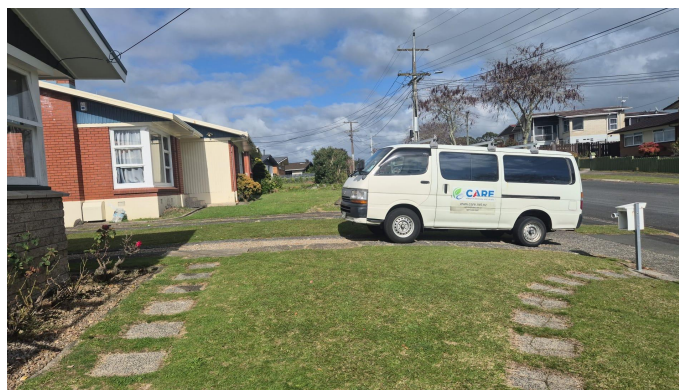
| Inspect and Review | Y/N | Comments |
|---|---|---|
| The waste route is visually clear. | Yes ▾ | From the DCU down the stairs to the Waste van parked on the grass |

Stage 4 - Waste route.
