## PROPERTY CHECK EXPRESS REPORT

| <b>Job Number</b> | 54378 |
| <b>Property Inspected</b> | 6/28 Beveridge Street, Christchurch |
| <b>Inspection Date</b> | 10 April 2026 |

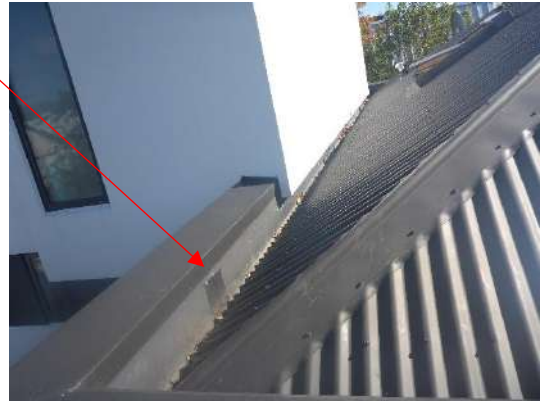
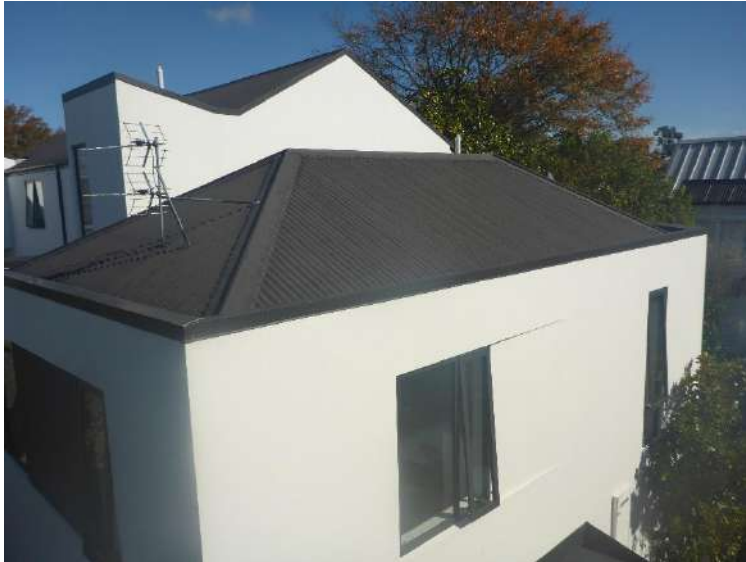
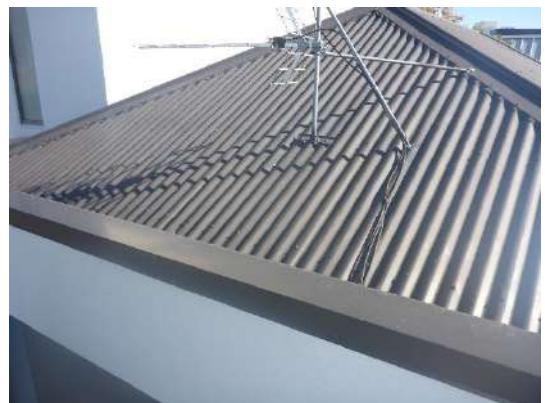
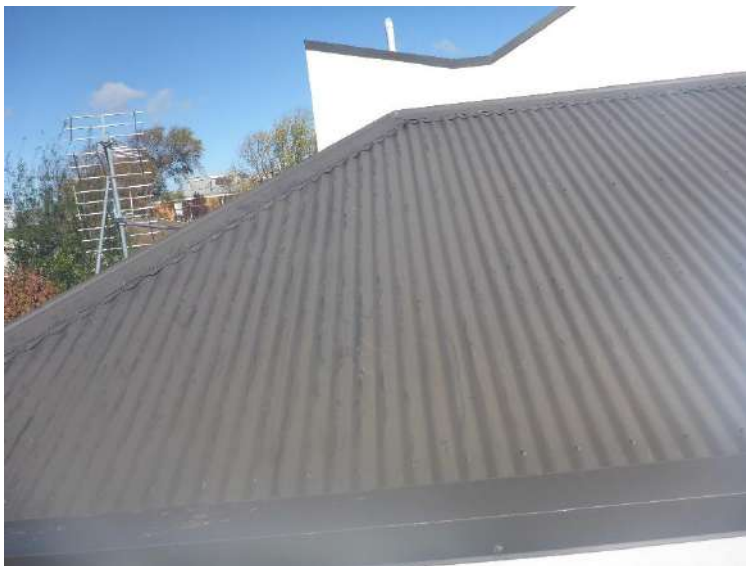
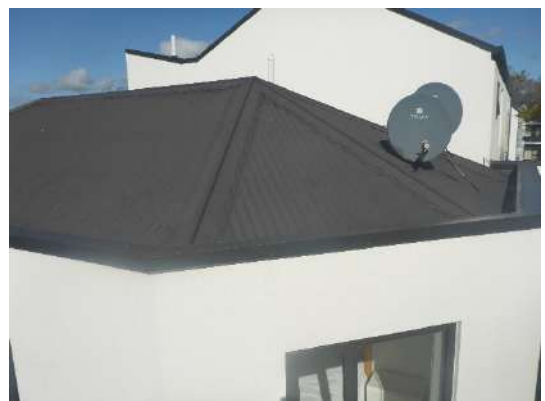
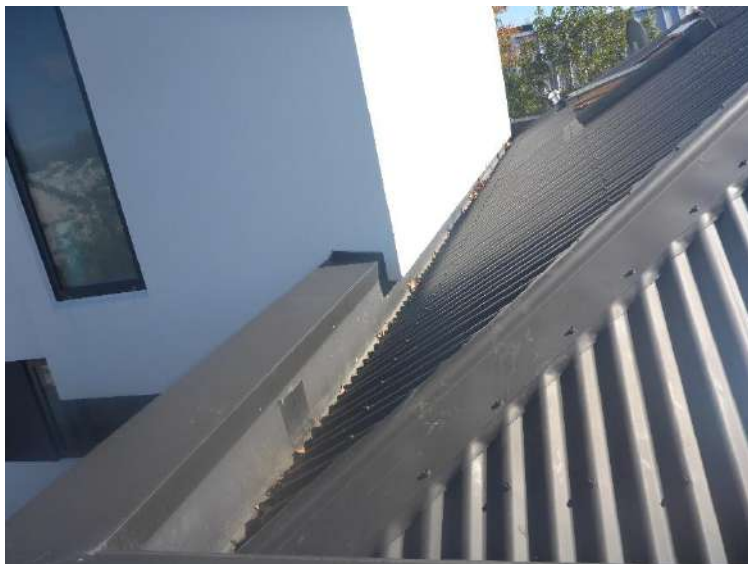
We identified what appears to be a patch to the metal gutter on the south elevation with the remote camera on the pole. We could not determine if this could be prone to leaking or not as that would require a close physical inspection using access equipment. However, there were no clear signs of issues with the patch and such repairs are common in butyl rubber.

The roof appears in good condition and should only require a low level of maintenance over the years.

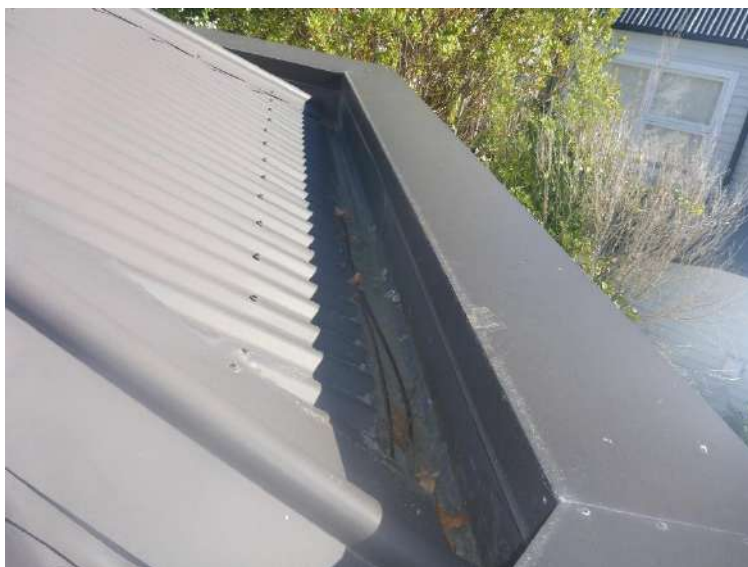
No significant defects identified.

Regular checks may be required to the internal roof gutters to check for blockages and carry out any required maintenance.

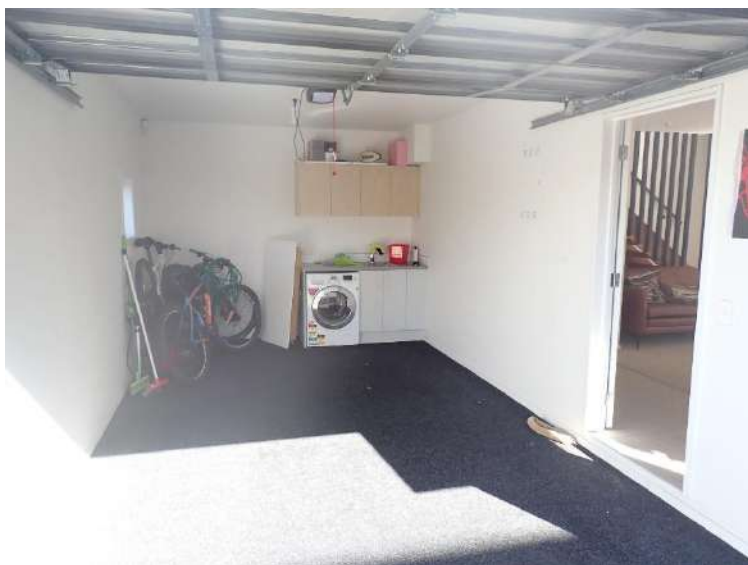
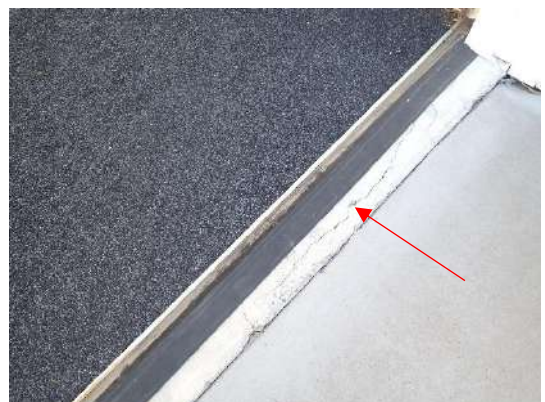
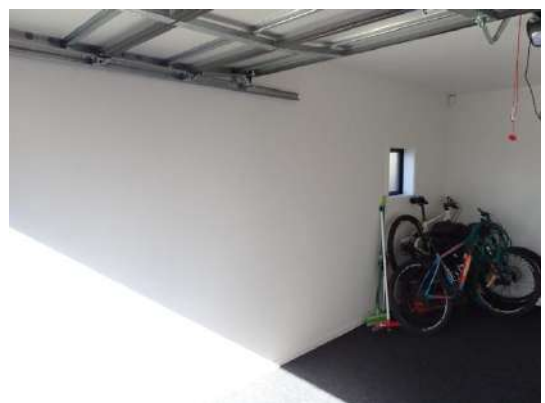
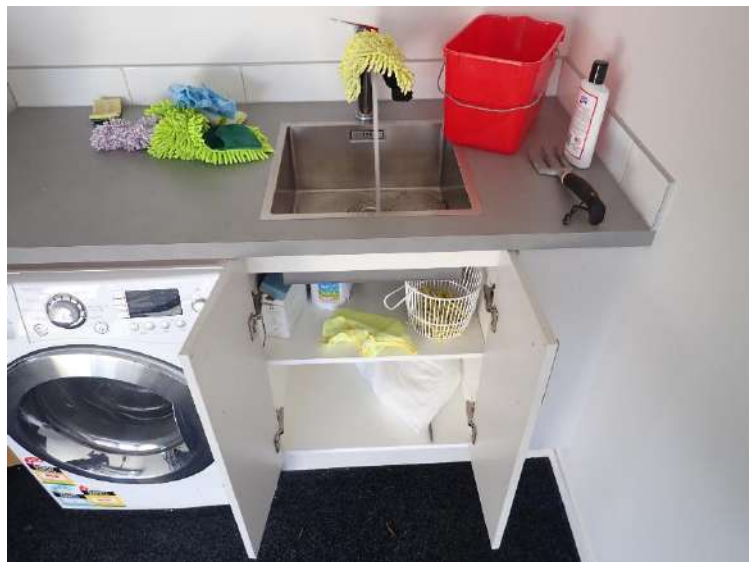
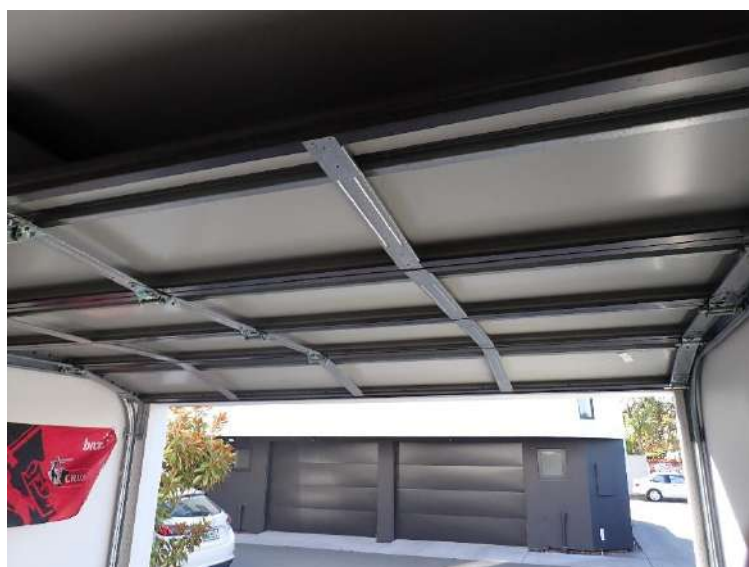
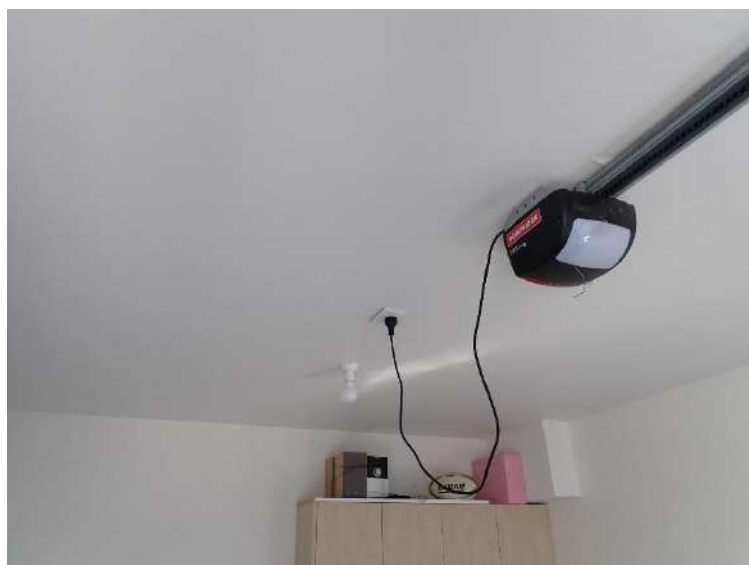
There is a crack to the threshold of the garage where repairs may be required.

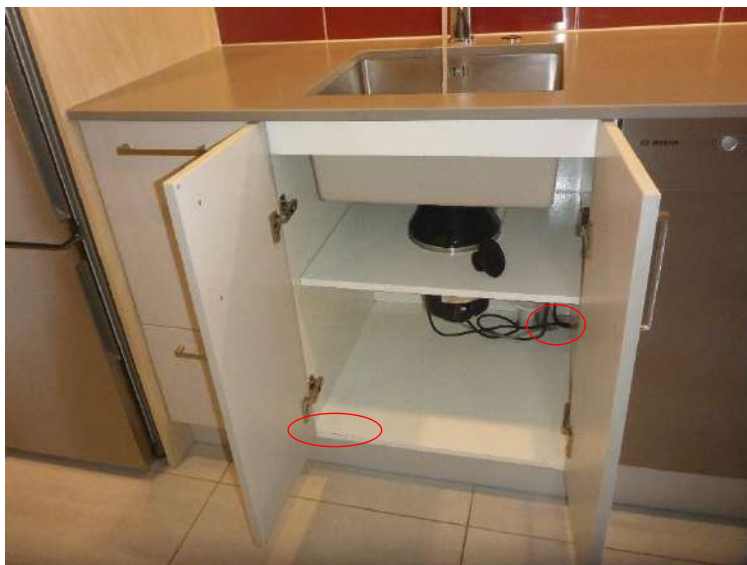
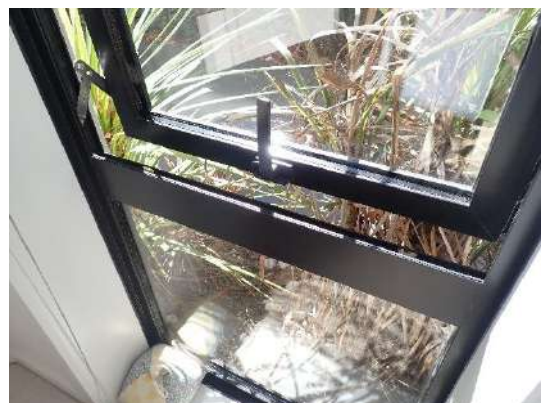
There is minor damage to the units below the kitchen sink from previous leaks and repairs to the damaged joinery may be considered.

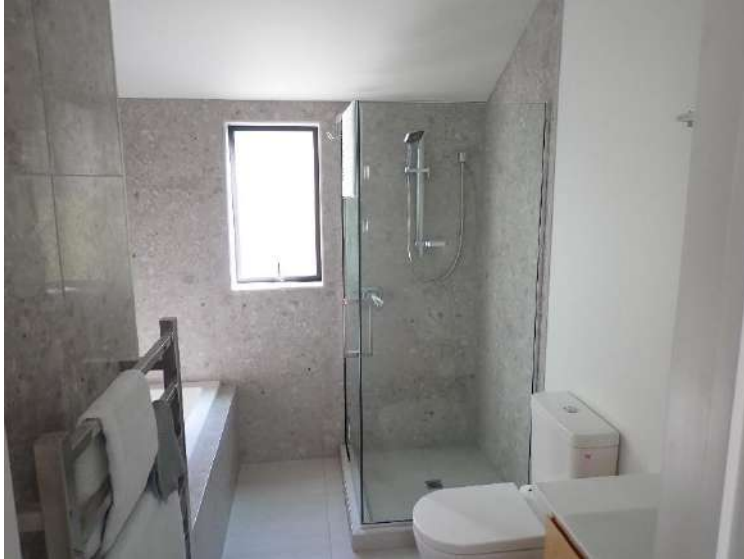
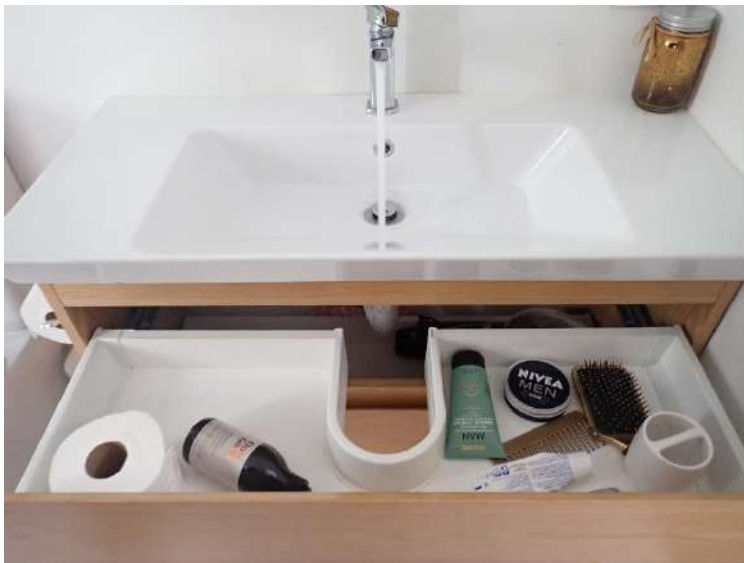
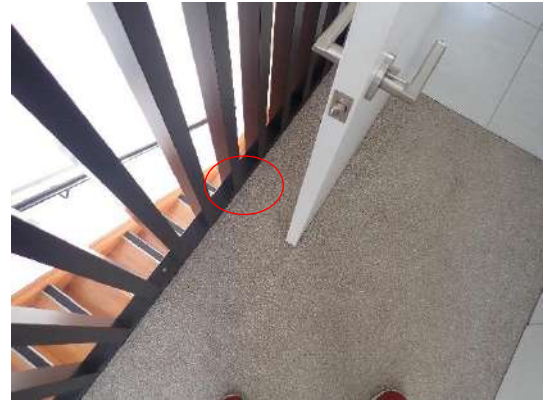
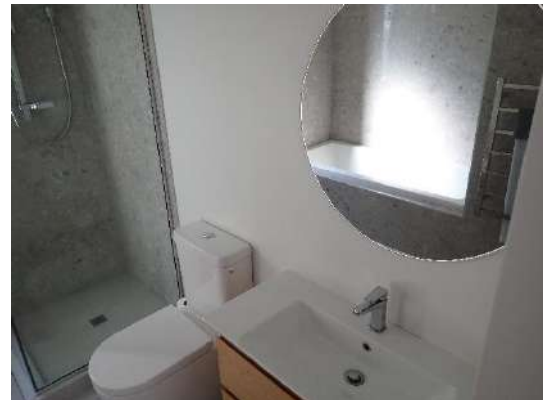
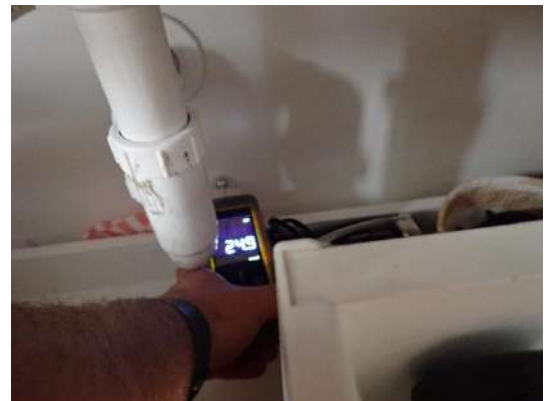
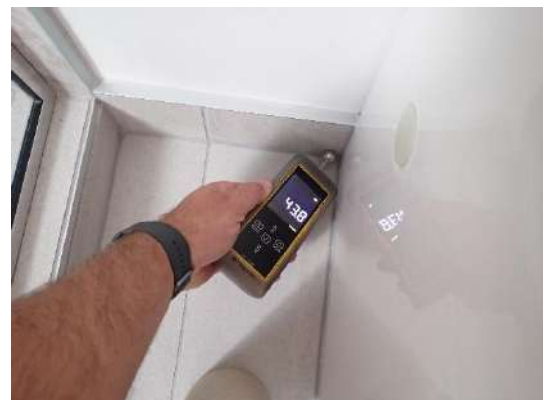
The bathroom door has no door stop and it strikes the balustrade on opening. Consideration could be given to installing a door stop in this area to prevent damage.
