## PROPERTY CHECK WEATHERTIGHTNESS REPORT

| <b>Property Inspected</b> | 6-28 Beveridge Street, Christchurch |
| <b>Inspection Date</b> | 4 June 2026 |

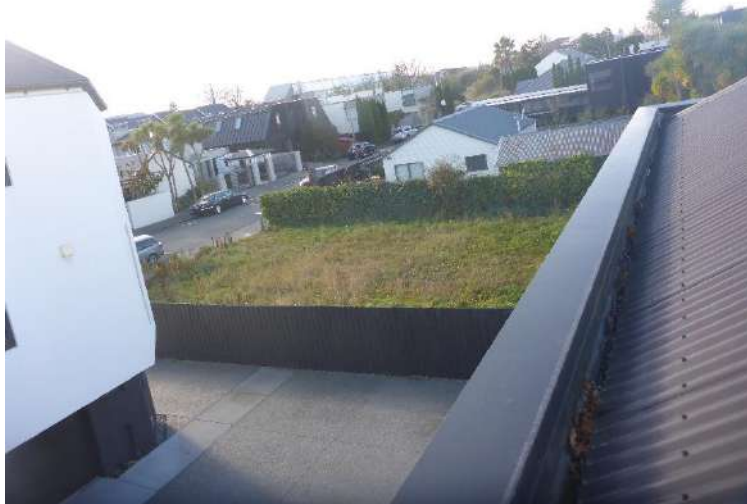
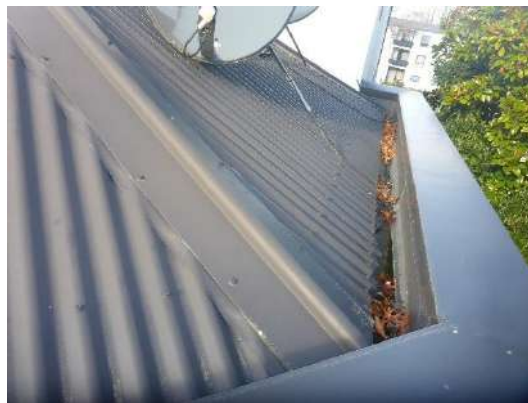
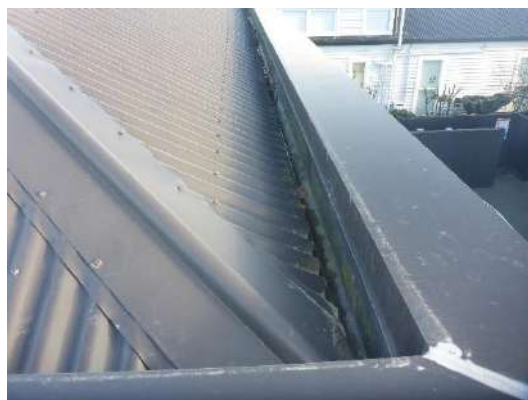
### Internal roof gutters

No significant weathertightness defects identified.

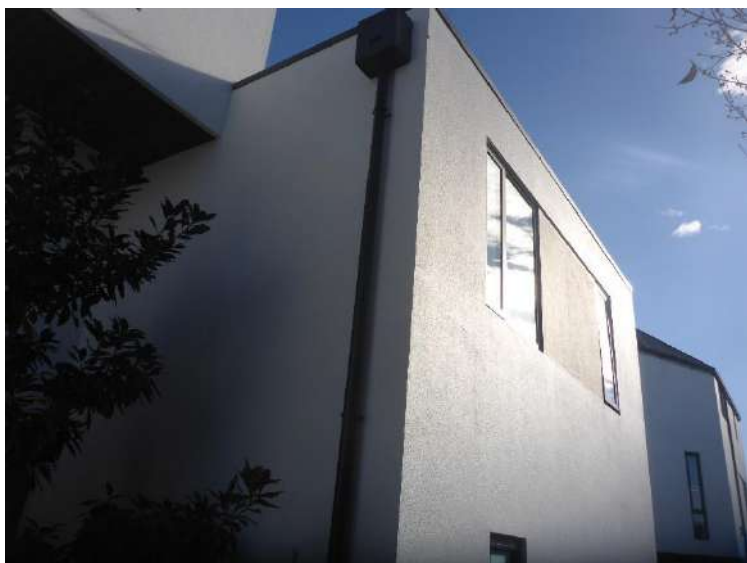
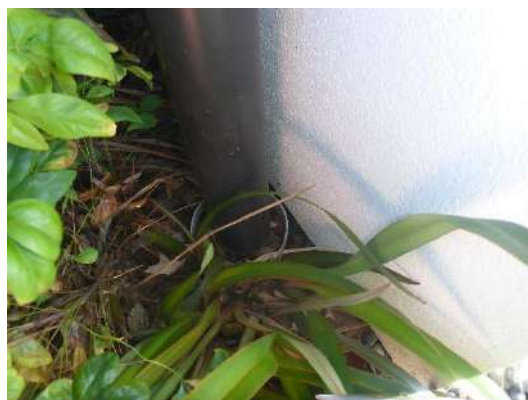
### Metal downpipes and rainheads

No significant weathertightness defects identified.

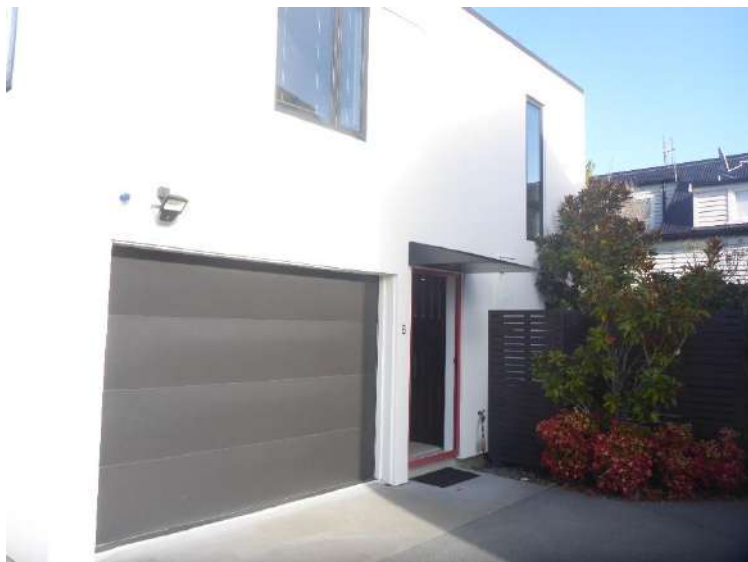
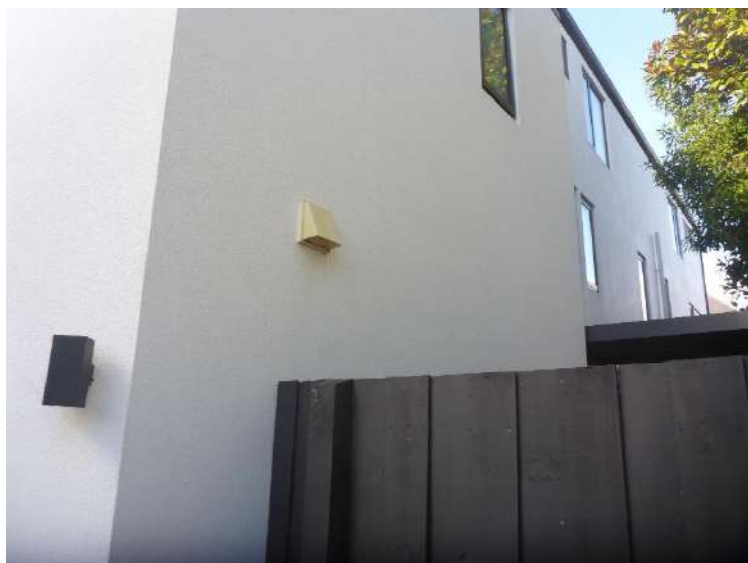
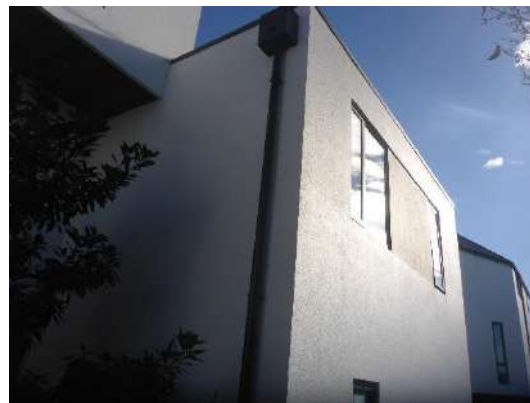
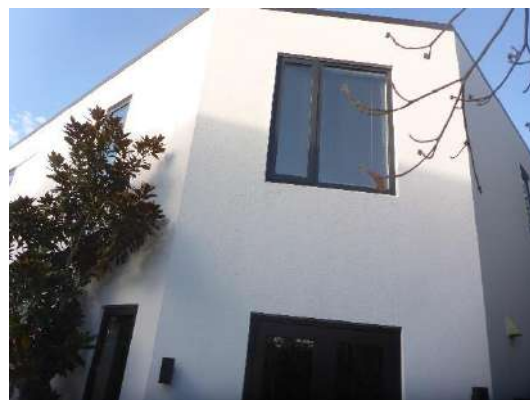
### AAC panel (Autoclaved Aerated Concrete Panel) over cavity system

The exterior cladding and paint are in good condition. No signs of weathertightness issues were identified. Repainting is likely to be required in approximately five years.

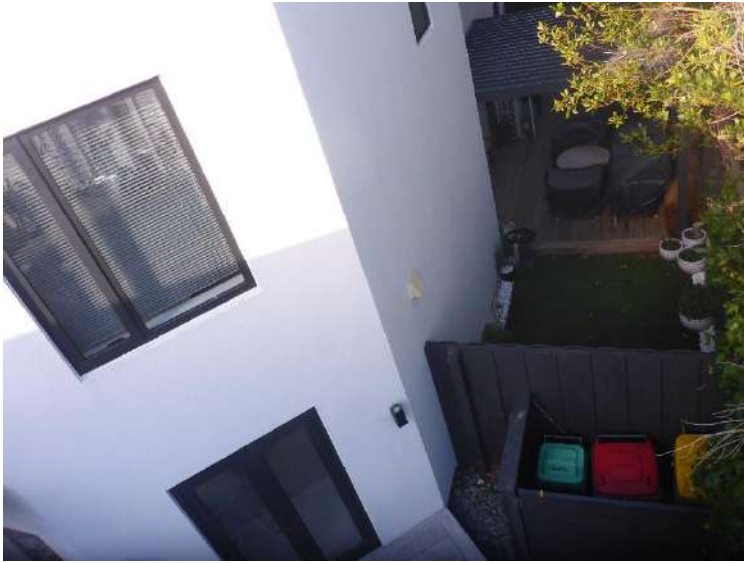
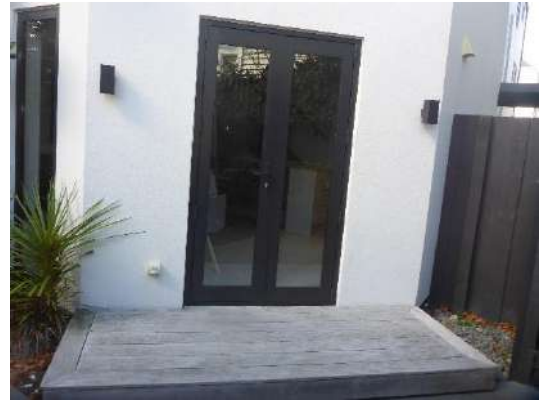
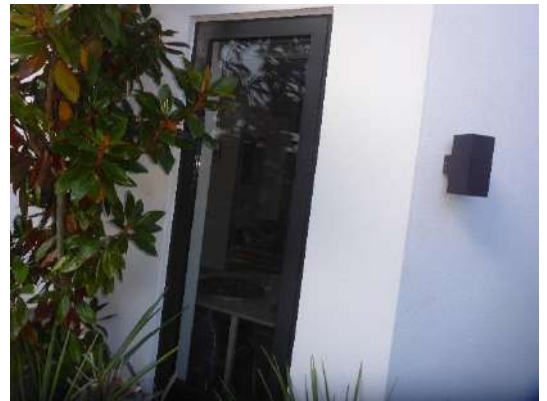
## EXTERIOR WINDOWS AND DOORS

No significant weathertightness defects identified.

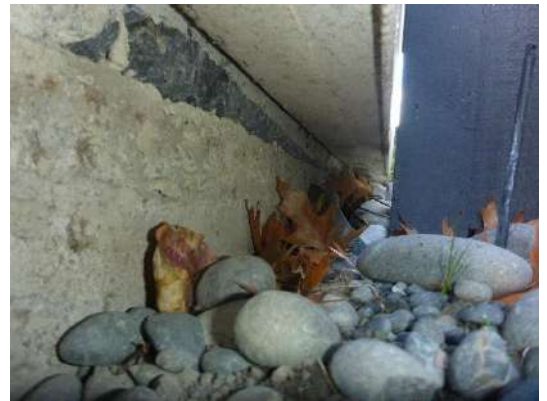
Concrete strip foundation

No significant weathertightness defects identified.

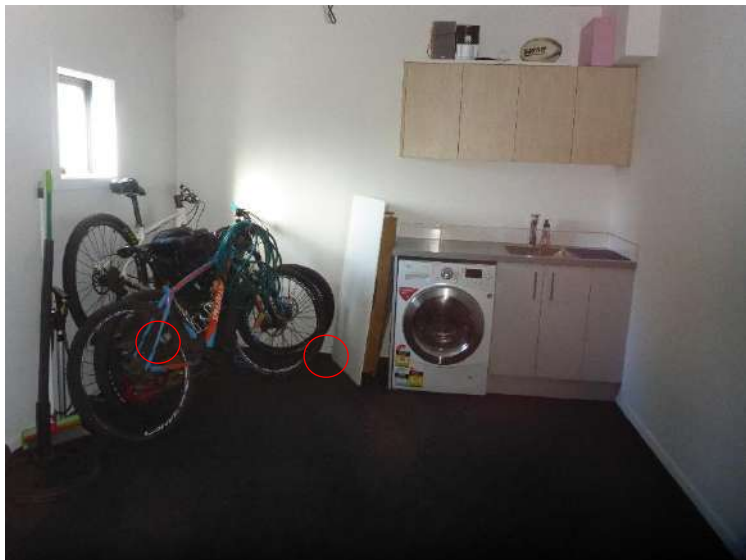
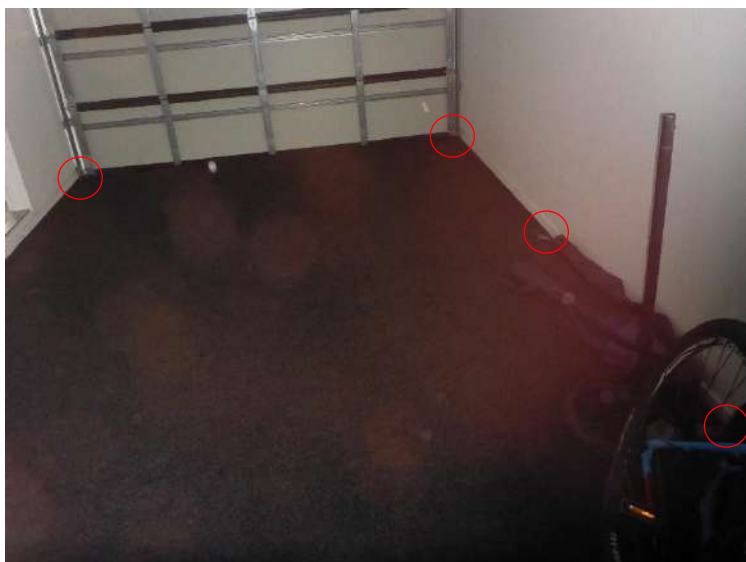
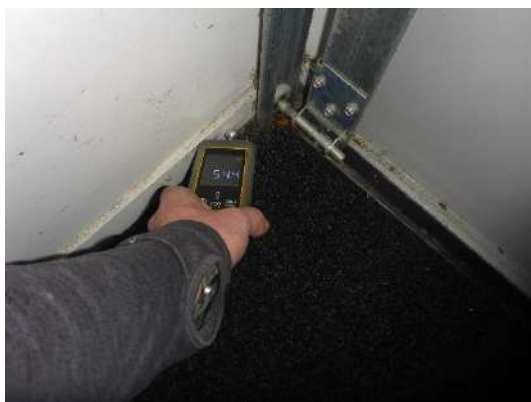
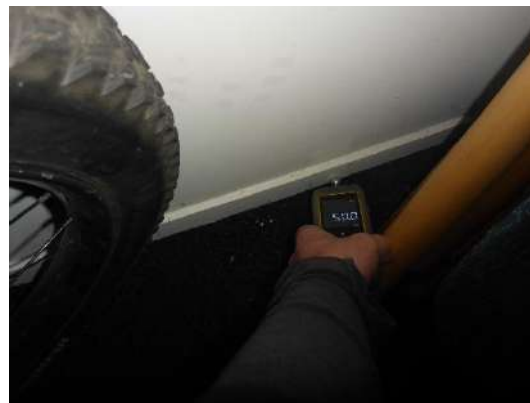
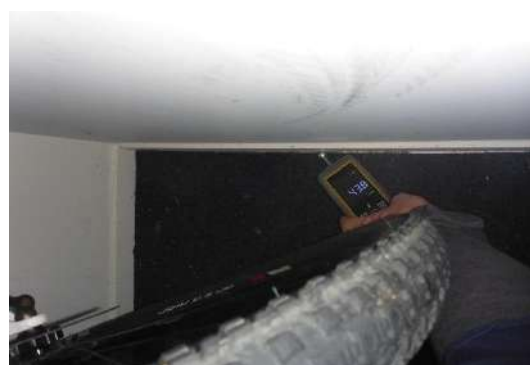
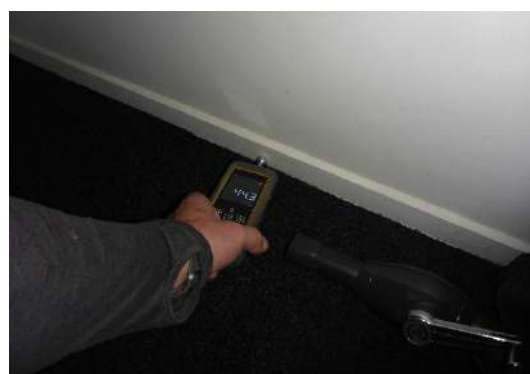
## GARAGE / LAUNDRY

No significant weathertightness defects identified.

Normal readings returned from moisture scanner.

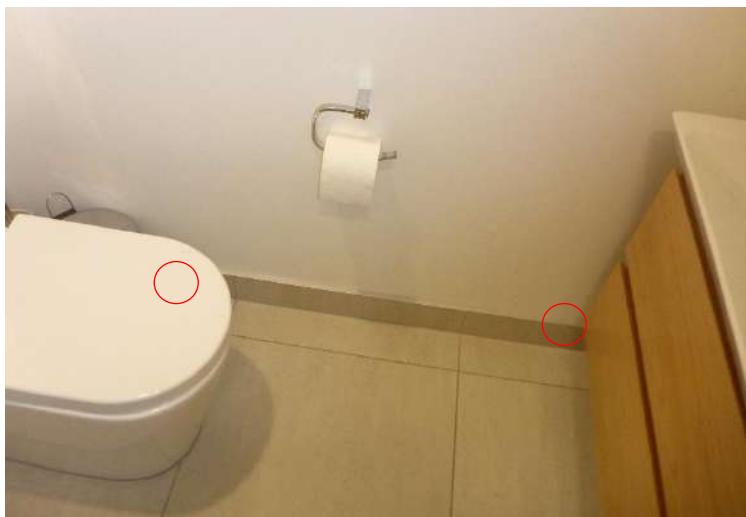
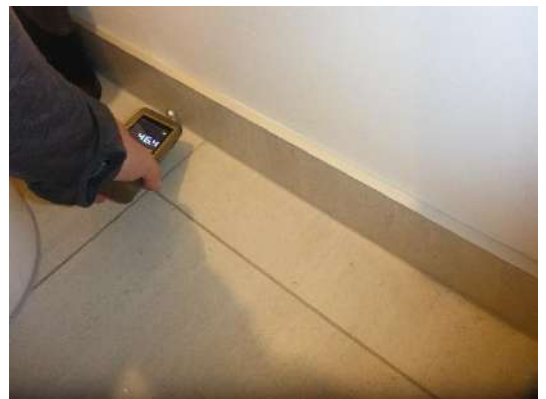
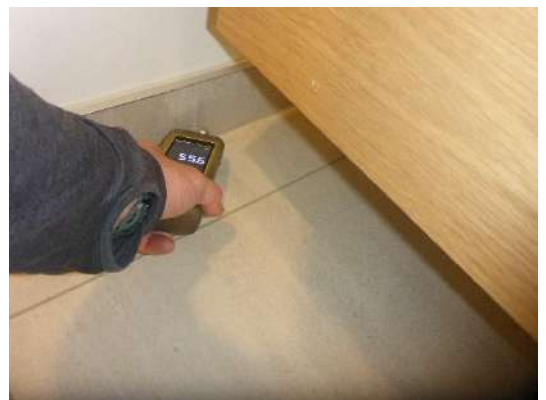
### TOILET

No significant weathertightness defects identified.

Normal readings returned from moisture scanner.

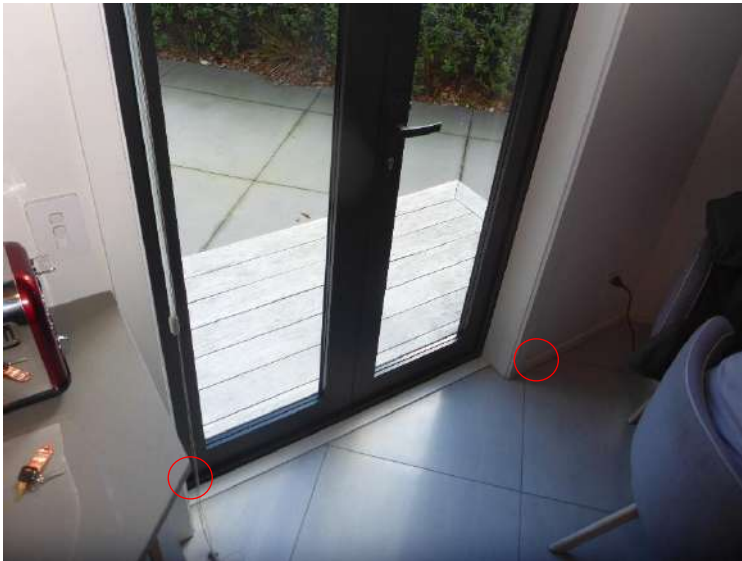
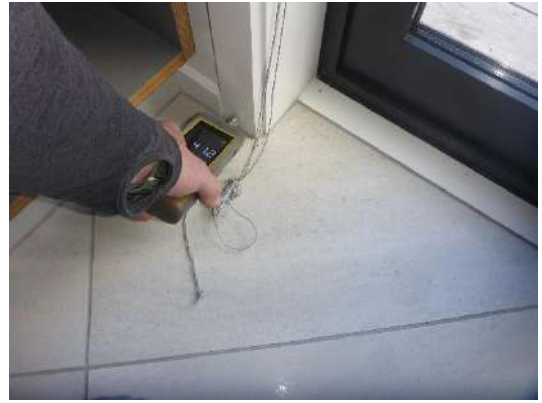
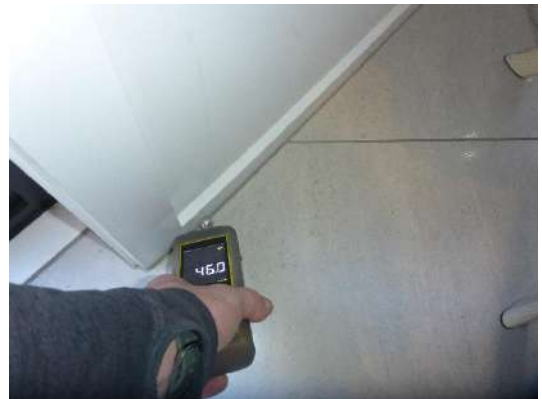
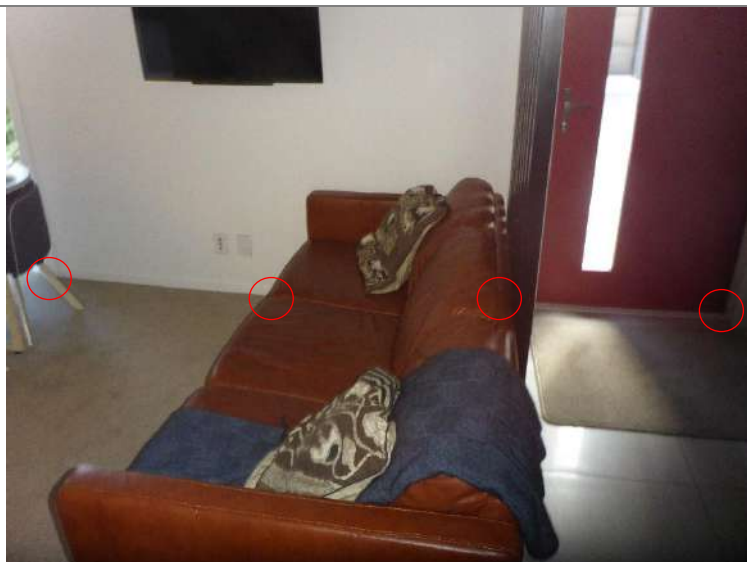
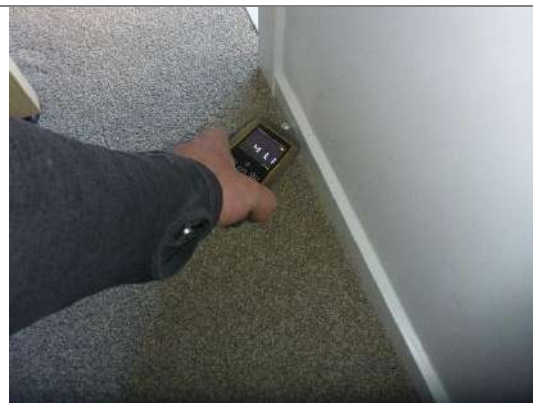
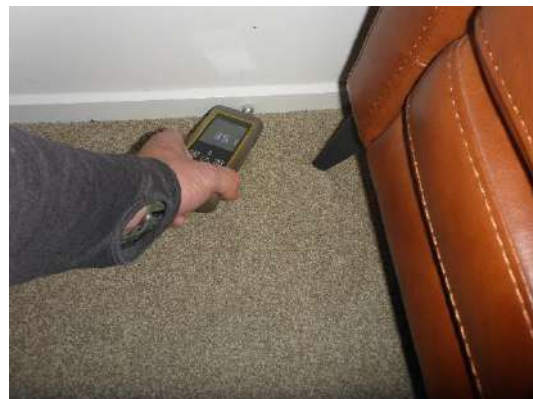
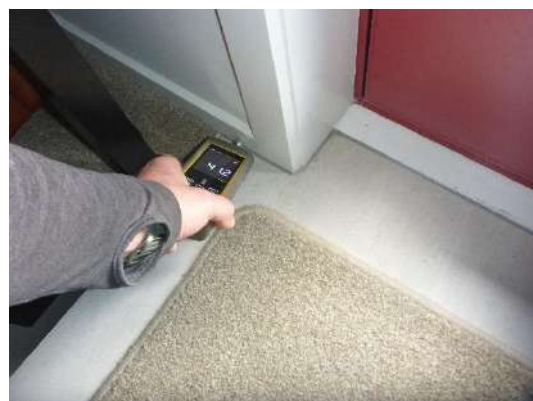
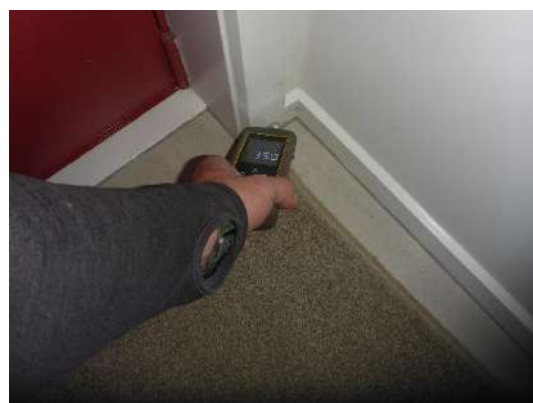
## KITCHEN / DINING / LOUNGE

No significant weathertightness defects identified.

Normal readings returned from moisture scanner.

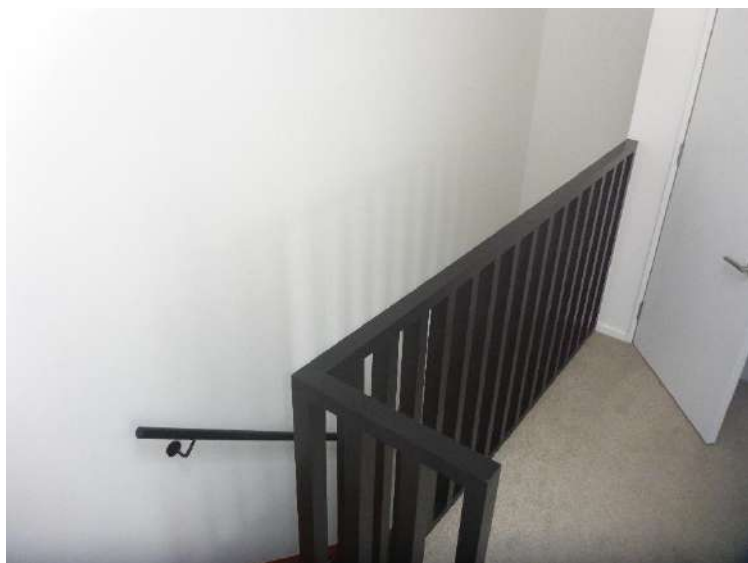
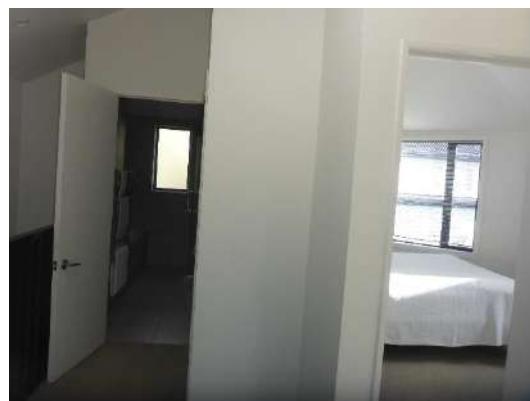
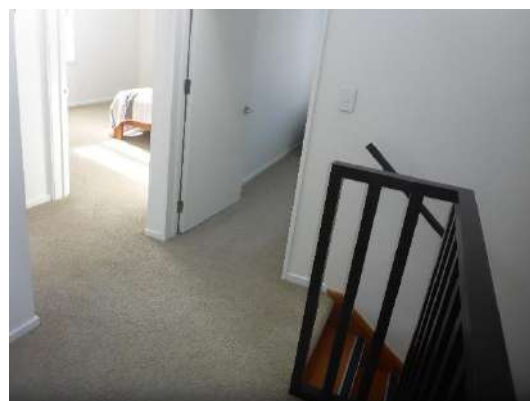
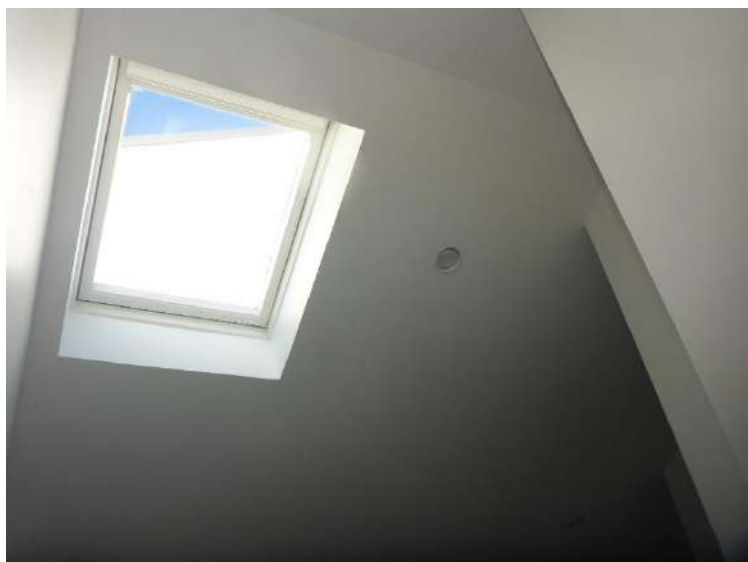
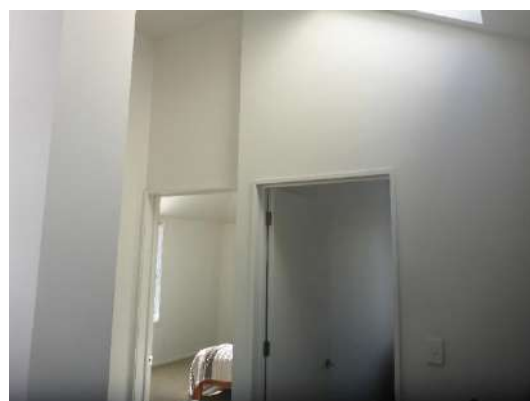
### HALLWAY / STAIRWELL

No significant weathertightness defects identified.

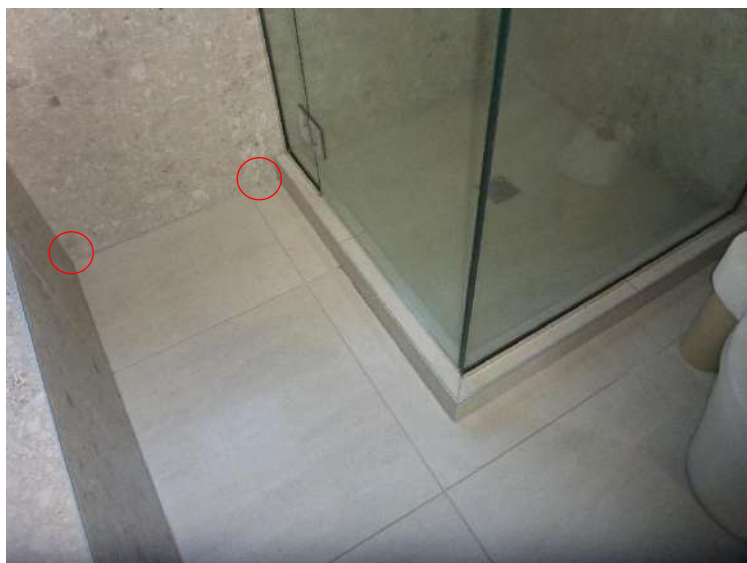
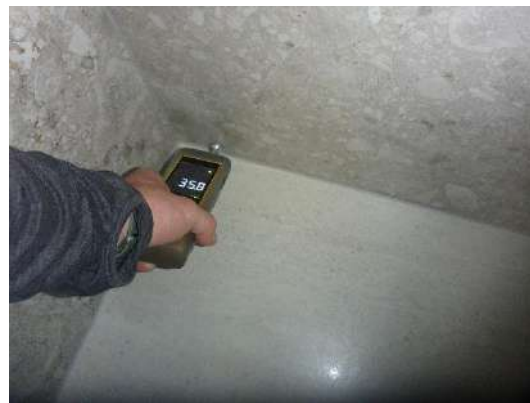
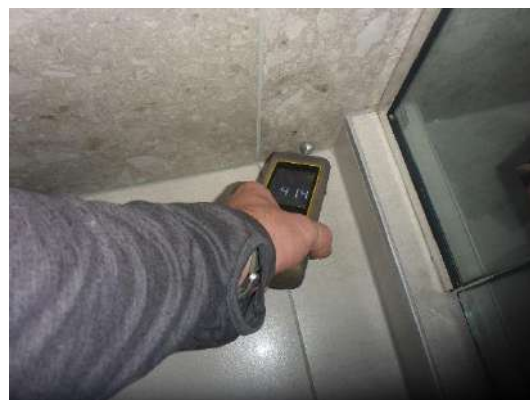
## BATHROOM

No significant weathertightness defects identified.

Normal readings returned from moisture scanner.

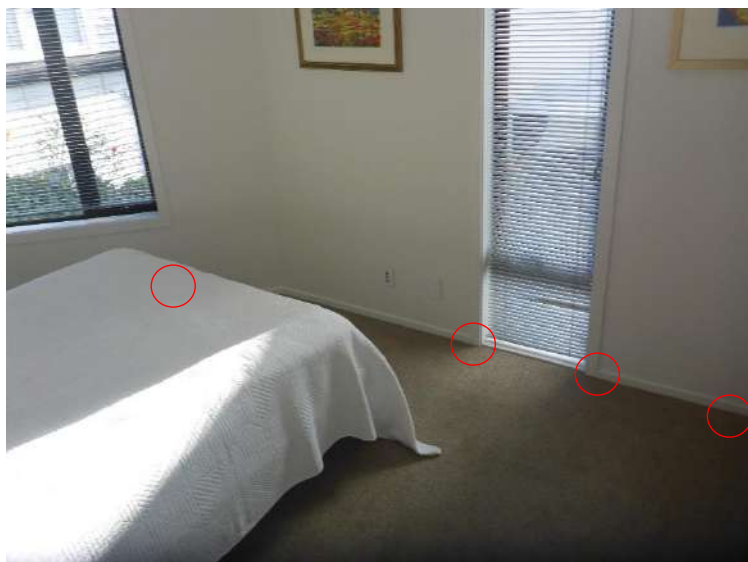
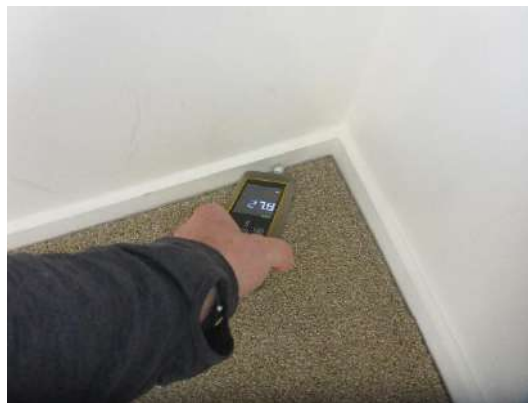
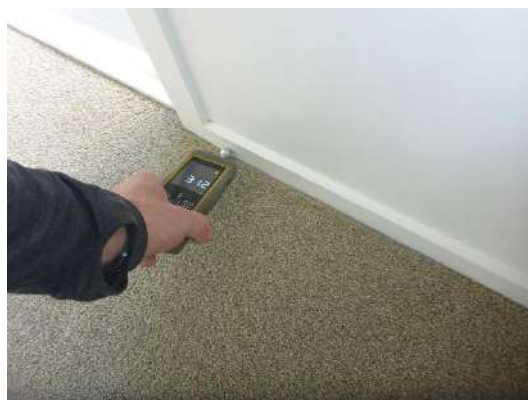
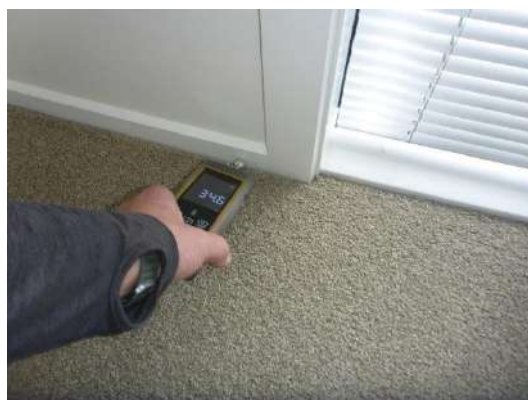
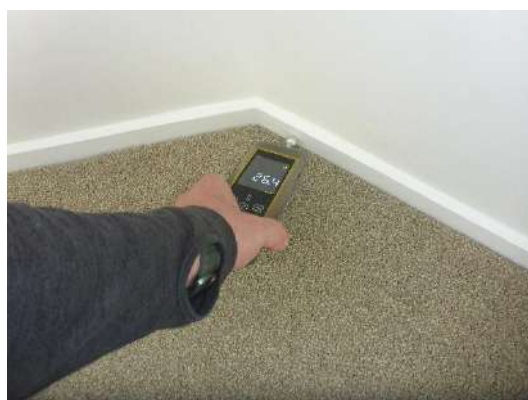
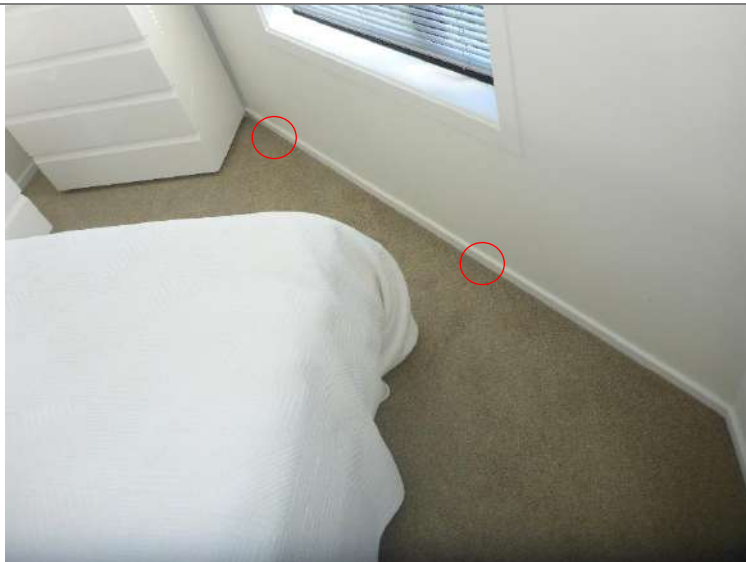
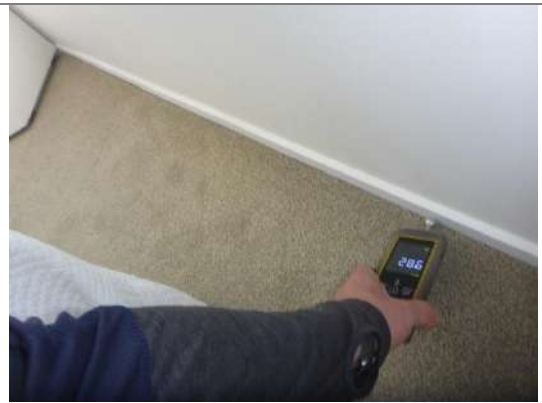
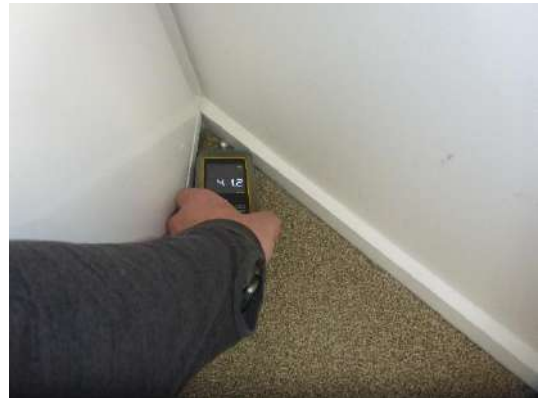
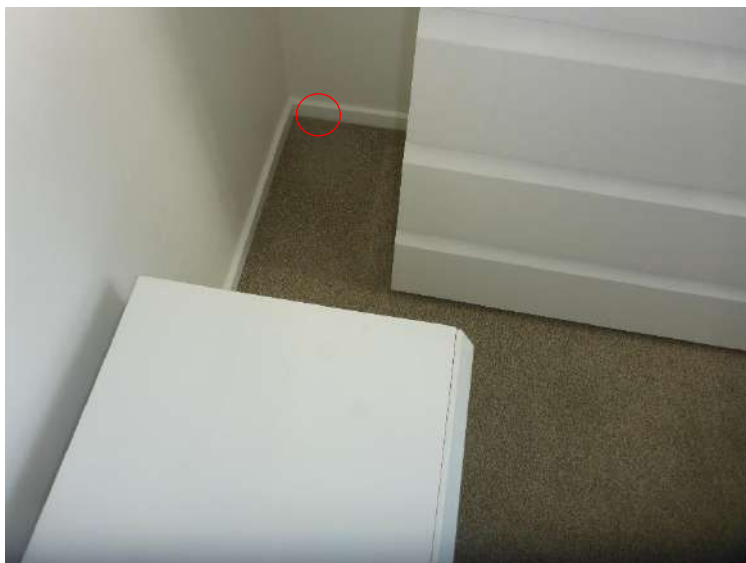
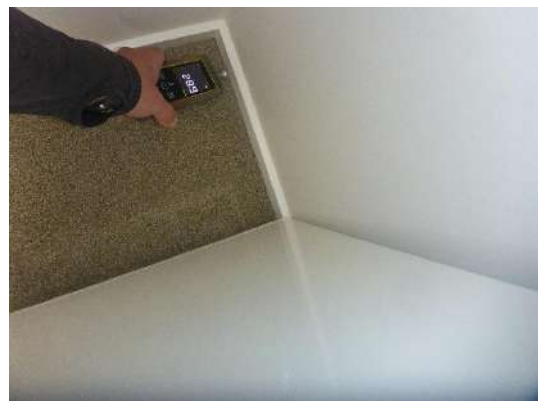
No significant weathertightness defects identified.

Normal readings returned from moisture scanner.

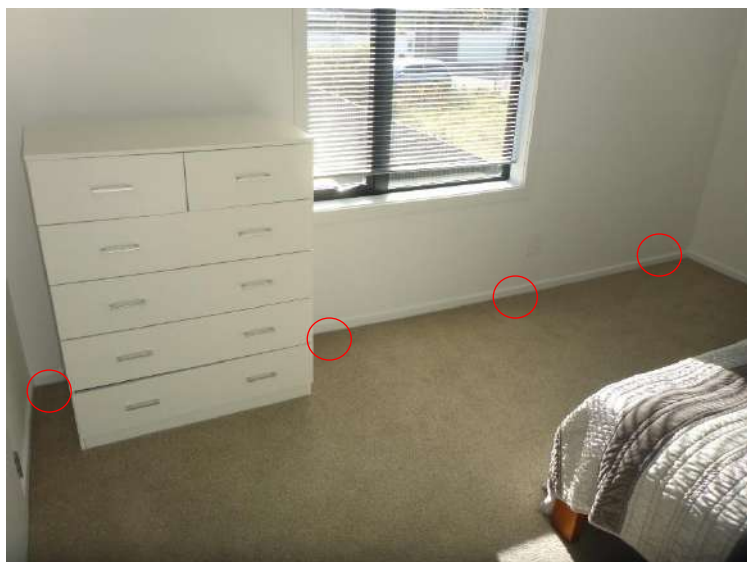
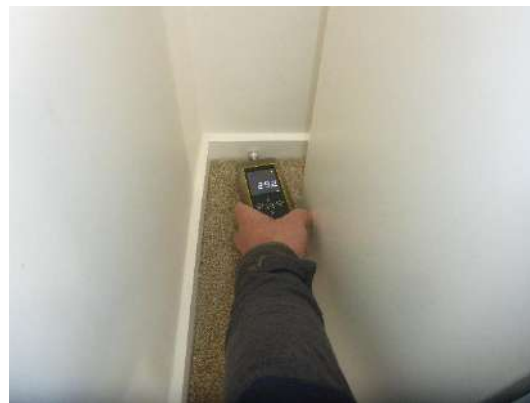
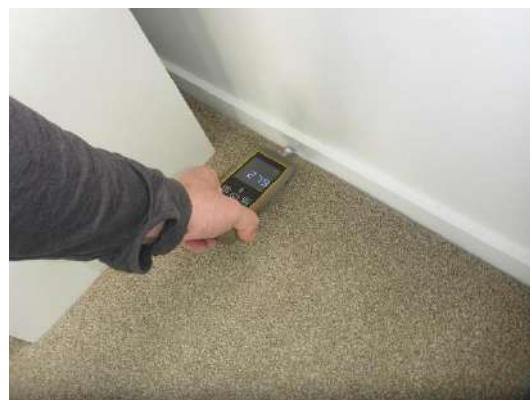
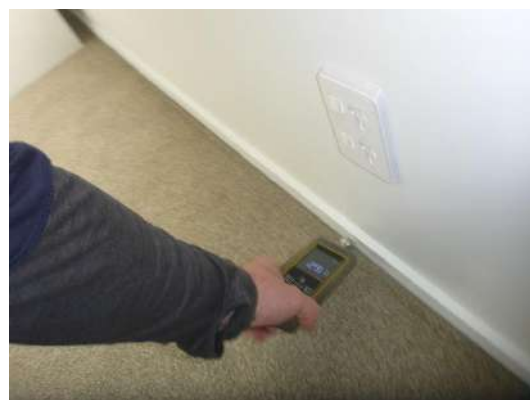
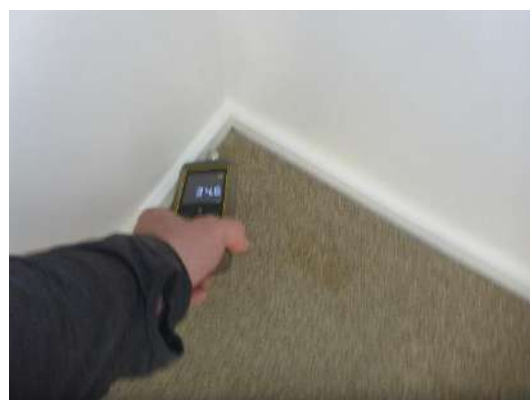
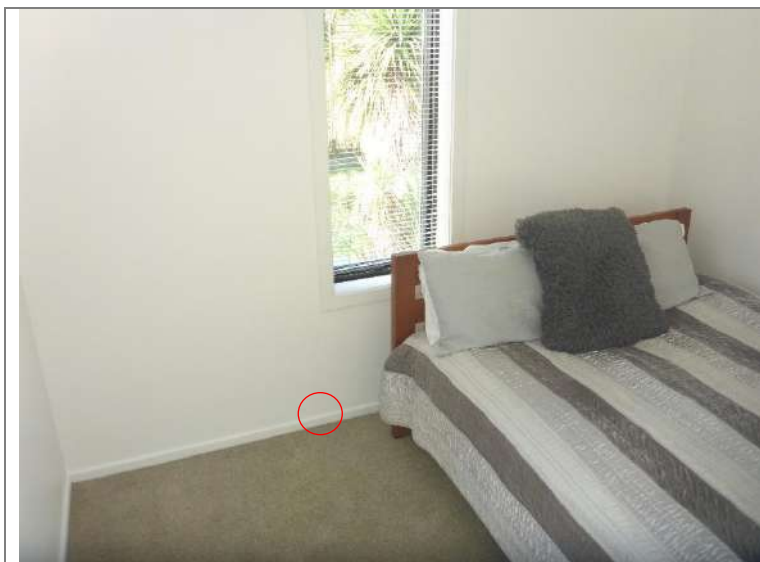
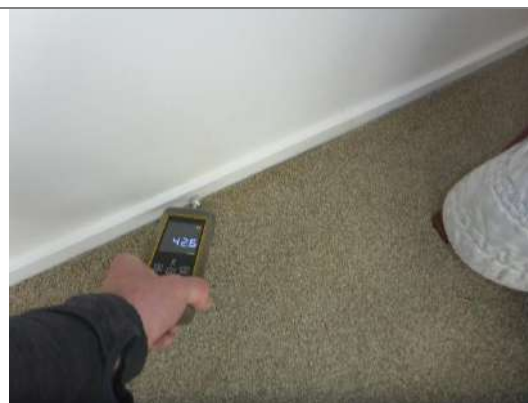
No significant weathertightness defects identified.

Normal readings returned from moisture scanner.

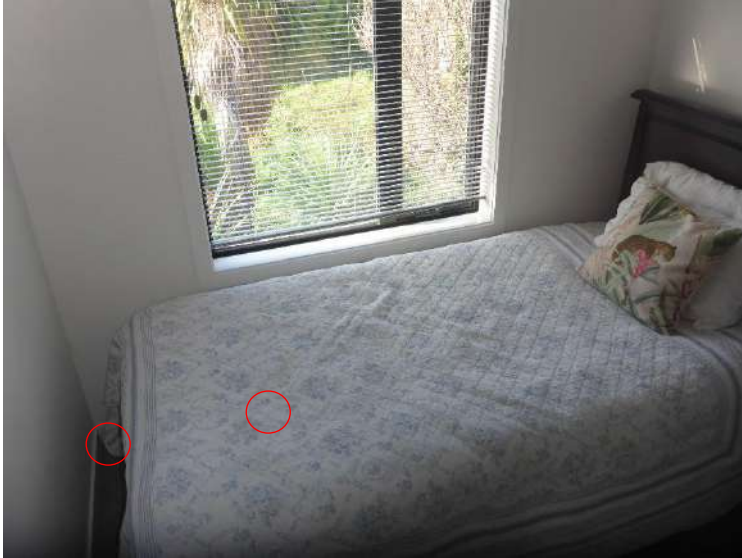
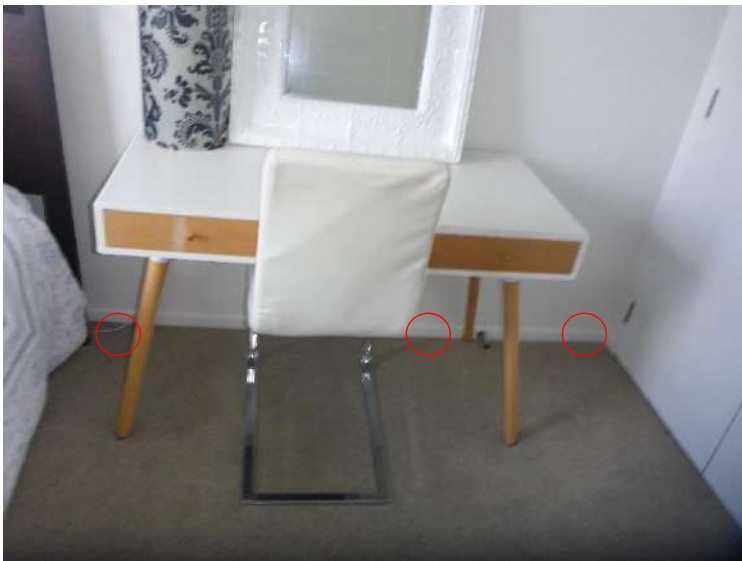
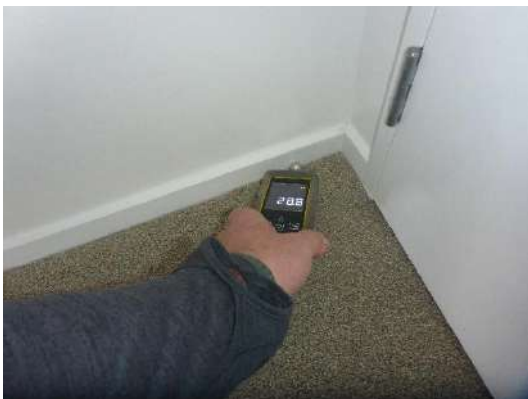
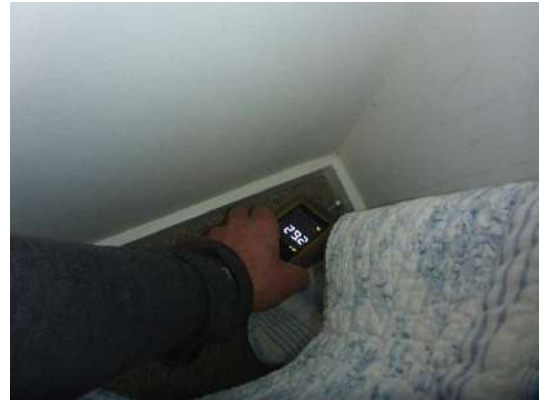
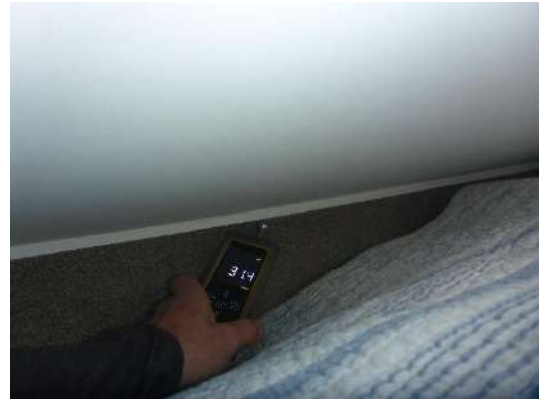
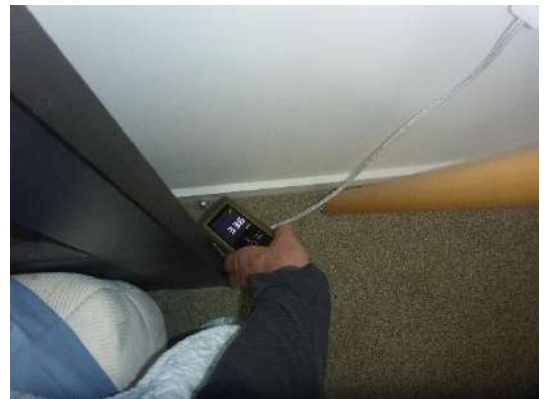
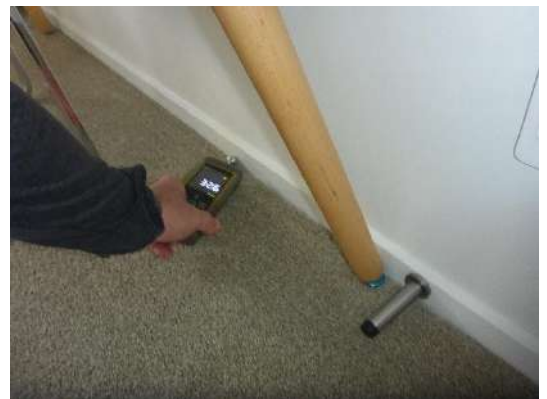
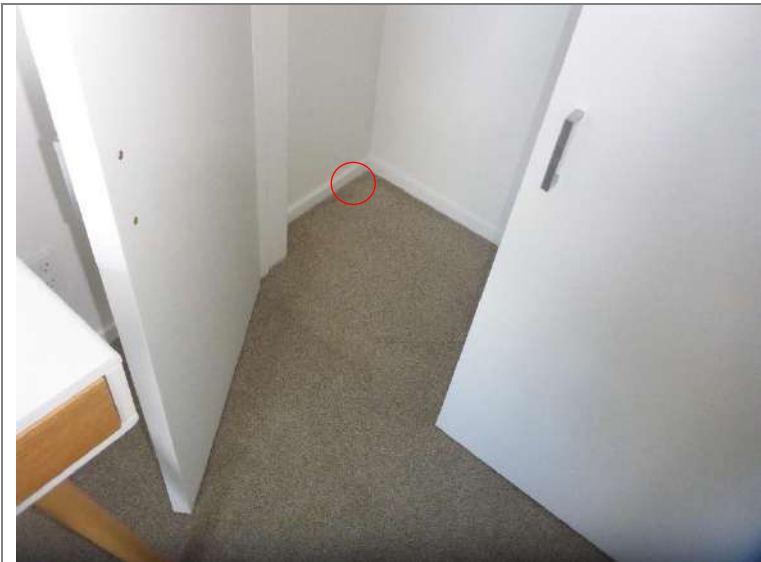
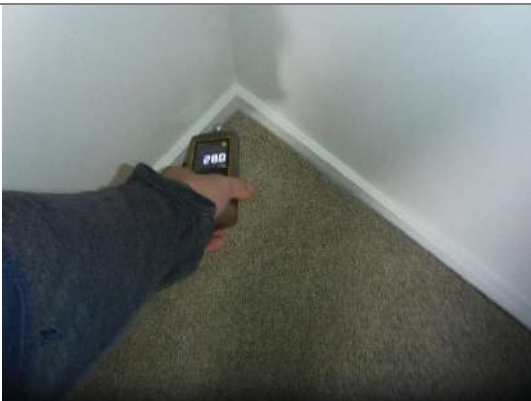
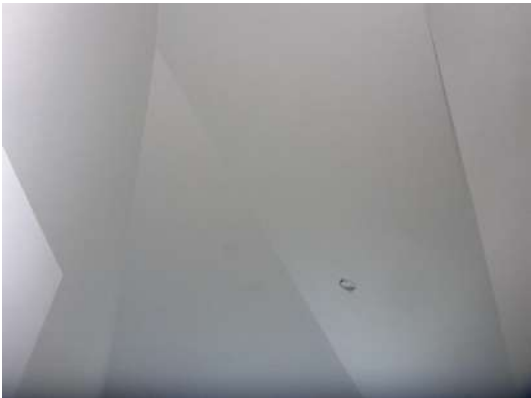
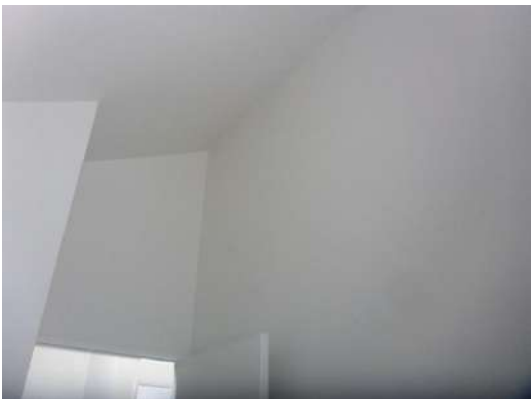
No significant weathertightness defects identified.

Normal readings returned from moisture scanner.
