# PRE-SALE BUILDING INSPECTION REPORT

for: Hamish Nimmo C/ Estate of L.Tod

15 Pratt Street  
Waikouaiti, Otago  
9510 New Zealand

Inspected by: Nathan Farrell | Inspection Date: 15 Jun 2026 | Ph: 027 4556106

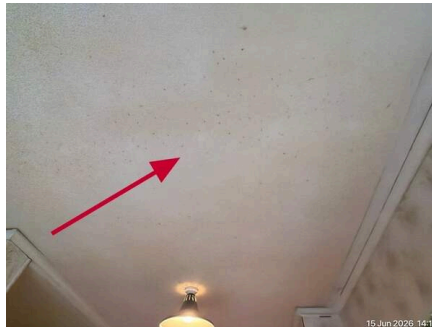
- Cracks and patches were sighted in the ceiling linings, this is commonly due to movement and settlement over time, some paint blemishes and staining were sighted also. Engage a plasterer and painter to improve these areas if desired.

#17: Paint deterioration and staining to the bathroom ceiling.

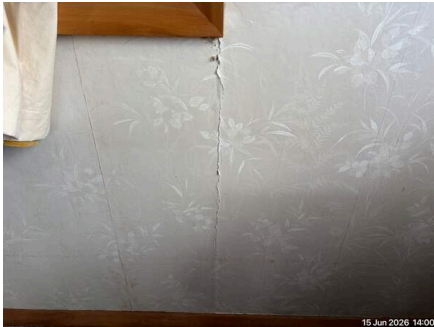
- Excessive Plaster cracks were sighted in the plasterboard wall linings. This is commonly due to movement and settlement over time and requires assessment by an engineer; some paint blemishes were also sighted. Engage a licensed builder, plasterer, and painter to improve these areas, if desired, after the structural repairs have been completed.

#18: Cracking visible in multiple locations.

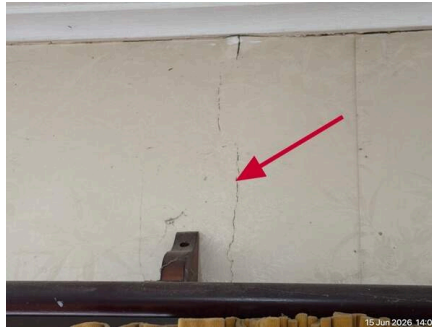
#19: Cracking visible in multiple locations.

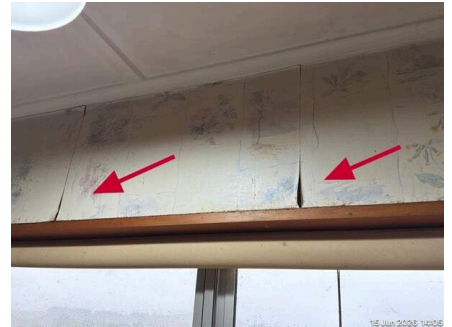
- Peeling and lifting of the wallpaper was sighted; this could be glued in place if desired.  
Further investigation

#20: Lifting wallpaper.

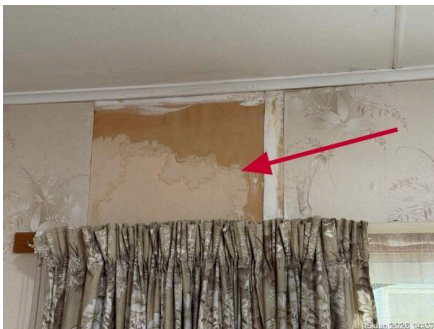
#21: Wallpaper missing.

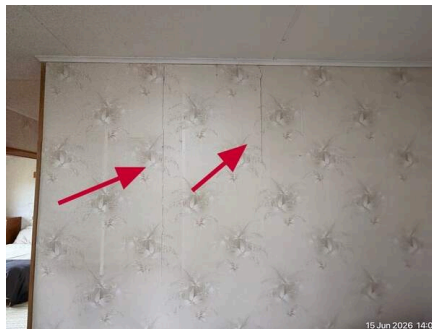
#22: Multiple cracks.

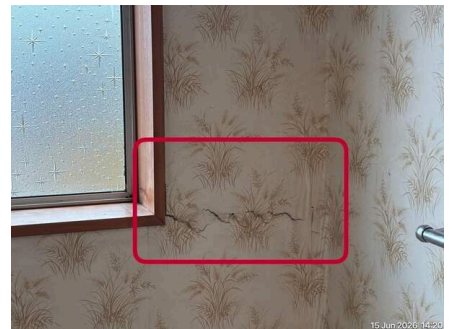
#23: Cracking to the bathroom linings.

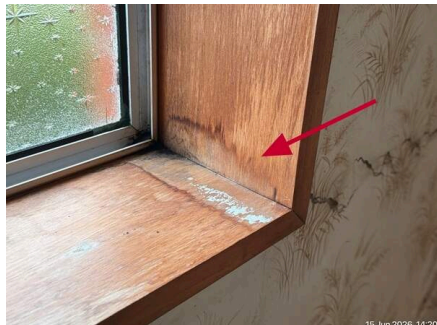
#28: Moisture staining.

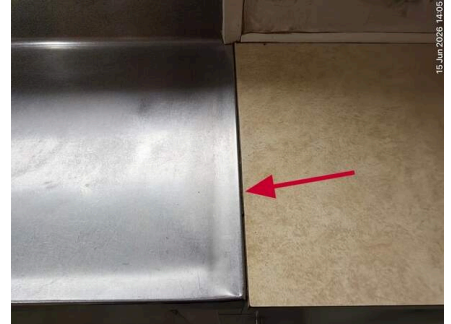
- The bench-top junction was not sealed, the installation of sealant would help protect the bench-top and cabinetry below from moisture.

#33: Gaps at the benchtop junction.

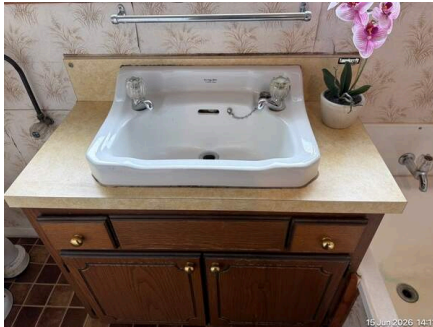
#56

- A leak was detected to the waste pipe below the basin. Engage a licensed plumber for repairs.  
Action Required

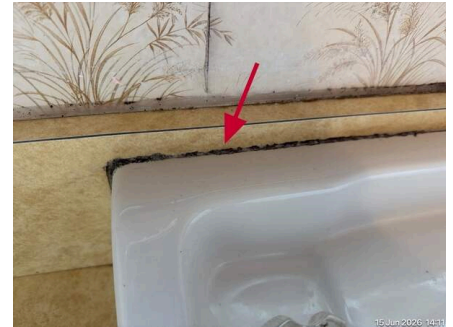
- Moisture damage and swelling are evident on the vanity unit. The silicone sealant at the vanity-to-wall junction exhibits deterioration and mould growth. Scrape out the degraded silicone and apply new sealant to prevent further moisture ingress and subsequent deterioration of the cabinetry and adjacent wall linings.

#58: Mouldy deterioration to the sealant.

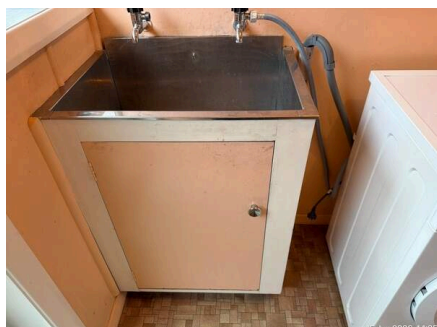
#62

**Details:** - The tub is not sealed at the wall junction, the installation of sealant would help prevent the potential deterioration of the cabinetry and wall lining behind.  
**Rating:** Minor Maintenance

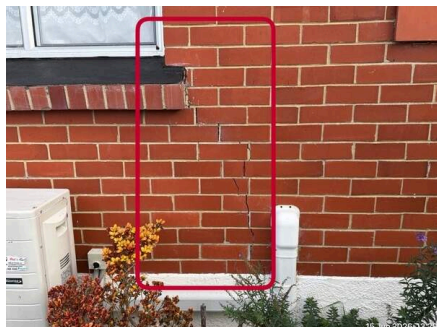
- A large number of cracks were sighted in the brick cladding. This is a sign of movement and could lead to further cracking. An engineer is required to assess and determine the cause and the best repair solution.

#76: Cracking to the northern face.

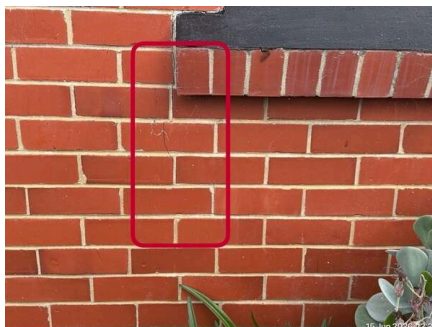
#77: Crack north face.

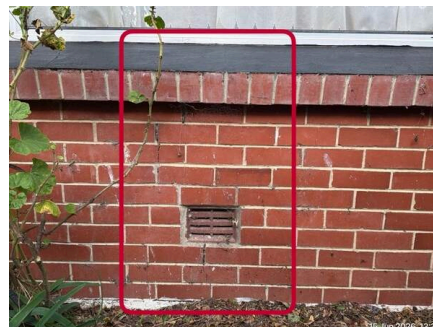
#78: Cracking western face.

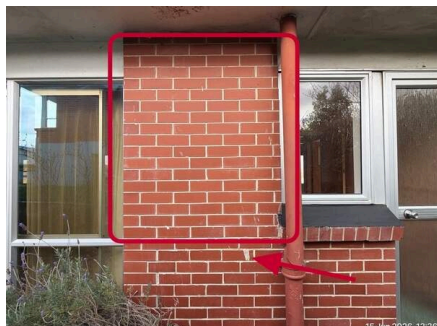
#79: Cracking and newer bricks in place indicating previous repairs.

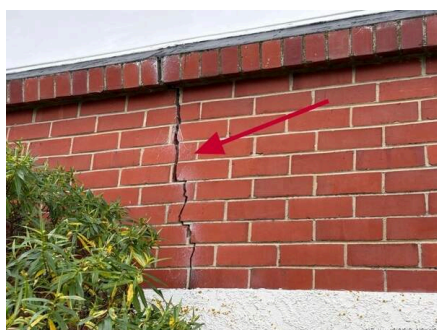
#82: Extensive crack to the south face.

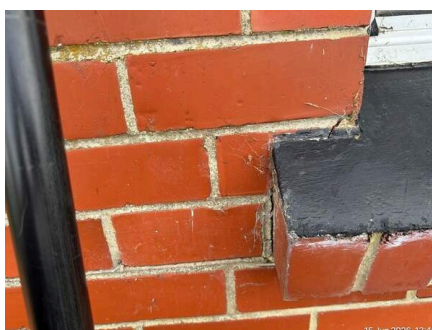
#83: Cracking and lateral movement visible to the SE corner.

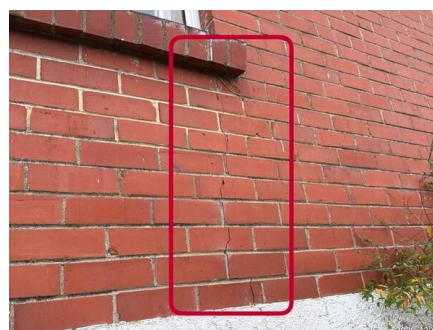
#84: Cracking to the eastern face.

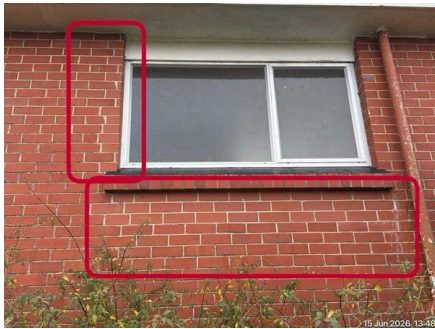
#85: Brick repairs visible to the eastern face.

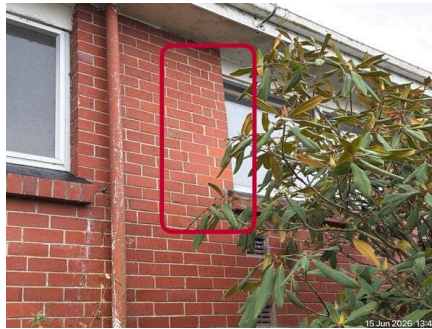
#86: Repairs visible eastern face.

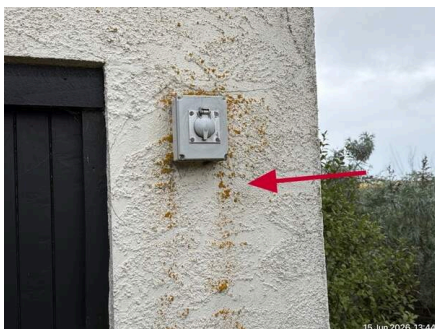
- Moss and lichen growth, alongside paint deterioration, are present around the exterior base of the basement. Engage a trade-qualified painter to prepare and repaint the affected surfaces.

#87: Moss and lichen growth to the foundation paint in various locations around the dwelling.

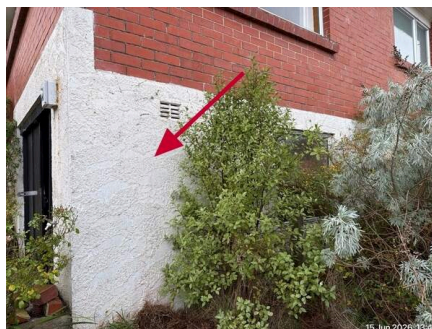
#88: General paint deterioration.

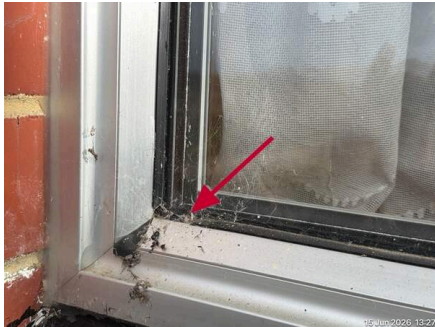
- Shrunken glazing rubbers were detected in some units, replacement of the glazing rubbers would be recommended to help improve the weather-tightness of the units.
  - Gaps were visible around the aluminium windows when closed, this is commonly due to the friction stays loosening, replacement of the stays is recommended in areas to enable the windows to pull up tight when closed.
- An aluminium joiner can complete this.
- Gaps were sighted at the window to cladding junctions, as photographed below. This could be allowing water ingress to the wall cavity. Upgrades to the junction are required to help prevent this. A licensed builder is required to assess and determine the best repair solution.
- Rating: Action Required

#90: Shrunken glazing rubbers.

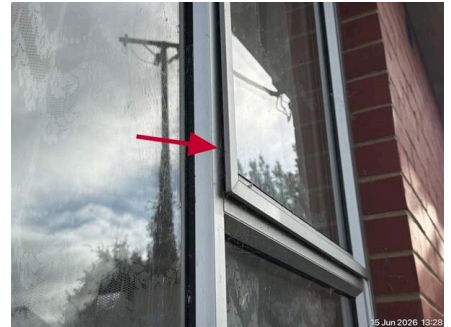
#92: Gaps around the closed sash

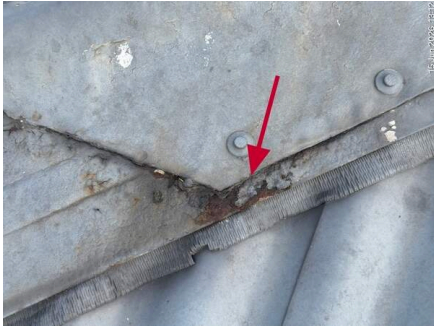
- Surface rust deterioration was detected to locations of the roof; further corrosion could lead to holes. Rust treatment repairs and re-coating would help reduce the corrosion. A licensed roofer is required to assess and determine the best repair solution.

#115: Corrosion present.

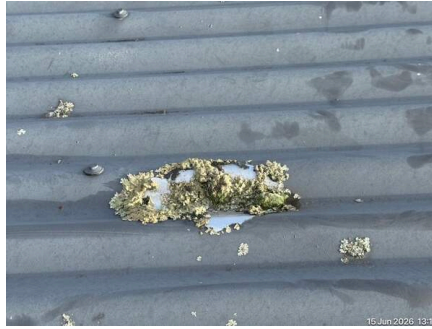
#116: Moss and lichen.

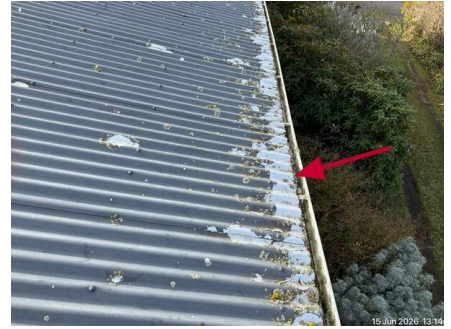
#117: Extensive sheet edge deterioration.

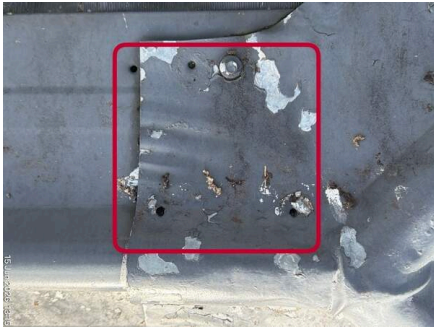
#118: Multiple unsealed penetration holes.

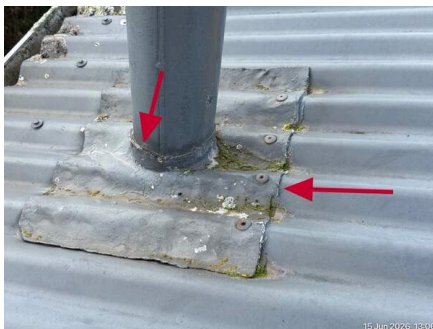
#119: Older penetration flashing showing signs of deterioration. And gaps around the pipe junction.

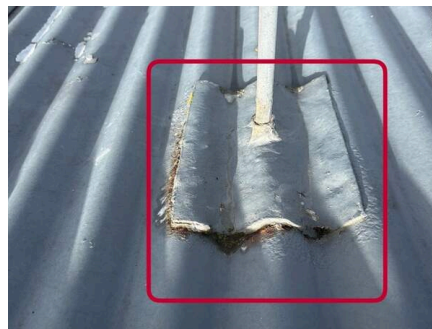
#120: Older flashing with corrosion and gaps present.

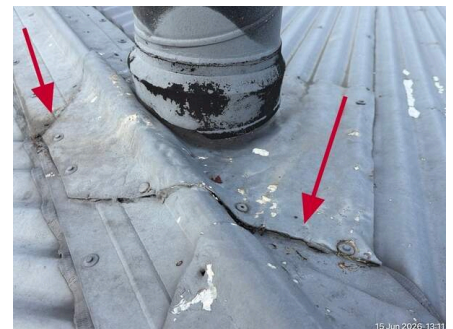
#121: Older flue penetration flashing with gaps visible and flashing corrosion visible.

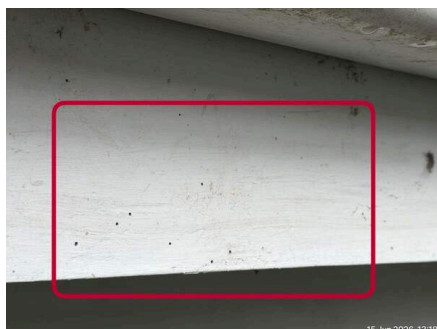
#127: Borer holes in the Fascia.

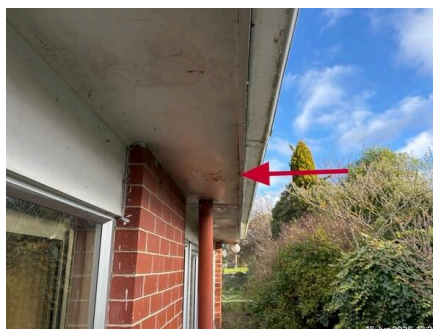
#128: Moisture staining and sagging visible to the eave linings.

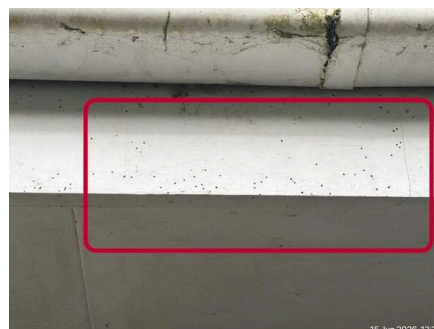
#129: Borer holes in the Fascia.

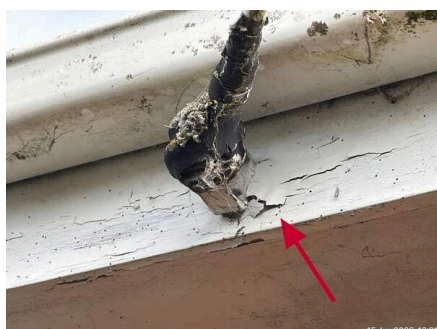
#130: Borer and paint deterioration.

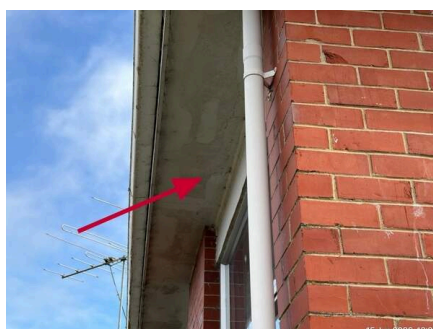
#131: Mould staining.

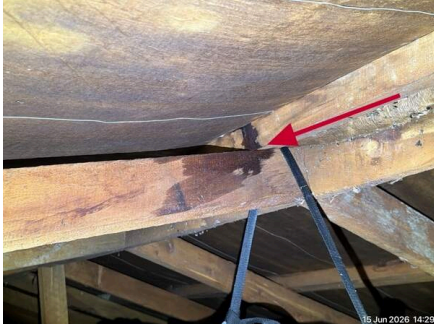
#138: Moisture staining to the framing visible.

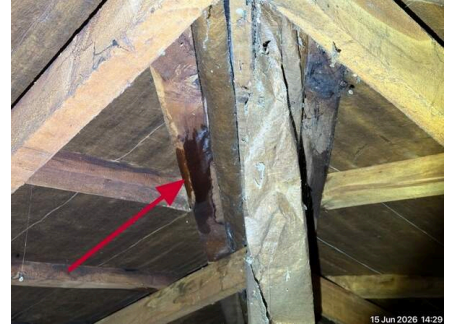
#140: Moisture staining to the framing visible.

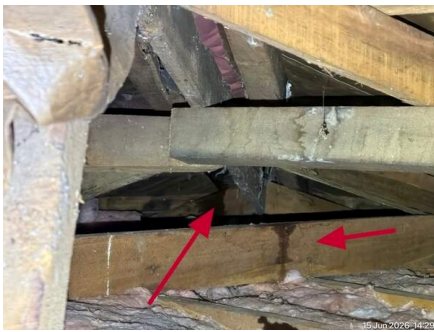
#141: Moisture staining to the framing visible.

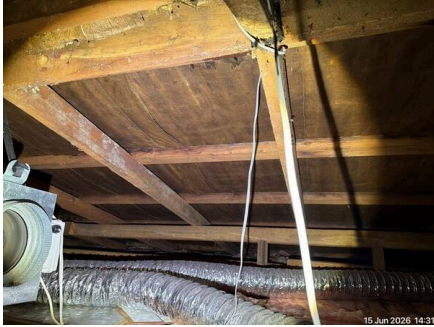
#145

**Details:** - Tears and holes were sighted in the roofing paper, repairs to the roofing paper can take place from inside the roof cavity to ensure it would perform if required.  
**Rating:** Minor Maintenance

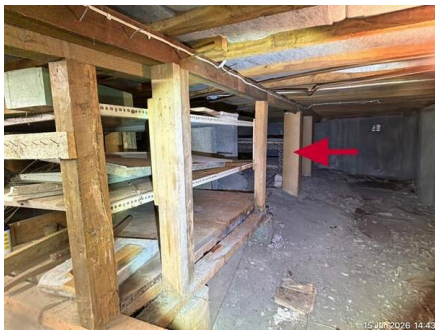
#159: Leaning piles visible.

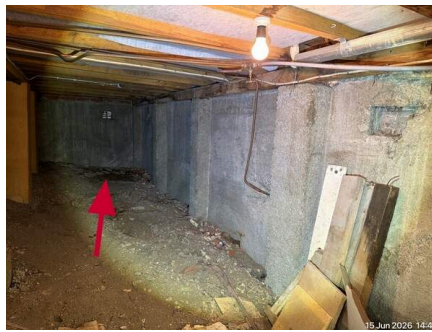
#160: Settlement noted to the northern and eastern sections of the foundation

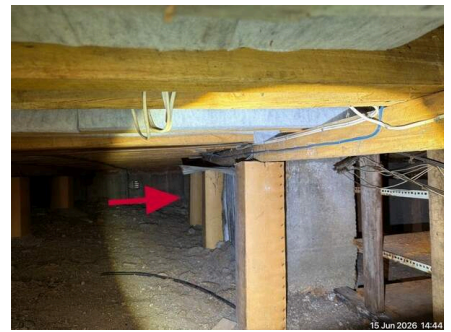
#161: Leaning piles visible.

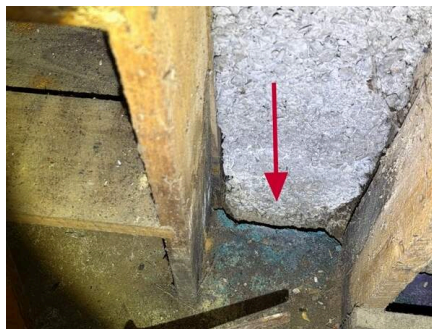
#163: Settlement noted to the northern and eastern sections of the foundation.

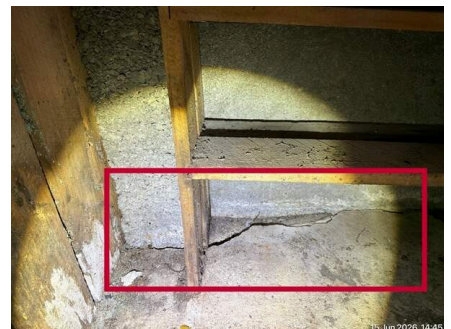
#164: Settlement noted to the northern and eastern sections of the foundation.

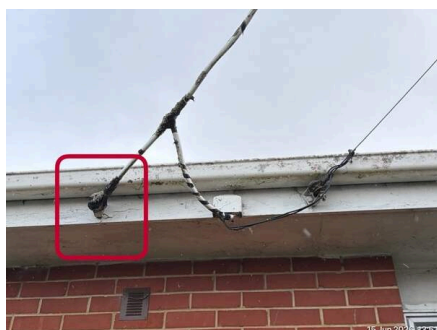
The overhead cable connection to the dwelling, the timber facia has excessive borer holes and deterioration visible. If further movement occurs, strengthening or replacement may be required.

#186: Structural integrity concerns due to borer and timber/ paint deterioration.

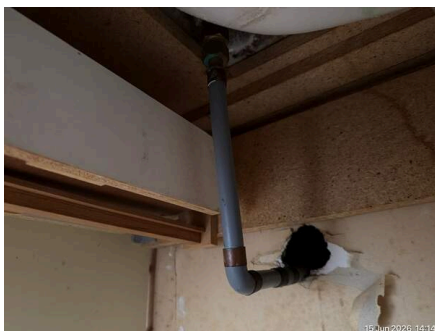
#198

**Plumbing Pipe Details:** - Grey Dux Qest pipe was sighted, I recommend further investigation takes place by a licensed plumber to determine if this piping has the same problems as the black Dux Qest, we recommend further investigation and if required replacement by a trade qualified plumber.  
**Rating:** Further Investigation

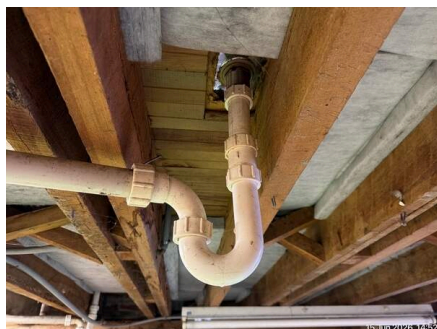
#201: Shower waste leak.

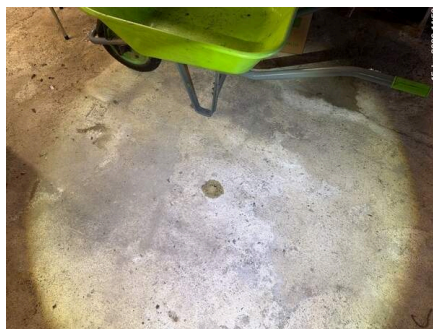
#202: Shower waste leak.

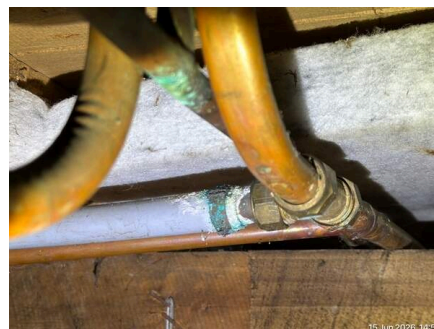
#203: Corrosion visible to the pipe connection in the subfloor under the HWC.

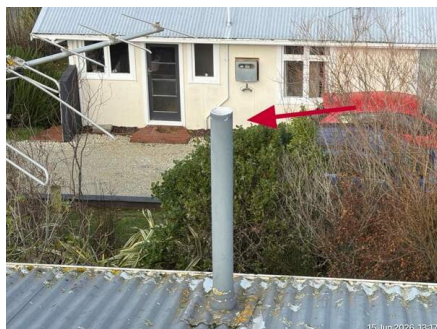
The vermin cap is missing from the plumbing terminal vent on the roof. This exposes the drainage system to potential blockages caused by debris, birds, or rodents entering the pipe. Engage a licensed plumber to supply and install a compatible vermin cap to protect the system.

#204: No vermin cap to the vent.

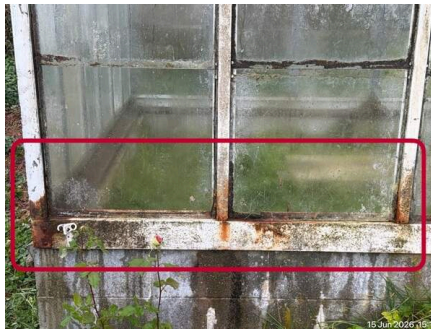
#225: Corrosion to the frame.

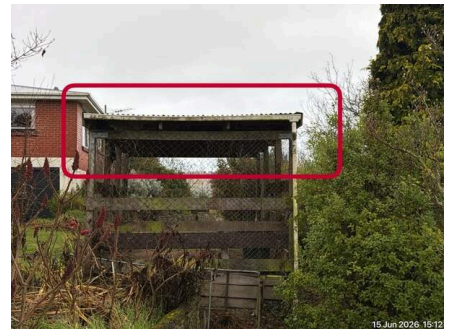
#226: Sagging visible to the frame.

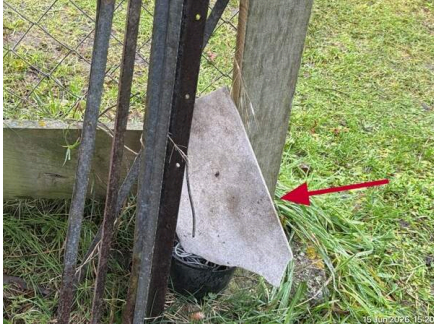
#244: Potential asbestos.
