Property Risk Assessment Report

Prepared for: Body Corporate 349938
Date: 27 October 2023
Inspected by: Tony Joyce

30 Heather Street
Parnell Auckland
New Zealand

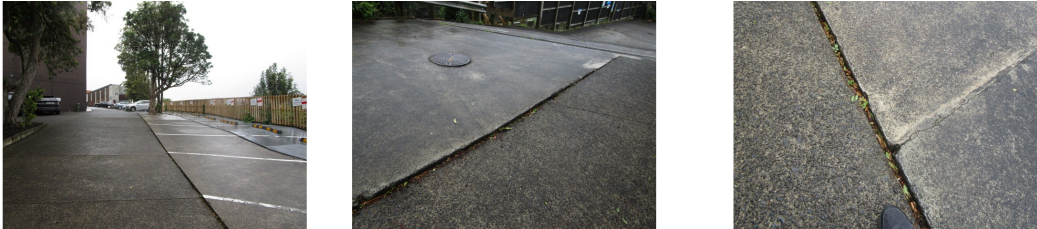
Item #: 4635456

Multiple tenants use this area, which means as a PCBU, there are overlapping duties with other parties.

Where the differing ground surfaces meet, there is a level change, creating a trip hazard.

We recommend consultation, co-operation and co-ordination with the other PCBUs, and their arrangements with shared overlapping duties to control risks.

We recommend remedial repairs.

At a minimum, we recommend the level changes be highlighted.

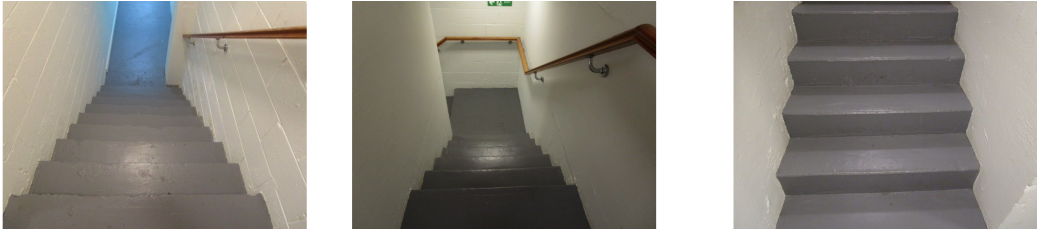
Risk Rating: M
Item #: 3750804

There is no edge delineation on the stair treads, which makes it difficult to discern each tread.

The lack of tonal contrast creates a potential trip hazard.

The installation of contrasting, non-slip nosings is recommended to highlight the leading edge of the stair treads as per NZBC Clause D1.3.3(g).

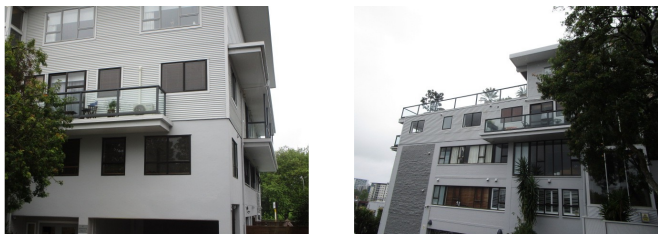
Risk Rating: H
Item #: 3750801

There are balconies on the building. There is a potential climb-over hazard where furniture is located against or near the balcony barriers.

This hazard is not a "Workplace" hazard in that it does not affect workers on-site. Although the balconies are not located in a common area, it is likely to affect occupants, particularly children. For this reason, we have classified it as a General Hazard, and we recommend the following controls.

We recommend the Occupants / Unit Owners be advised of the dangers of placing furniture and / or planter boxes against or near balcony barriers and that children on the external balconies are supervised.

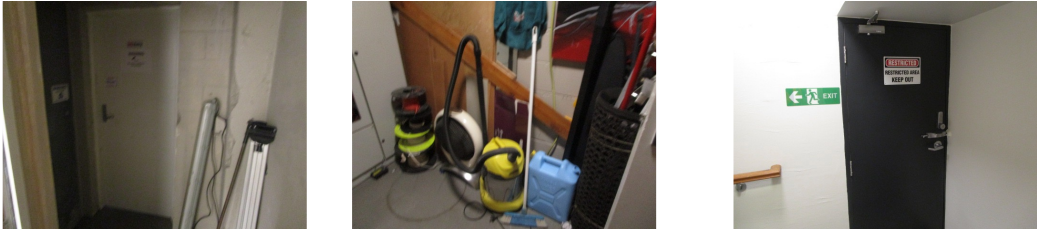
Level / Floor: Ground Location: Main Switchboard Room

The items are trip hazards for anyone working in the room and have the potential to obstruct the electrician who needs clear access to equipment.

We recommend rubbish and other items be removed to keep the Switchboard room clear, as required by the Australian / NZ Wiring Rules.

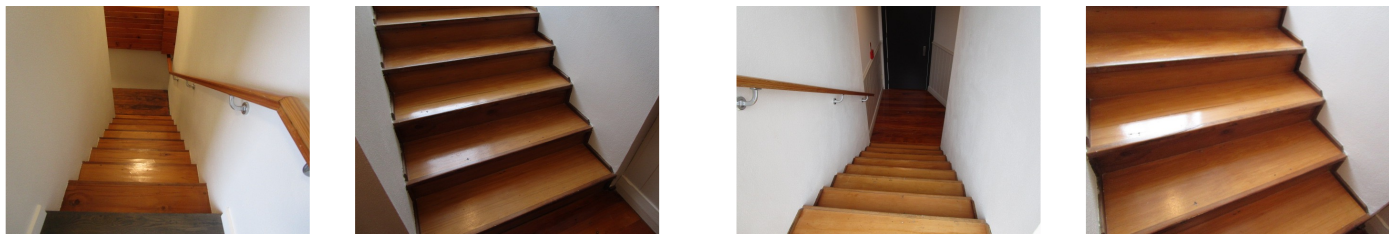
Risk Rating: N/A
Item #: 3750794

The treads and nosings on the stairs are in good condition.

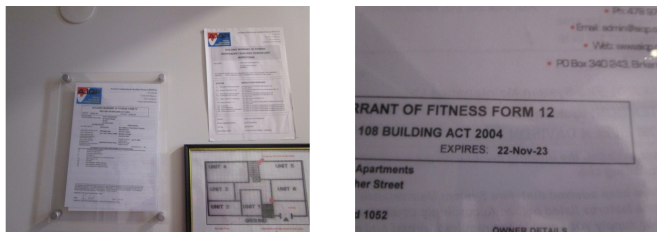
Risk Rating: N/A
Item #: 3750796

Hazard Description:
Building Warrant of Fitness (BWofF) is current.

.....
Recommended Hazard Control:
No action required.

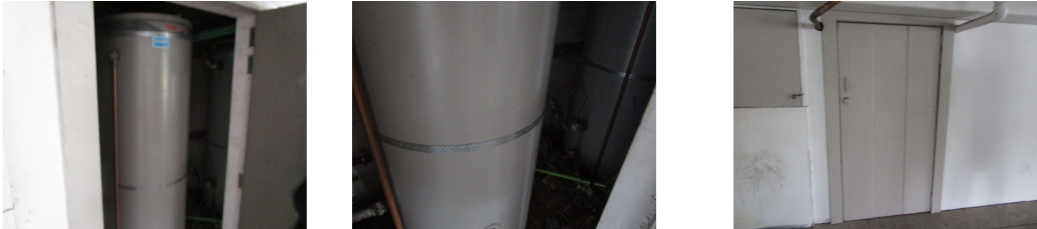
Level / Floor: Ground Location: Carpark

Hazard Description:
The hot water cylinder has been secured to prevent movement.

Recommended Hazard Control:
No action required.

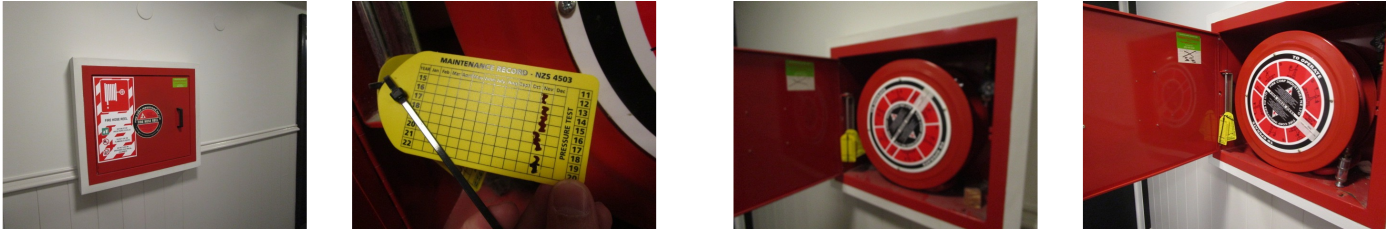
Level / Floor: All Levels Location: Corridors

Hazard Description:
The fire hose reel servicing is up to date.

Recommended Hazard Control:
No action required.
