## SAFE & SANITARY REPORT

4 PUKEKO STREET

HILLCREST

## SAFE AND SANITARY REPORT

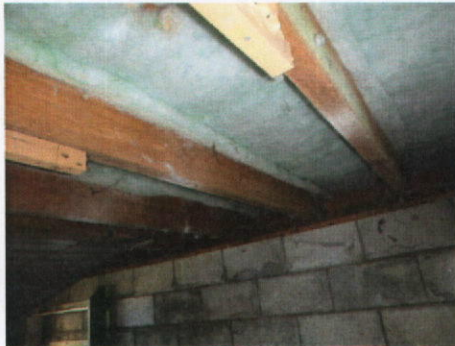
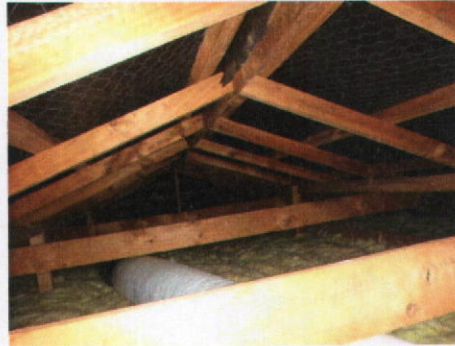
- Framing is 100 x 50. Pitched truss roof framing, all is solid and in reasonable condition.

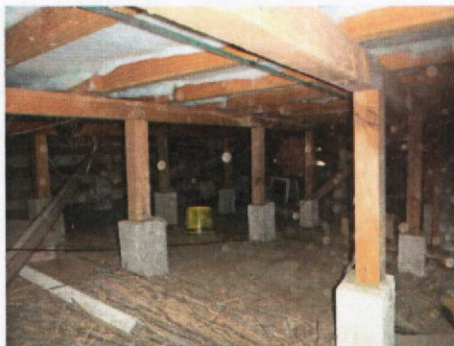
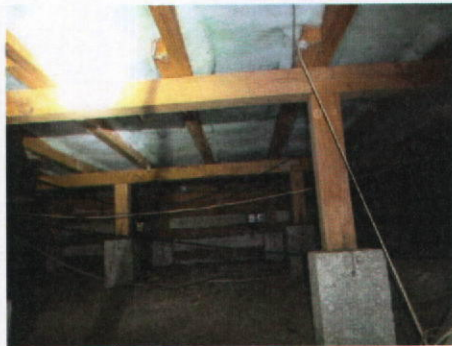
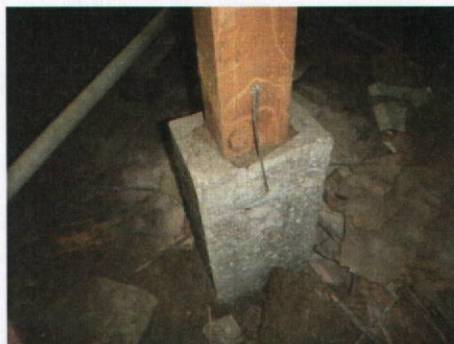
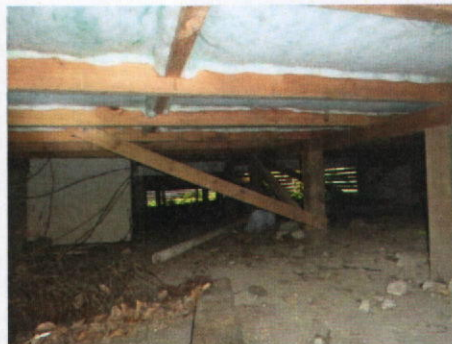
- Foundations are a concrete block to the garage. Pile construction to the dwelling. Concrete block pile, 4 x 3 piles and 4 x 3 bearers, 6 x 2 joists and T & G flooring. All in reasonable condition.

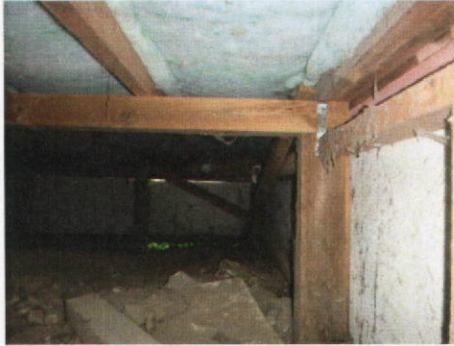
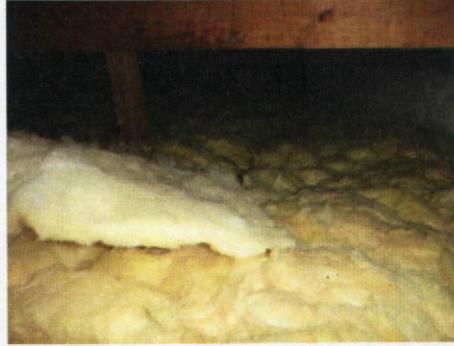
- Insulation is polyester wool to the underside of the flooring. Bradford gold installed to ceiling cavity.

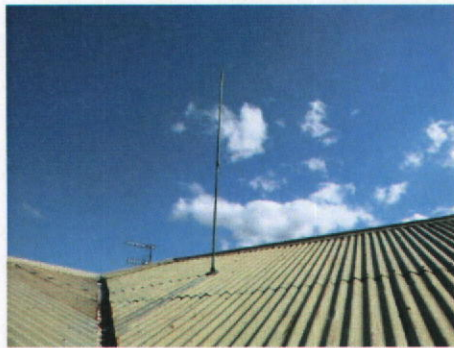
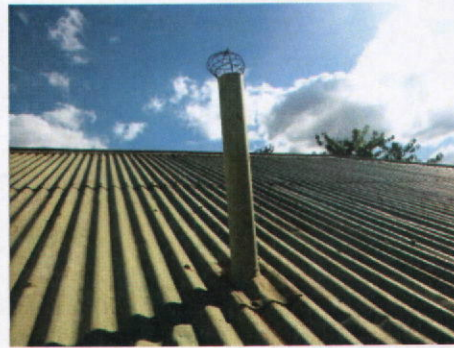
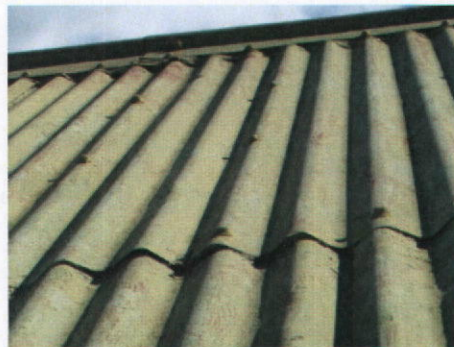
- Roofing is corrugated iron roofing, 75mm lead head nails. Lead flashings, all in reasonable condition and well installed.

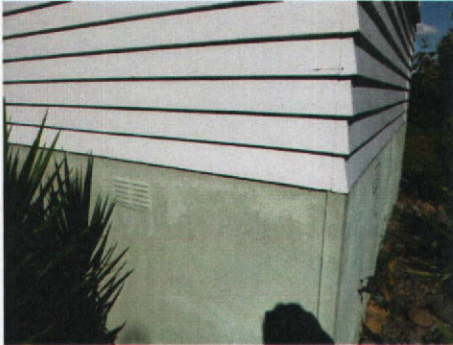
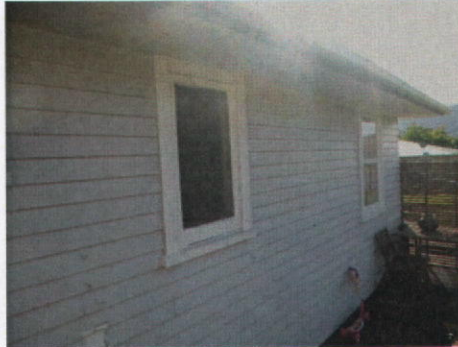
- Exterior cladding is wooden weatherboard, All solid and in reasonable condition with no weather tight issues.

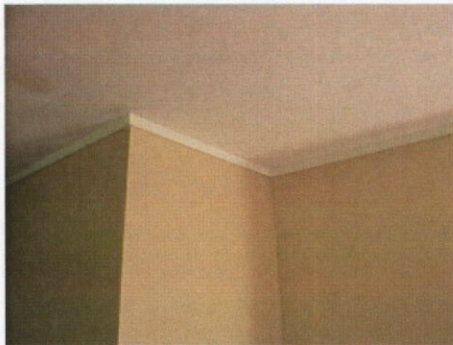
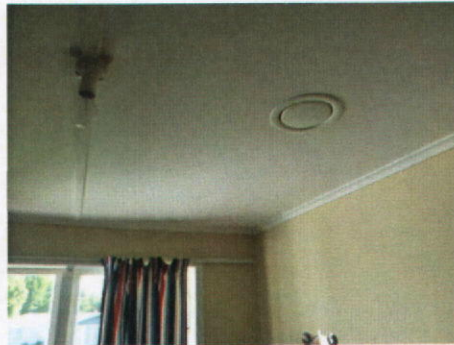
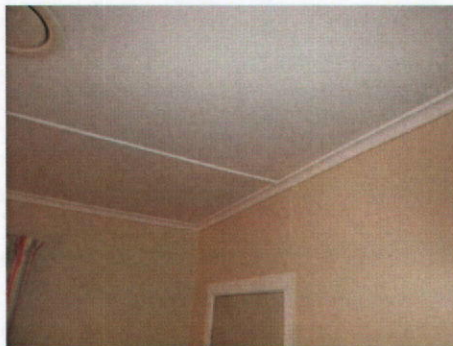
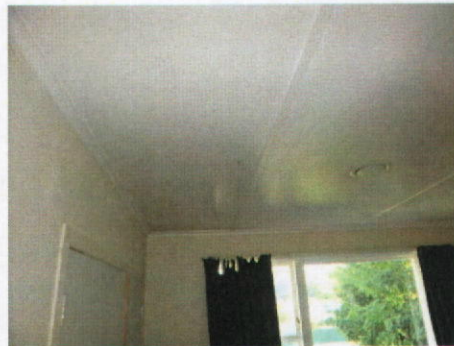
- Interior ceiling and walls are Gib plasterboard, all in reasonable condition.

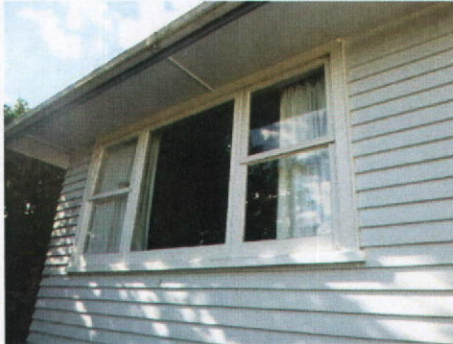
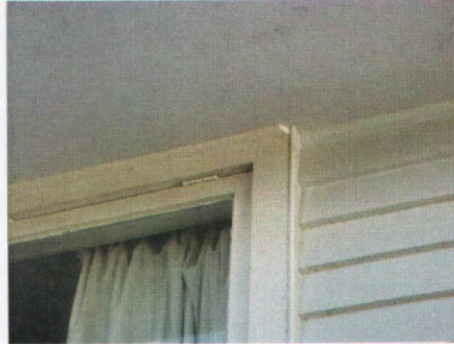
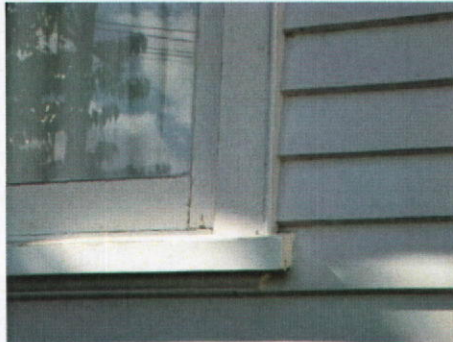
- Exterior wooden joinery, single glazed with plenty of natural light and ventilation, all well installed and in working condition.

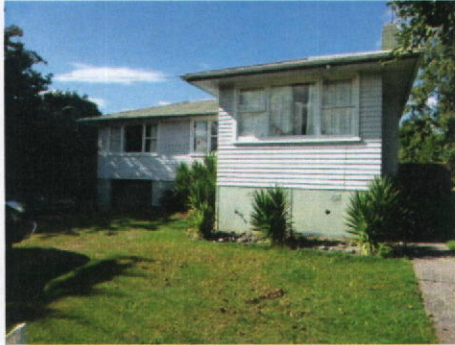
- Site is falling from the rear to the front of the boundaries. Dwelling is elevated with no signs of flooding.

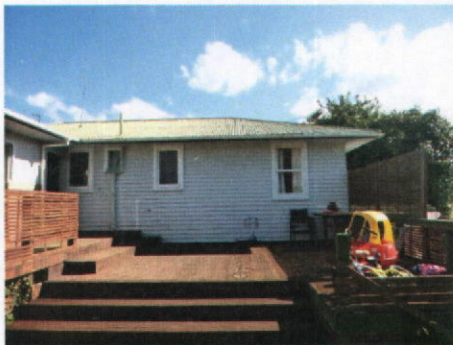
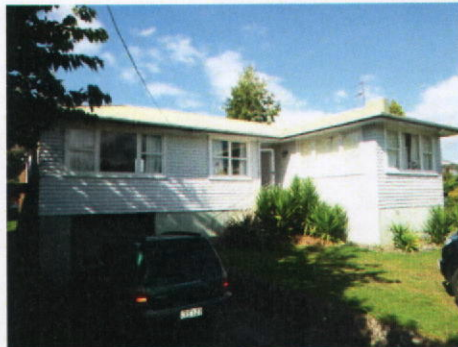
- Floor plan is a single level with basement garage.

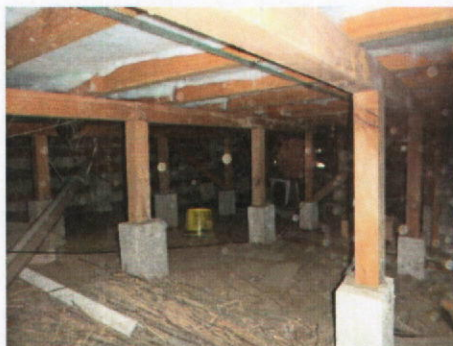
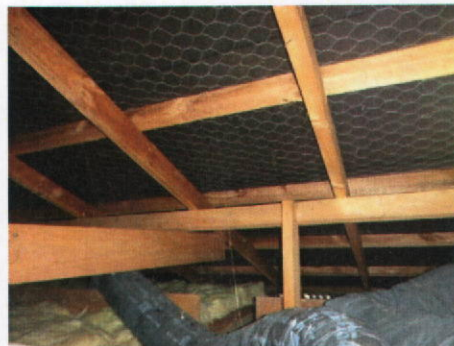
- Moisture was not present to the areas inspected.

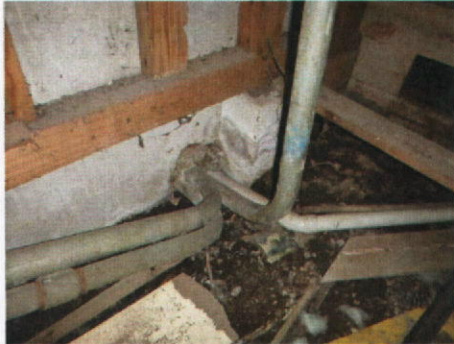
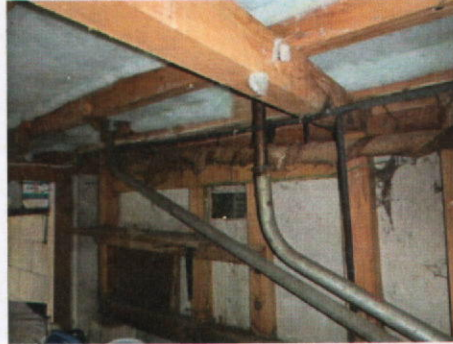
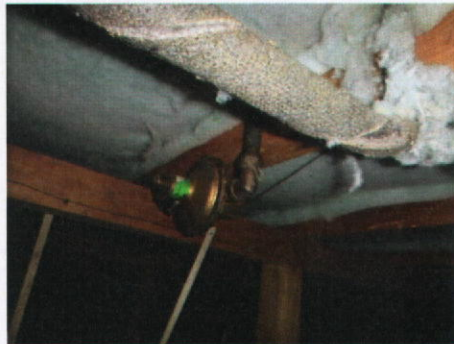
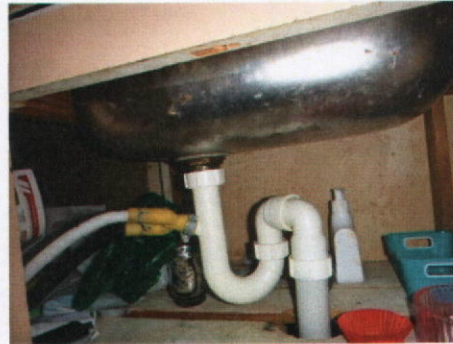
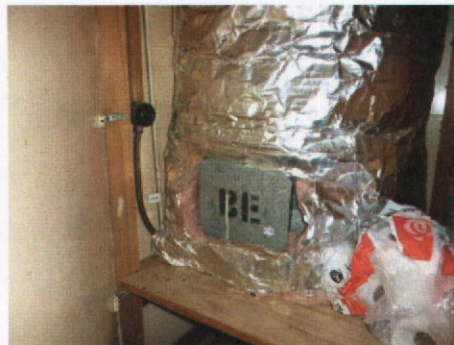
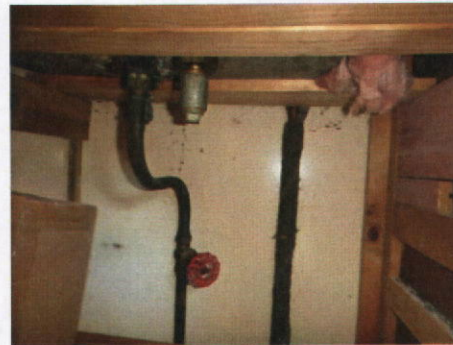
- Plumbing and waste fitting are a mixture of copper pipes with galvanised piped wastes falling into gully traps, all in reasonable condition.

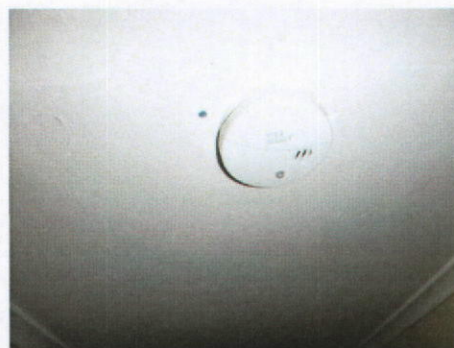
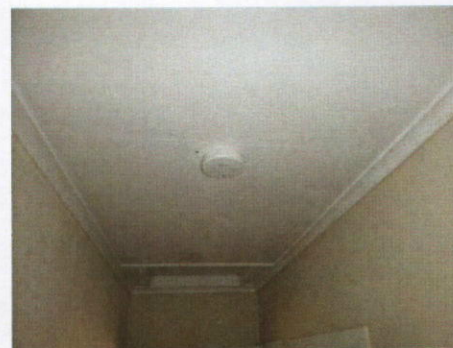
- Smoke alarm has been installed to the centre of hallway, which was tested and working at the time of inspection.

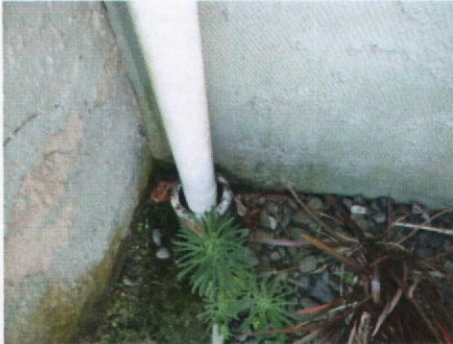
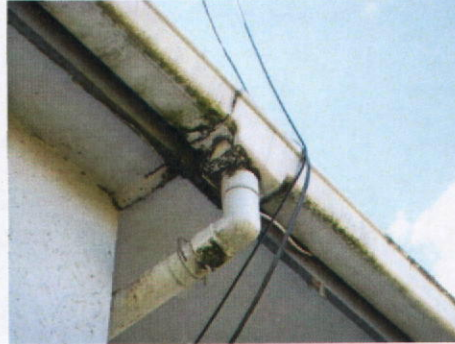
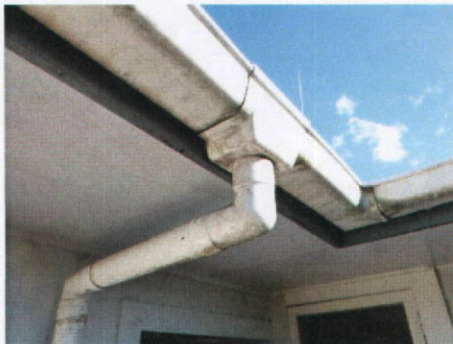
- Marley Classic storm cloud guttering system with 65mm downpipes falling to drains/soak holes, all in reasonable condition.

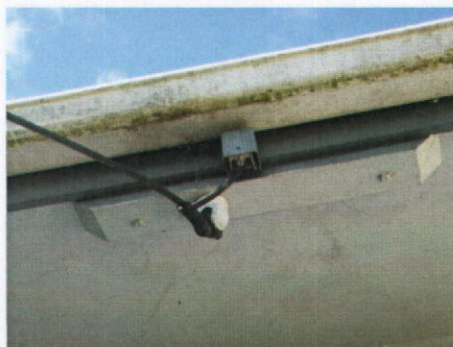
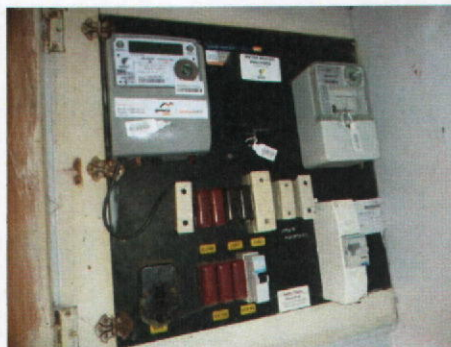
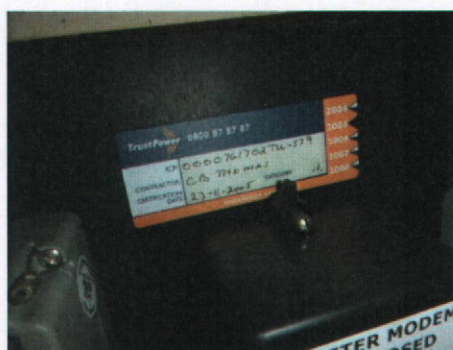
- The Switchboard / meter box is located outside the laundry door and all looks to be safe and in reasonable condition.
