## RESIDENTIAL HOUSE INSPECTION COPY

18 Downing St  
Christchurch, Canterbury Region 8025

11/06/2026

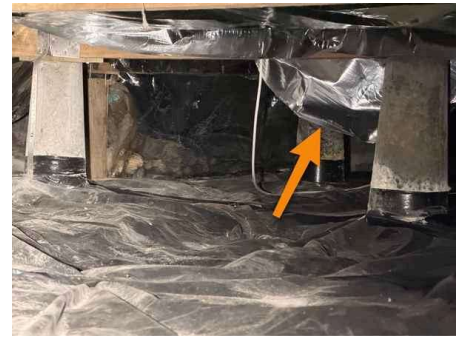
**DAMAGE TO FOIL INSULATION**

Damage has been noted to the foil insulation, a ban on repairing foil insulation came into effect in 2016 due to issues from the risk of electrocution, it is recommended that the insulation is removed and replaced, an insulation company will be able to provide further assistance.

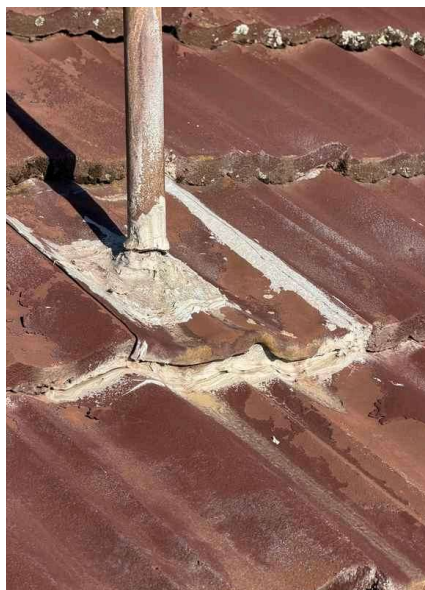
previous repairs noted to vent.

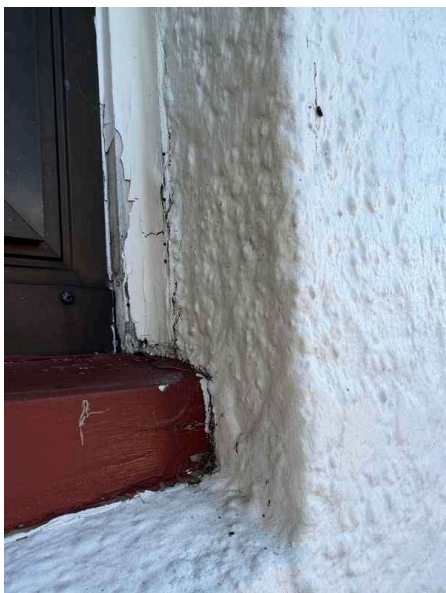
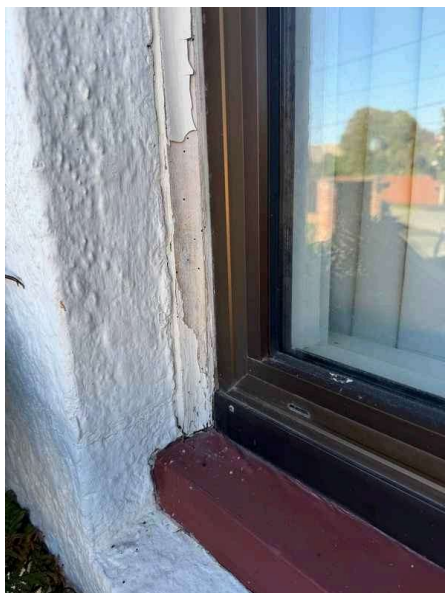
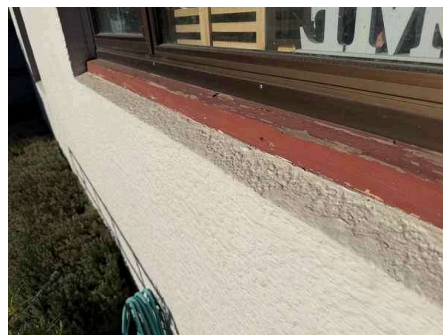
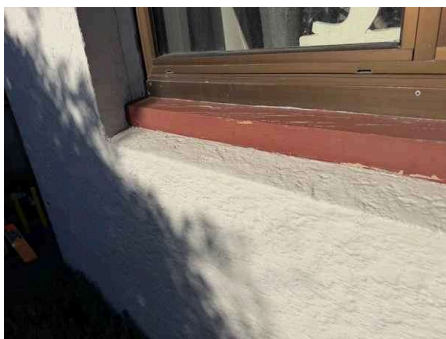
Timber coatings are worn and or deteriorated, maintenance to the paint system is recommended. Minor decay and borer to trim noted.

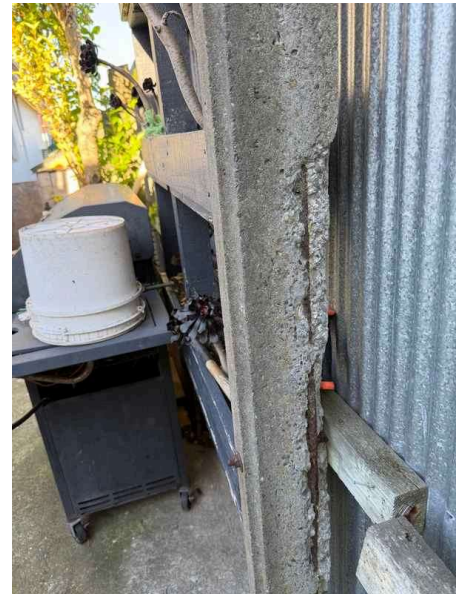
**CONCRETE FENCE POSTS CONCRETE SPALLING**

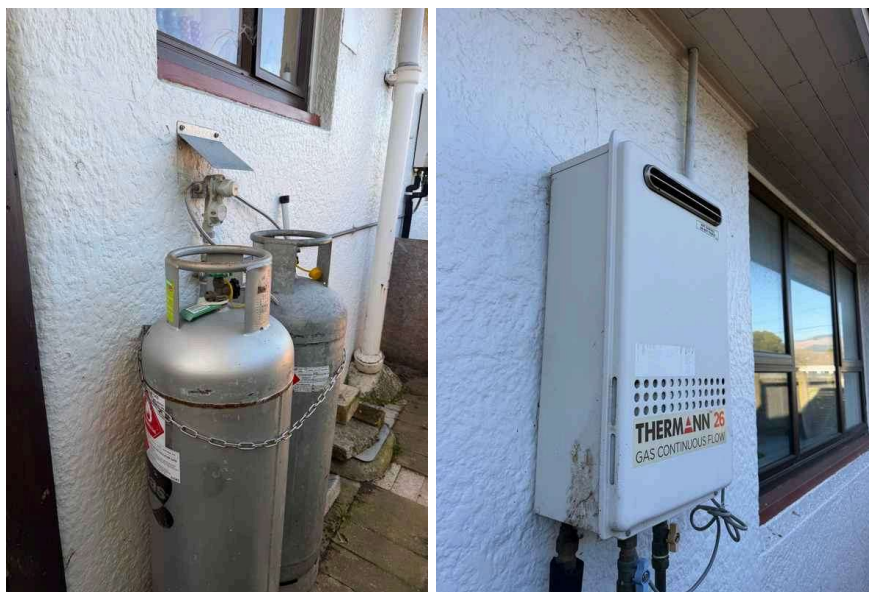
The water heater is installed to the exterior of the dwelling, it is in good condition with no issues noted at the time of inspection.

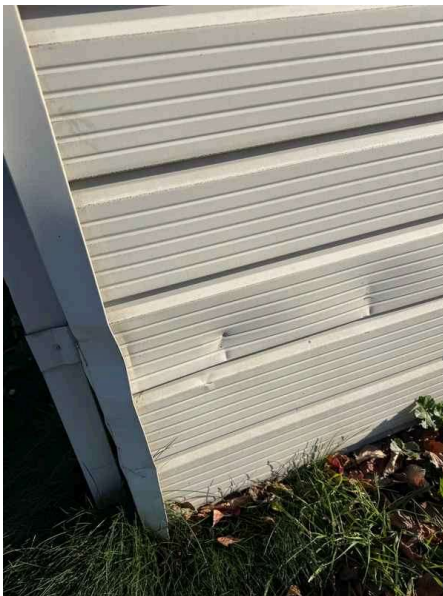
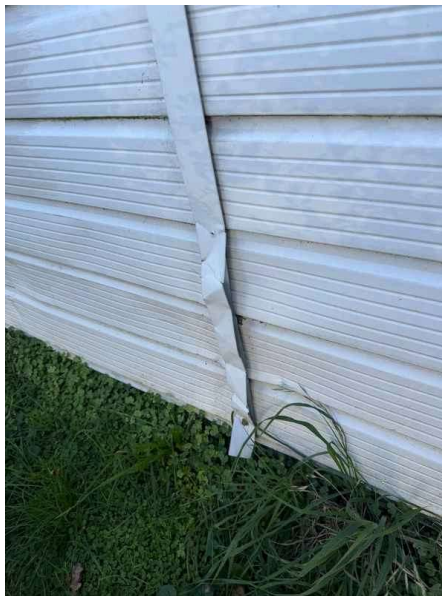
**IMPACT DAMAGE TO CLADDING NOTED**
