File No. 05312/096-00  
Document No. 375988  
vdp

**Re: External cladding inspection – 32 Hanna Street, Te Aroha**

## *Pre Purchase Report*

*32 Hanna Street*

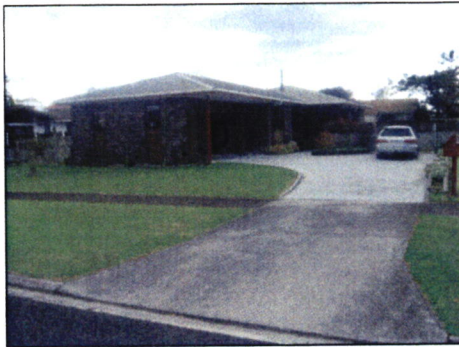
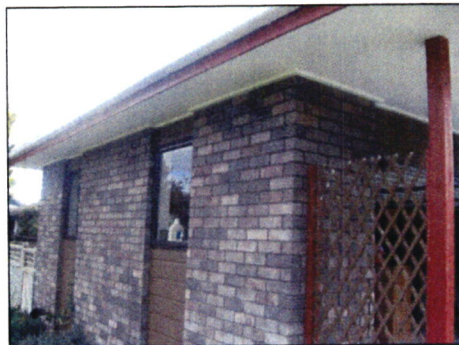
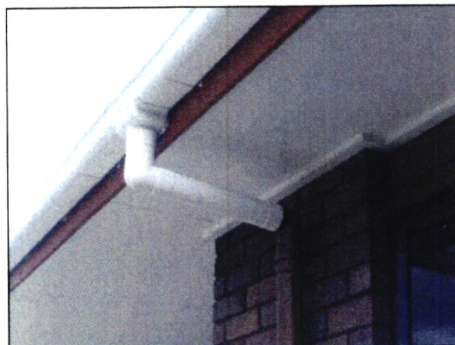
The property is of standard timber framed construction, founded on a concrete block ring foundation, with timber piles and timber sub-flooring. Clad in a combination of Monier brick and Hardies Hardiplank with aluminium joinery, timber fascia boarding, PVC down pipes/guttering and trough type roofing with Hardies sheeting to the eaves and soffits, (photos 1-3).

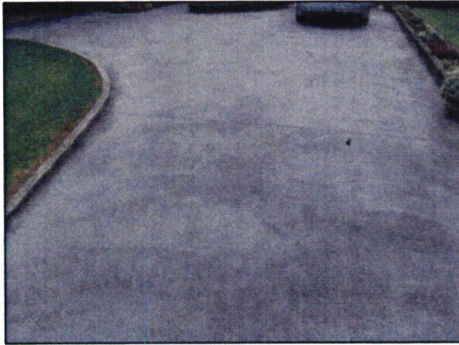
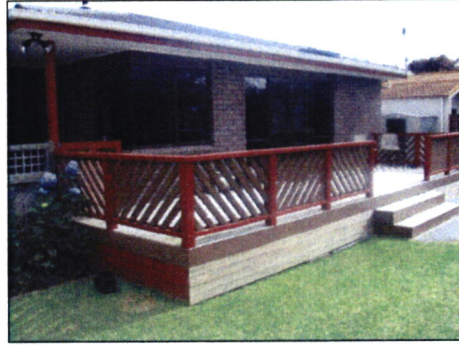
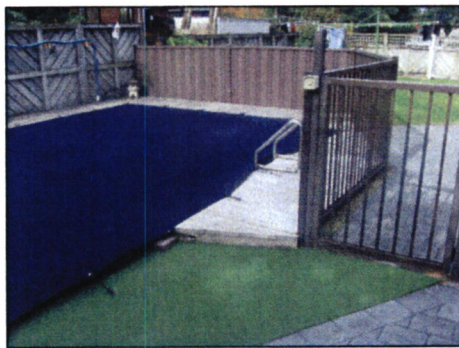
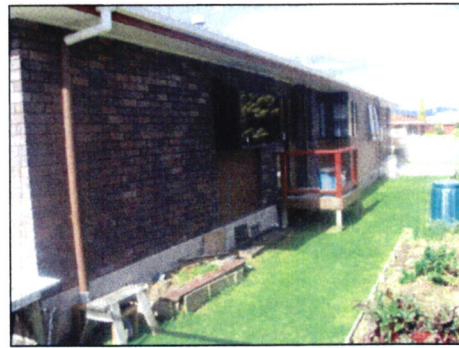
There is a timber deck on the northeast elevation giving access to the lounge and front door, with a smaller deck on the south elevation giving access to the laundry.

An in-ground pool is located on the northeast elevation, which has been fully fenced. Access is via an out-ward opening gate that has a lockable latch, (photos 4-7).

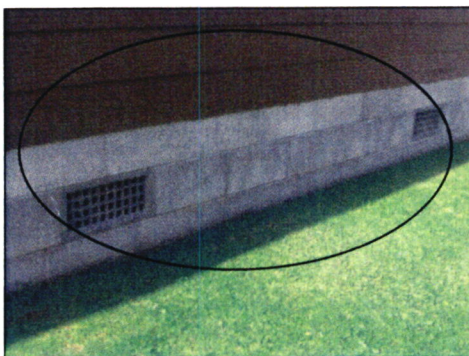
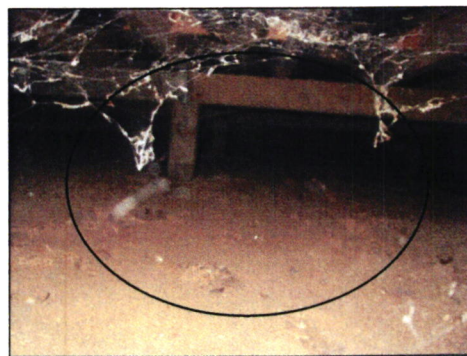
No obvious settlement or movement was observed to the concrete block ring foundation or timber sub-flooring. The sub-soil was dry at the time of the inspection. Air vents were evident in the concrete block ring foundation. The vents allow for air movement and aid in keeping the sub-soil dry, (photos 8-9).

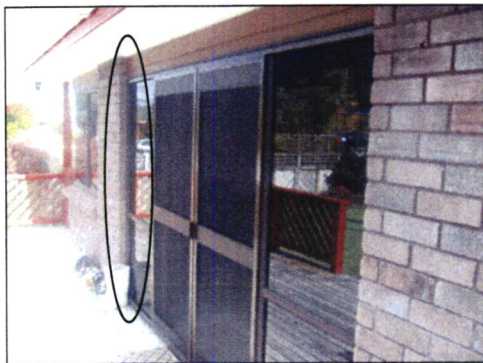
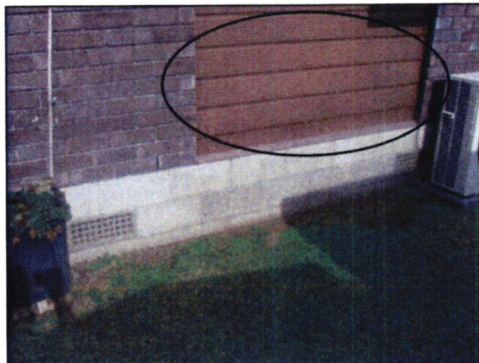
There are visible signs of movement on the exterior cladding that is consistent with settling of the dwelling. Gradual settling and movement usually occurs within the first 12-18 months of construction.

It is the writer's opinion that the settling is not detrimental to the dwelling.

The fast setting non-shrink mortar (general-purpose mortar) finish between the Monier bricks has been grouted and brushed off to manufacturer specifications. The fibre cement Hardiplank has an even coat of paint, giving maximum protection. Where the Hardiplank abuts the exterior joinery and brick a high performance multi-purpose modified silicone sealant, that is prime less and paintable has been used. Sealants are only a stop gap measure and need to be inspected regularly, (photos 10-11).

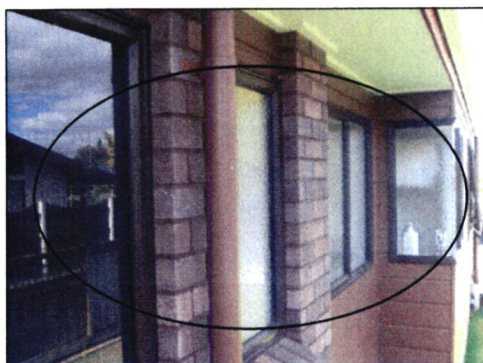
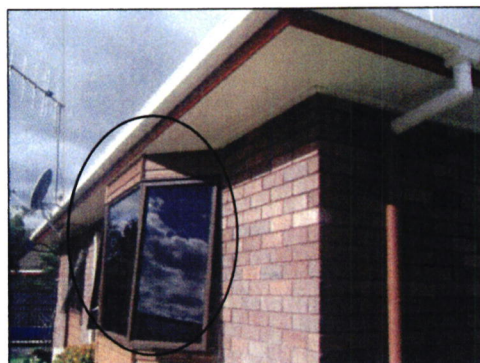
The aluminium windows and doors were tried operated freely. There are condensation channels on all aluminium windows. These require regular cleaning to allow the condensation/water to disperse freely.

The window and door flashings appear to have been installed to manufacture specifications.

There are aluminium head flashings around the window and door joinery. Regular checks of the rubber seals around the glass is recommended, due to the sun's UV rays breaking down the rubber, (photos 12-13).

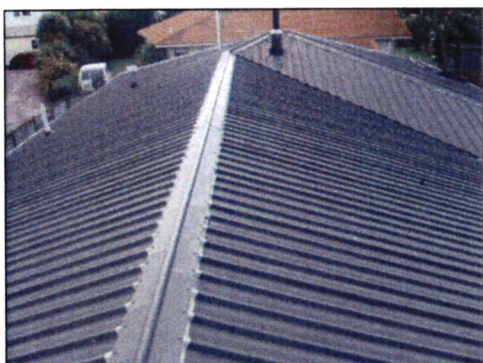
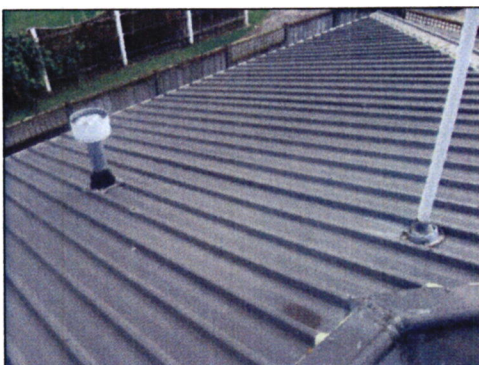
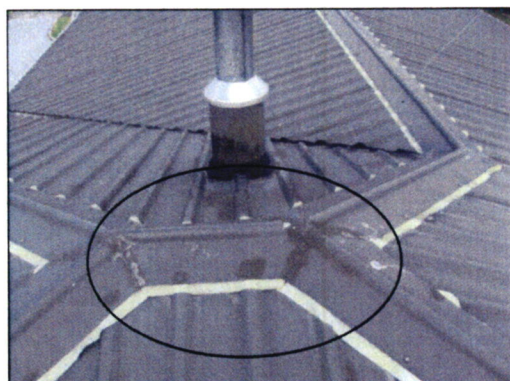
The trough type roof and penetrations appeared well fixed. Regular maintenance and visual inspections of the roof, guttering and down pipes are required to maintain the building envelope.

Minor remedial work has been undertaken to the roof, where red rust has appeared. An anti-rust primer has been applied to the affected areas. It is the writer's opinion that the red rust is not detrimental to the roofing.

Building paper and netting have been applied to the underside of the roofing, (photos 14-16).

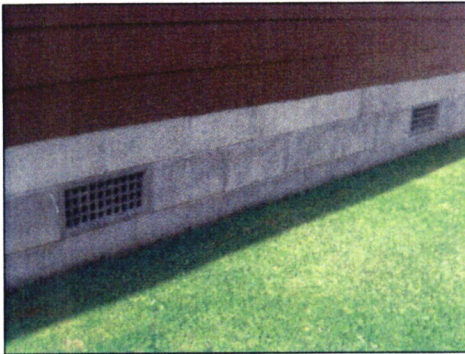
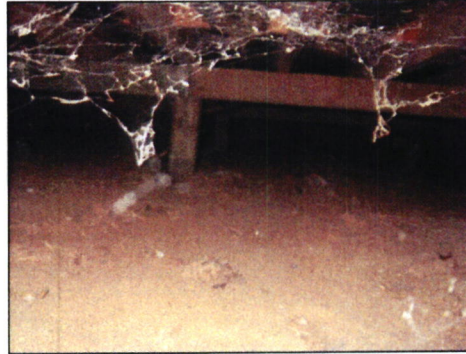
#### 4.03 Foundation - concrete block/timber

No obvious settlement or movement was observed to the concrete block ring foundation or timber sub-flooring. The sub-soil was dry at the time of the inspection. Air vents were evident in the concrete block ring foundation. The vents allow for air movement and aid in keeping the sub-soil dry.

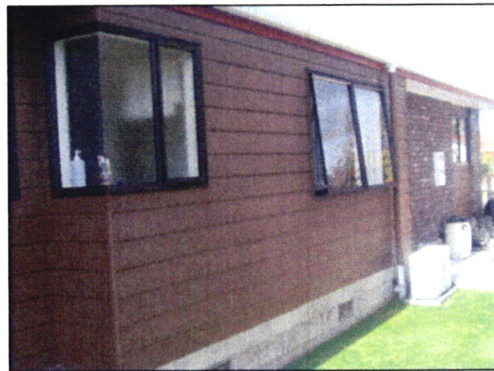
#### 4.04 Exterior Cladding

There are visible signs of movement on the exterior cladding that is consistent with settling of the dwelling. Gradual settling and movement usually occurs within the first 12-18 months of construction. It is the writer's opinion that the settling is not detrimental to the dwelling.

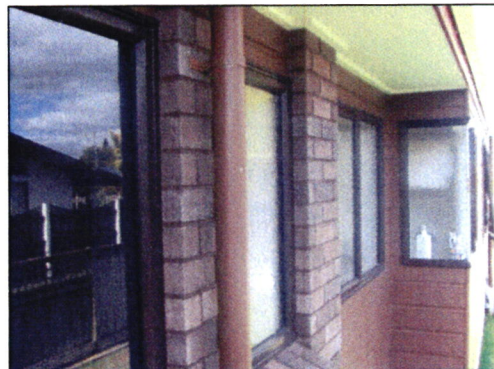
#### 4.05 Joinery

The aluminium windows and doors were tried and operated freely. There are condensation channels on all aluminium windows. These require regular cleaning to allow the condensation/water to disperse freely.

The window and door flashings appear to have been installed to manufacturer specifications.

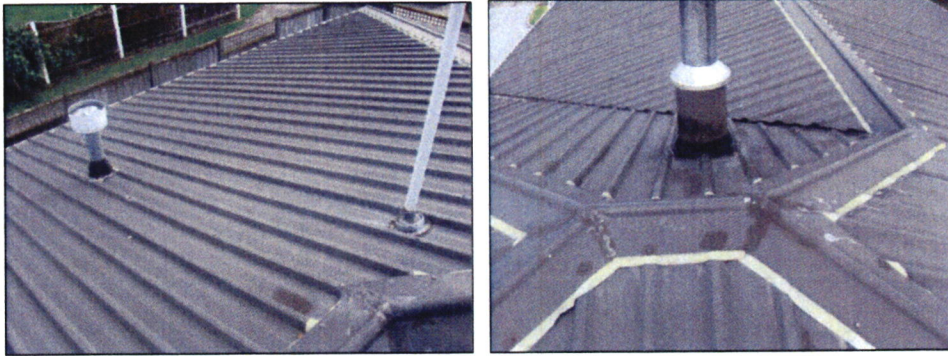
**4.06 Roofing/Guttering**

The trough type roof and penetrations appeared well fixed. Regular maintenance and visual inspections of the roof, guttering and down pipes are required to maintain the building envelope.

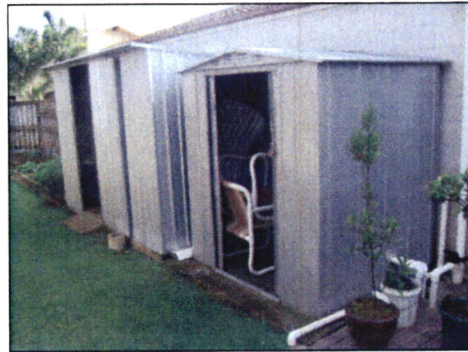
**4.07 Out buildings**

2x galvanised garden sheds, located on the northwest boundary of the property. Approximately 3.0 x 1.5mts and 1.5 x 1.5mts respectively.

One currently used as an implement storage shed and the other houses the swimming pool pump etc. It is recommended that a secure lock be attached to the pump shed door (if used for chemical storage).
