PRE-SALE BUILDING INSPECTION REPORT

for Gaylene Leadley

10 Rowanwood Close
Halswell, Christchurch
8025 New Zealand

Inspected by: Jordyn Ellis | Inspection Date: 15 Jan 2026 | Ph: 0210534077

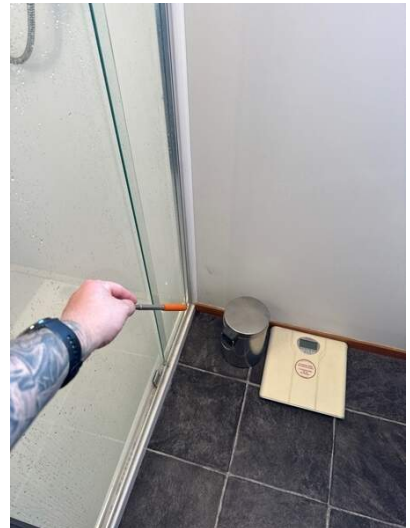
- When the shower was spray tested, leaking was detected in the bottom right-hand corner of the unit. A tradesman shower installer is required to assess and repair the leak.

#44: Screen leak

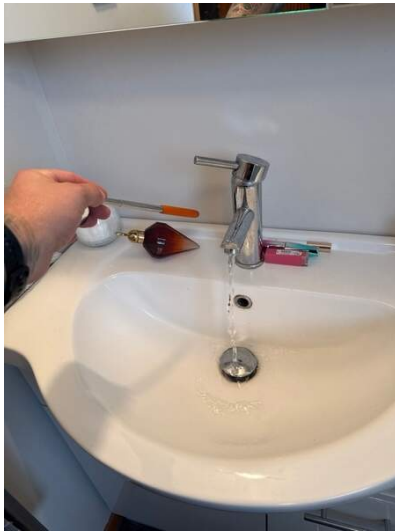
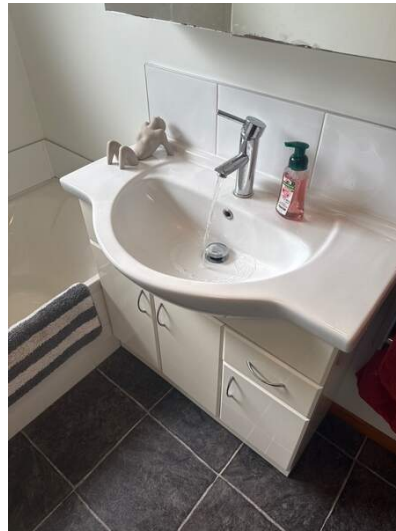
- The vanity located below is not sealed at the wall junction, the installation of sealant would help prevent the potential deterioration of the cabinetry and wall lining behind.

#48: Not sealed at wall junction - #49
First-floor bathroom

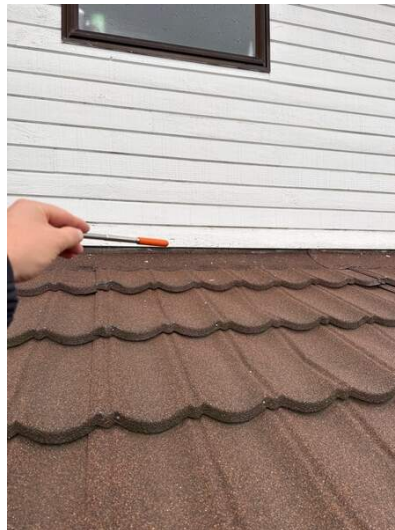
- Minor deterioration to the paint coating was sighted in localised areas of the cladding. To seal and help protect the timber from decay and movement, repairs to the affected areas are recommended now. A trade-qualified painter would complete the work.

#70: Minor paint deterioration - Eastern elevation

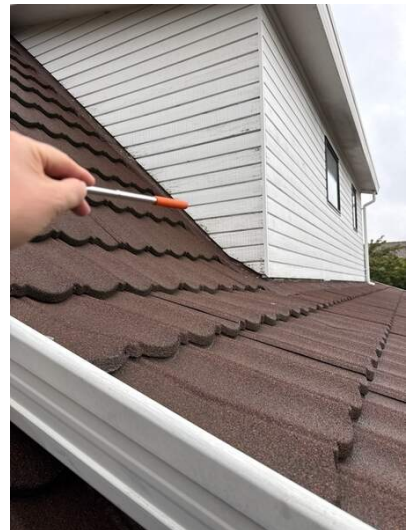
#71: Minor paint deterioration - Eastern elevation

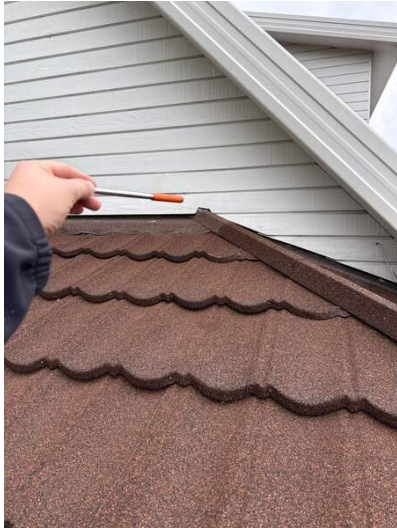
#72: Minor timber split - Southern elevation

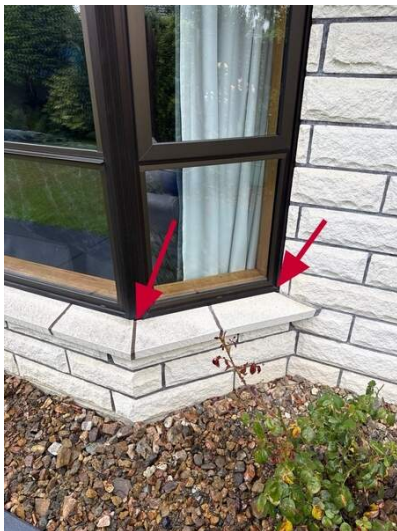
- Gaps were sighted to the mortar located below. This is a risk area for potential water ingress into the wall cavity. Repair to this can be undertaken by a bricklayer.

#73: Gaps to mortar - Western elevation

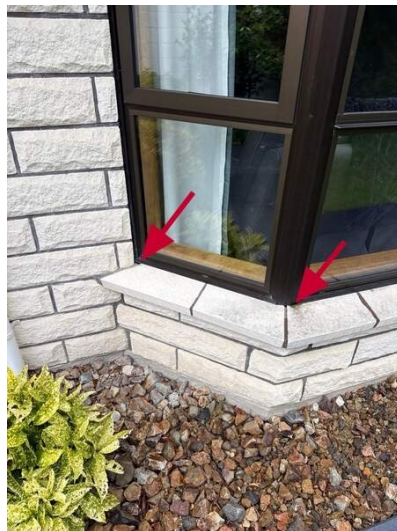
#74: Gaps to mortar - Western elevation

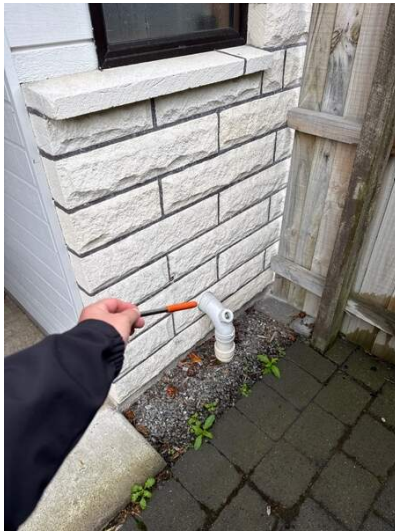
Cladding Penetration Details: - The located penetrations require sealing around the perimeter to ensure they are watertight. A licensed builder should be engaged to complete the work.

#75: Unsealed cladding penetrations - Eastern elevation

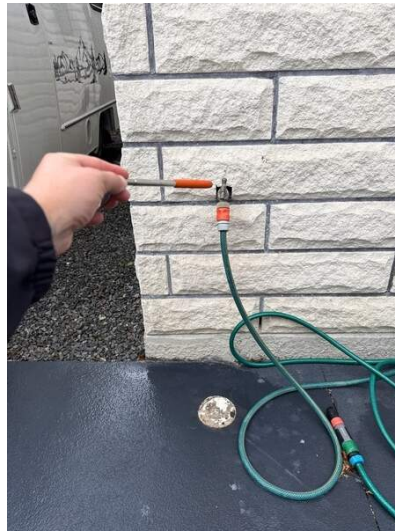
#76: Unsealed cladding penetration - Northern elevation

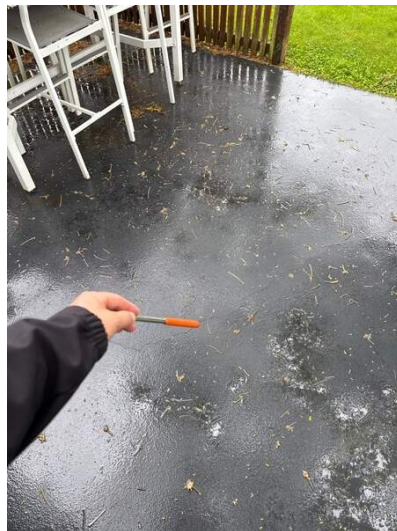
- Cracks were sighted to the concrete patio from general settlement and movement. These appear superficial and can be filled as a repair strategy if required.

#81: Cracking to concrete

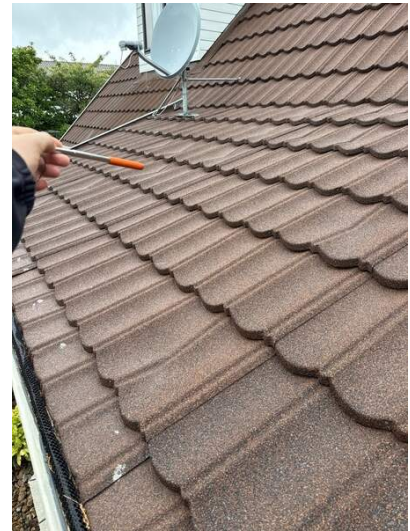
- Dented tiles were sighted, which can allow water to sit in the tiles and lead to rust deterioration and potential holes in the tiles. Monitor these for performance going forward.

#95: Tile dents - Western elevation

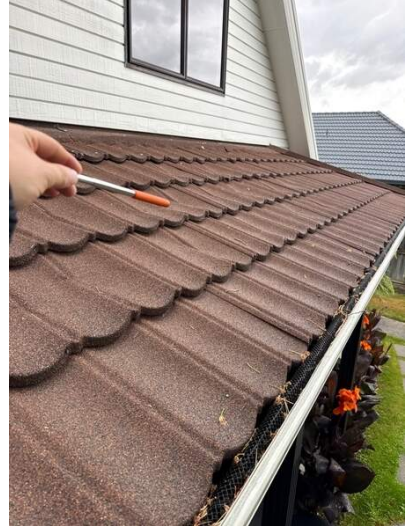
#98: Tile dents - Southern elevation

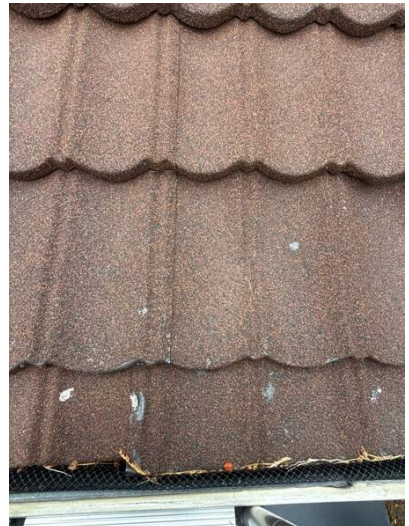
- Minor deterioration was detected to the roof coating, this can be common due to age although the bare metal can be susceptible to corrosion. Re-coating the roof would help prevent this. A licensed roofer is required to assess and determine the best repair solution.

#101: Minor coating deterioration

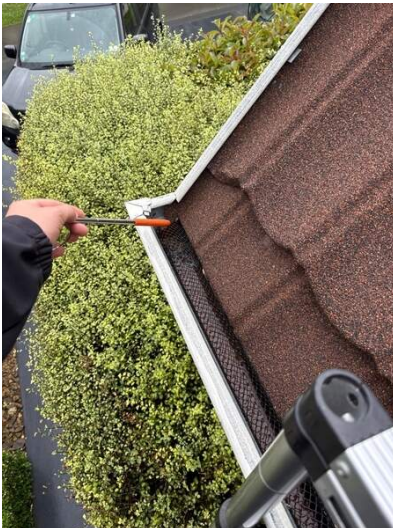
- Minor surface rust was sighted to the gutter insert located below. Rust treatment can take place to help prevent further deterioration.

#103: Surface rust - Western elevation

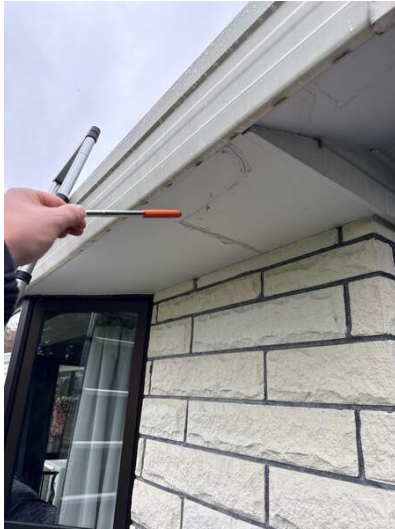
- Cracks were detected to the eave linings located below. A licensed builder can be engaged to assess and determine the best repair solution.

#104: Cracked eave lining - Western elevation

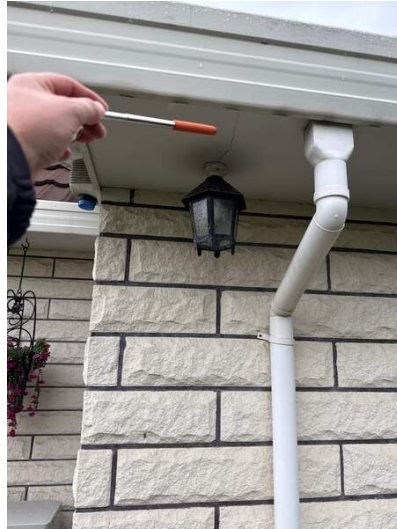
#105: Cracked eave lining - Western elevation

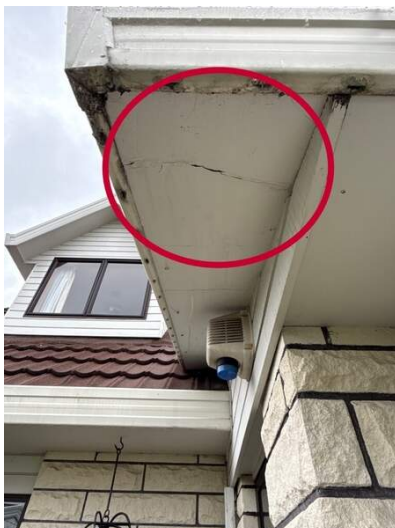
- Moisture staining and elevated moisture readings were sighted to the underside of the eave linings on the western elevation. Gaps were sighted at the barge/fascia flashing junctions, which could potentially be allowing water to enter the eave cavity. A licensed roofer is required to investigate and determine if repairs/upgrades are required. The condition of the timber framing in these areas is unknown, further investigation is required.

#113: Elevated moisture location - Western elevation

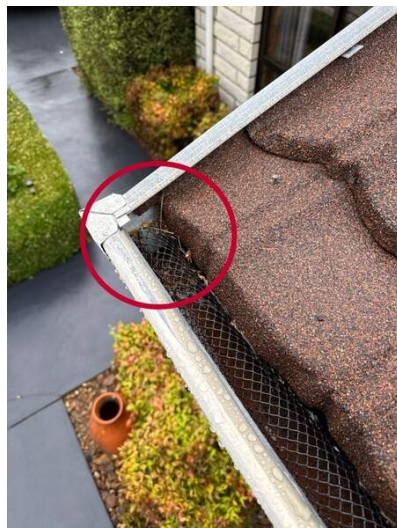
#114: Gaps at barge flashing junction - Western elevation

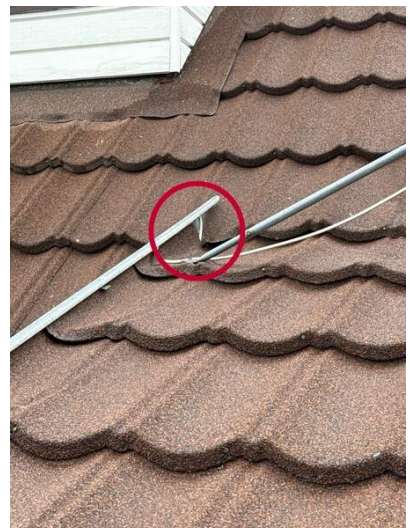
#115: Gaps at barge flashing junction - Western elevation

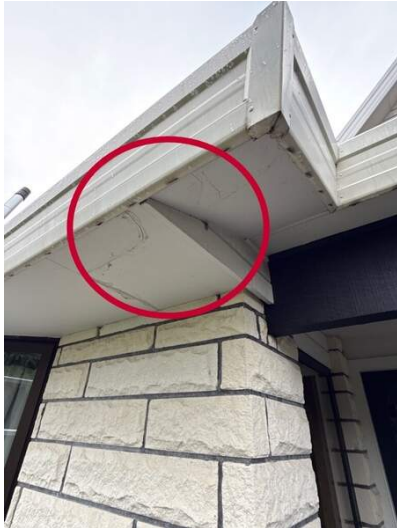
#116: Elevated moisture location
- Western elevation

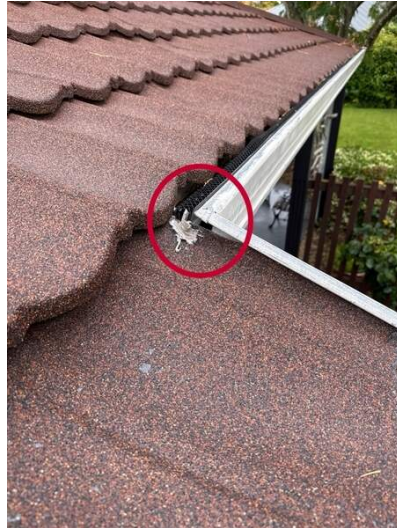
#117: Gaps at fascia - Western
elevation

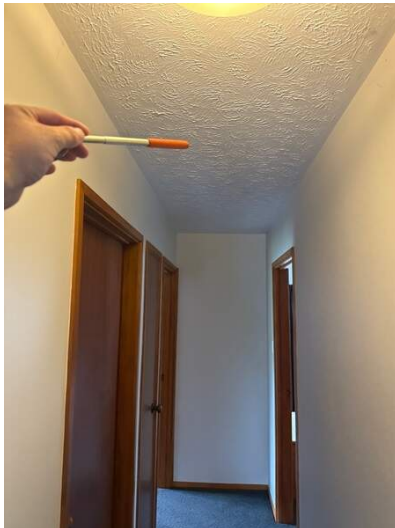
There was an inadequate number of smoke alarms. Refer to the details below.

#136: Smoke alarm required -
Hallway

I recommend installing more smoke alarms as this can be a safety risk without them. There must be at least one working smoke alarm within 3 metres of each bedroom door or every room where a person sleeps, in multi-storey or multi-level homes (including split levels) there must be at least one smoke alarm on each level or storey.

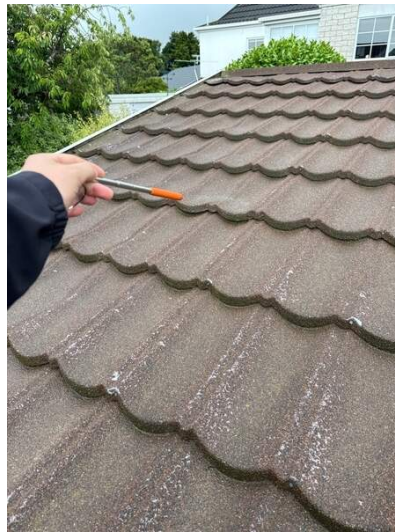
- Dented tiles were sighted, which can allow water to sit in the tiles and lead to rust deterioration and potential holes in the tiles. Monitor these for performance going forward.

#147: Tile dents

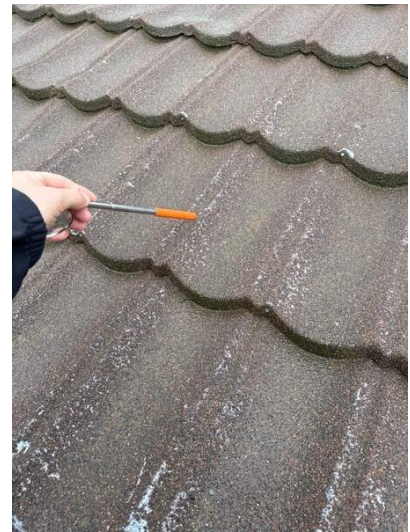
- Minor deterioration was detected to the roof coating, this can be common due to age although the bare metal can be susceptible to corrosion. Re-coating the roof would help prevent this. A licensed roofer is required to assess and determine the best repair solution.

#148: Minor coating deterioration

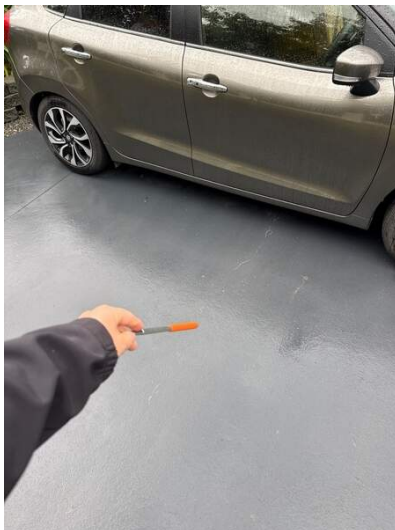
- Cracks were sighted to the concrete from general settlement and movement. These appear superficial and can be filled as a repair strategy if required.

#155: Cracking to concrete

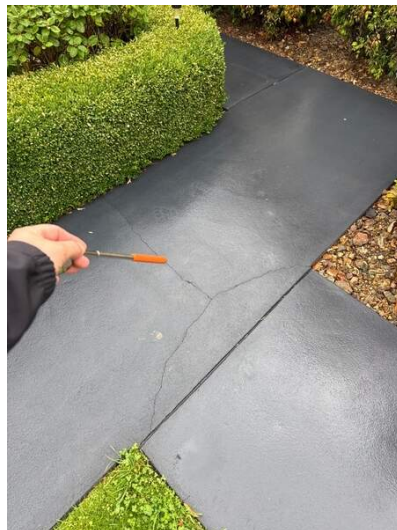
#156: Cracking to concrete
