Healthy Home Assessment

**5B James Laurie Street
Henderson
Auckland 0612**

#03304

02 June 2021

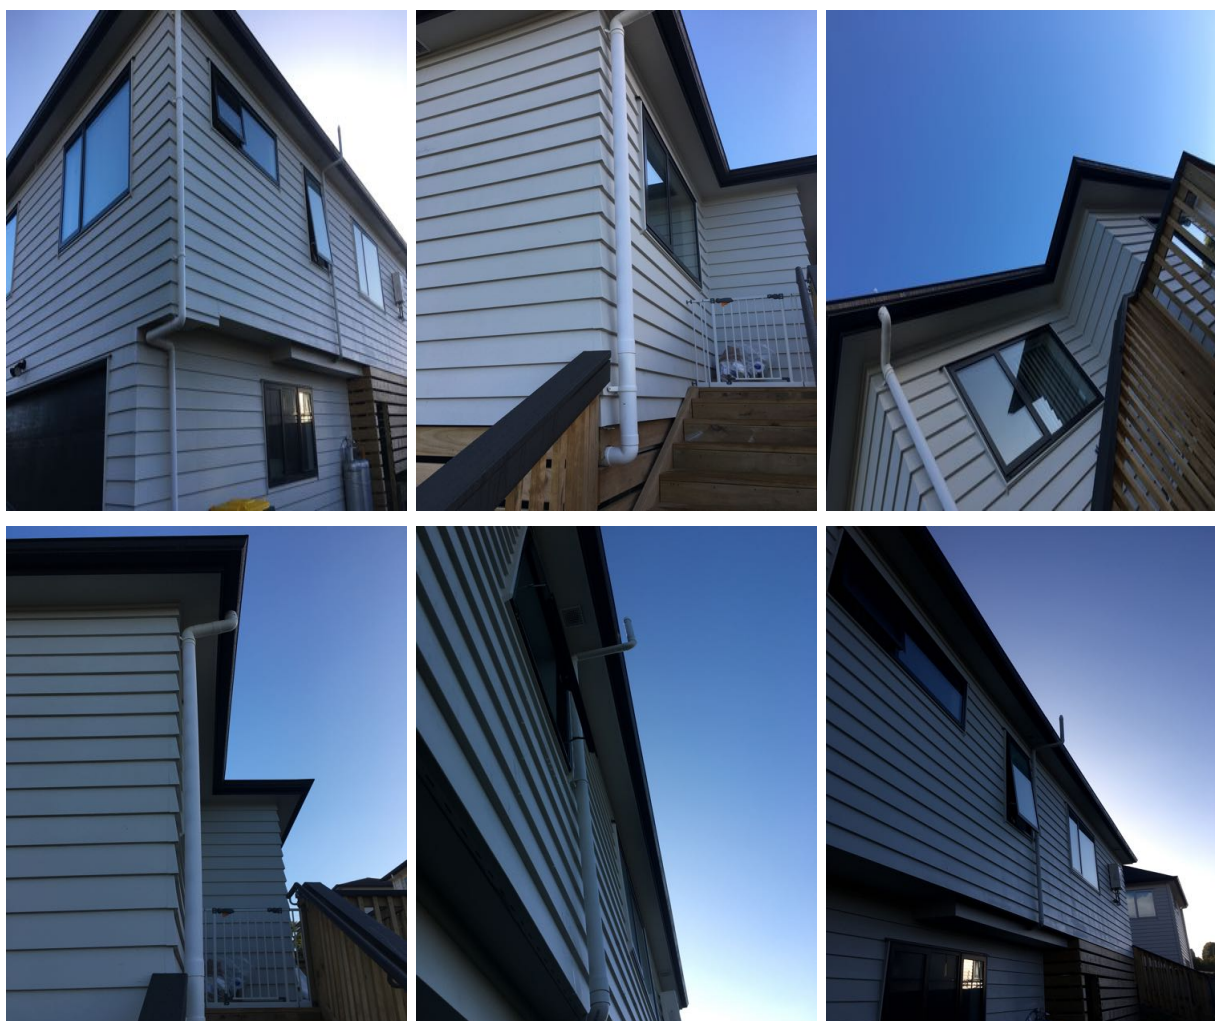
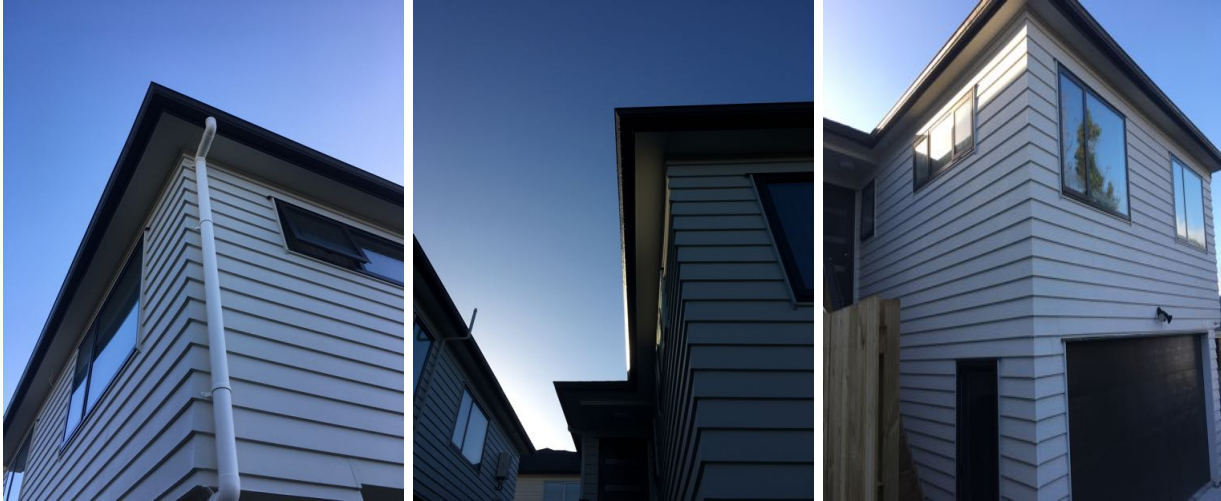
Photograph all gutters

- Are gutters present to take water away from all parts of the roof? **Yes**
- Are all gutters connected to a downpipe (either directly or via a connected gutter)? **Yes**
- Do gutters appear to be of sufficient size not to overflow during normal rain? **Yes**
- Do gutters appear to have sufficient fall for water to flow? **Yes**
- Are all gutters in good condition? (all intact and all attached to the house) **Yes**
- Are there any blockages or obstructions in the gutters? **No**

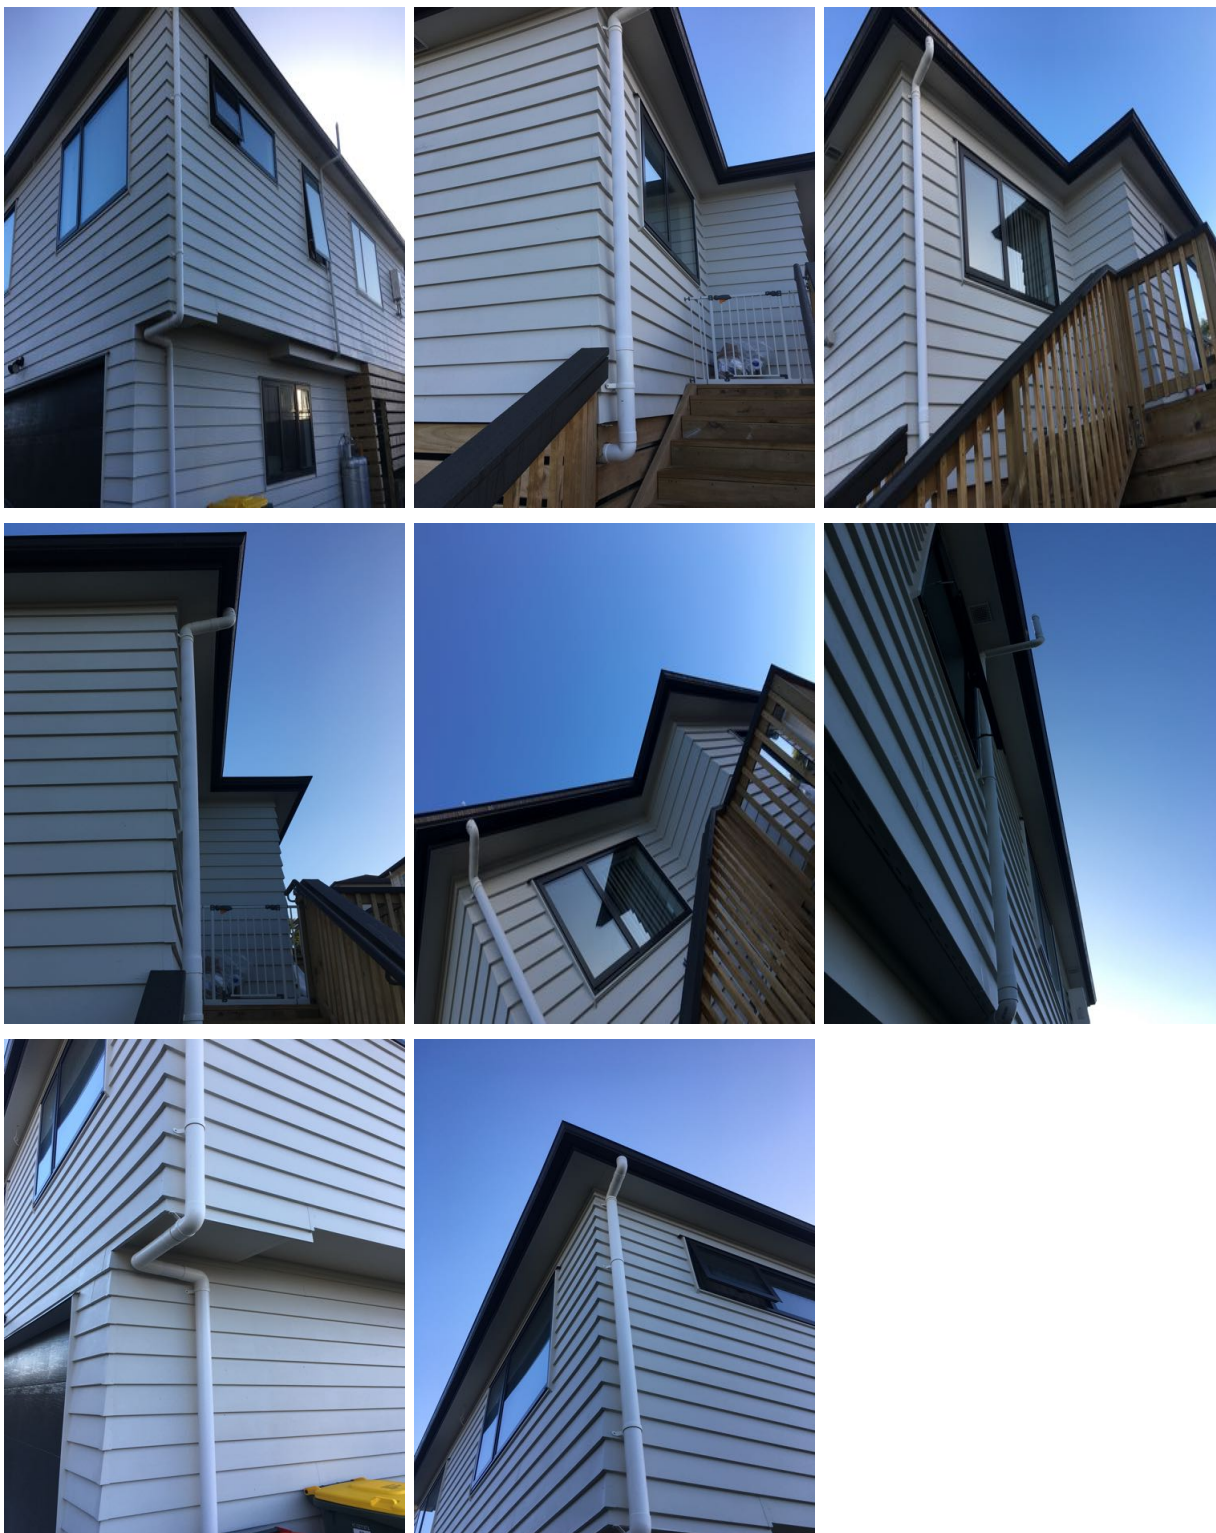
Photograph all downpipes, gully traps and drains

Are there any obstructions or blocks in the drain?

No

Does the downpipe go to an appropriate outfall?

Council Storm Water

Can you identify any leaking downpipes or gully traps?	No
Are any downpipes discharging water under the floor or onto the ground next to the house?	No
Is there any surface water from surrounding ground, paths or driveways flowing under the house?	No
Is there any water rising up through damaged brick, concrete masonry or concrete foundations or concrete floors?	No
Are you able to visually identify any leaks coming from the pipes?	No

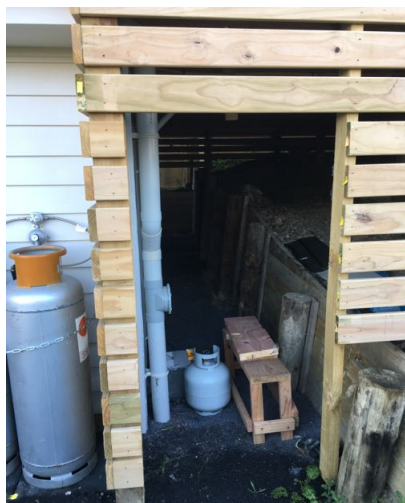
Photograph the external profile of the sub floor

- Does the property have an accessible subfloor? **Yes**
- Is there an existing entry point to the subfloor? **Yes**
- Can you identify any flooding, pooling or leaking pipes in the subfloor space? **No**
- Is at least 50% of the subfloor obstructed by either a masonry foundation wall, fibre cement sheets, timber skirting, other parts of the building/adjoining structures, rock/soil or any other permanent/semi-permanent structure? **Yes**
- Does the perimeter cladding contain multiple continuous gaps of more than 20mm or is it trellis? **Yes**
- As the subfloor is well ventilated a moisture barrier is not required

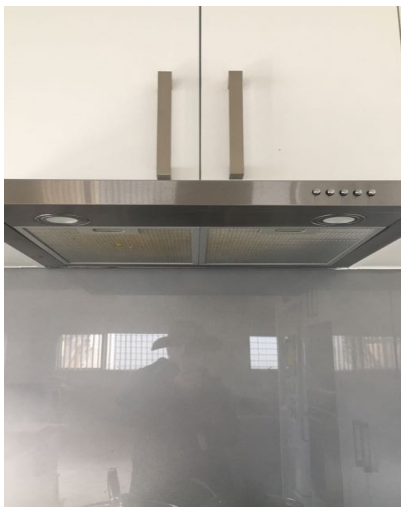
Photograph of vent

Is the fan in good working order?

Yes

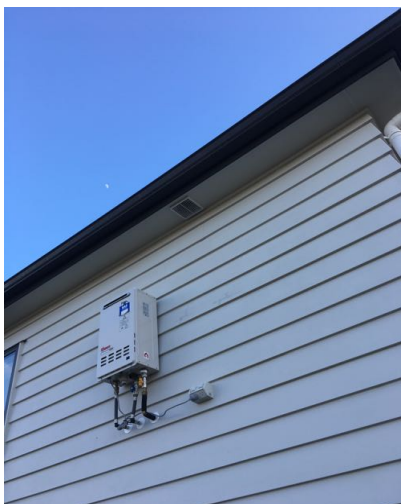
Photograph of external vent

Does the fan vent to the outdoors?

Yes

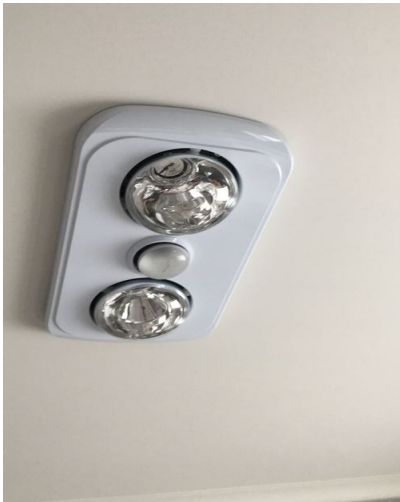
Does the bathroom have an extractor fan?	Yes, installed prior to 1 July 2019
What is the make and model? Unable to confirm	
Photograph of vent

Is the fan in good working order?

Yes

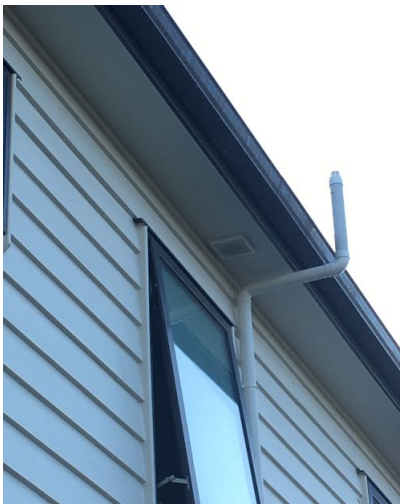
Photograph of external vent

Does the fan vent to the outdoors?

Yes

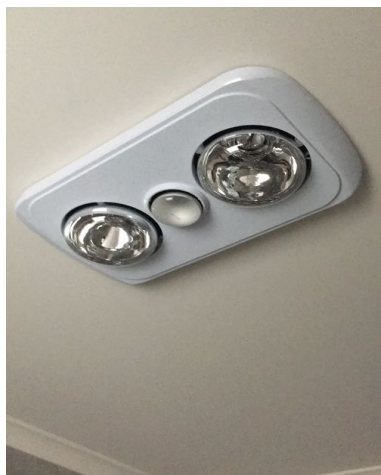
Photograph of vent

Is the fan in good working order?

Yes

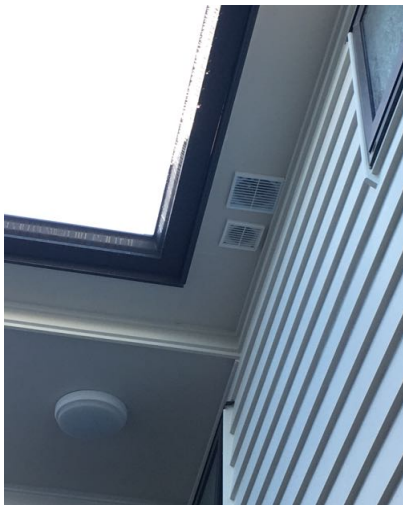
Photograph of external vent

Does the fan vent to the outdoors?

Yes

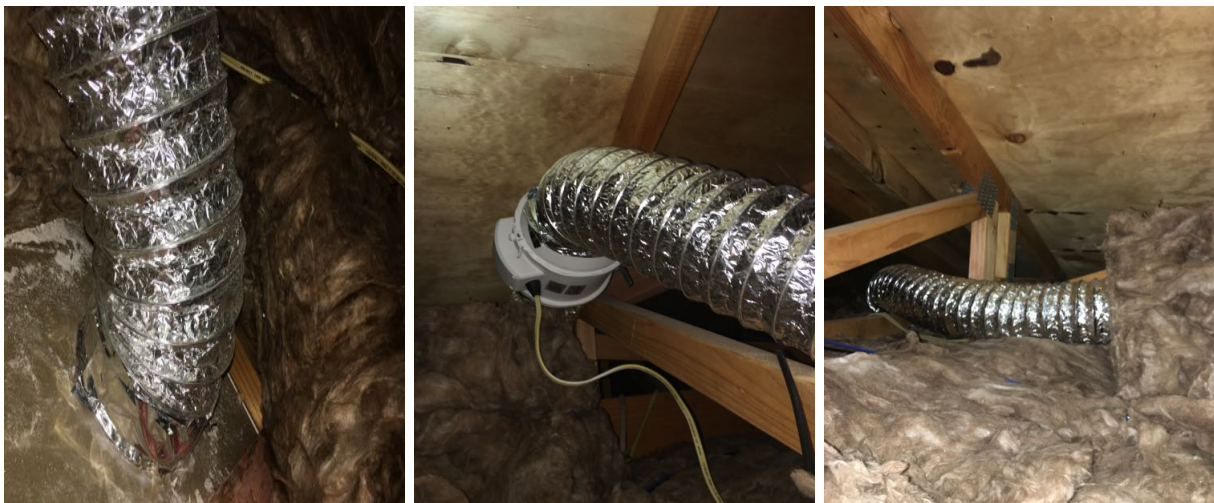
Photograph of ducting

Is all ducting connected, intact and installed so that extracted air can flow freely through it?

Yes

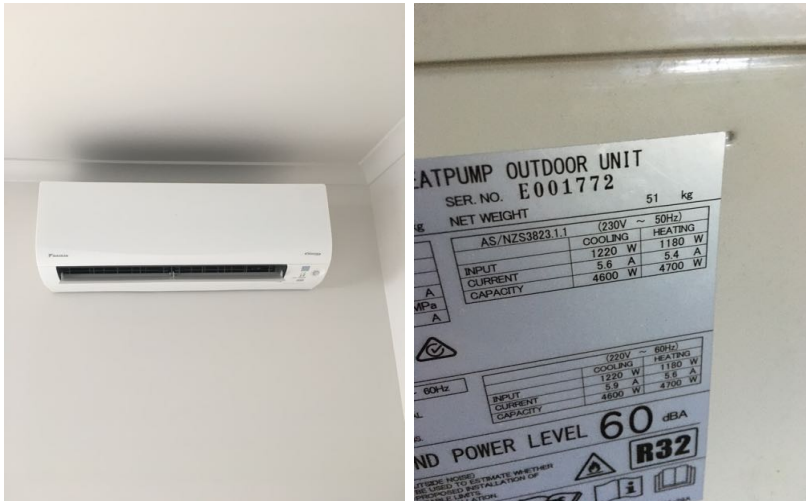
Photograph of heating source

What is the kW capacity?

5.4

Does the heat source work?

Yes

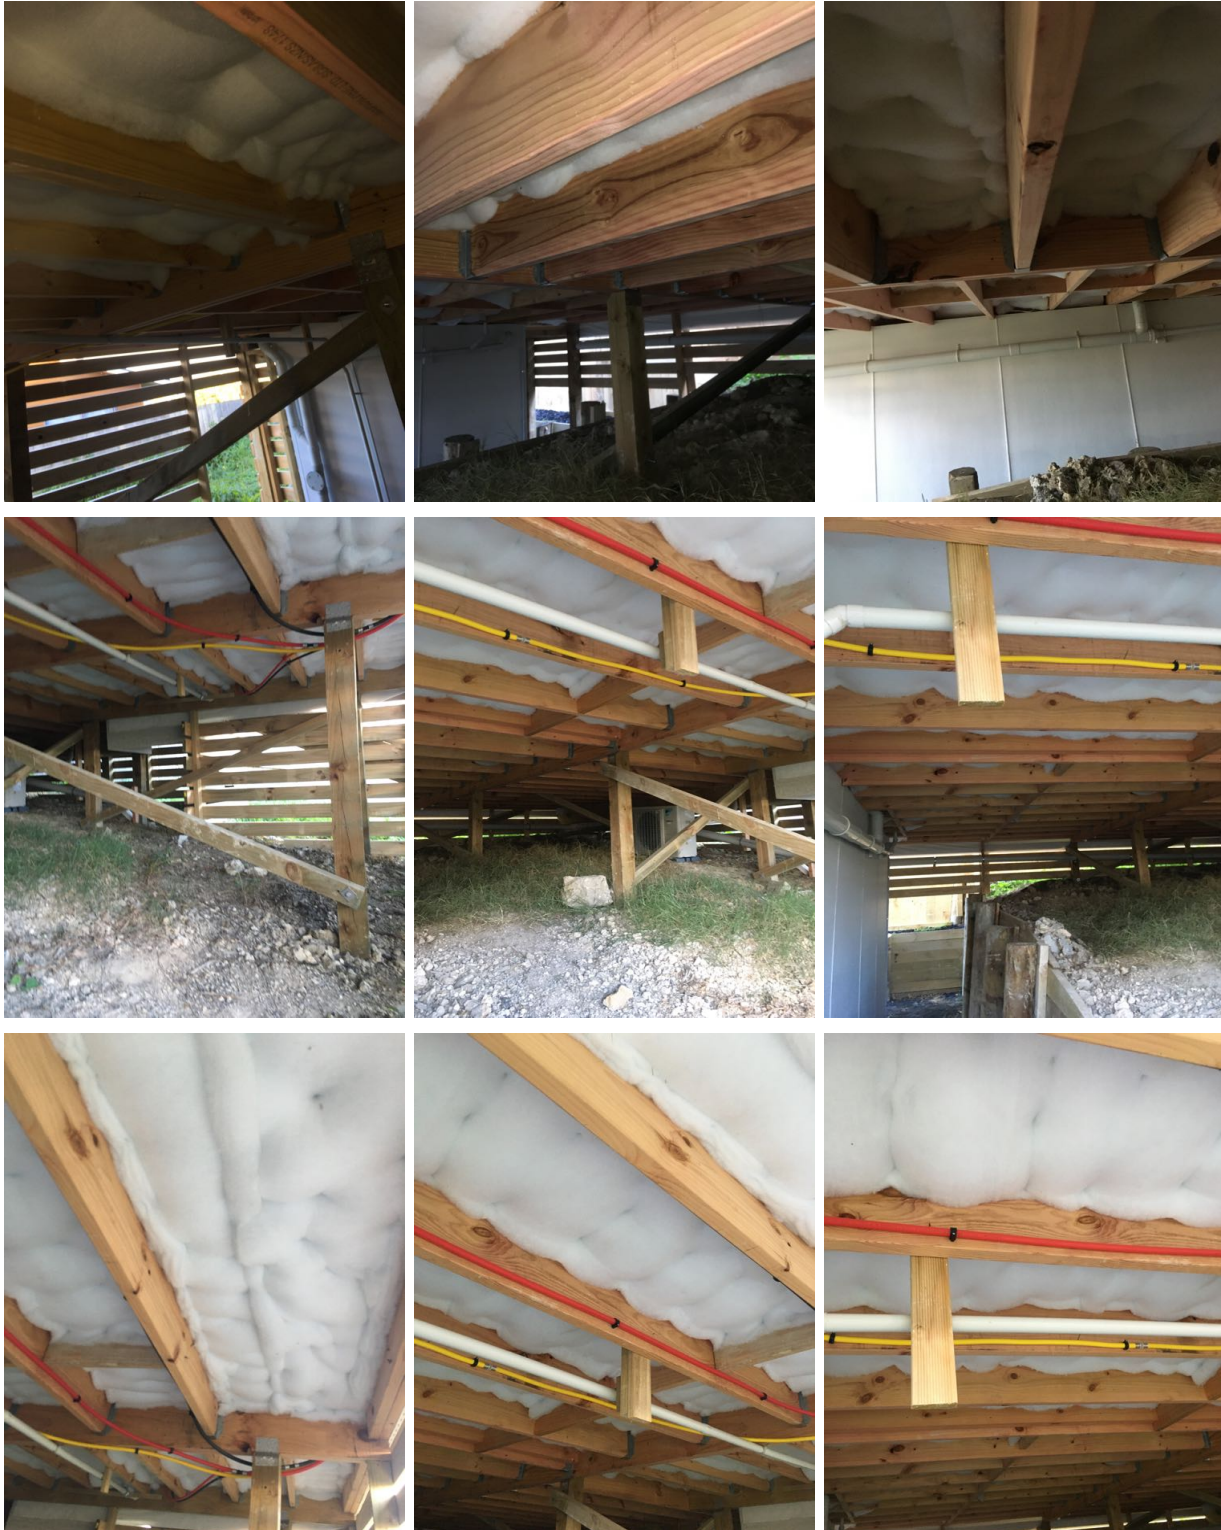
Photograph

Does the underfloor insulation meet the requirements of the insulation standard?

Yes

What is the R value of the underfloor insulation?

1.5

Polyester blankets or segments

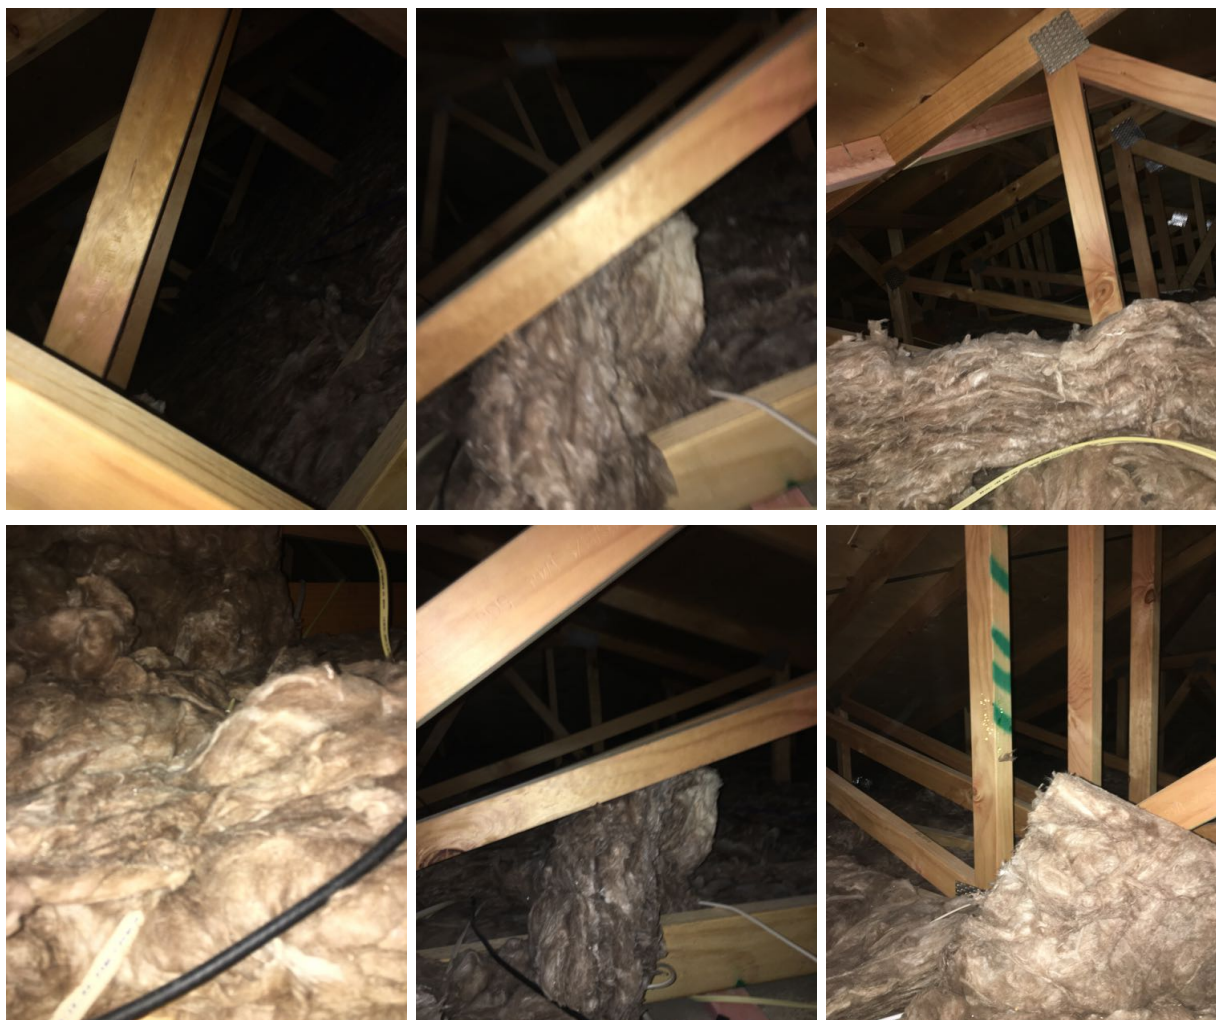
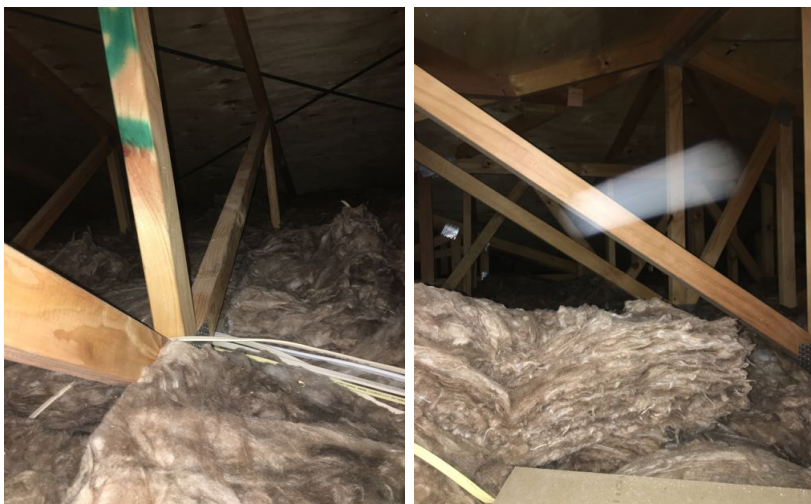
Photograph

What is the R value of the ceiling insulation?

3.6

210 mm

Ceiling Insulation material
Glasswool(batts and rolls)

Yes
