KIWI HOUSE INSPECTIONS

Weathertightness & Building Inspection Report on 267B Glenfield Road, Glenfield

Address of Property: 267B Glenfield Road
Glenfield
Auckland

INDEPENDENT BUILDING INSPECTION
267B Glenfield Road

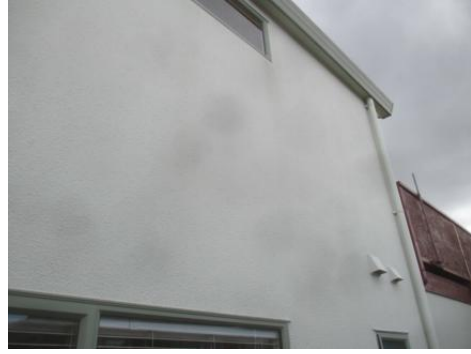
No cavity

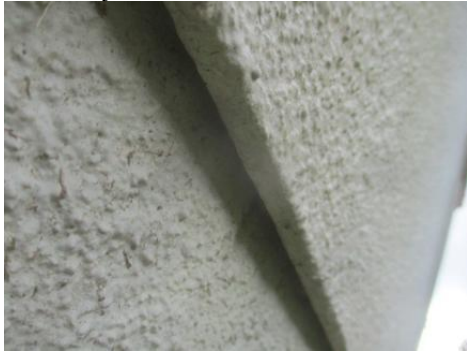
Control joint

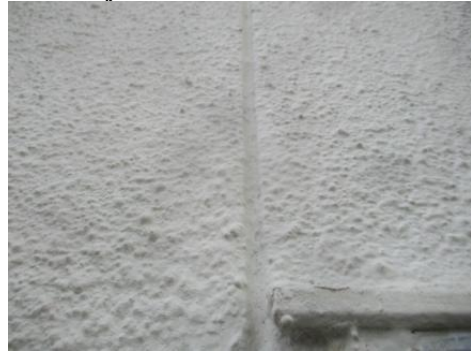
Also, it is imperative that all penetrations through the cladding are kept well sealed as these are potential areas for moisture ingress to occur over time – these penetrations include wastepipes, vents and ventilation grills, overflow pipes, electrical meter board, exterior joinery, etc.

Keep penetrations well sealed

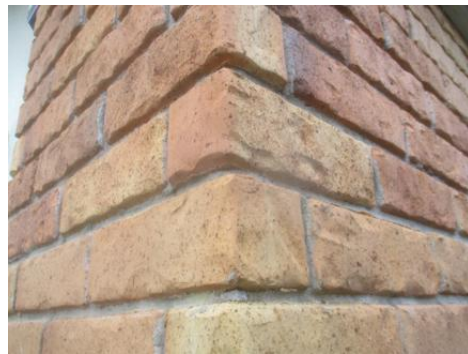
The remainder of the exterior cladding to the dwelling is of brick veneer, installed over a timber frame, with a 45-70mm drained and vented cavity.

Cavity system

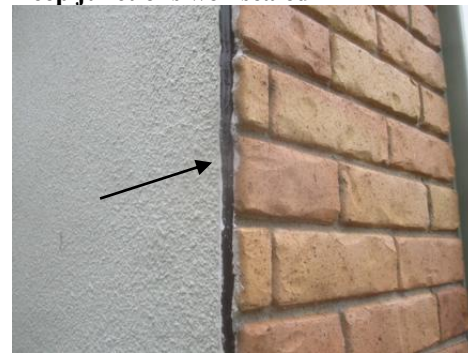
Keep junctions well sealed

NOTE: Please ensure junctions between the cladding types are kept well sealed.

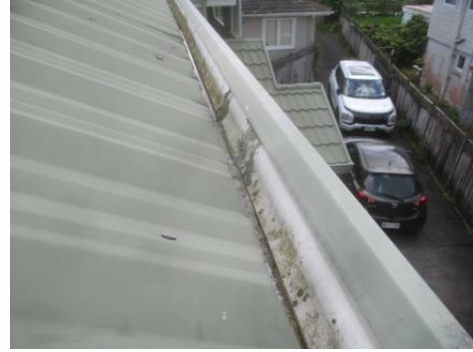
Roof flashings are well installed, suitably fixed and sealed appropriately in accordance with good trade practice. NOTE: Kick-out flashings have been retrospectively installed. Please ensure roof-to-wall junctions remain well sealed as this is a critical junction.

Kick-out flashings

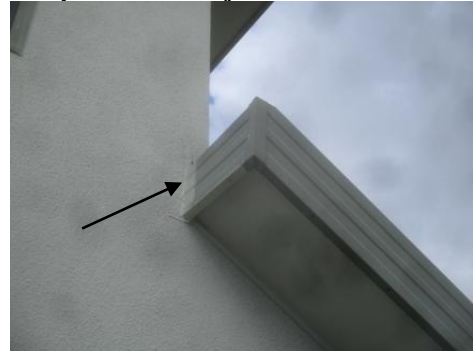
Keep roof-to-wall-junctions well sealed

No eaves in some locations

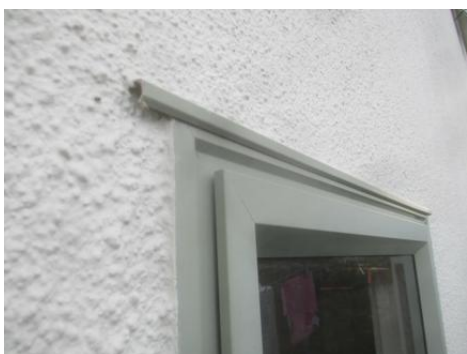
NOTE: Although head flashings have been installed, there is no adequate jamb flashing to the sill or side of the windows, and there is no air gap between the flashing and cladding; therefore, silicone sealant is relied on to form the weather seal. Cracks may appear between the joinery and cladding, due to variation in thermal expansion rates between the aluminium and plaster. Re-sealing the joinery to the cladding should be undertaken as part of the maintenance plan. Mitered corner junction also must be kept well sealed.

Keep well sealed

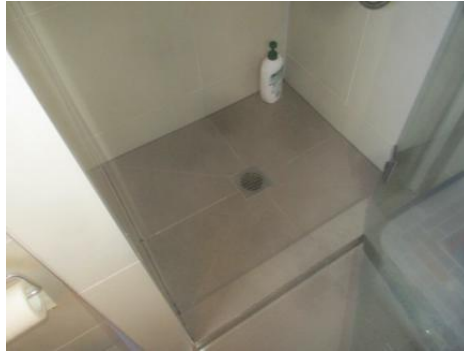
NOTE: A tiled shower has been installed in the ensuite. We are unable to comment on the condition of the waterproofing as it is concealed; however, all moisture readings were within acceptable limits at the time of inspection, and there was no visual damage.

Tiled shower

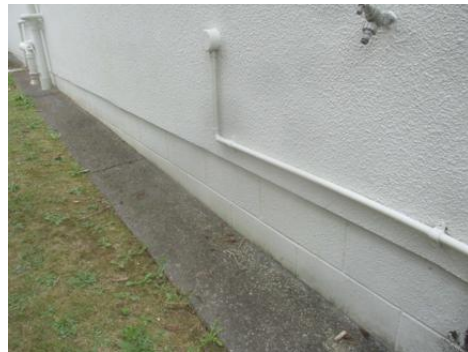
NOTE: The cladding system has been taken down to the ground in some locations. It is now generally accepted that the bottom edges of plaster systems of this type should be kept clear of finished exterior ground levels to ensure that surface water is not absorbed into the back edges of the plaster and transferred into the internal framing by means of capillary action. Installing a channel drain along here is an acceptable solution. Moisture readings were within acceptable limits at the time of inspection.

Cladding in contact with grounds

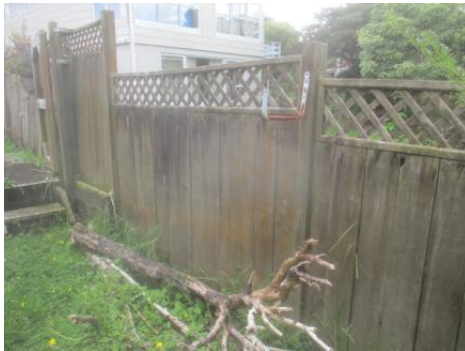
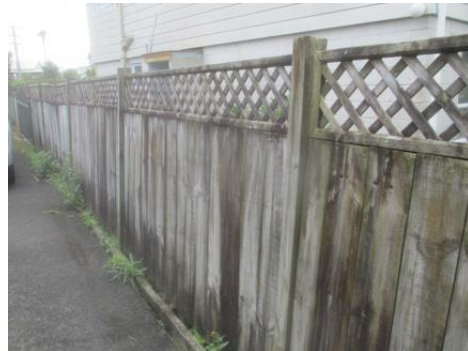
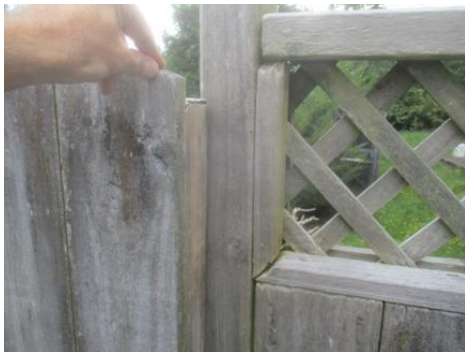
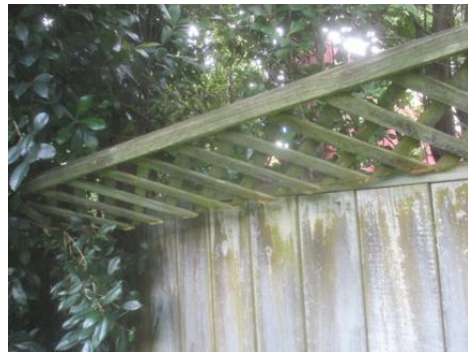
Areas to Note: Fences are in average condition - several sections are on a lean and unstable – these will require repair. Some trellis is damaged.

Fences on a lean

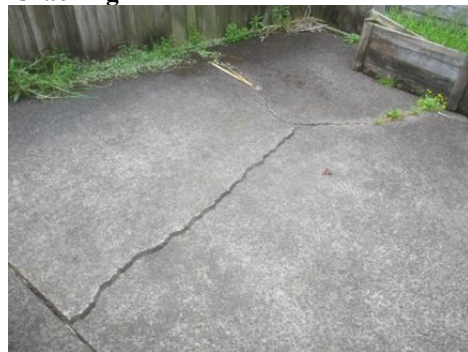
Area to Note: There is movement and cracking at the end of the driveway.

Cracking

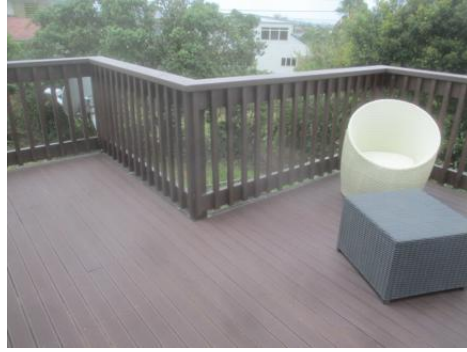
There is not adequate clearance between the bottom edges of the cladding and the deck; therefore, there is potential for moisture ingress to occur via capillary action up through the cladding and be transferred into the internal timber framing.

Inadequate clearances

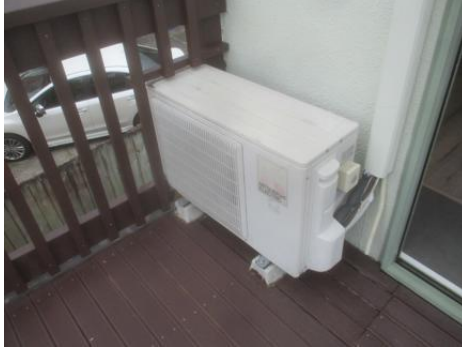
Areas to Note: Butynol generally has a maximum lifespan of 25 years; therefore, it is due for replacement. The position the heat pump unit is located is not compliant as it can be climbed.

Non-compliant location
