FIRST REPORT - INITIAL ASSESSMENT - EARTHQUAKE

To: IAG New Zealand
Attn: Claims Officer
Date: 29/09/2017
Claim Ref: HHH1708995
Gallagher Bassett Ref: C57982

Insured Name: Barbara Wear
Situation of Loss: 51 SEFTON STREET
Suburb: BELFAST
City: Christchurch
Date of Loss: 14/11/2016
Sum Insured: \$
Excess: 200

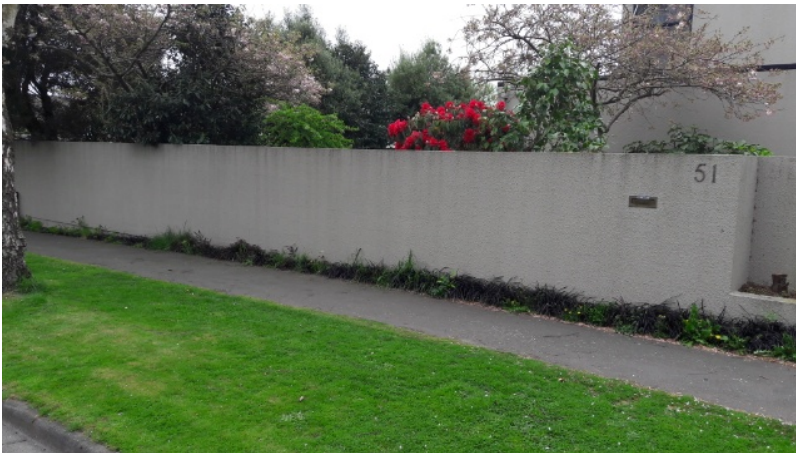
Figure 2 : Plaster block fence- No visible EQ damage - No action required.

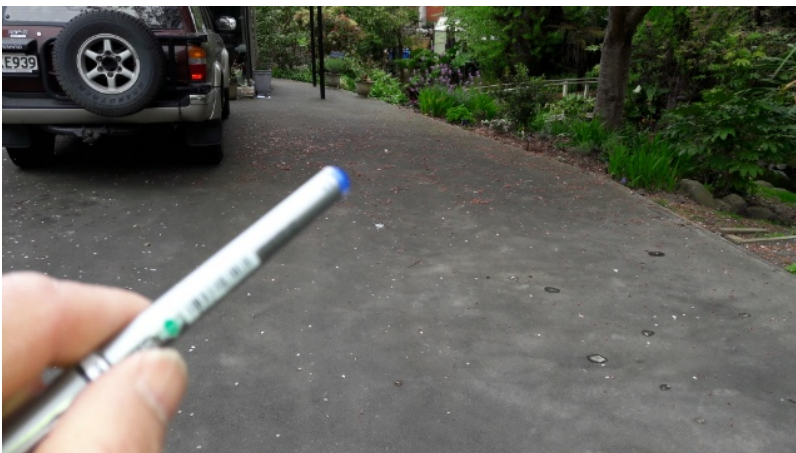
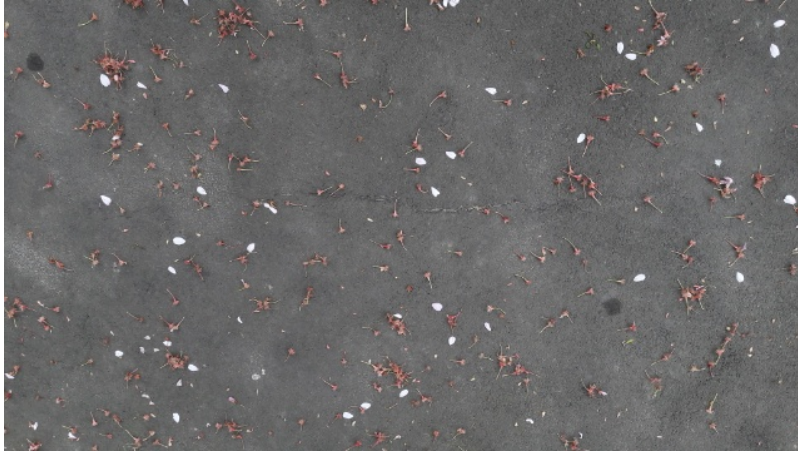
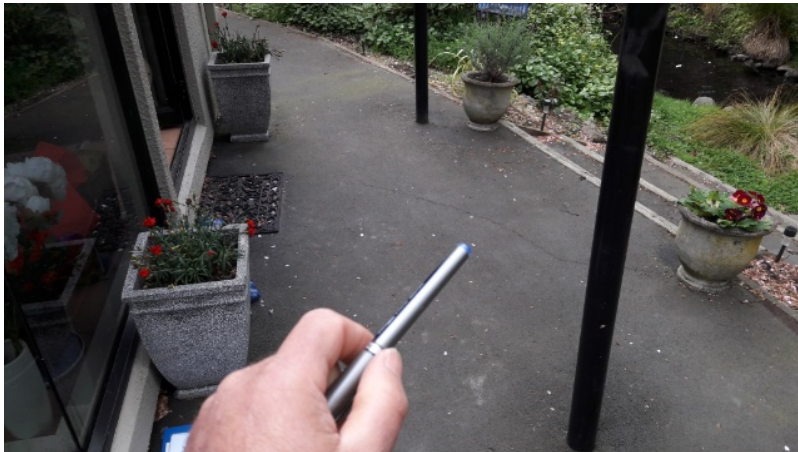
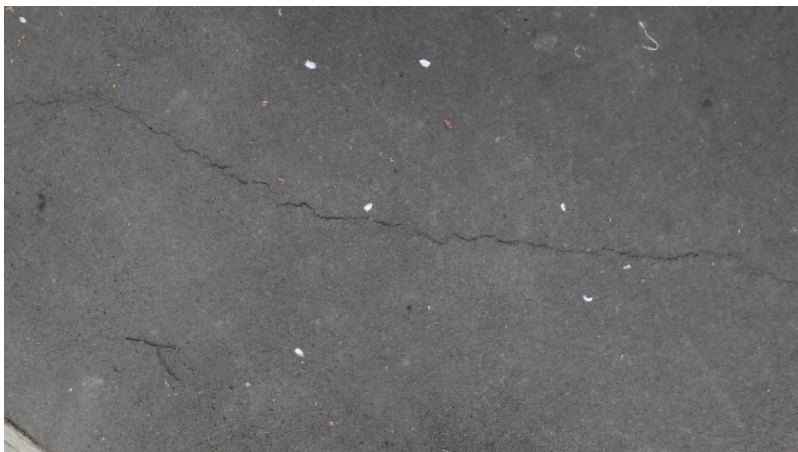
Your Insured advised of further areas of concern in relation to the cracks within the asphalt drive. However, it is our opinion that these areas as listed below are not Kaikoura earthquake event related and are invalid as evidenced by the following:

- Cracks appear historical and well worn.
- Given that the house is located within approximately 5-6 m of a stream and there are trees that line the property, it would appear that these fine cracks are caused due to the gradual subsidence over time and the tree roots.

Figure 3 : Asphalt drive- area of concern raised by the insured. These are not EQ related. refer to report notes.

Figure 4 : Asphalt drive- area of concern raised by the insured. These are not EQ related. refer to report notes.

Figure 5 : Asphalt drive- area of concern raised by the insured. These are not EQ related. refer to report notes.

Figure 6 : Asphalt drive- area of concern raised by the insured. These are not EQ related. refer to report notes.

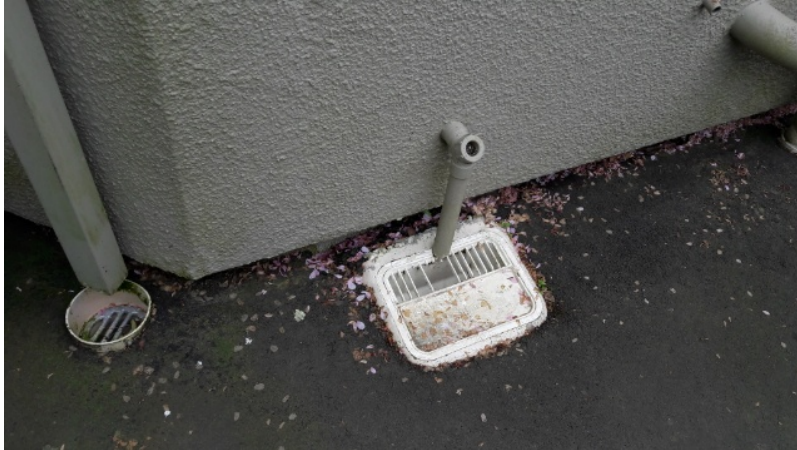
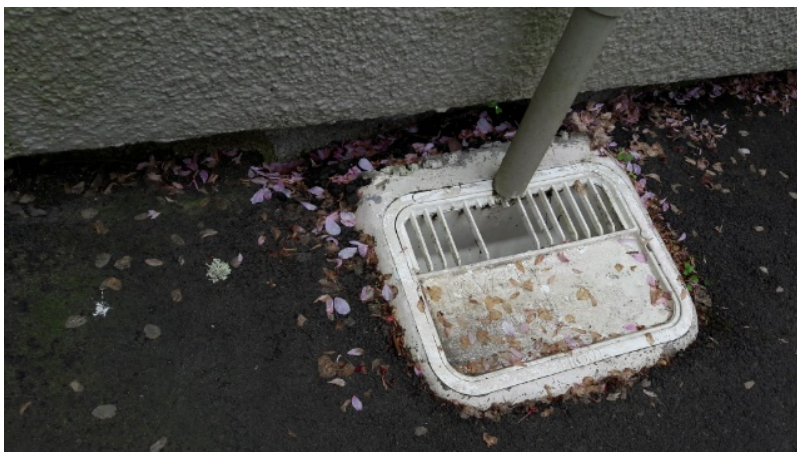
The Insured also advised of further areas of concern in regard to the waste pipe, that comes out the wall into the gully trap located on the south side where the stream runs . However, it is our opinion that this area as listed below is not Kaikoura earthquake event related and is invalid as evidenced by the following:

- This is a result of gradual subsidence as well, where its has settled towards the stream over time. There appears to be no fresh evidence of earthquake movement or separation where the asphalt meets the house foundation. The drainage gully trap has pulled away from the house indicating that the waste pipe does not meet the gully trap as it once would have.

Figure 7 : Services- Gully trap/waste pipe - area of concern raised by the insured. This is not EQ related as the gully trap has pulled away from the foundation over time as evidenced by the historical and discoloured gap between the asphalt surrounding the gully trap and the foundation. The nearby stream would be a contributing factor causing gradule settlement over time. Stream is approximately 5-6 metres away.

Figure 8 : Services- Gully trap/waste pipe - area of concern raised by the insured. This is not EQ related as the gully trap has pulled away from the foundation over time as evidenced by the historical and discoloured gap between the asphalt surrounding the gully trap and the foundation. The nearby stream would be a contributing factor causing gradule settlement over time. Stream is approximately 5-6 metres away.

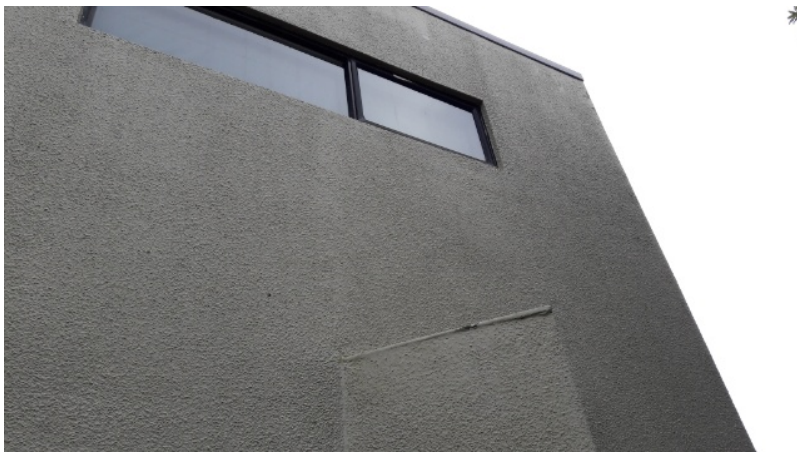
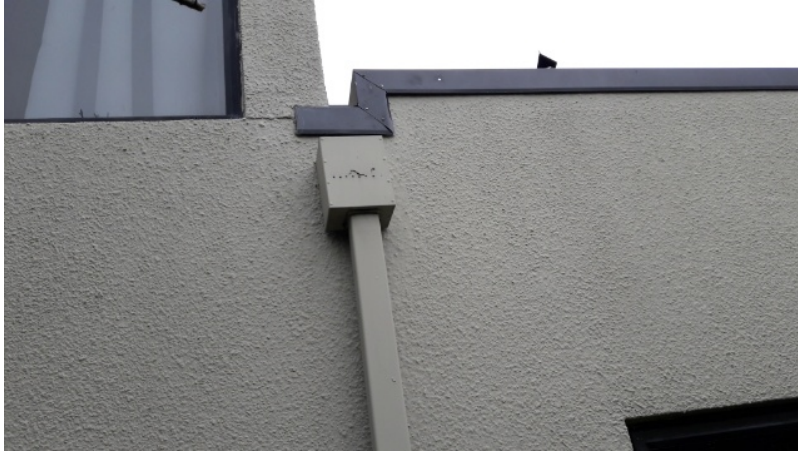
The exterior wall cladding consists of plaster render over what appears to be Hardie backer and displays no visible earthquake related damage.

Figure 9 : Plaster render of what appears to be hardie backer rather than Poly. No visible EQ damage.

Figure 10 : Plaster render of what appears to be hardie backer rather than Poly. No visible EQ damage.

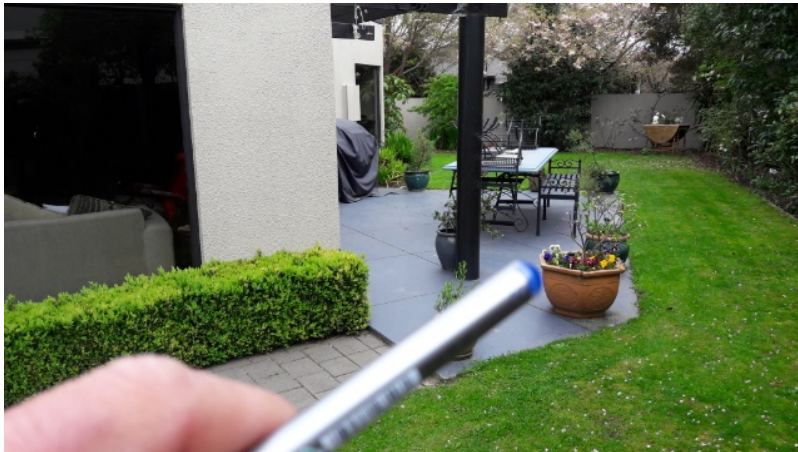
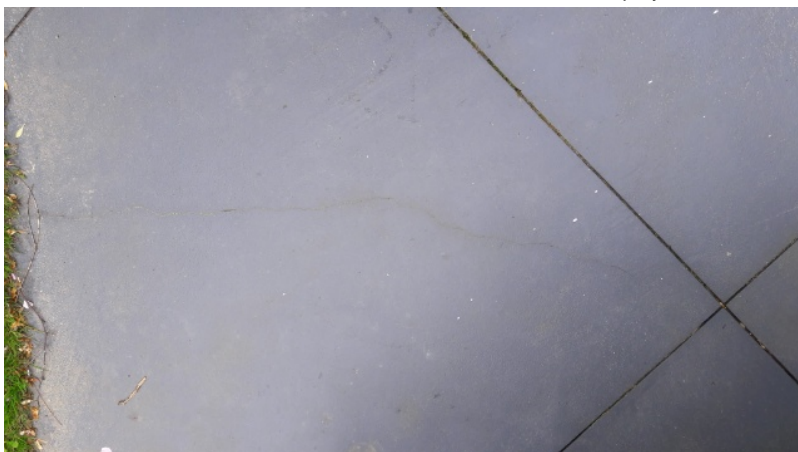
We note: The Insured advised previous claims were cash settled and repairs have not been undertaken. This is in relation to the patio area as advised by the Insured over the phone.

Figure 11 : Insureds partner 'Tom' advised of area of concern to crack in patio. This is not EQ related as evidenced by the rounded edges and debris in the crack. this crack has also been sealed over and displays no fresh related EQ damage.

Figure 12 : Insureds partner 'Tom' advised of area of concern to crack in patio. This is not EQ related as evidenced by the rounded edges and debris in the crack. this crack has also been sealed over and displays no fresh related EQ damage.

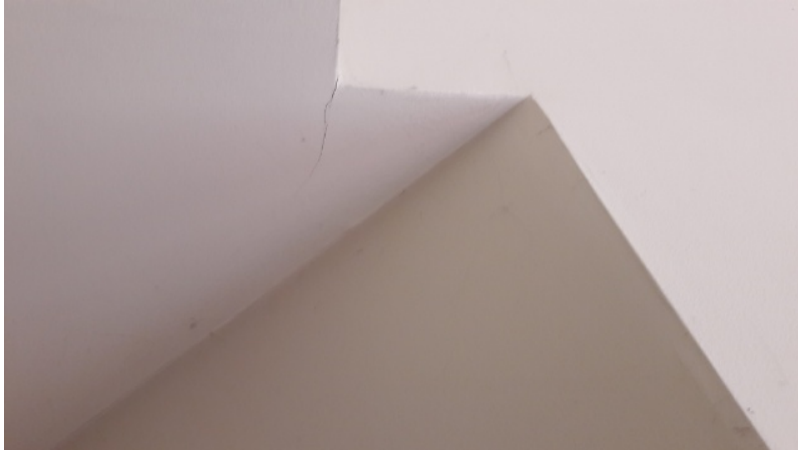
Figure 13 : Front entry- old dark crack observed. Not from this event.

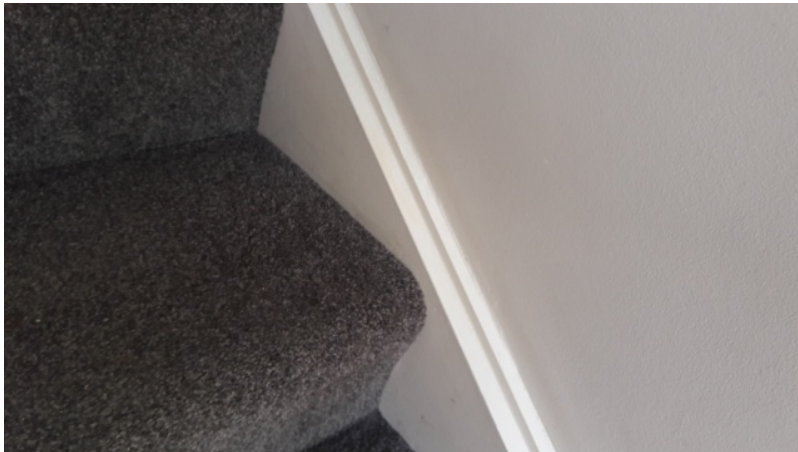
Your Insured advised of further areas of concern in regard to the gap between the beading and the wall that runs up the stair stringers on each side. However, it is our opinion that this area as listed below are not Kaikoura earthquake event related and are invalid as evidenced by the following:

- There is no fresh appearance of any tearing affect. The paint surface has not fractured.

Figure 14 : Stairs no visible damage where stringer and beading meet the wall linings.

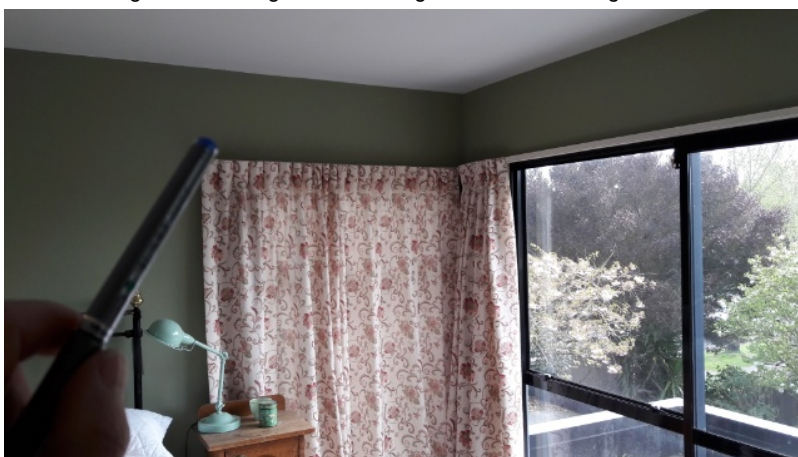
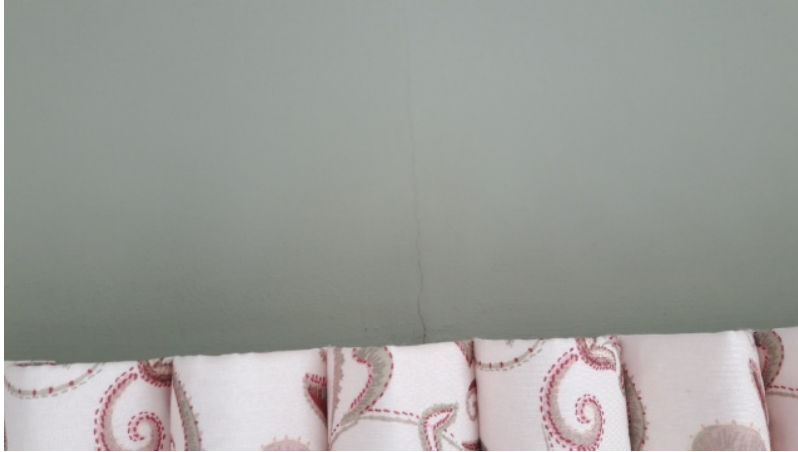
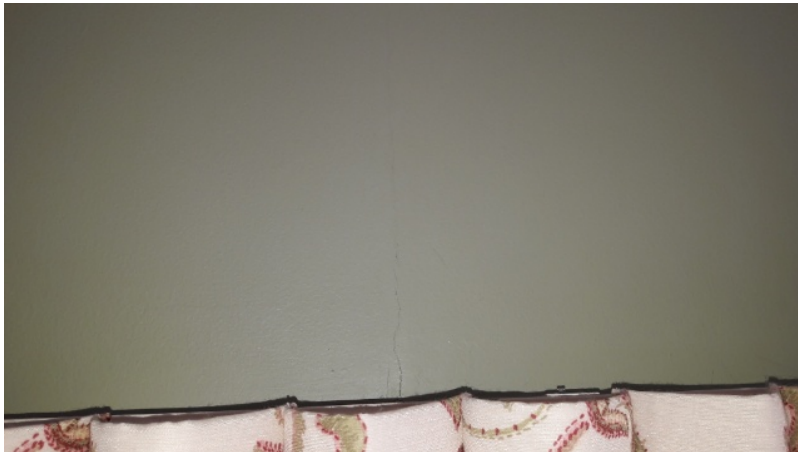
The dwelling displays multiple areas of superficial damage predominately caused by the shaking of

the structure.

Figure 15 : Bedroom 2 -(1) fresh cracking to wall linings

Figure 16 : Bedroom 2 -(1) fresh cracking to wall linings

Figure 19 : Bedroom 2 -(1) fresh cracking to wall linings

This will respond to targeted repair options.

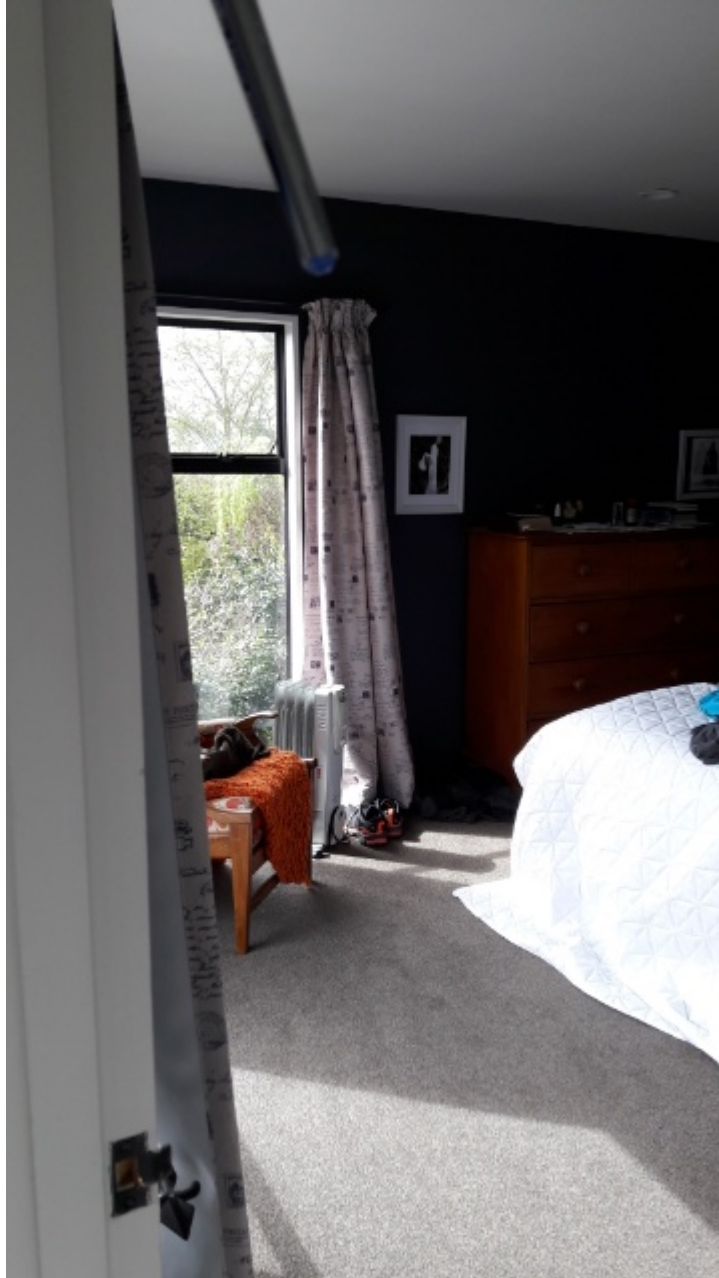
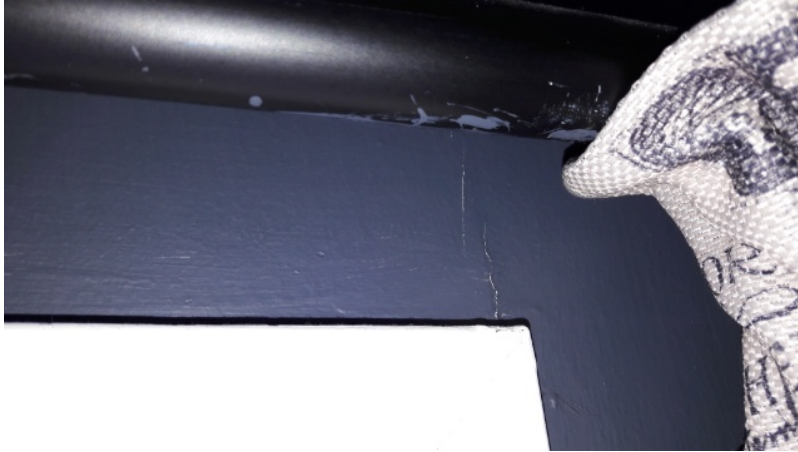
Figure 17 : Bedroom 1 -(2) fresh cracking to wall linings

Figure 18 : Bedroom 1 -(2) fresh cracking to wall linings
