Long Term Maintenance Plan

2024 – 2053
(30-YEARS)

Body Corporate 434350
37 Waipa Street
Birkenhead
Auckland

Prepared by RAWA Limited
Aug/Sep 2024

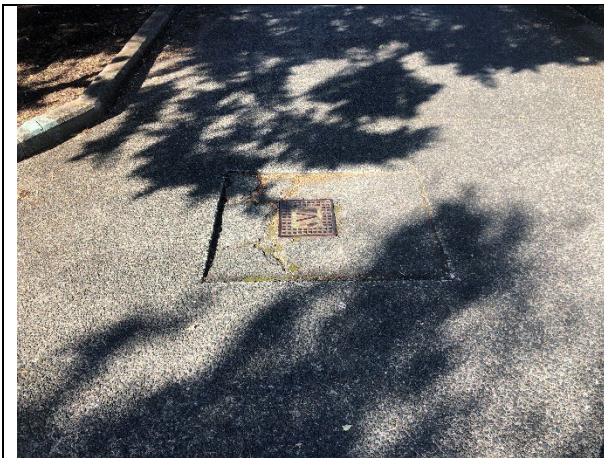
CRACKED AND SUNKEN CONCRETE SURROUND TO WATER SLUICE VALVE TO BE REPLACED ADJ. PU-23

We noted several areas of cracking within the driveway which will require grinding and filling / sealing to ensure further cracking and deterioration of the driveway is restricted. In addition, we noted several areas of damaged kerbs and areas around water sluice valves adjacent PU-23. An allowance has been made to repair kerbing and concrete surrounds.

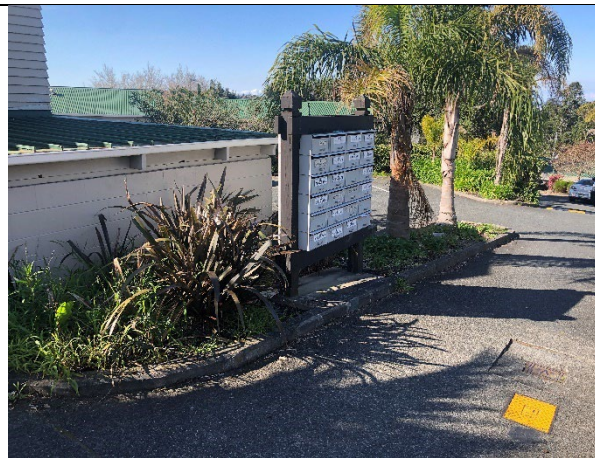
LETTER BOXES IN GOOD ORDER
ANOTHER SLUICE VALVE SURROUND TO BE REPLACED
LANDSCAPING REQUIRED

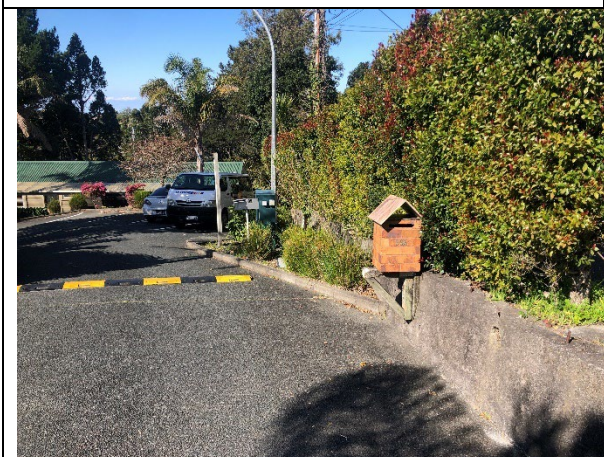
SPEED-BUMB END CAP TO BE REPLACED

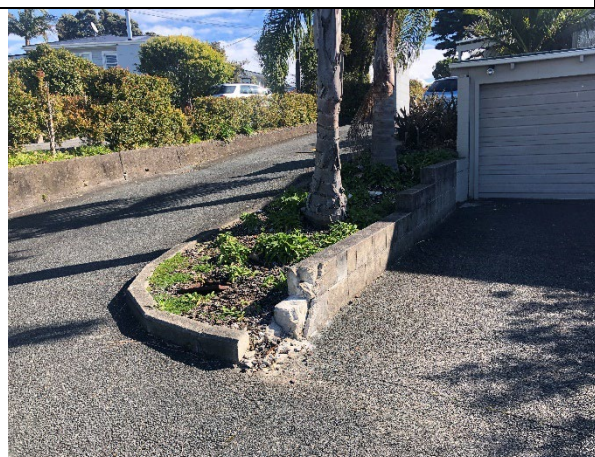
DAMAGED BLOCK WALL AND KERB, PU-23 GARAGE

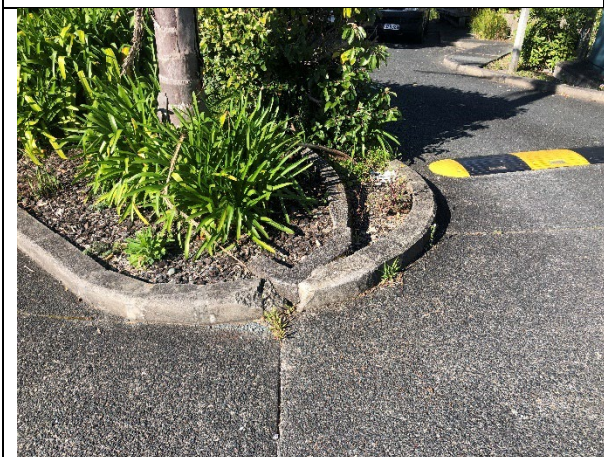
EXAMPLE OF DAMAGED KERBING, PU-23

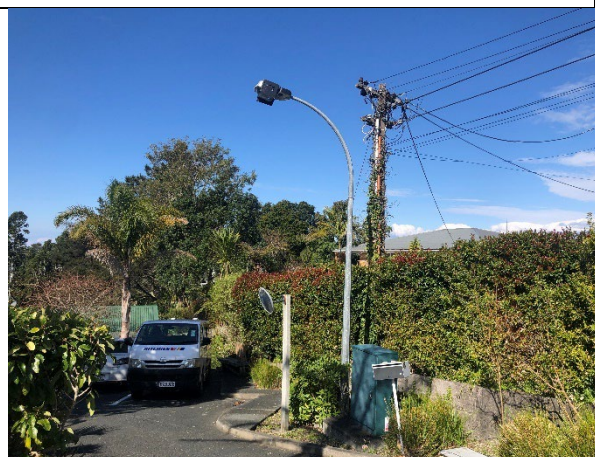
STREETLIGHT TO SECTION AND LAMP TO BE REPLACED.
MIRROR BASEPLATE TO BE REPAIRED AND REFIXED IN PLACE.

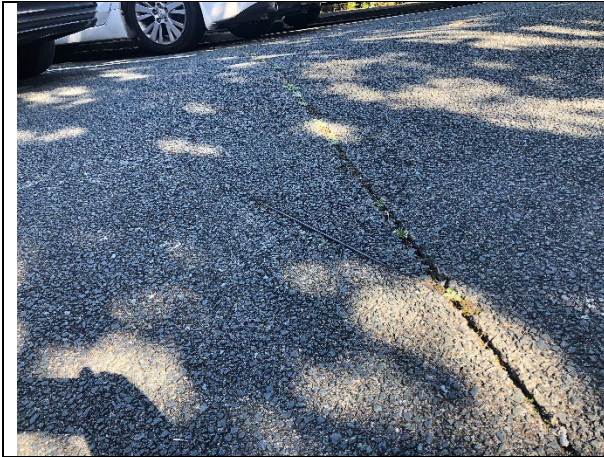
REINFORCING MESH SHOWING AT SURFACE OF CONCRETE, PU-11

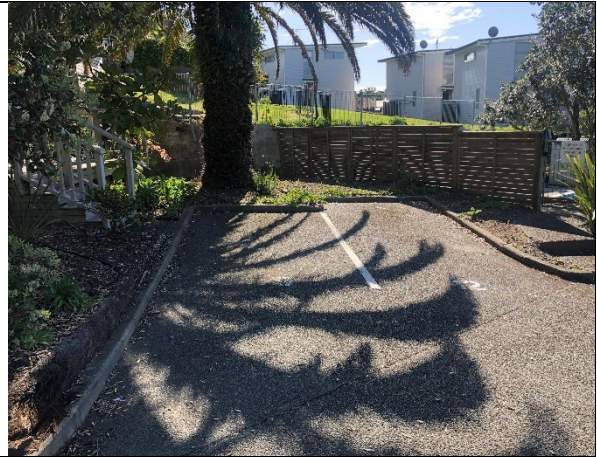
DAMAGED KERBING, AU-53, AU-54.

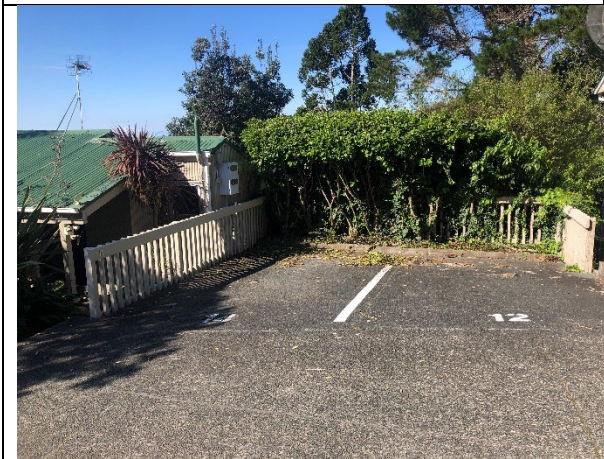
OVERGROWN LANDSCAPING AU-55, AU-56

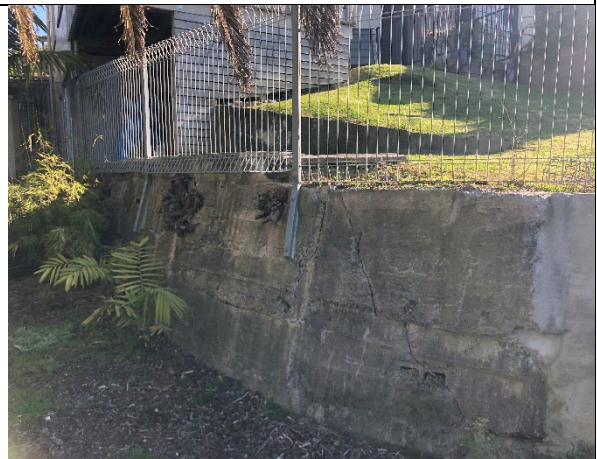
CRACKED RETAINING WALL, PU-7

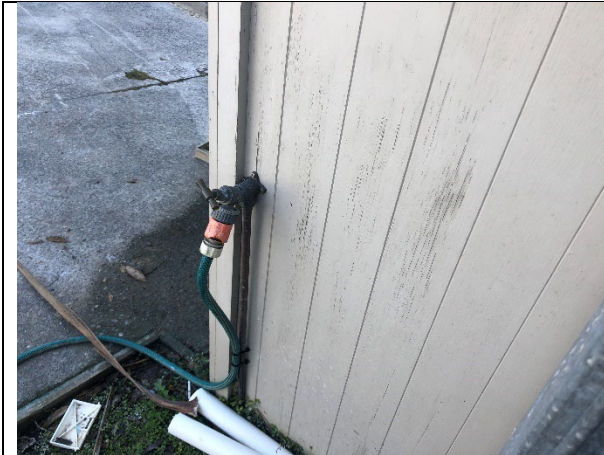
POOSIDE WATER TAP REQUIRES A VACUUM-BREAK TO BE INSTALLED (VERY INEXPENSIVE BUT NECESSARY).

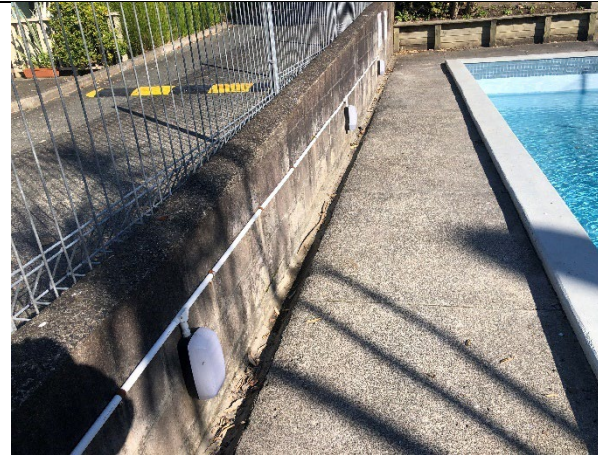
POOL-SIDE LIGHTS NEED REPLACEMENT (FULL OF WATER).

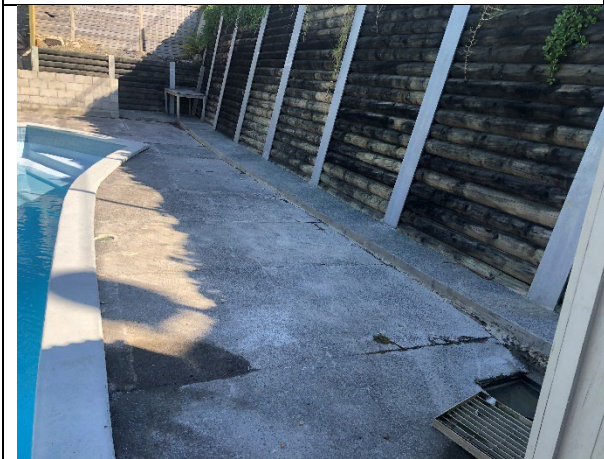
POO-SIDE PATIO CONCRETE NEEDS REPLACEMENT
SURFACE WATER SUMP NEEDS UNBLOCKING

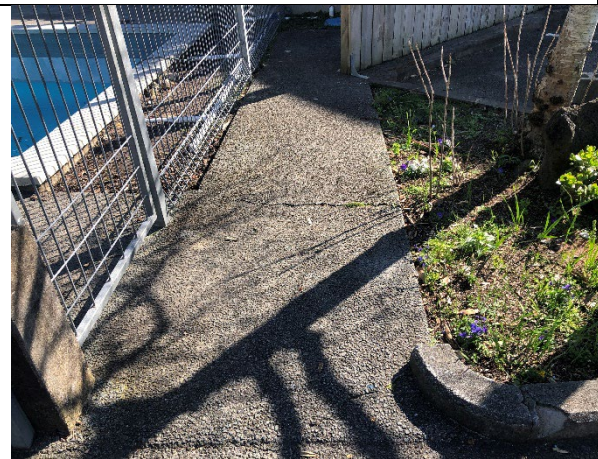
POOL PATH CRACKED

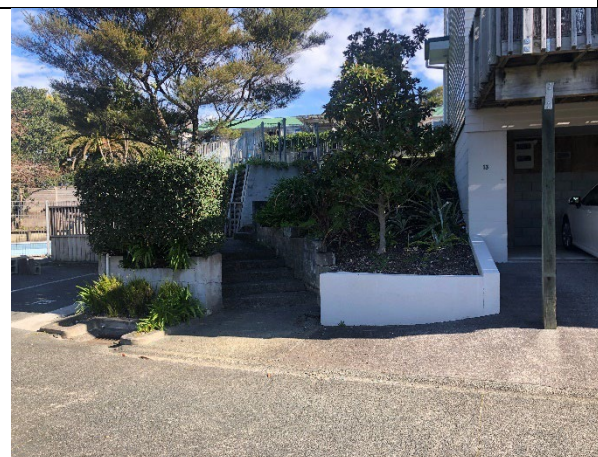
EXAMPLE OF EXCESSIVE SIZED TREE SPECIMEN WITHIN
BLOCK PLANTER.
TREE ROOTS ARE PUSHING BLOCK WALL OUTWARD.
TREE TO BE REMOVED AND WALL REPAIRED, PU-13 &
POOL.

We noted several areas within the site requiring additional landscaping focus in the first 1-to-2 years. There are several planters around the site that have overly large tree specimens within that need to be removed to reduce to the pressure on the surrounding block wall planter structure(s).

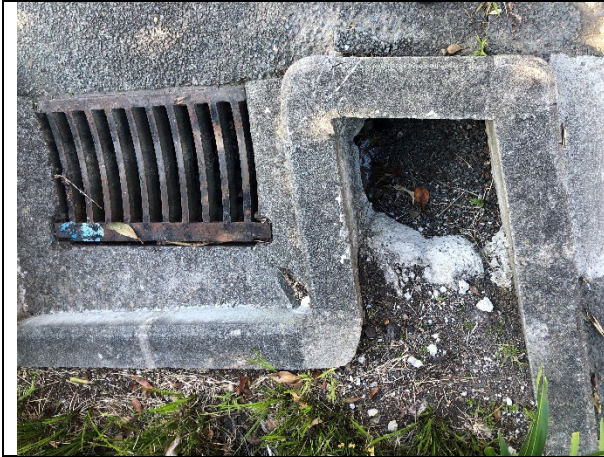
NOVACOIL DRAIN ENTERING SIDE OF CESS PIT REQUIRED REPAIR, PU-13 & POOL.

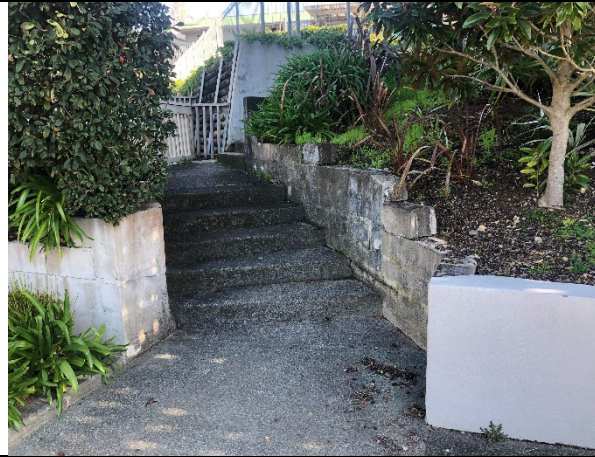
AS ABOVE, PU13 & POOL.

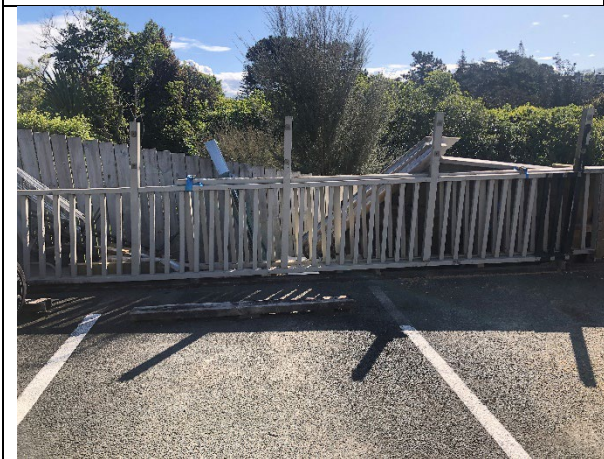
DEMOLITION DEBIS TO BE REMOVED PU-19, AU-43

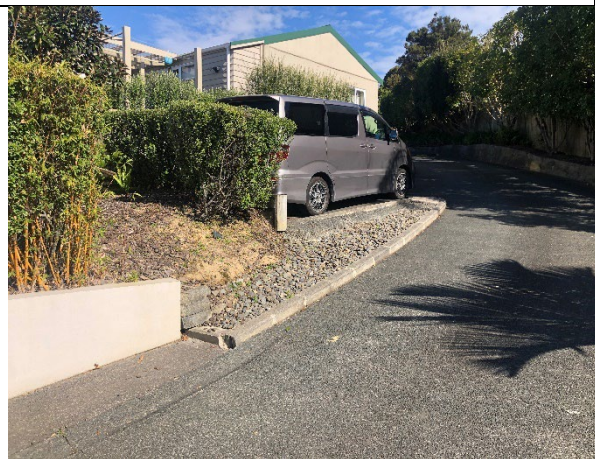
DAMAGED KERBING AU-37, PU-2.

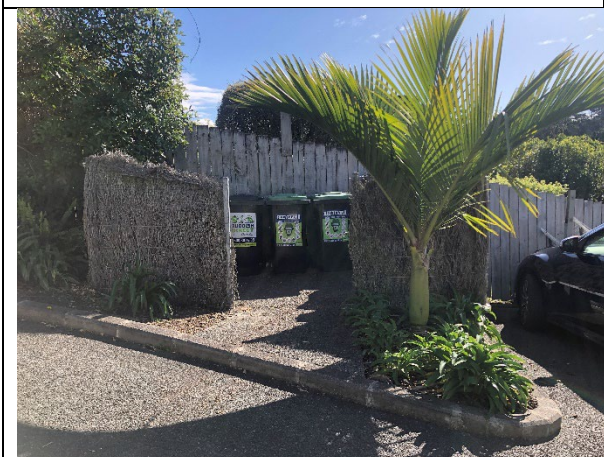
BRUSH-STICK FENCING AROUND RUBBISH AREA TO BE REPLACED, AU-38.

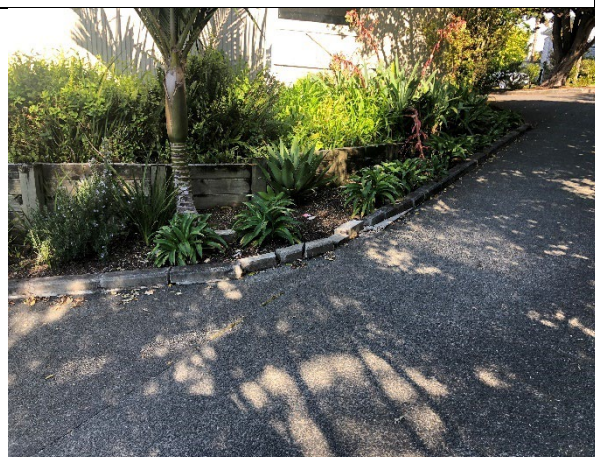
DAMAGED KERBING NORTH-WEST SIDE OF PU-23

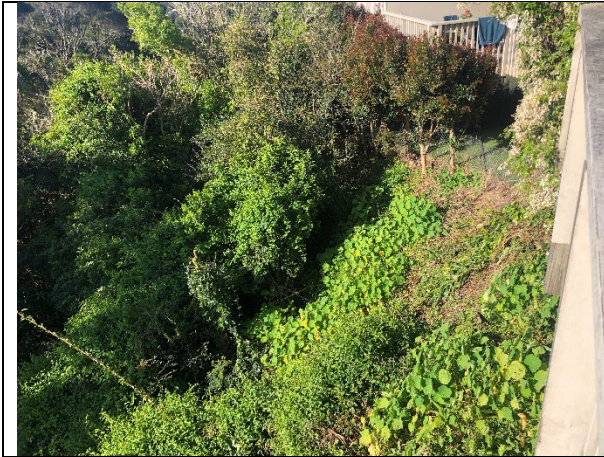
There is a large common area of overgrown area to the north of PU-18 that required immediate attention in year-1 of the plan.

COMMON AREA TO THE NORTH OF PU-18 REQUIRES EXTENSIVE MAKING GOOD.

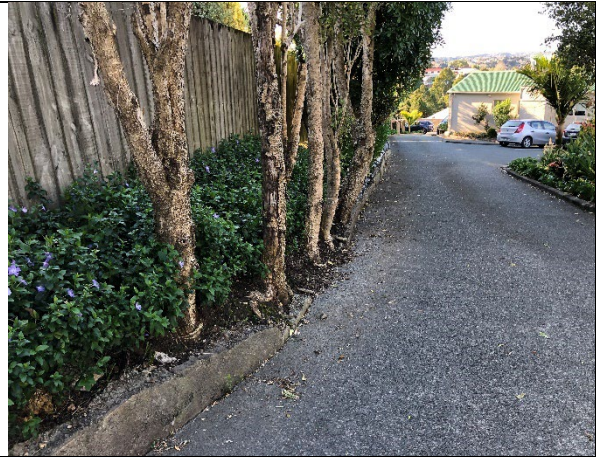
EXAMPLE OF EXCESSIVE SIZED PLANTING WITHIN CONFINED PLANTER.
REMOVE TREES AND MAKE GOOD KERBING
