FIRST REPORT - INITIAL ASSESSMENT - EARTHQUAKE
To: IAG New Zealand
Attn: Claims Officer

Date: 20/09/2017
Claim Ref: [REDACTED]
Gallagher
Bassett Ref: [REDACTED]
CLAIMS DETAILS
Insured Name: Jessica Kirkland Standfield **Sum Insured:** \$
Situation of Loss: 38 Papawai Drive **Excess:** 200
Suburb:
City: Rangiora
Date of Loss: 14/11/2016
Reserve

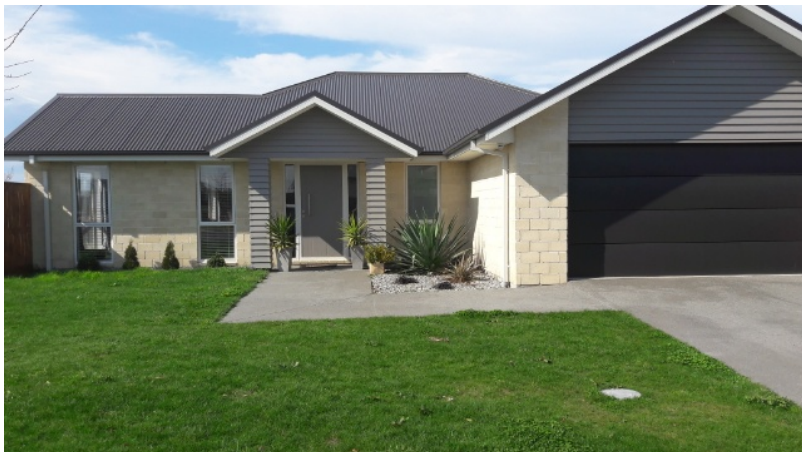
Figure 1 : Insured risk

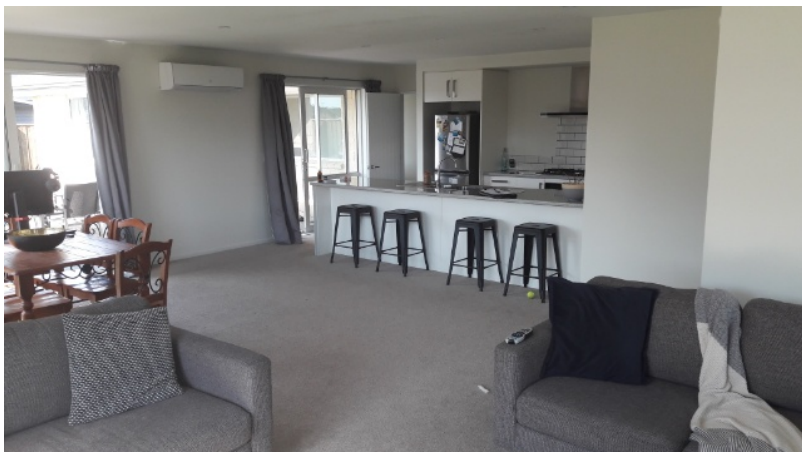
Figure 2 : Kitchen/Dining/Lounge overview

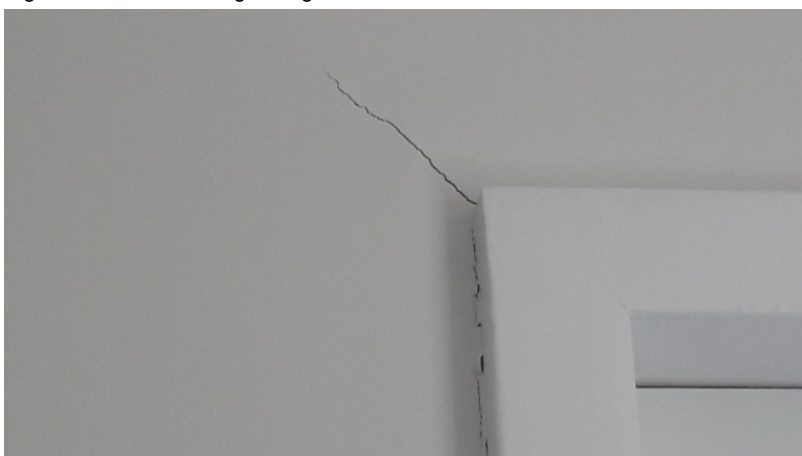
Figure 3 : Kitchen/Dining/Lounge wall crack

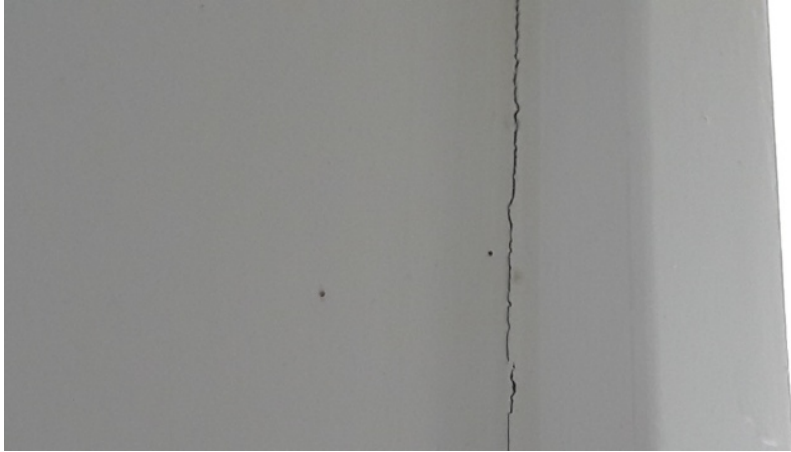
Figure 4 : Kitchen/Dining/Lounge jamb movement

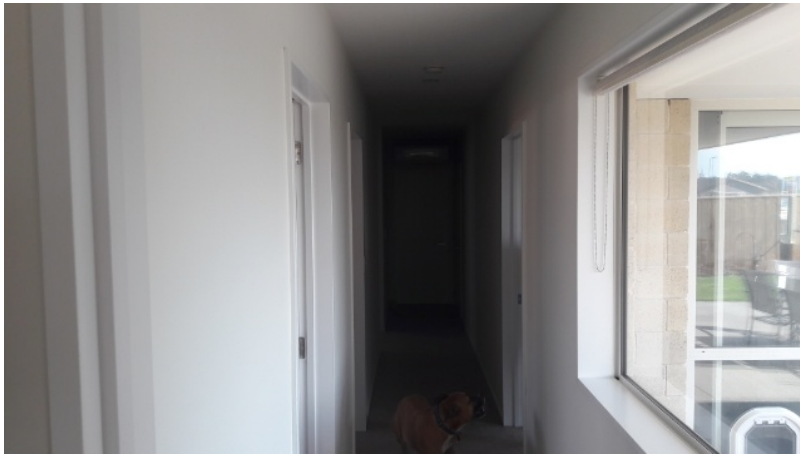
Figure 5 : Hallway overview

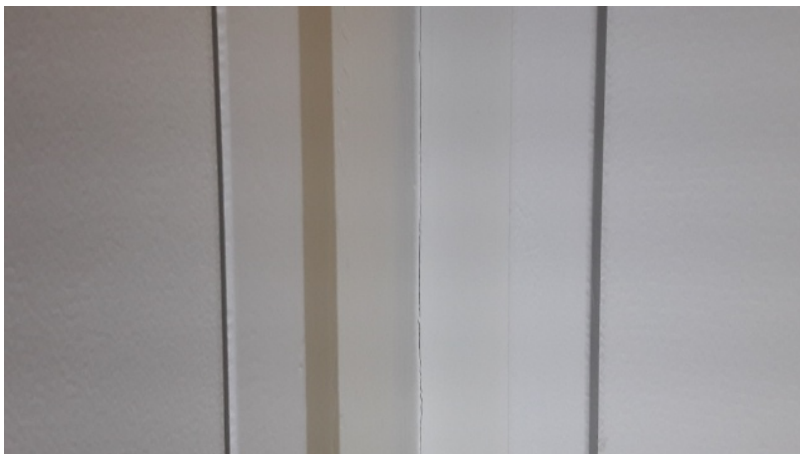
Figure 6 : Hallway wall cracking

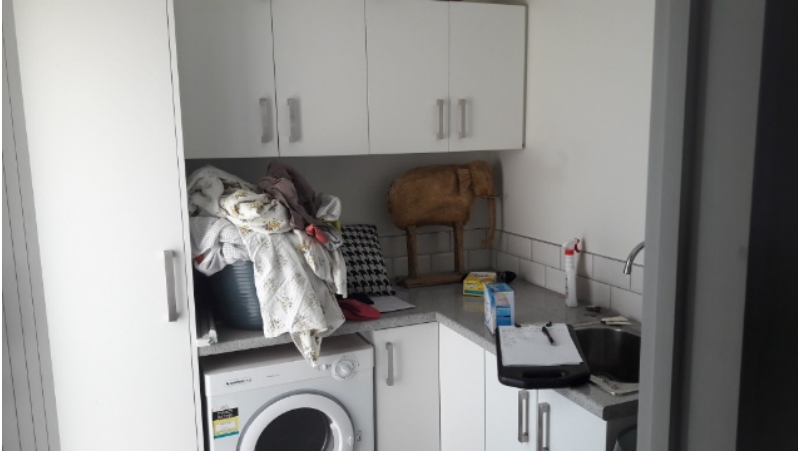
Figure 7 : Laundry overview

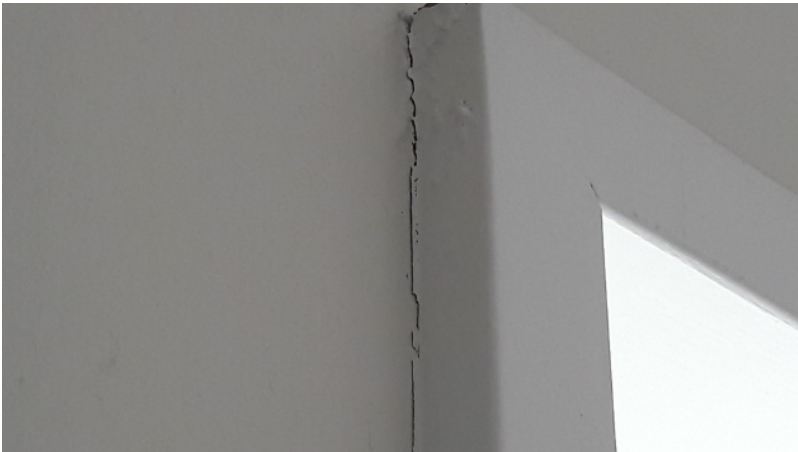
Figure 8 : Laundry jamb movement

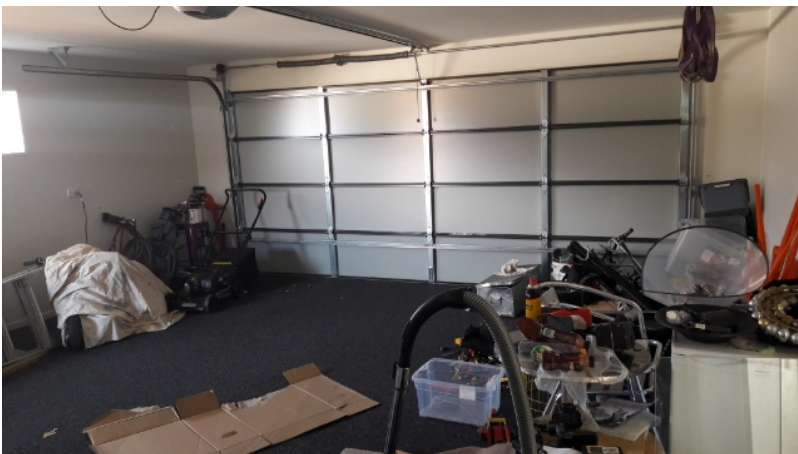
Figure 9 : Garage overview

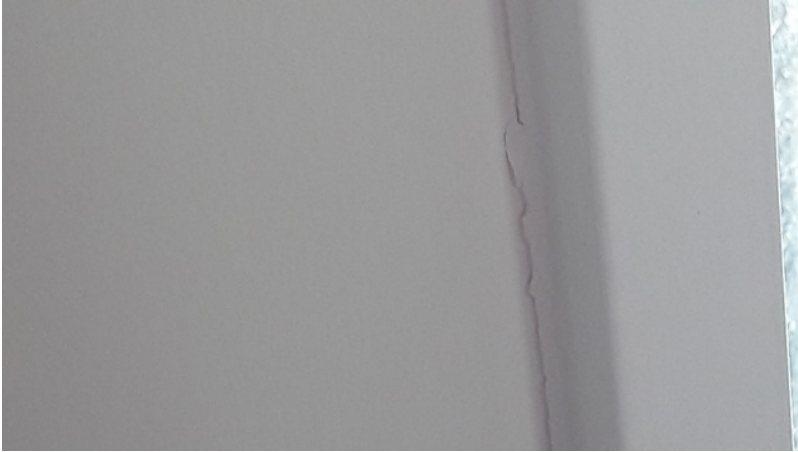
Figure 10 : Garage wall crack

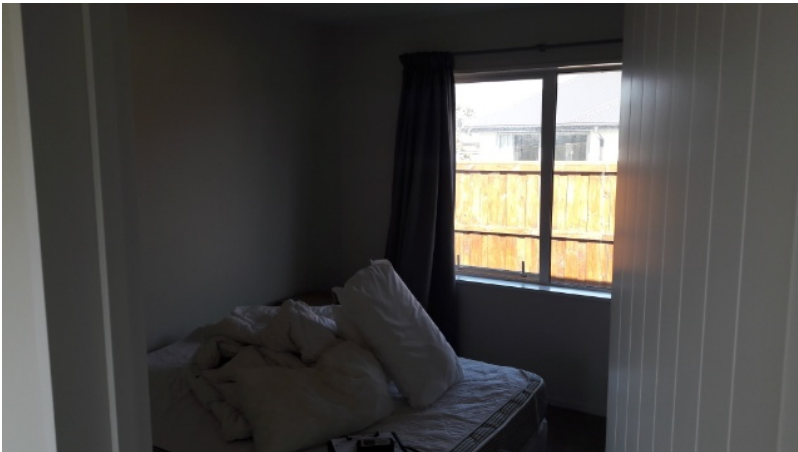
Figure 11 : Bedroom 2 overview

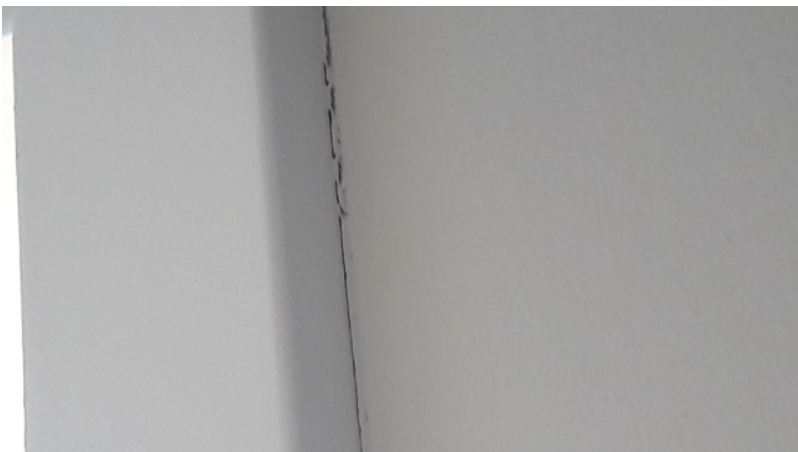
Figure 12 : Bedroom 2 jamb movement

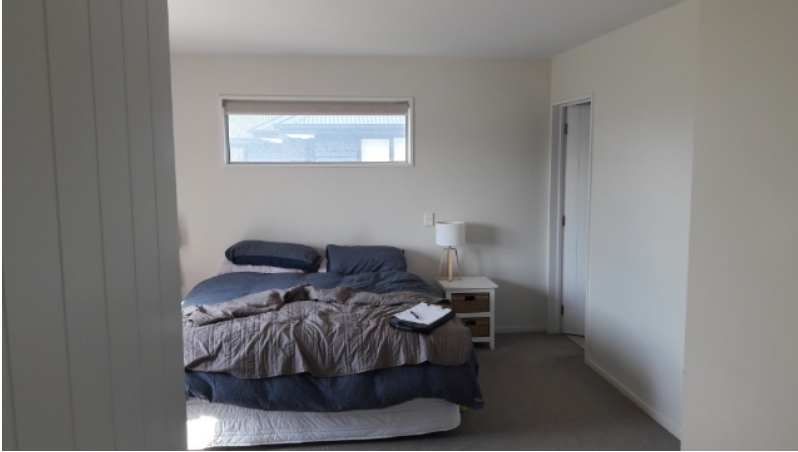
Figure 13 : Master Bedroom overview

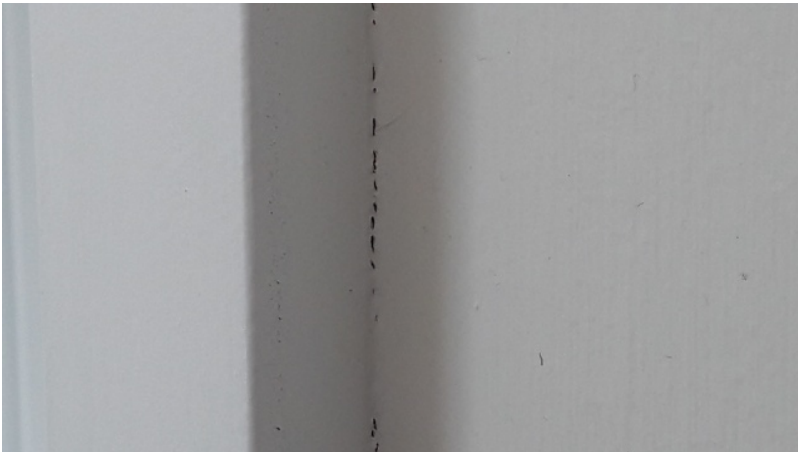
Figure 14 : Master Bedroom jamb movement

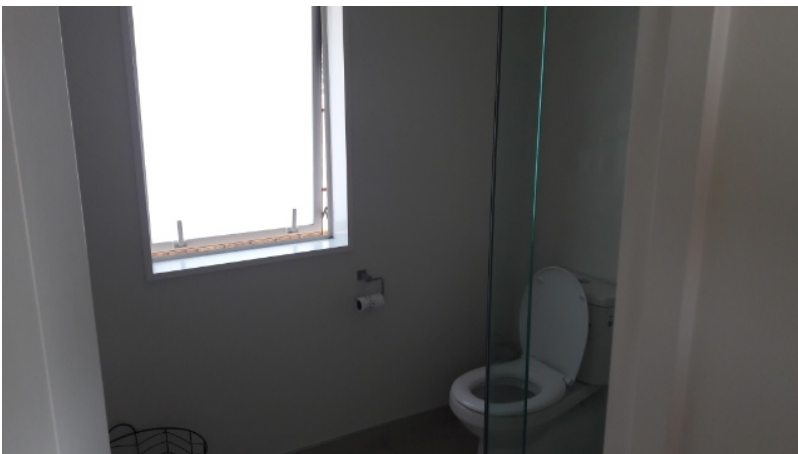
Figure 15 : Ensuite overview

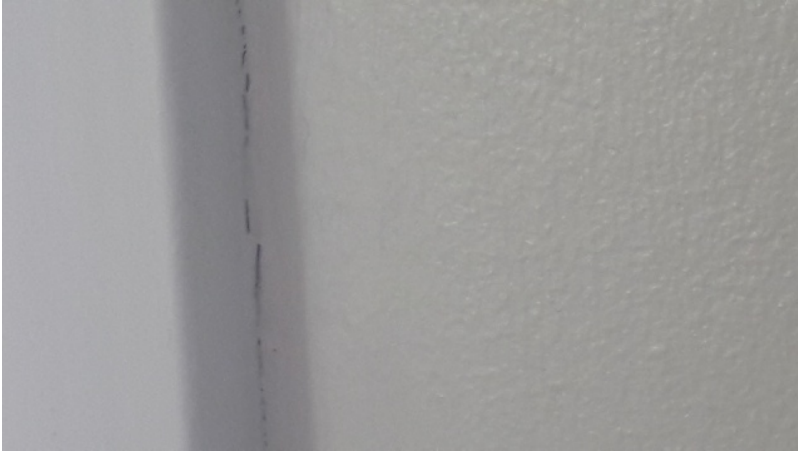
Figure 16 : Ensuite jamb movement

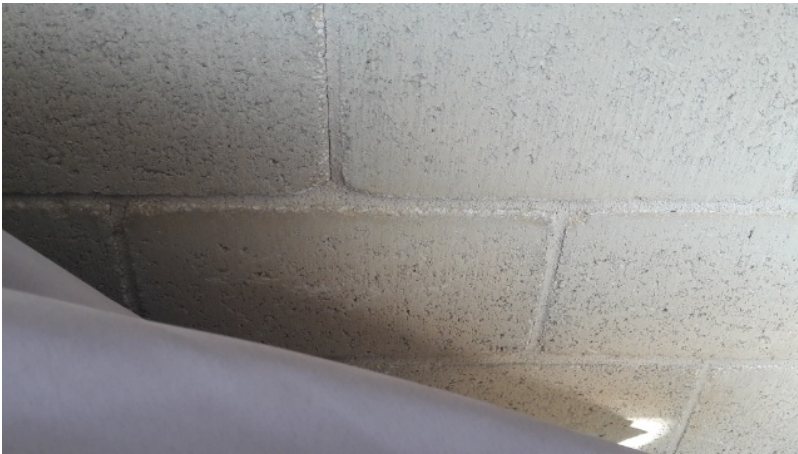
The building envelope consists of a brick veneer and displays multiple areas of displacement. Noted damage was isolated to the east, south and north elevations.

Figure 17 : Brick step cracking

This damage will respond to targeted repair options, as detailed in our scope of works.

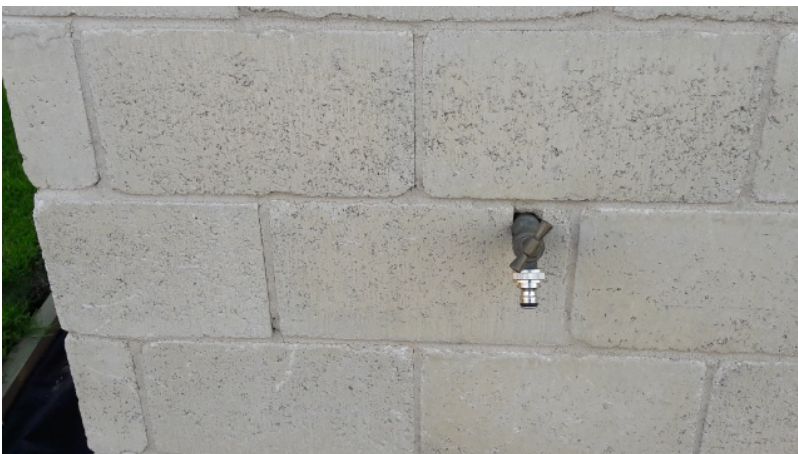
Figure 18 : Brick step cracking
