Inspection Report #58

Description	Inspection Report 1 - Branthwaite Lot 33
Status	Submitted
Assignee	Alice Chen (ACH)
Date	29-01-2020

Project Name	Branthwaite
Project Location	Lot 33
Inspection Location	Foundation excavation
Date / Time of the inspection.	29 Jan 10:00
People / Equipment / Materials / etc on Site	Gottadigg

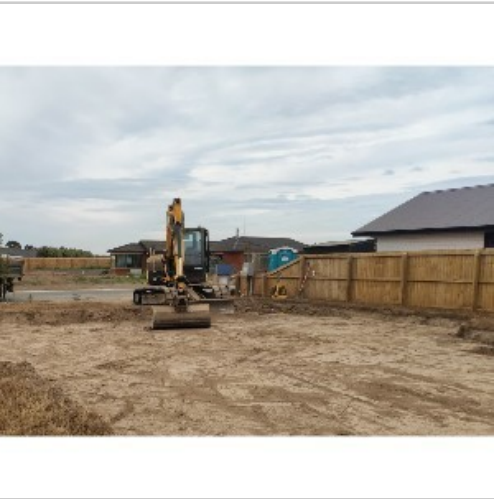
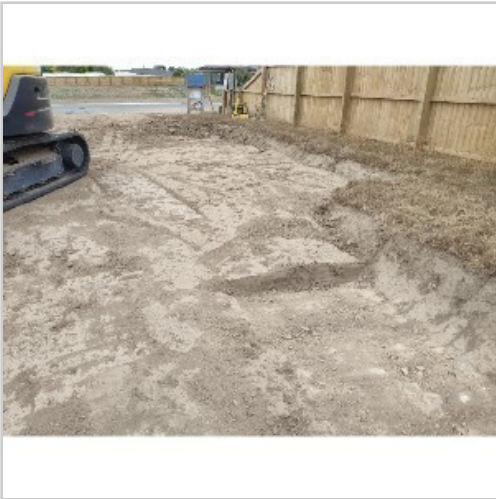
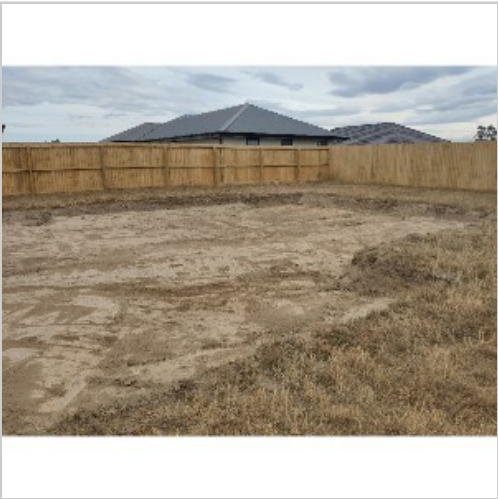
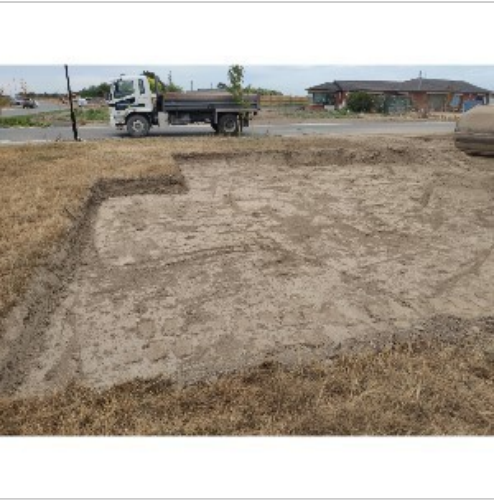
Completed an inspection of the excavated site. The materials at the base of the excavation was as expected and all topsoil had been removed.
