Inspection Report #62

| Description | Inspection Report 2 - Branthwaite Lot 33 |

| Project Name | Branthwaite |
| Inspection Location | Foundation reinforcing |

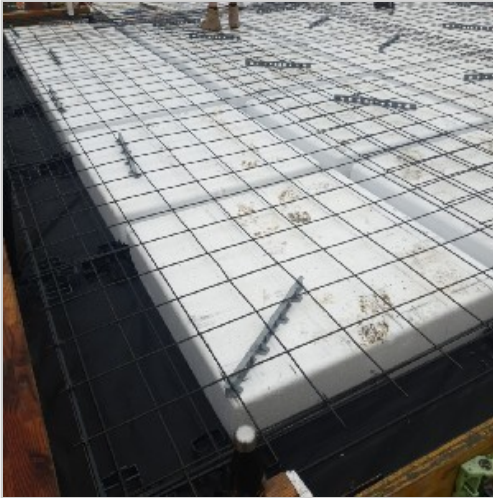
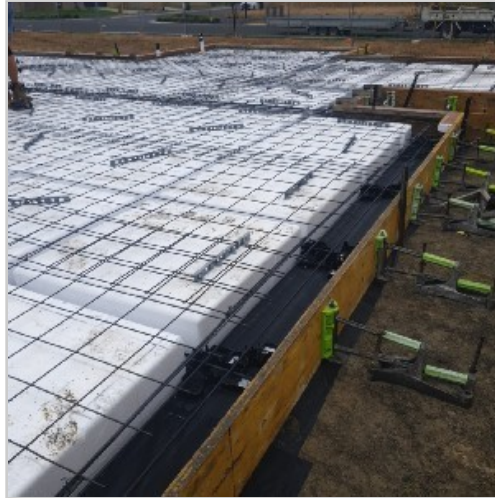
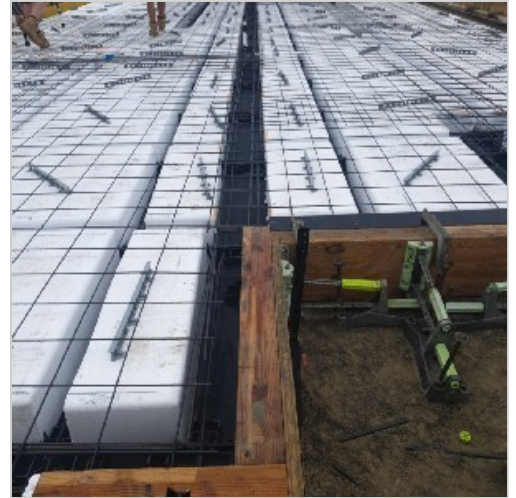
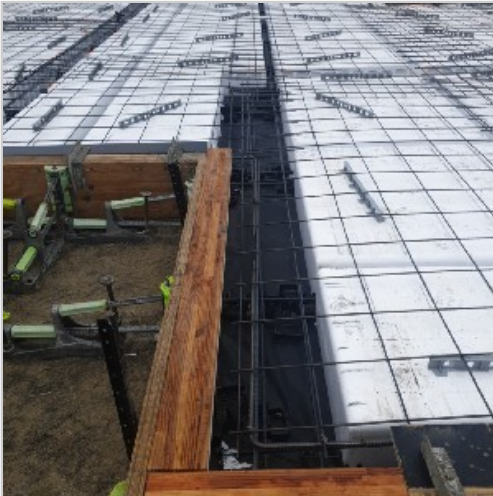
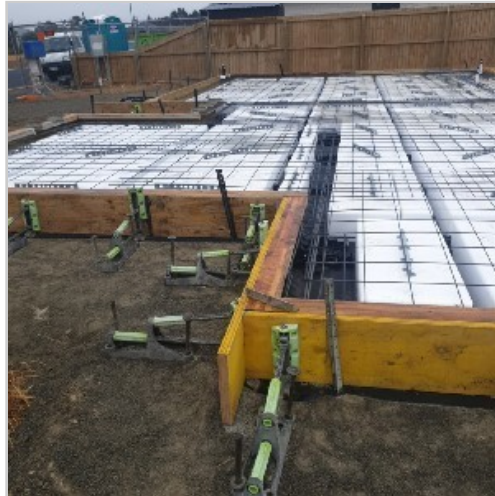
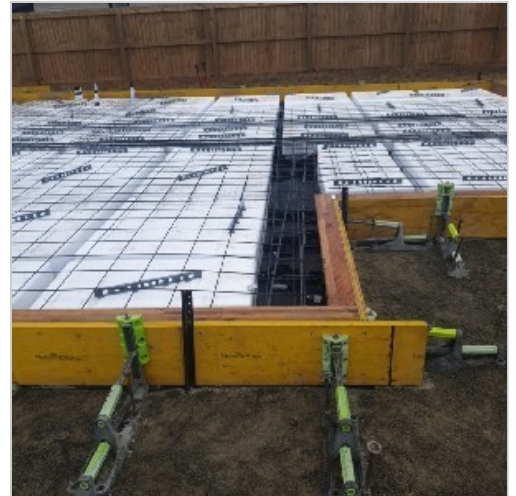
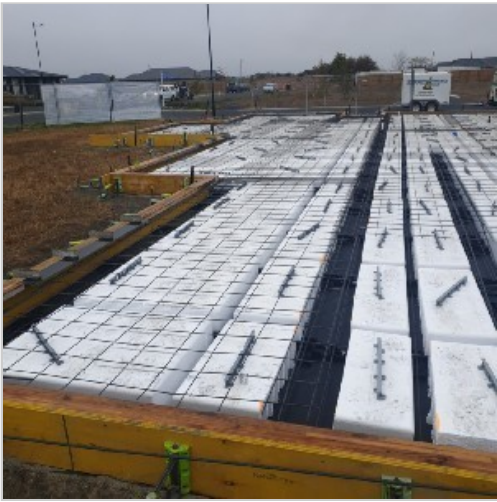
Completed an inspection of the reinforcing and slab construction prior to placing concrete. The reinforcing sizes and positions were in accordance with the design documentation.
