Healthy Home Assessment

**17 Lithgow Place East
Glengarry
Invercargill 9810**

Prepared by
Paul Fieten

Job Number
#42900

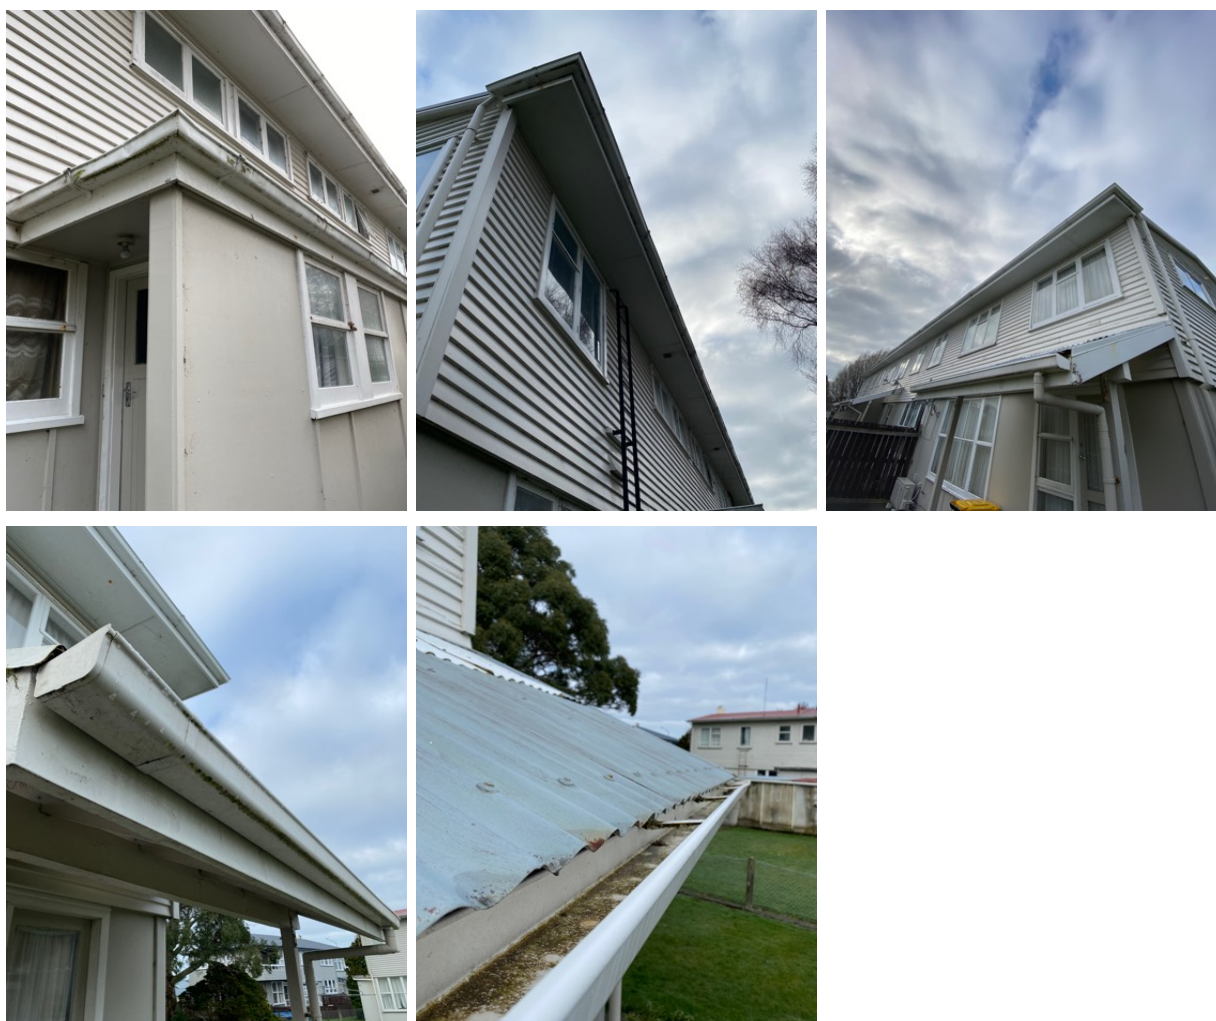
Photograph all gutters

Are gutters present to take water away from all parts of the roof?

Yes

- Do gutters appear to have sufficient fall for water to flow? **Yes**
- Are all gutters in good condition? (all intact and all attached to the house) **Yes**
- Are there any blockages or obstructions in the gutters? **No**

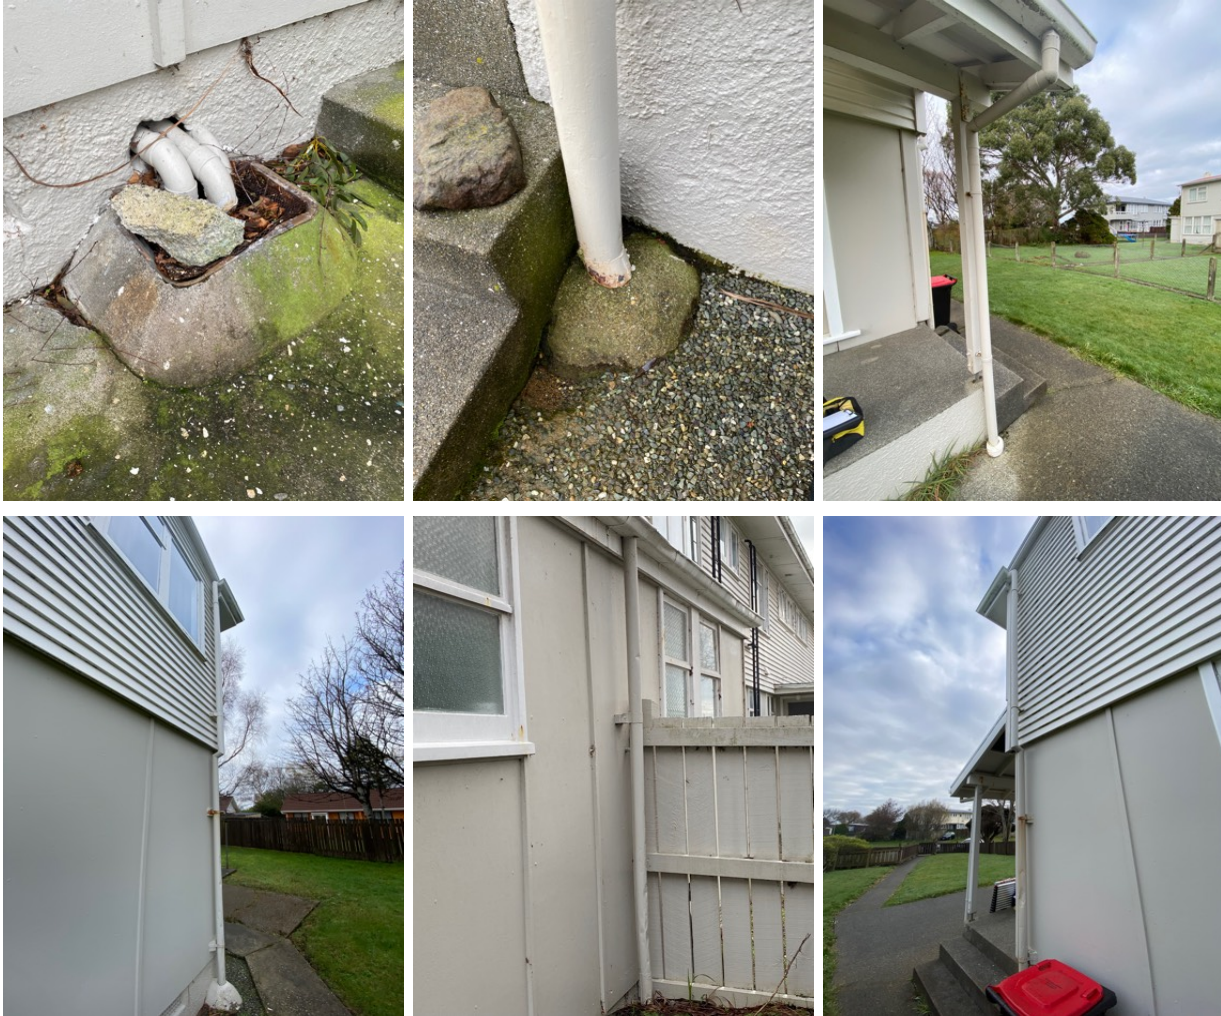
Photograph all downpipes, gully traps and drains

Are there any obstructions or blocks in the drain?

No

Can you identify any leaking downpipes or gully traps?

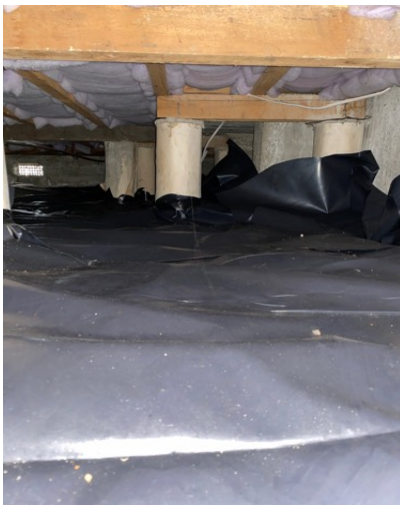
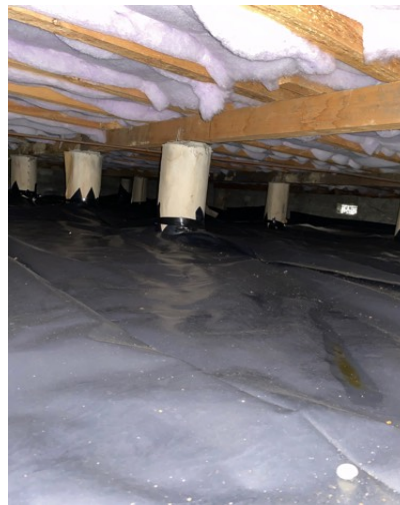
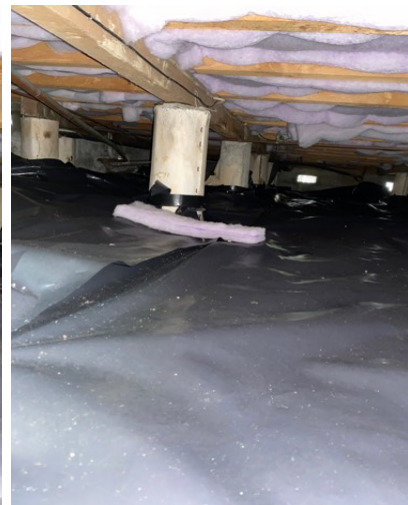
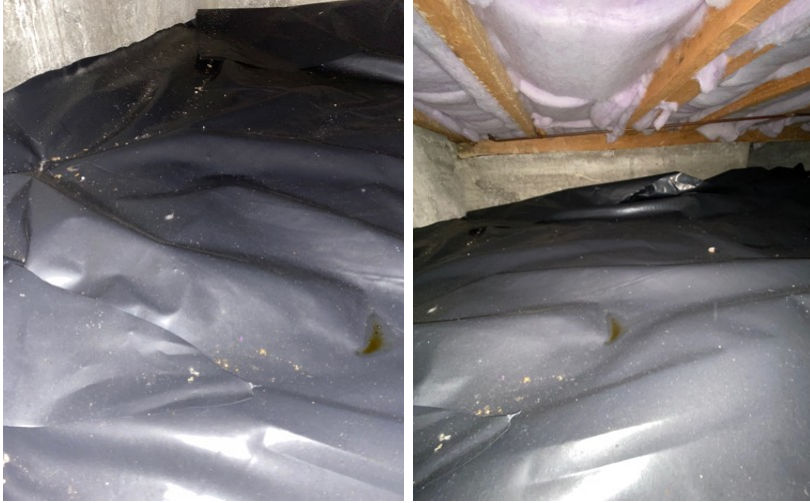
Photograph the subfloor space

Can you identify any flooding, pooling or leaking pipes in the subfloor space? **No**

**Yes, installed after July 1
2019**

No

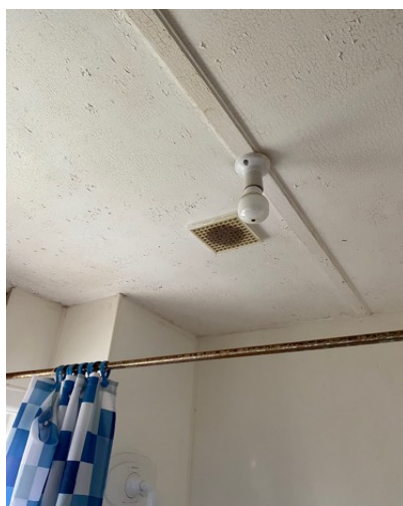
Photograph of vent

Yes, installed prior to 1 July 2019

Yes

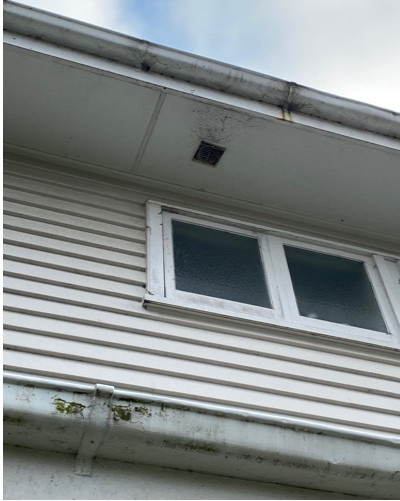
Photograph of external vent

Unable to confirm

No

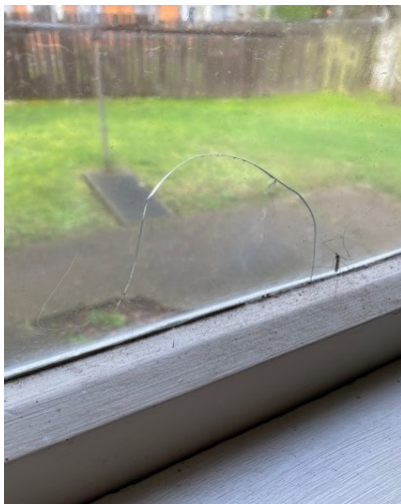
Yes

Photograph of break/ crack

Is the break creating a draught?

No

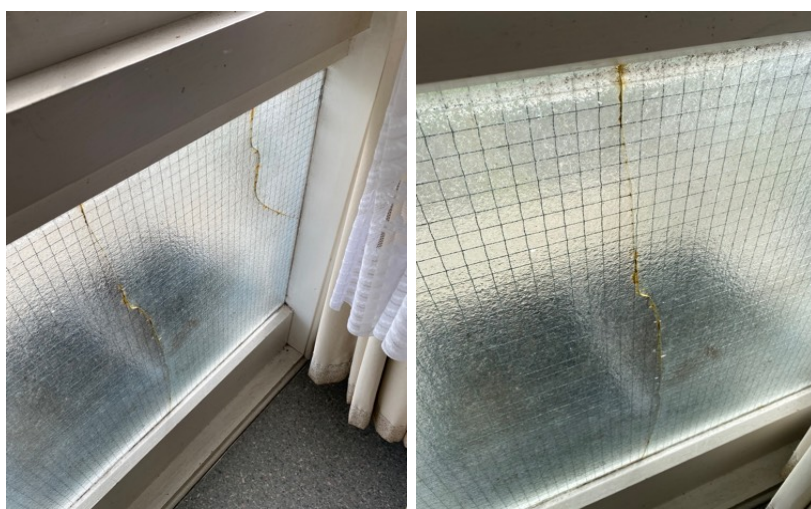
Yes

Photograph of break/ crack

Is the break creating a draught?

No
