Healthy Home Assessment

**19 Lithgow Place East
Glengarry
Invercargill 9810**

Job Number
#42902

Location
19 Lithgow Place East, Glengarry, Invercargill,
Southland

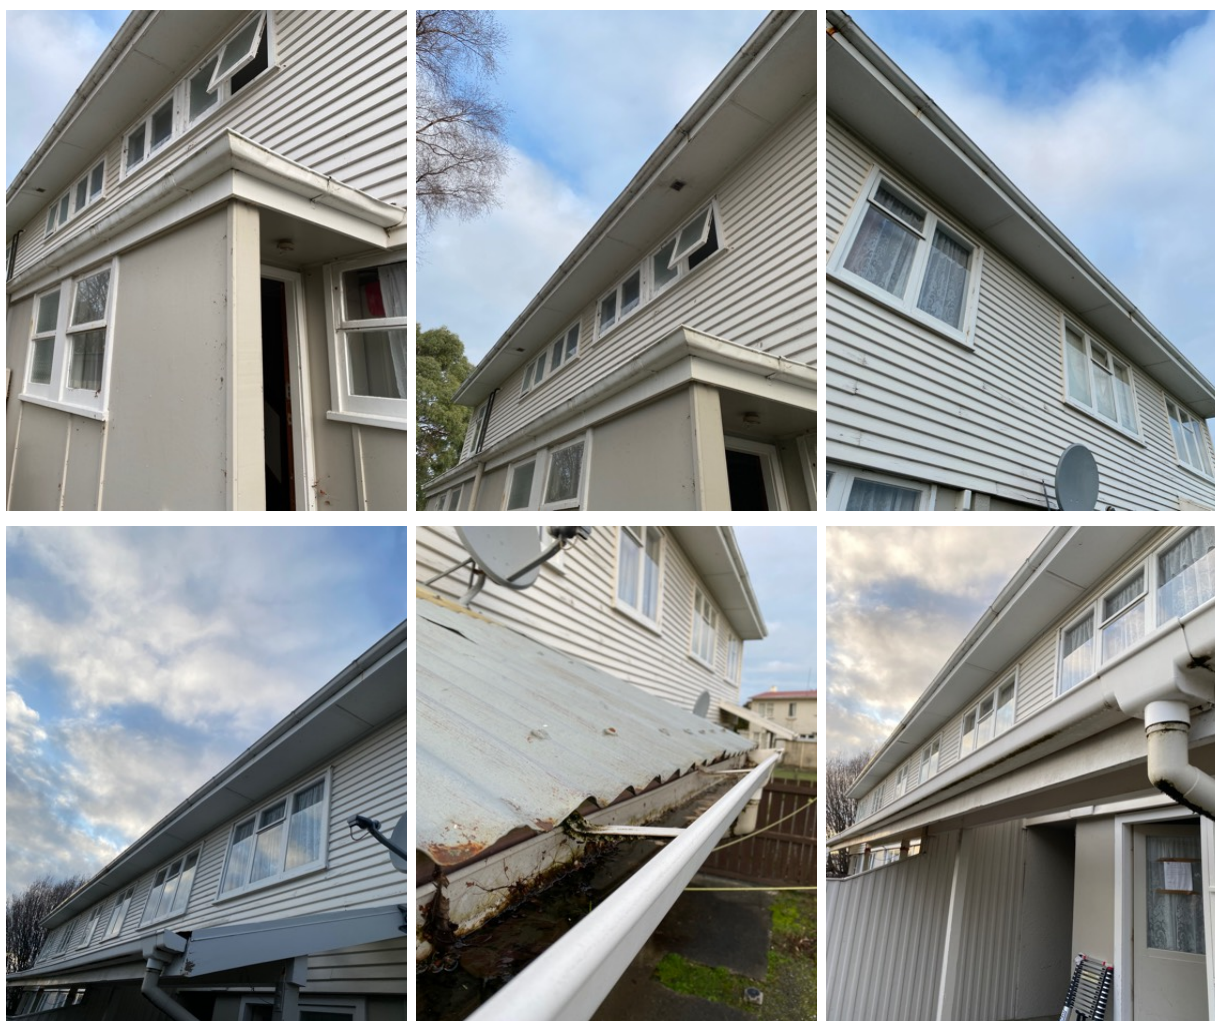
Photograph all gutters

Fine

External

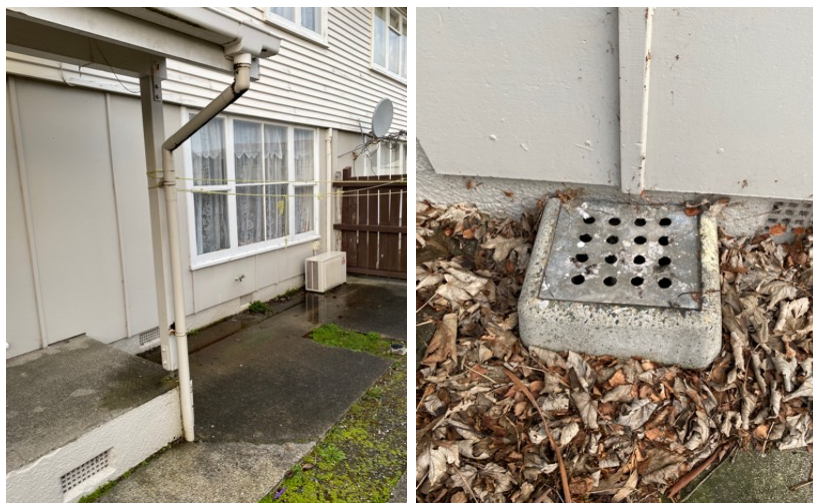
Photograph all downpipes, gully traps and drains

No

Council Storm Water

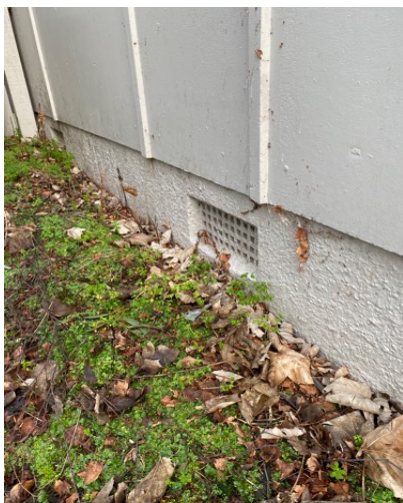
Photograph the external profile of the sub floor

Does the property have a subfloor? **Yes**

Is at least 50% of the subfloor obstructed by either a masonry foundation wall, fibre cement sheets, timber skirting, other parts of the building/adjoining structures, rock/soil or any other permanent/semi-permanent structure? **Yes**

Does the perimeter cladding contain multiple continuous gaps of more than 20mm or is it trellis? **No**

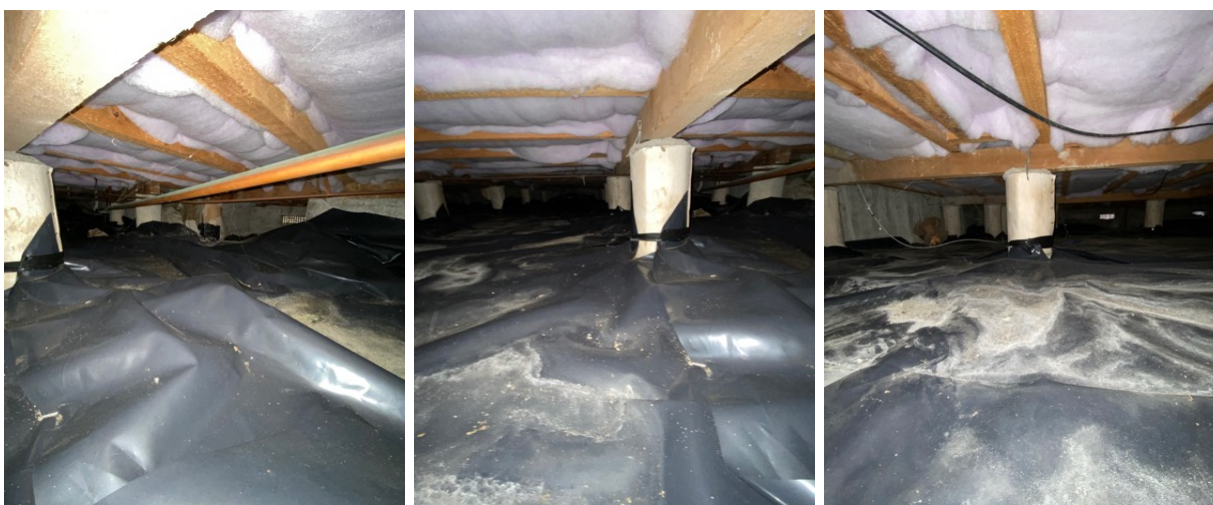
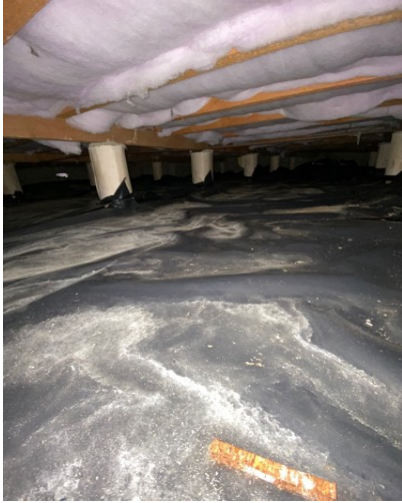
Photograph the subfloor space

**Yes, installed prior to July 1
2019**

No

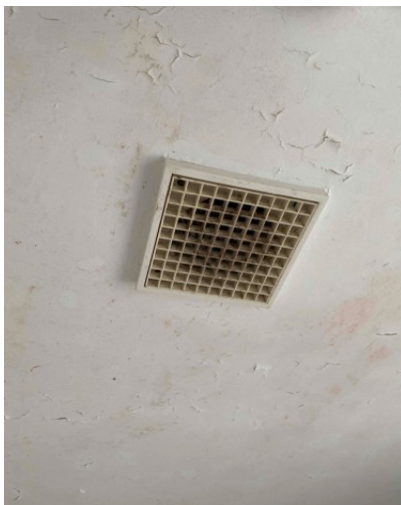
Photograph of vent

Yes, installed prior to 1 July 2019

Yes

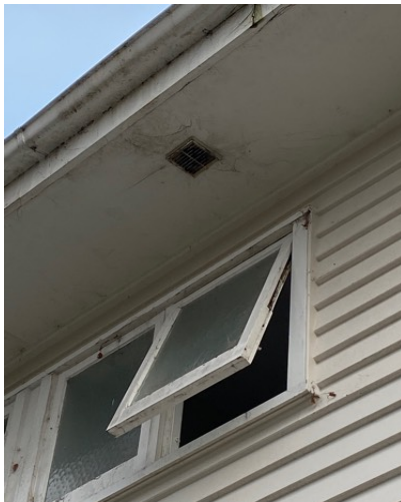
Photograph of external vent

Yes

enclosed

No

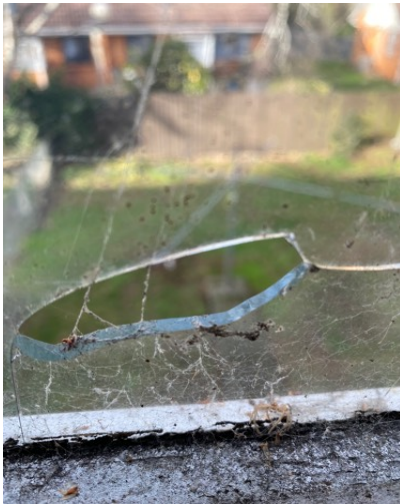
Photograph of break/ crack

Yes

No

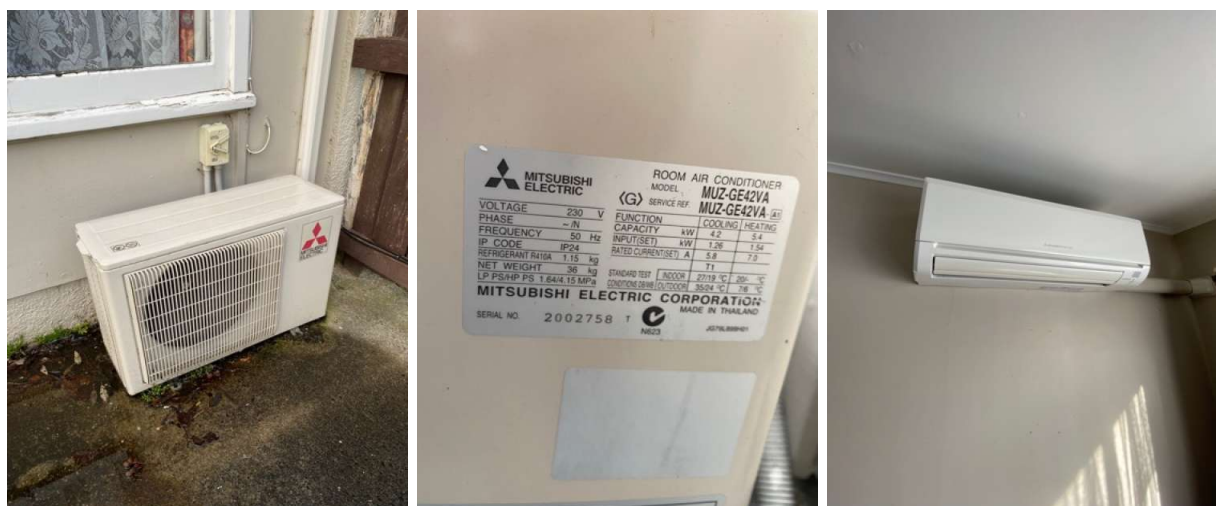
Photograph of heating source

What is the make and model?
Mitsubishi MUZ GE42VA

Yes

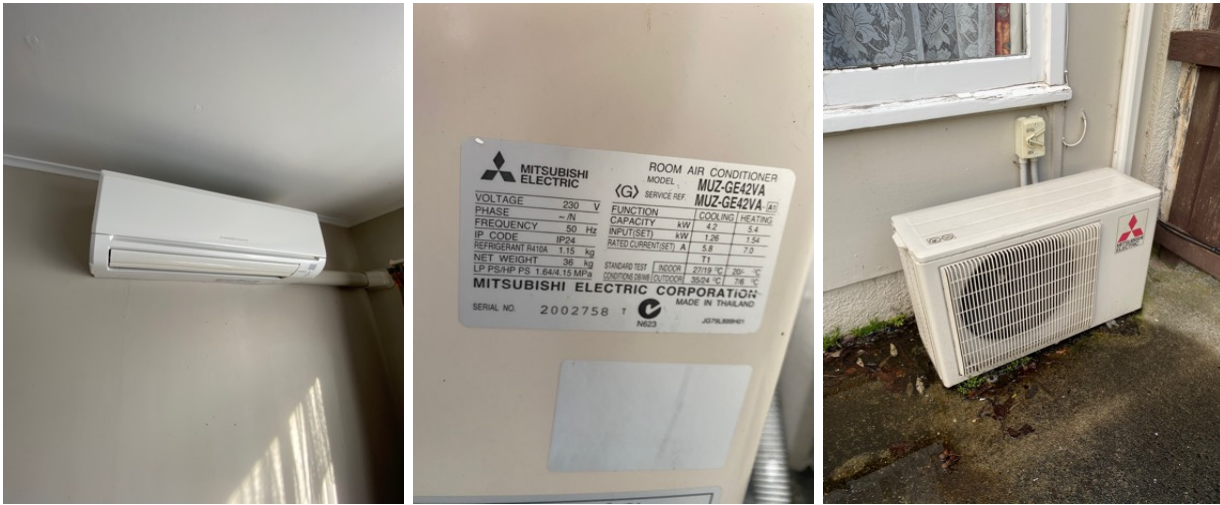
Photograph of heating source

Heat pump

5.4

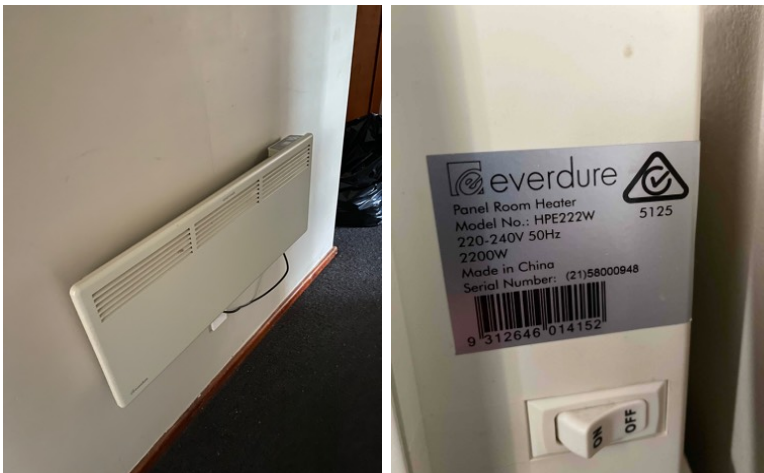
Photograph of heating source

Wall fixed electric heater

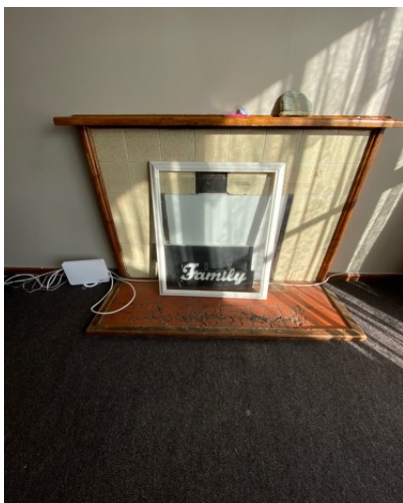
Photograph of heating source

Open fire

Yes

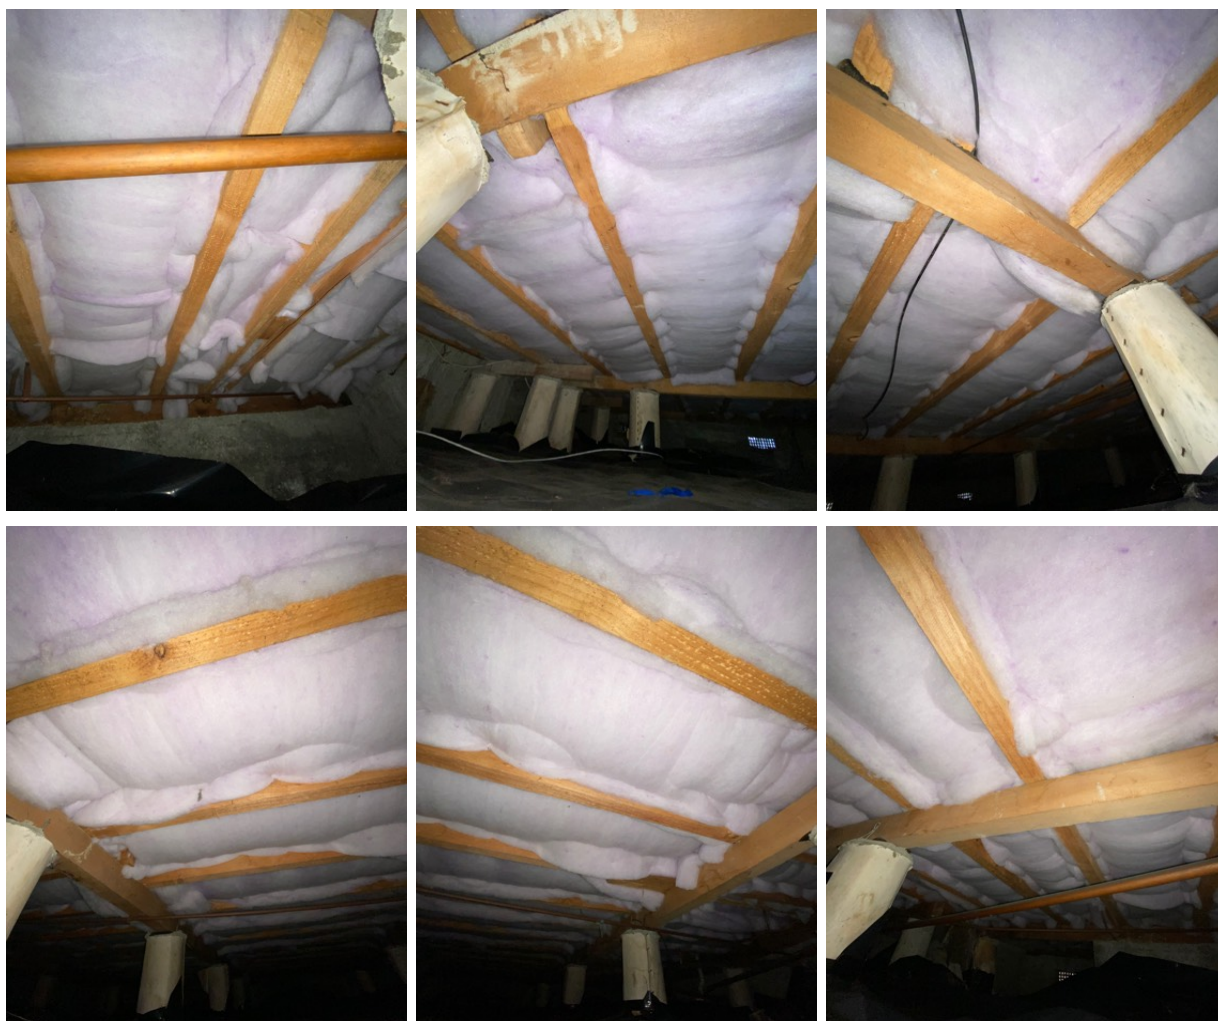
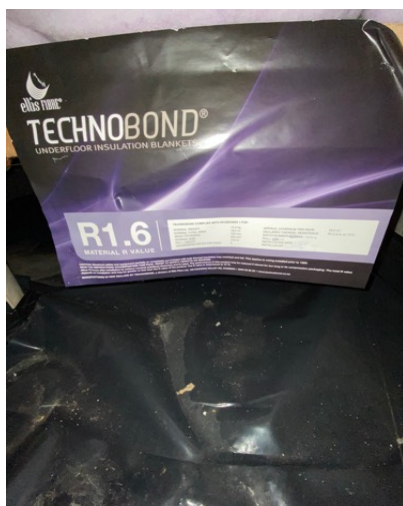
Photograph

Reason: Habitable area

1 layer(s)

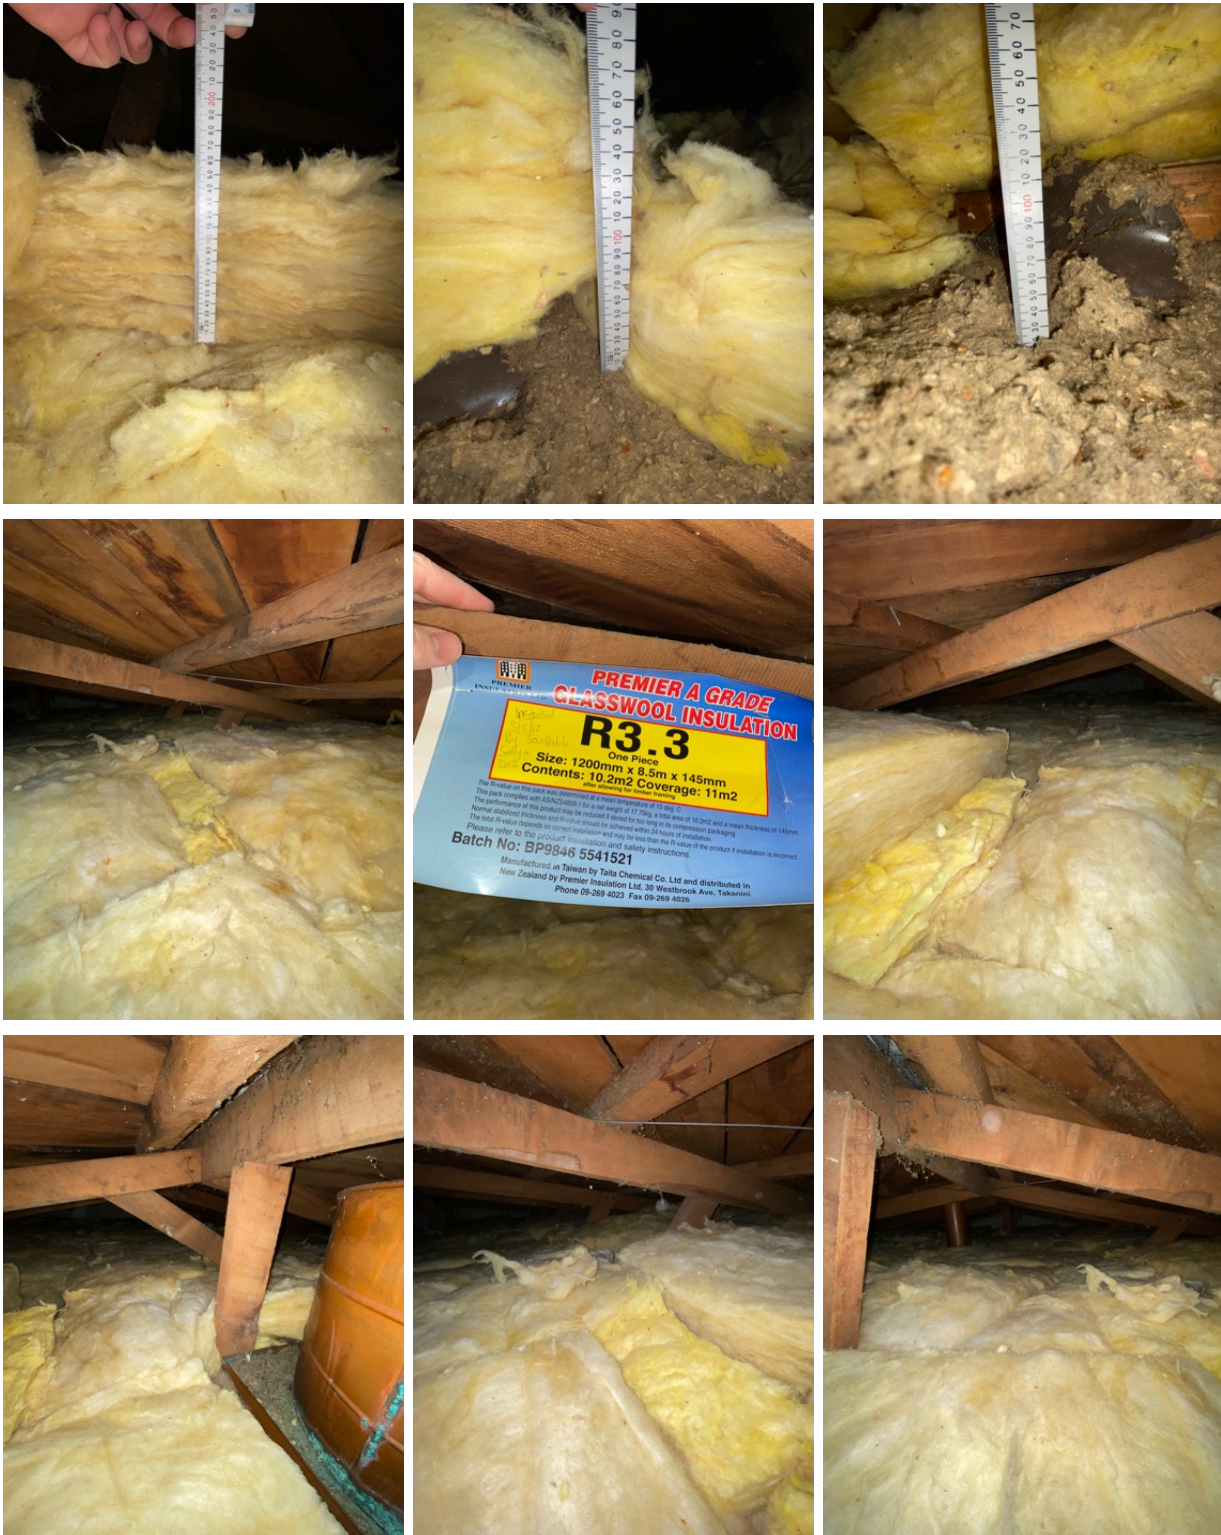
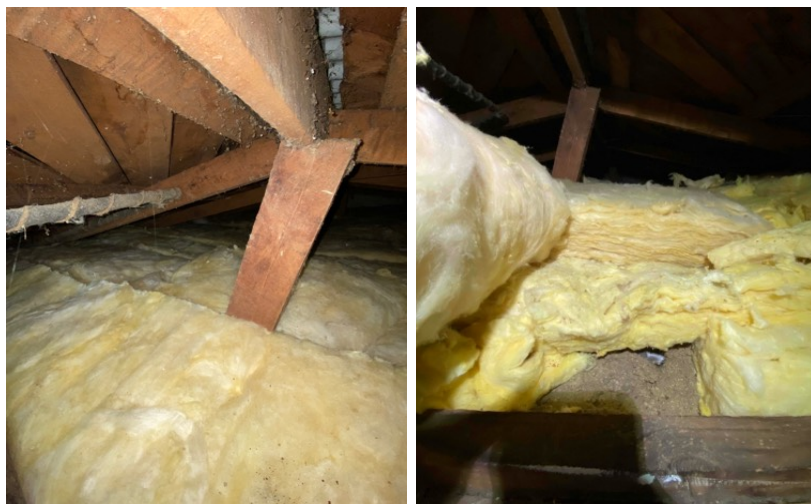
Photograph

3 layer(s)

Ceiling Insulation material
Loose-fill(cellulose and vermiculite)
