Healthy Home Assessment

**21 Lithgow Place East
Glengarry
Invercargill 9810**

Job Number
#42904

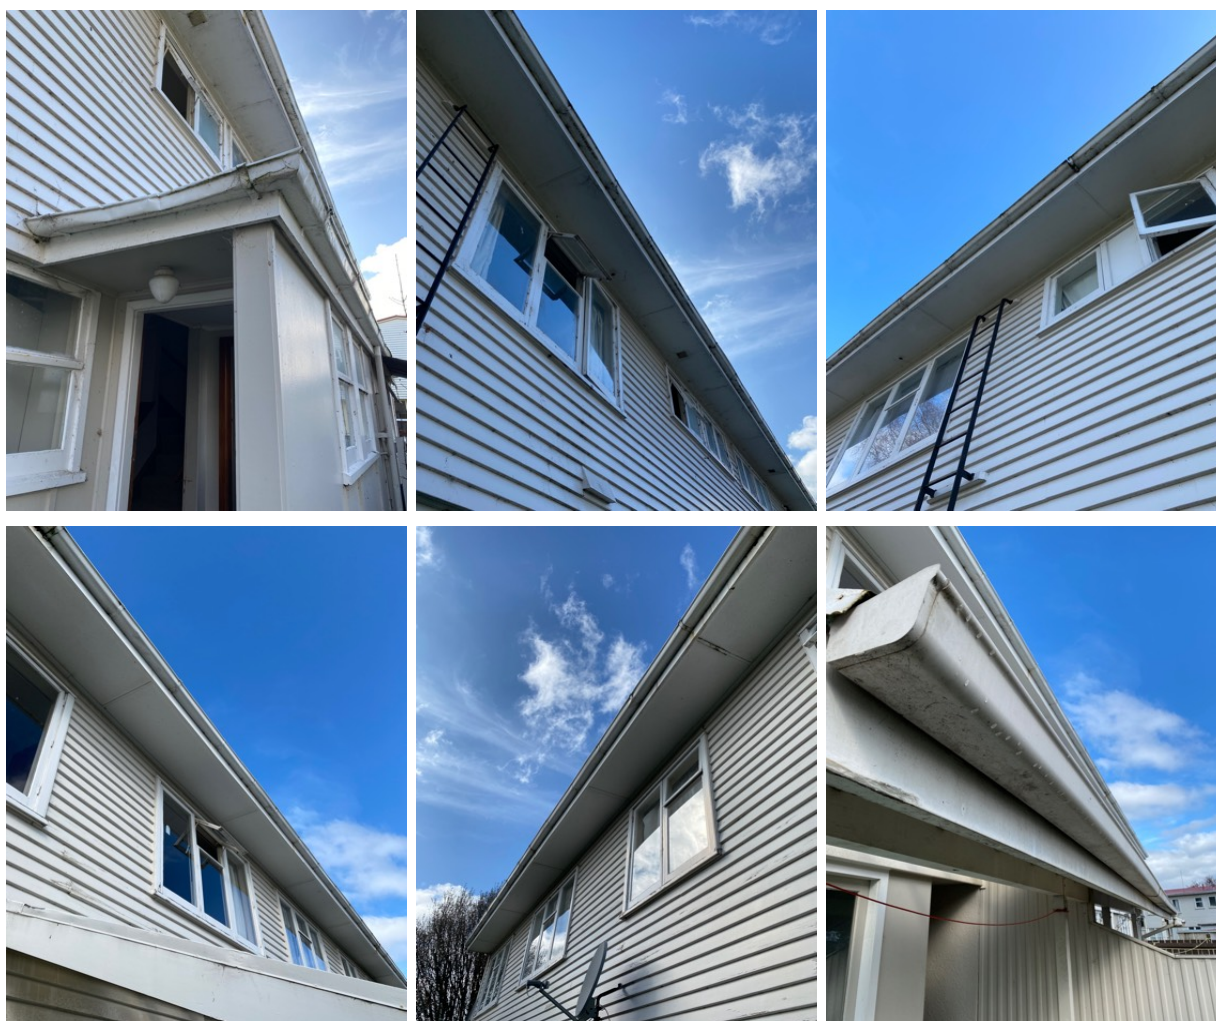
Photograph all gutters

External

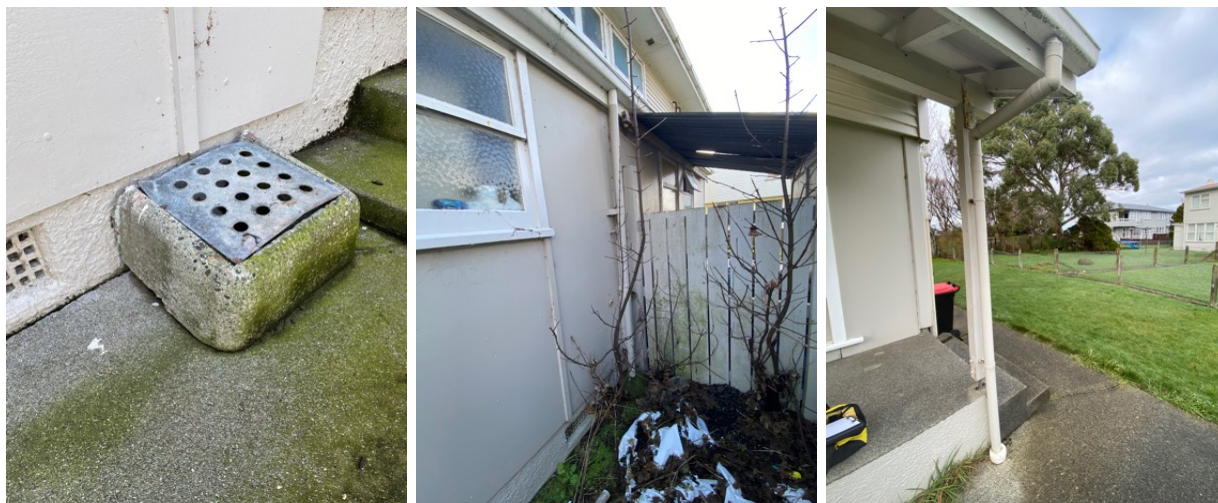
Photograph all downpipes, gully traps and drains

No

Council Storm Water

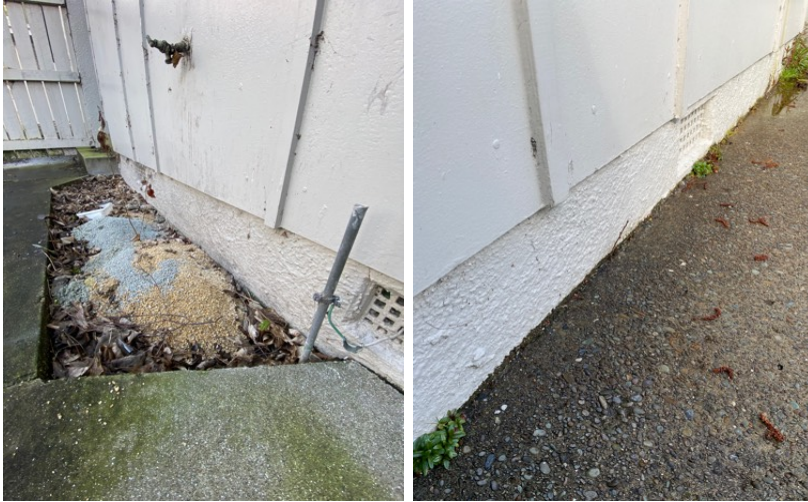
Photograph the external profile of the sub floor

Is at least 50% of the subfloor obstructed by either a masonry foundation wall, fibre cement sheets, timber skirting, other parts of the building/adjoining structures, rock/soil or any other permanent/semi-permanent structure? **Yes**

Does the perimeter cladding contain multiple continuous gaps of more than 20mm or is it trellis? **No**

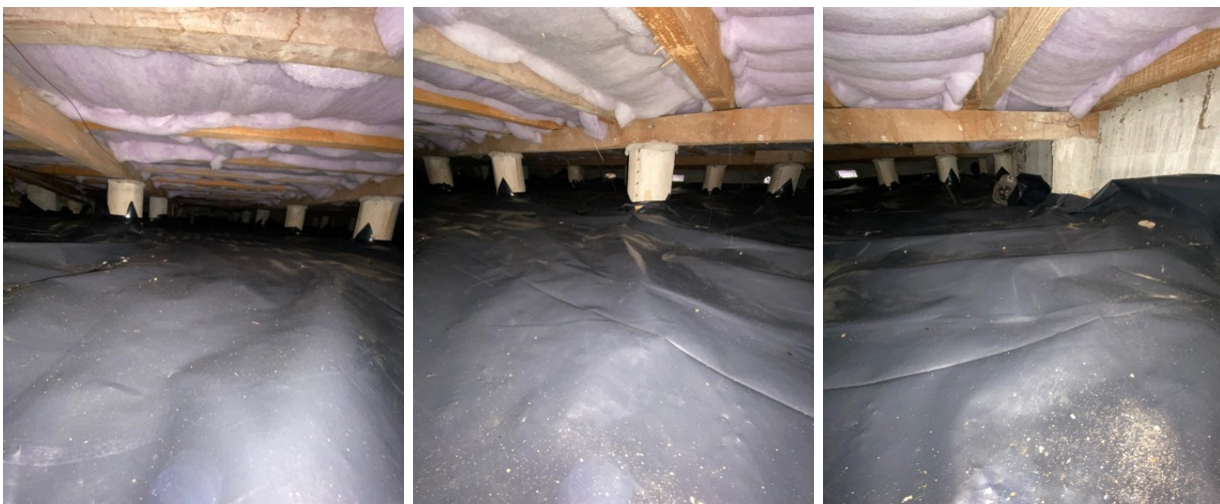
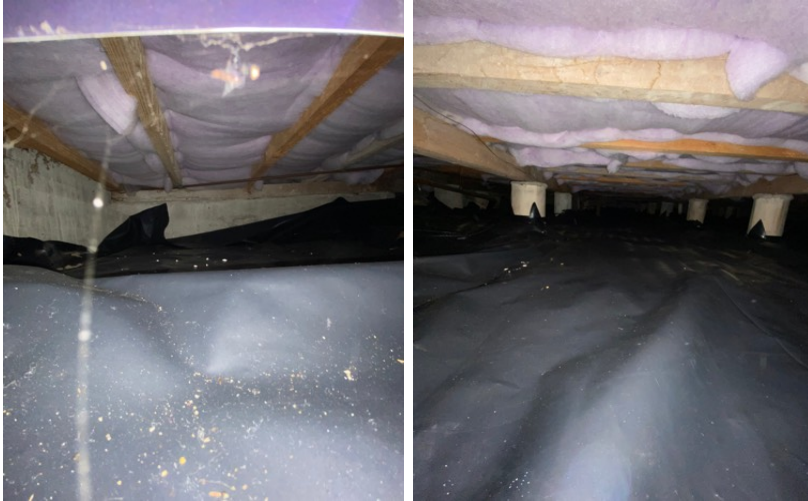
Photograph the subfloor space

**Yes, installed prior to July 1
2019**

No

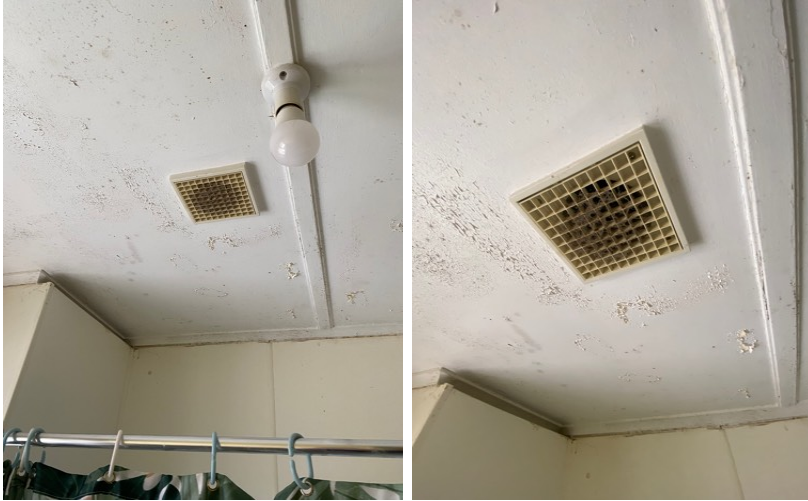
Photograph of vent

Yes, installed prior to 1 July 2019

Yes

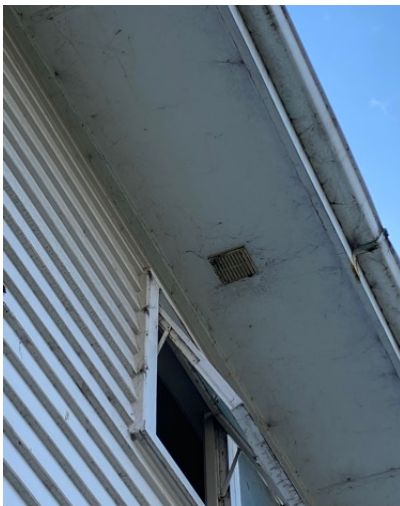
Photograph of external vent

Yes

Unable to confirm

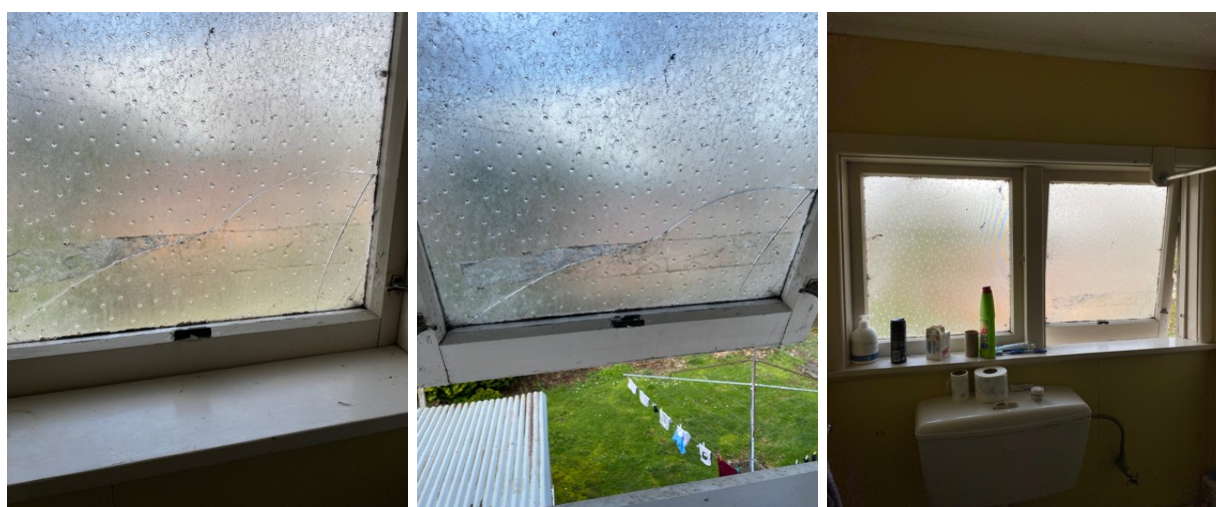
Photograph of break/ crack

Is there any broken or cracked panes of glass? **Yes**

Is the break creating a draught? **No**

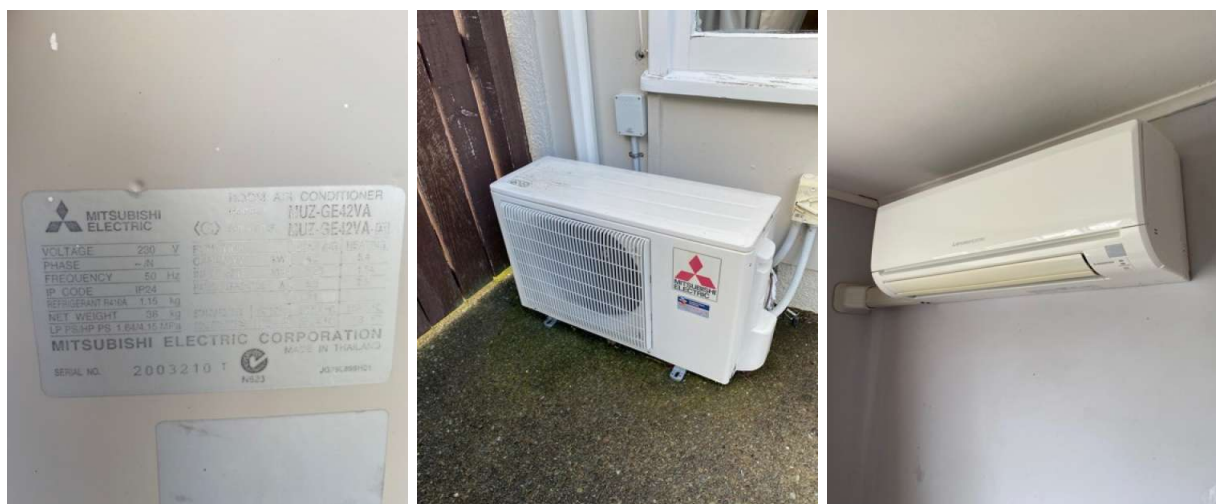
Photograph of heating source

What is the make and model?
Mitsubishi MUZ GE42VA

Yes

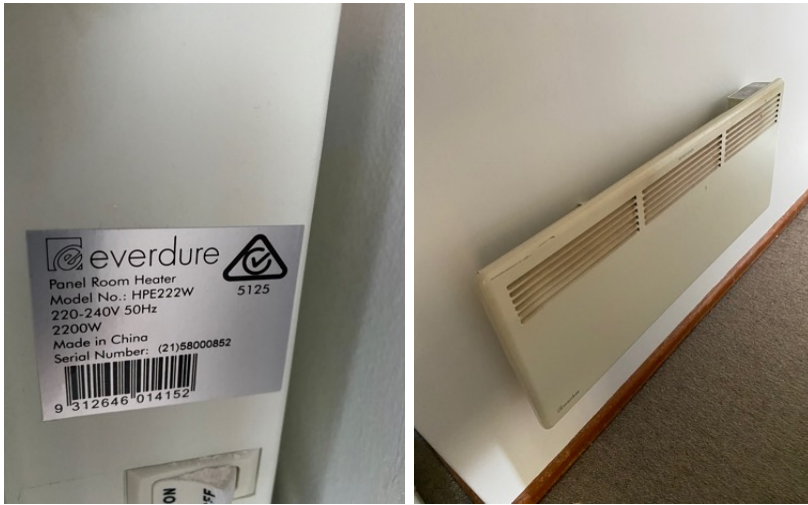
Photograph of heating source

Wall fixed electric heater

2.2

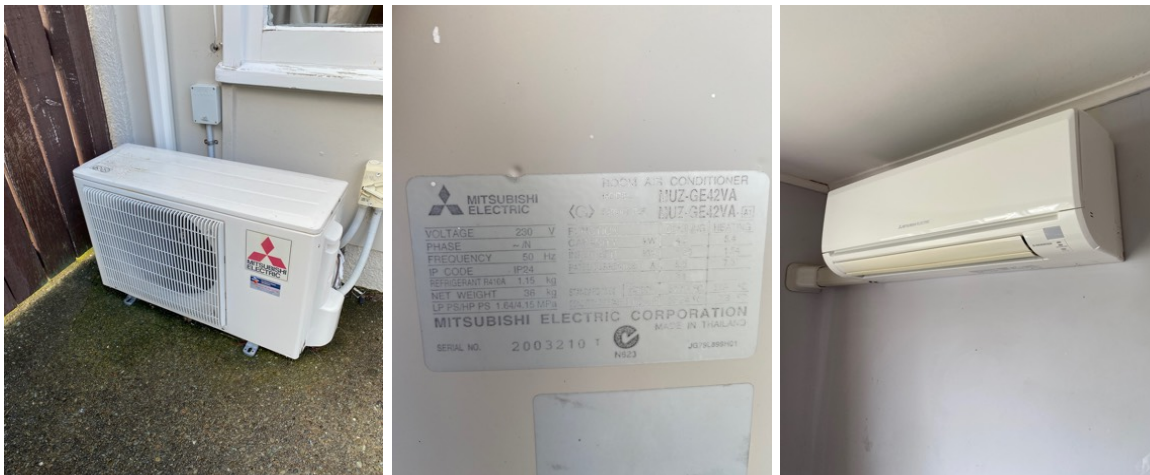
Photograph of heating source

Heat pump

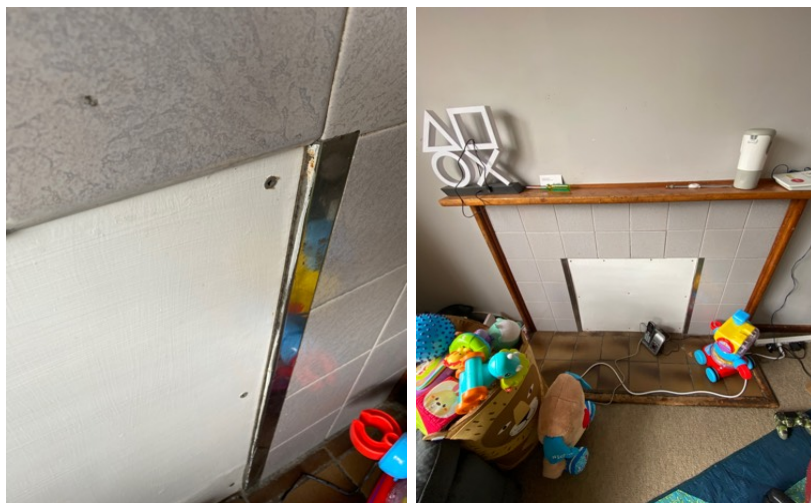
Photograph of heating source

Open fire

Yes

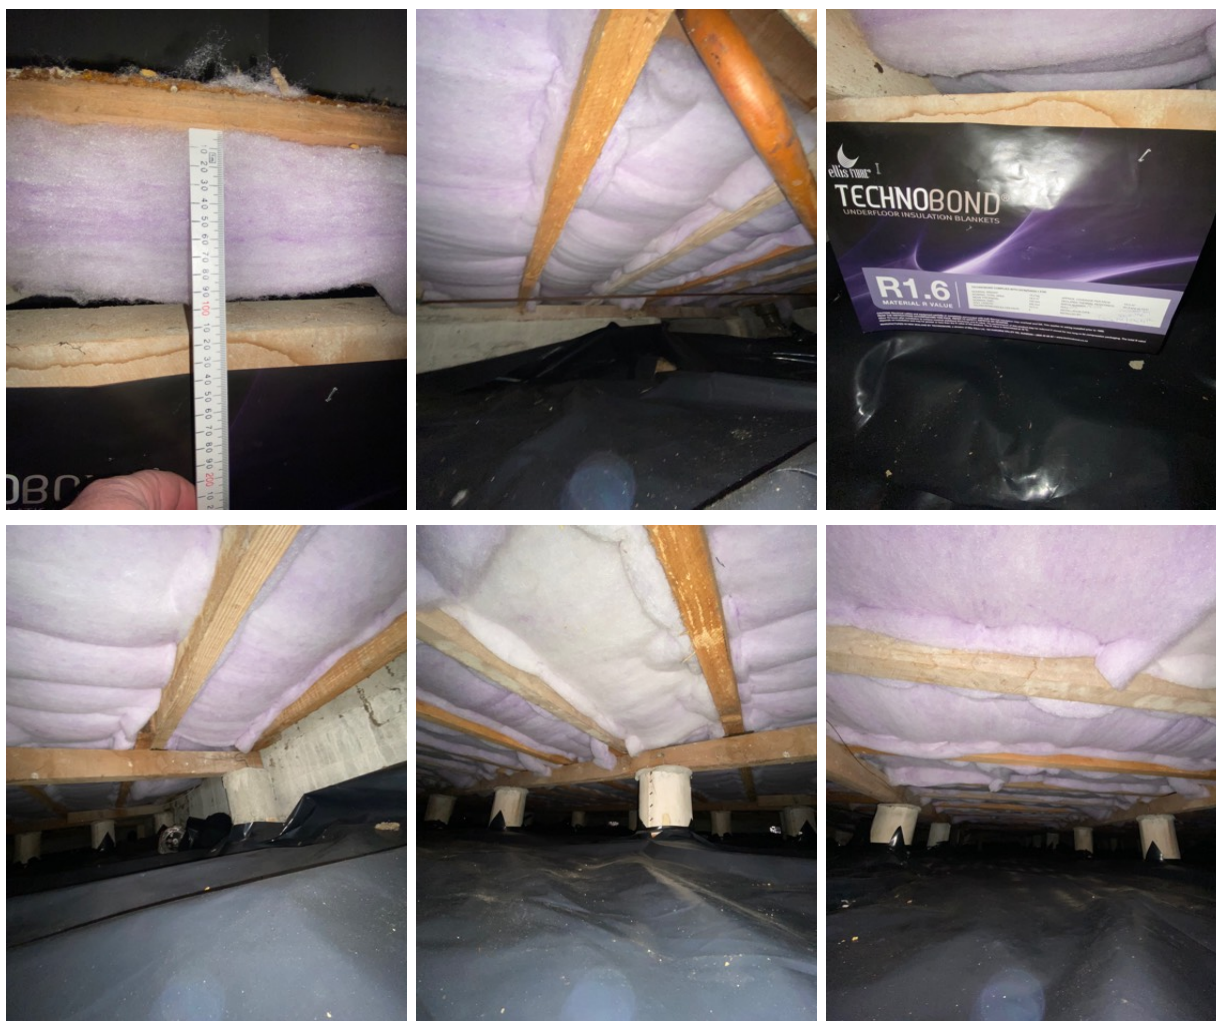
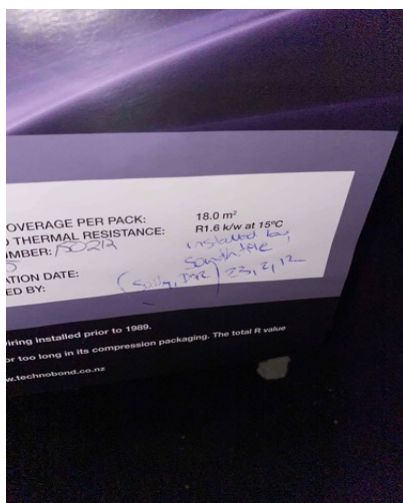
Photograph

Reason: Habitable area

1 layer(s)

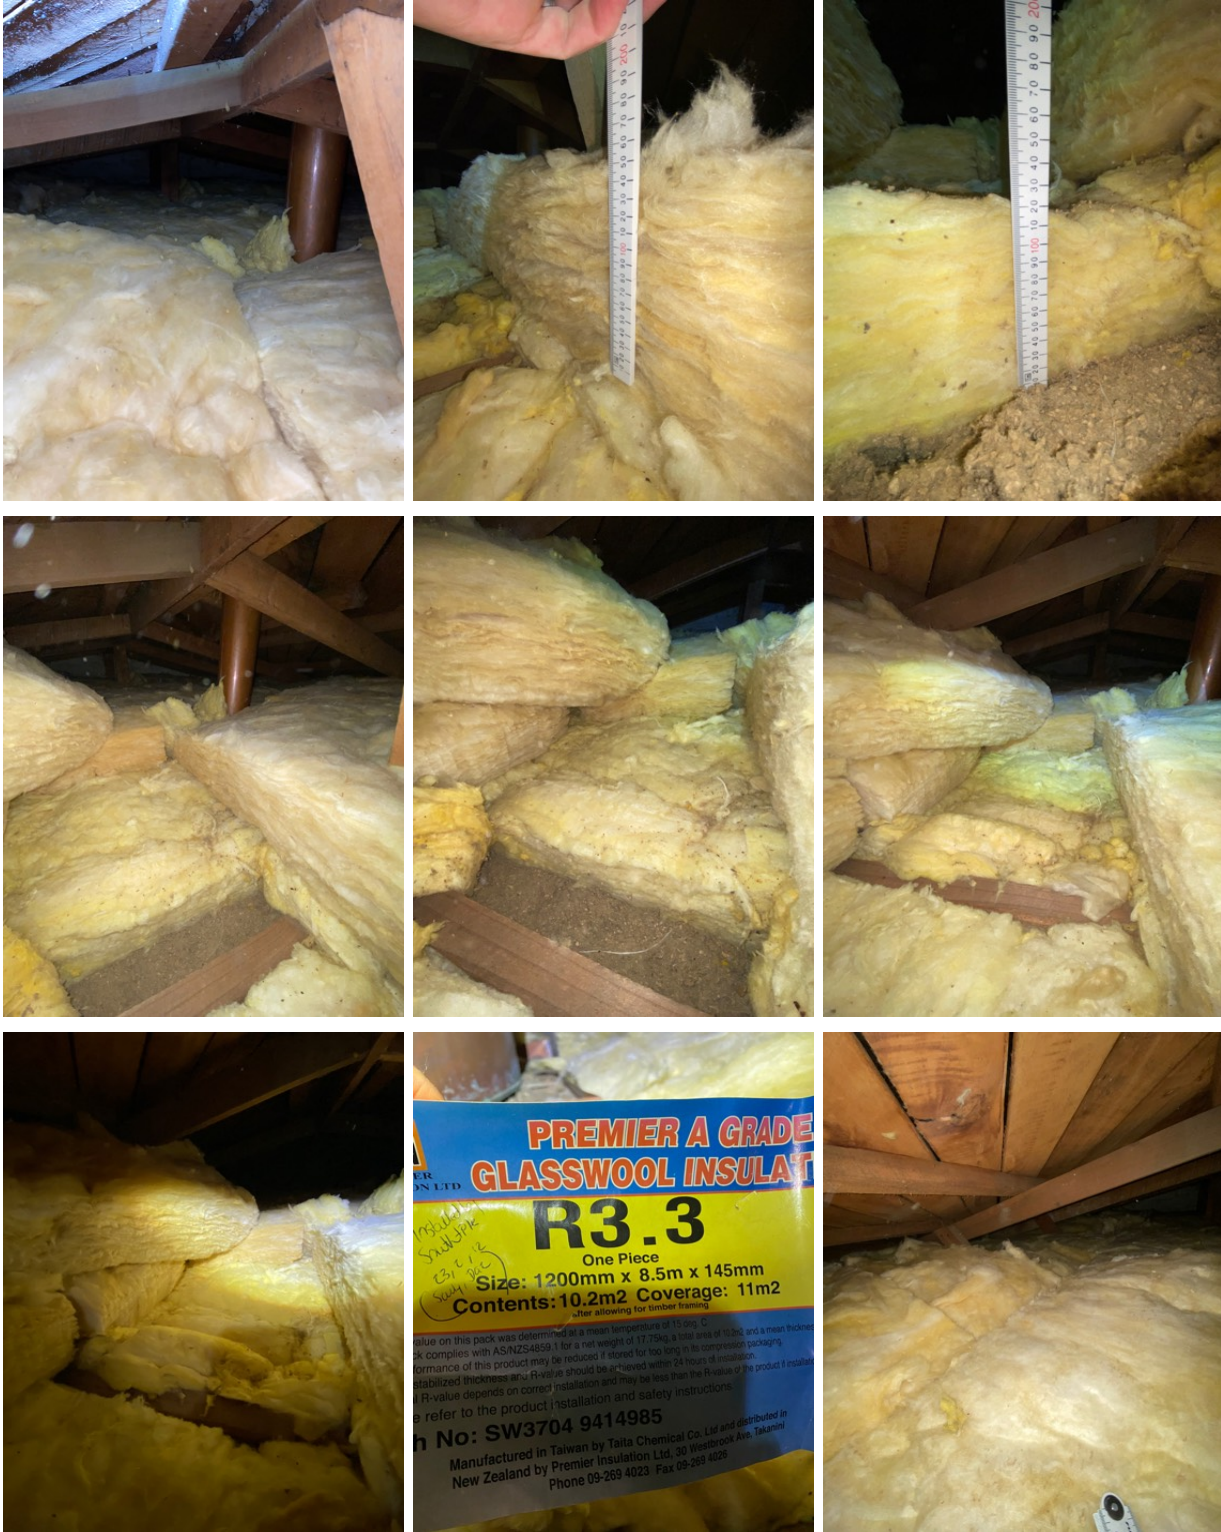
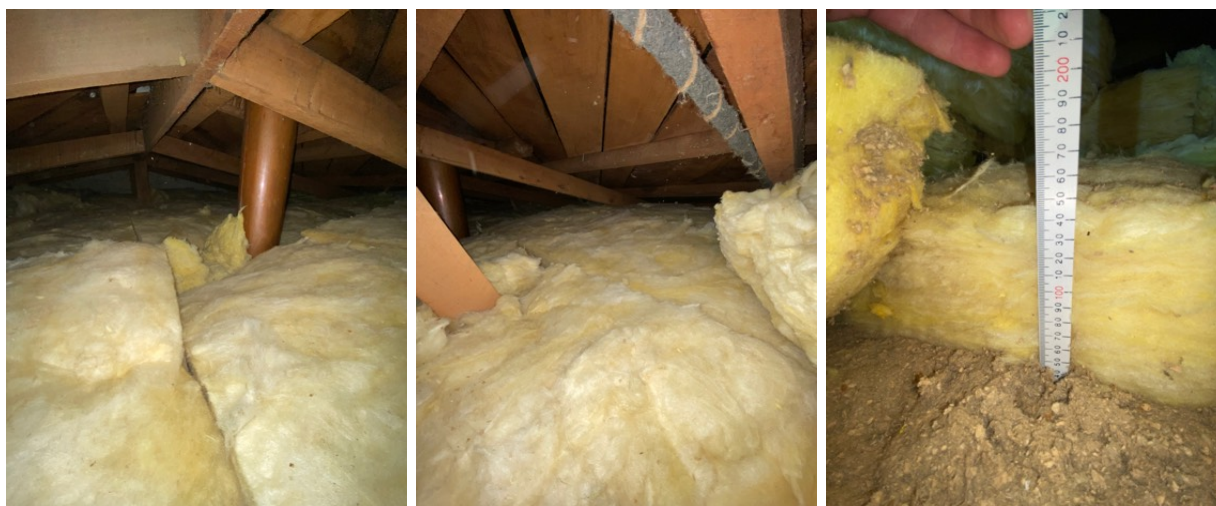
Photograph

3 layer(s)

Ceiling Insulation material
Loose-fill(cellulose and vermiculite)
