# Healthy Home Assessment

**23 Lithgow Place East  
Glengarry  
Invercargill 9810**

Job Number  
#42909

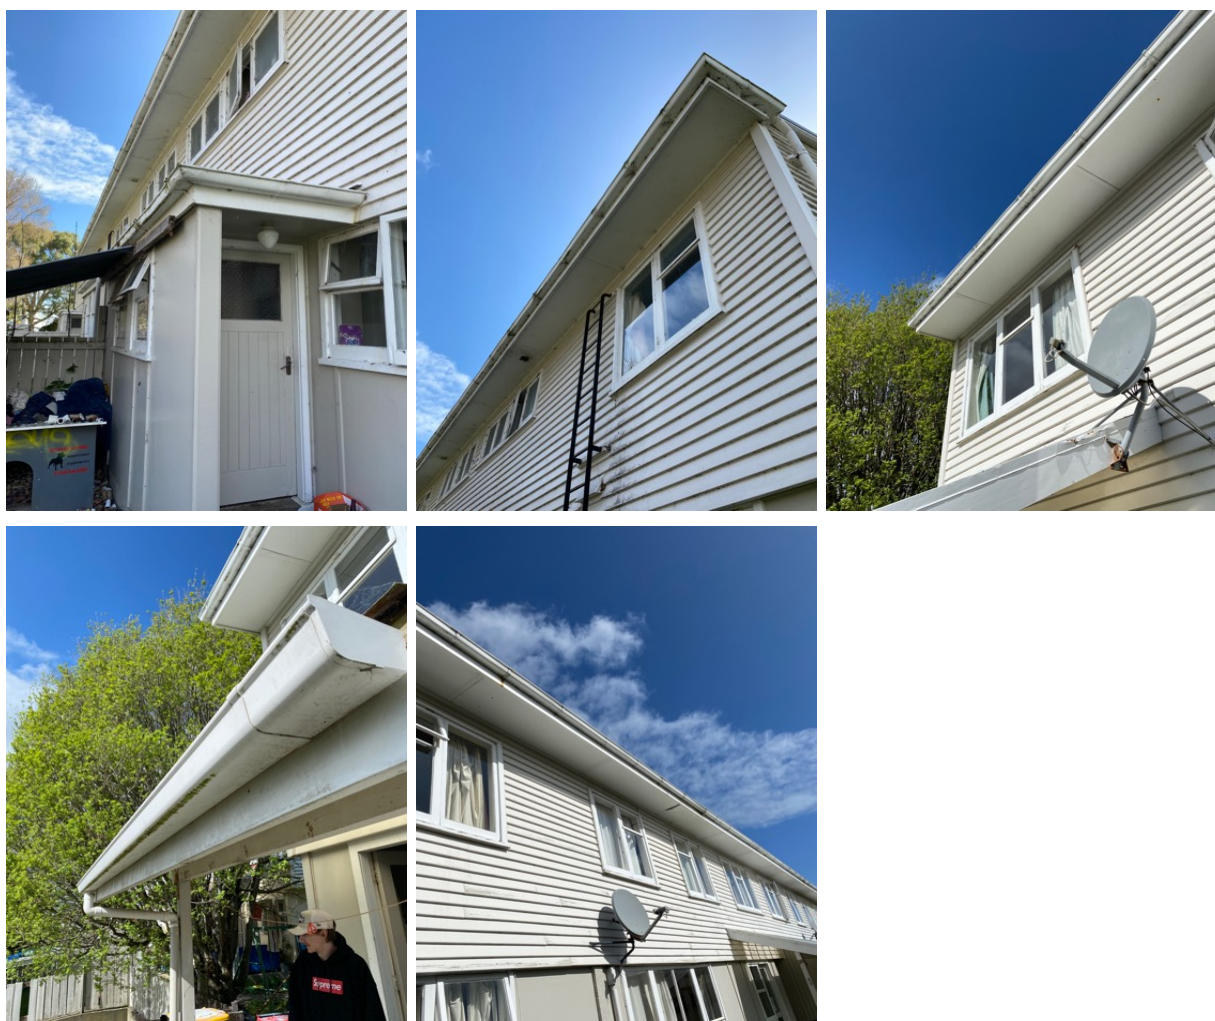
Photograph all gutters

Are gutters present to take water away from all parts of the roof?

**Yes**

Are all gutters in good condition? (all intact and all attached to the house) **Yes**

Are there any blockages or obstructions in the gutters? **No**

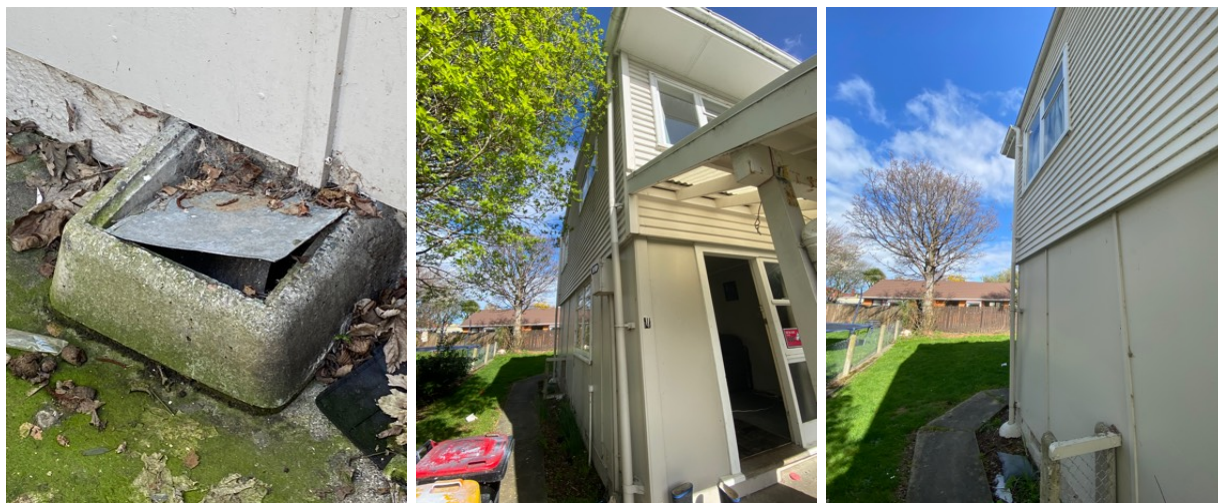
Photograph all downpipes, gully traps and drains

Are there any obstructions or blocks in the drain?

**No**

Can you identify any leaking downpipes or gully traps?

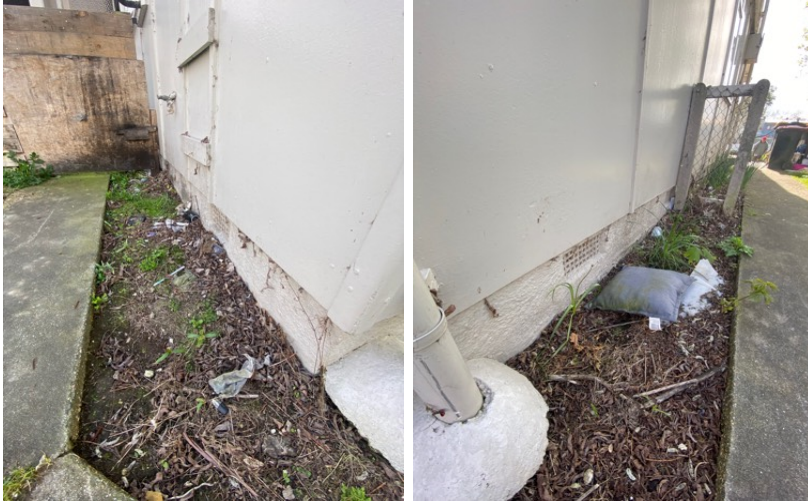
Photograph the external profile of the sub floor

Is at least 50% of the subfloor obstructed by either a masonry foundation wall, fibre cement sheets, timber skirting, other parts of the building/adjoining structures, rock/soil or any other permanent/semi-permanent structure?

**Yes**

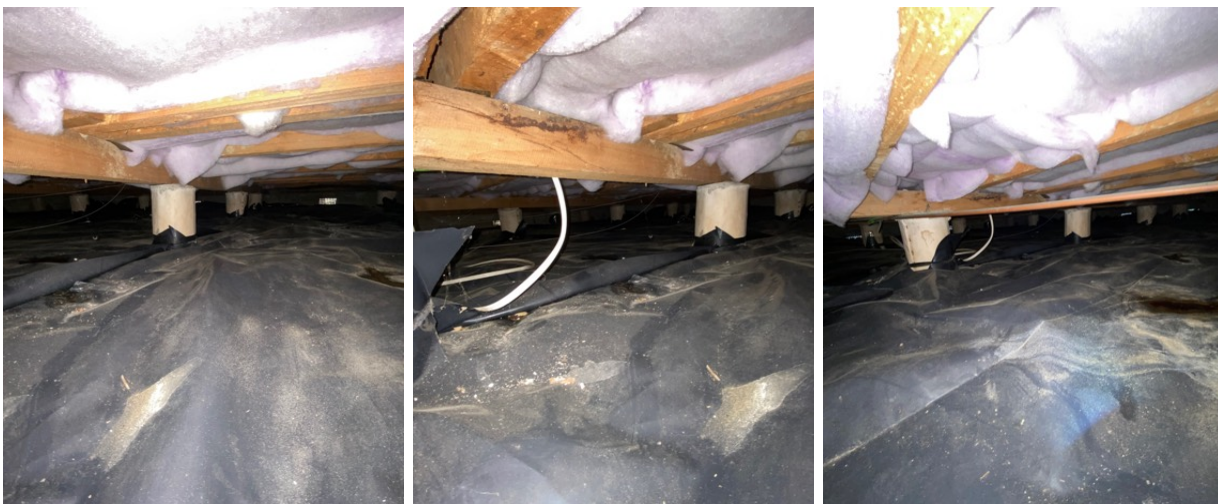
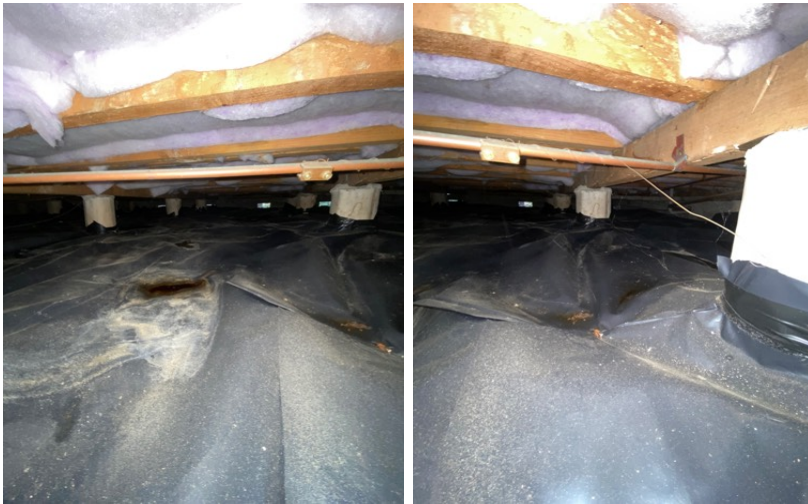
Photograph the subfloor space

Is there an existing ground moisture barrier?

**Yes, installed prior to July 1  
2019**

Does it have any significant tears or holes that may let moisture through?

**No**

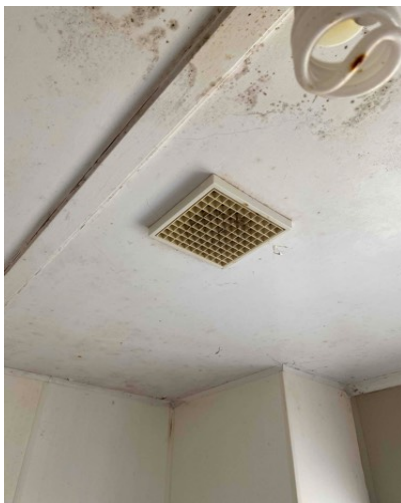
Photograph of vent

Does the bathroom have an extractor fan?

**Yes, installed prior to 1 July 2019**

Is the fan in good working order?

**Yes**

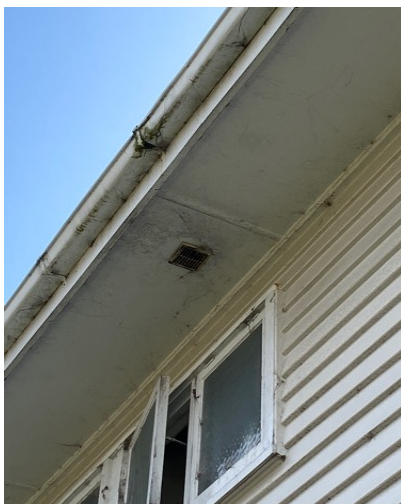
Photograph of external vent

Does the fan vent to the outdoors?

**Yes**

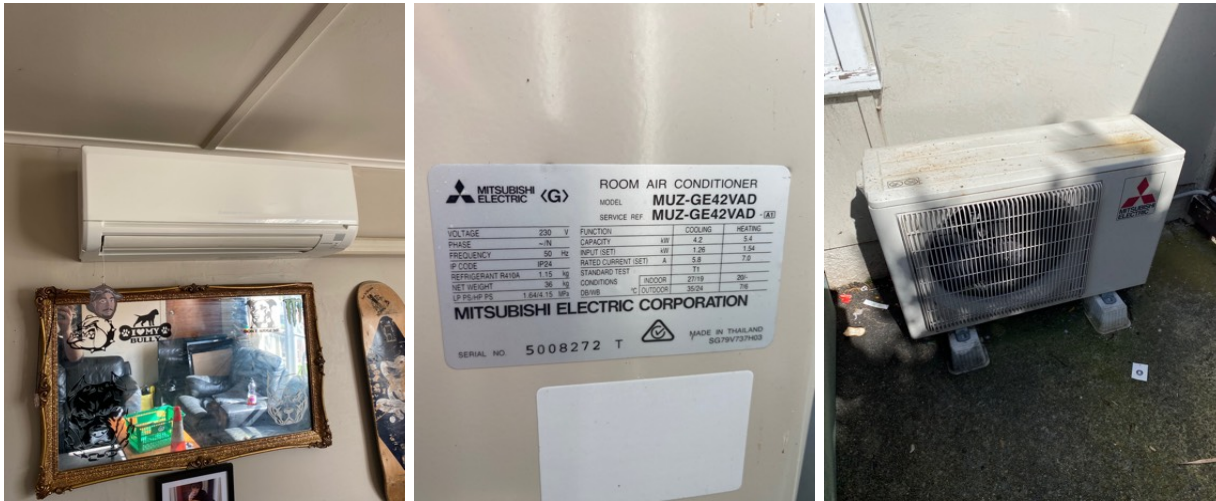
Photograph of heating source

Mitsubishi muz-ge42vad

Is the heater located in the living room or providing heat directly to the living room (eg through a duct or vent)?

Yes

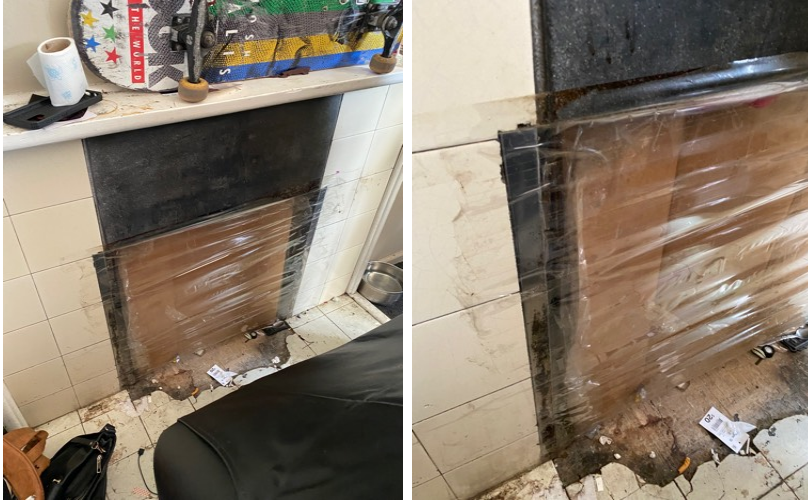
Photograph of heating source

No brand. Blocked.

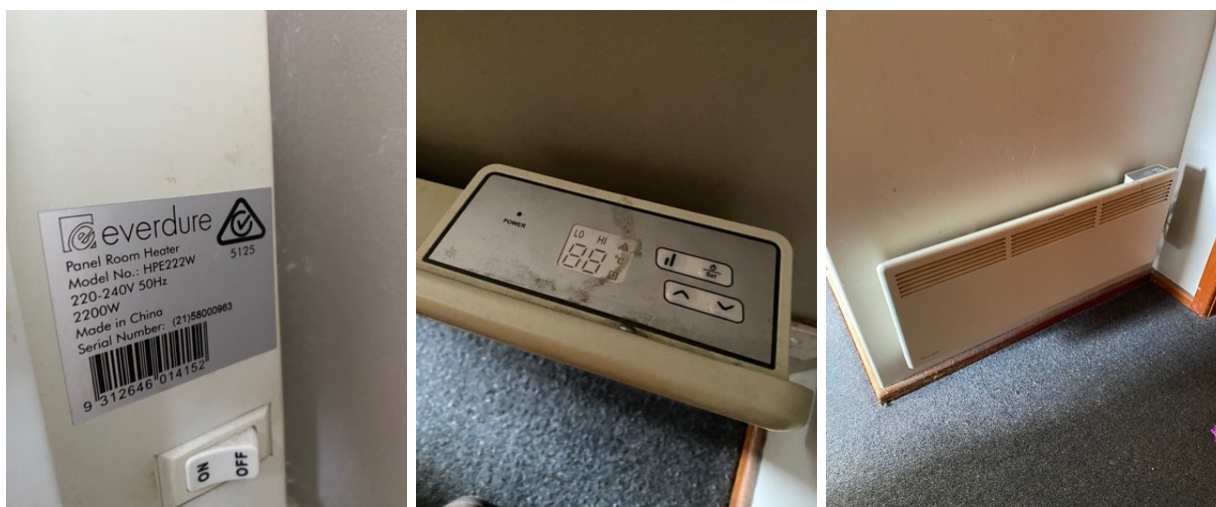
Photograph of heating source

Wall fixed electric heater

What is the kW capacity?

2.2
