Asset Property Inspections

59 Morningside Road, Morningside,
Whangarei

Residential Property Inspection

Inspection date: 11th April 2024

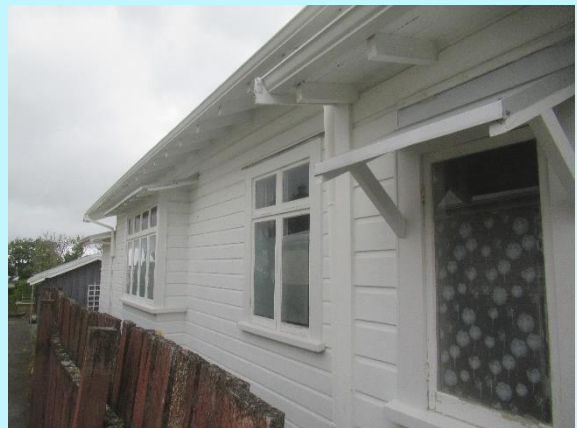
Western side elevation with damaged fencing and ancillary dwelling against the boundary

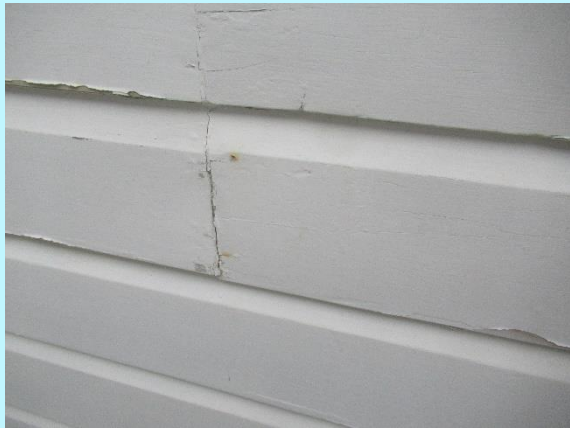
The original external cladding has some areas with cosmetic splitting and paint deterioration however we noted no significant decay.

The cladding is original with some splitting and deterioration consistent with age and wear

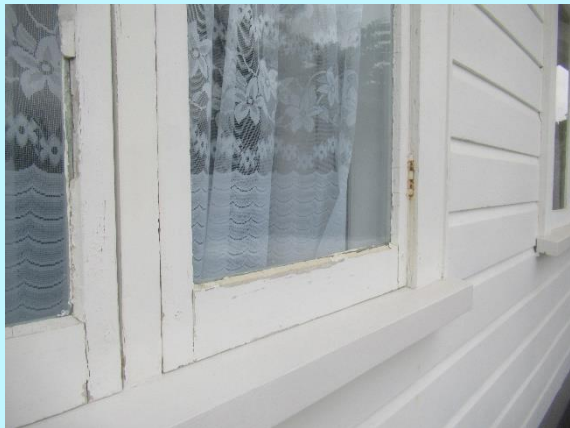
The timber windows are also original and are beginning to deteriorate in parts.

Deterioration and missing glazing putty in the windows are now due for renovation and repairs

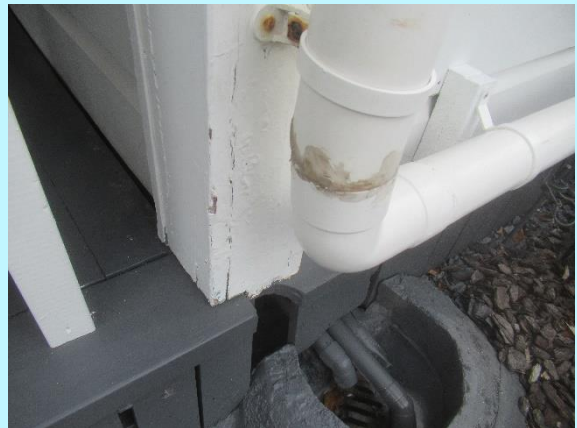
Deterioration and some decay in the external trims that will require ongoing maintenance and repair

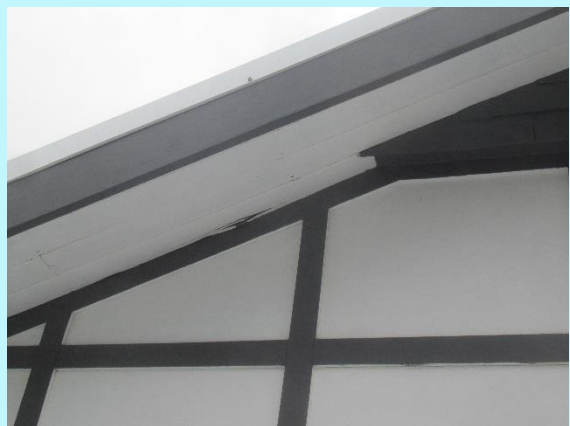
The timber soffit lining is deteriorated the soffit are reasonable however maintenance is needed

| Feature | Attributes & Possible Defects | Comments |
|---|---|---|
| Eaves, fascia and soffits | | Painted timber sarking with timber fascia's and barges with some old surface deterioration and some damaged sarking |

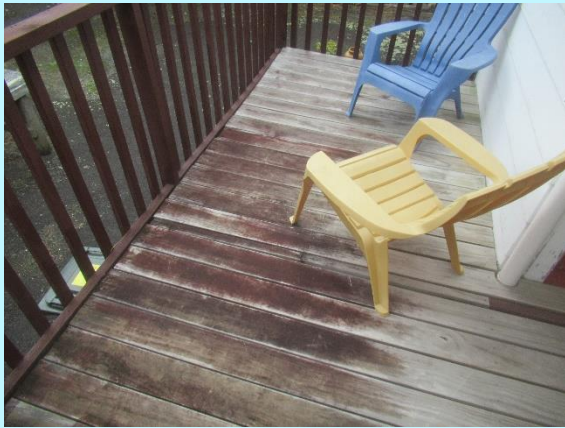
The front and rear decks are due some work around the foundations and jack framing

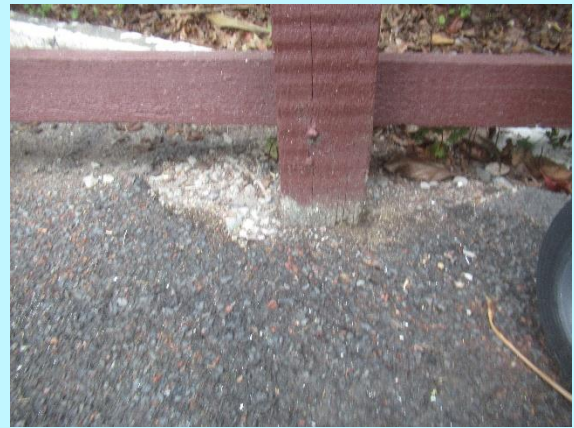
The front and rear decks are reasonable and have recently been renovated however we did note the piles supporting the rear decks are decaying and are due an upgrade for safety soon.

Decay and out of plumb piles noted below the rear elevation decks, repairs are due soon

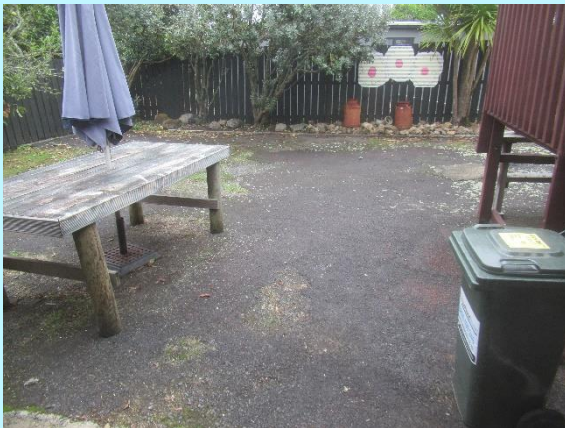
Formed concreted drive with some deterioration and slumping requiring upgrades and repair

| Feature | Description |
|--|---|
| Paths steps and driveways | Formed concrete and asphalt drive and parking with cracking and displacement. This appears to be age and wear and not from a significant structural event |

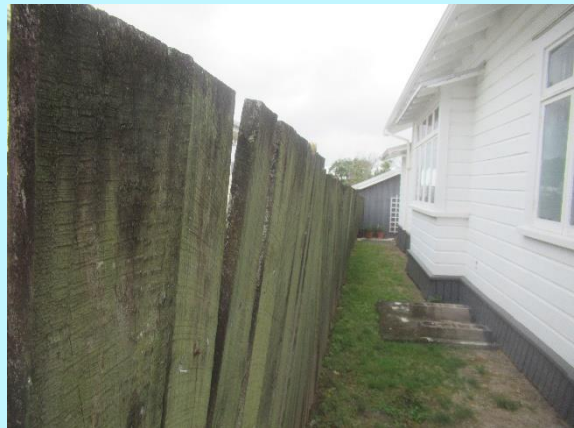
The timber fencing at the boundary has failed and is leaning into the property

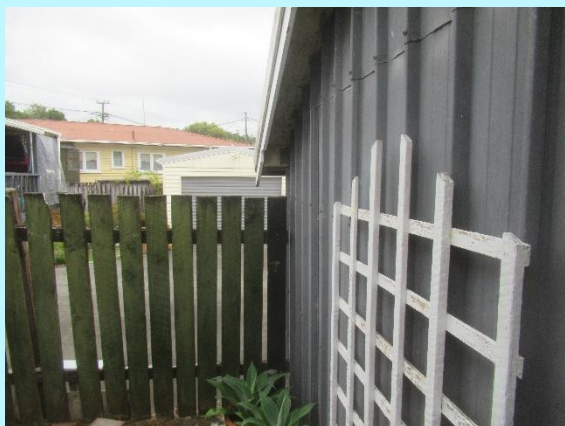
This ancillary building is on the boundary and is discharging water runoff to the adjacent dwelling

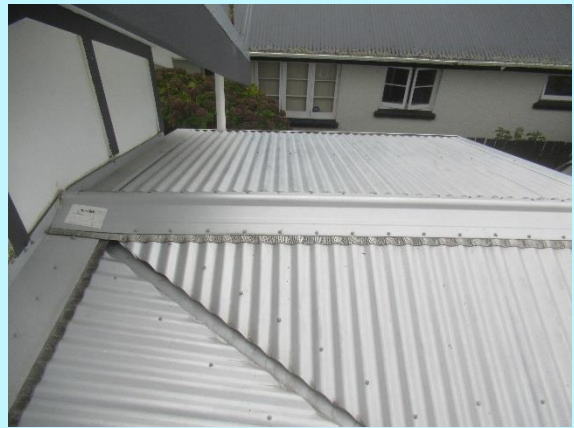
The roof should be cleaned and chemwashed to inhibit lichen growth and preserve condition

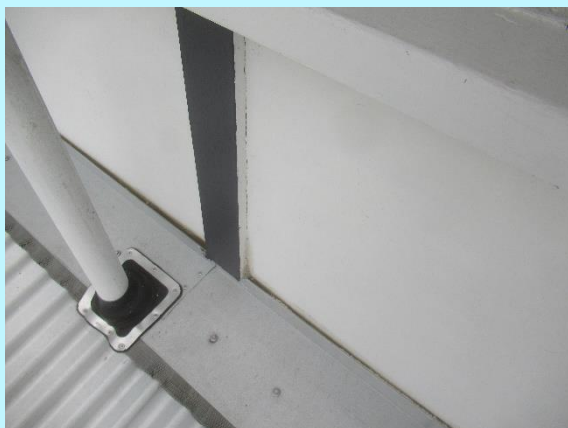
The apron flashings are face fixed and rely on silicone to be weathertight – maintain the silicone

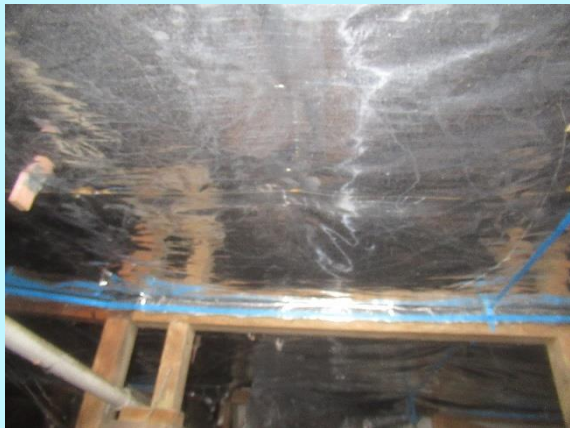
The subfloor is installed with foil insulation, and this prevents a visible inspection of the underside of the flooring therefore we cannot confirm the condition of the flooring and framing above the foil insulation.

The subfloor is fitted with foil insulation which prohibits a view of the underside of the flooring

| Feature | Description |
|--|---|
| Ground vapour barrier and subfloor insulation | <p>The dwelling is fitted with foils sisalation.</p> <p>Foil sisalation is now banned because of the risk of electrocution when repairing or replacing this product – we recommend a more efficient subfloor insulation is installed</p> |

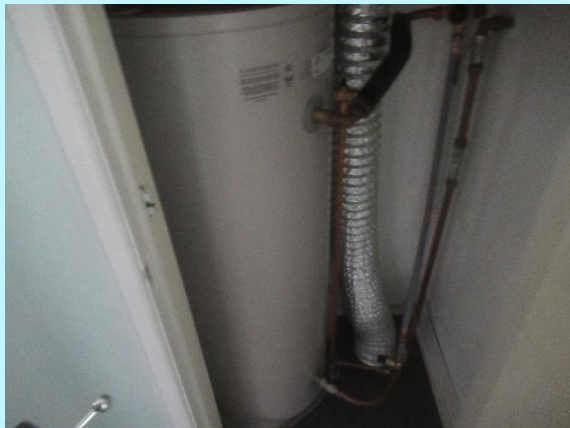
Recently fitted mains pressure cylinder -consider adding seismic restraints and a safe tray here

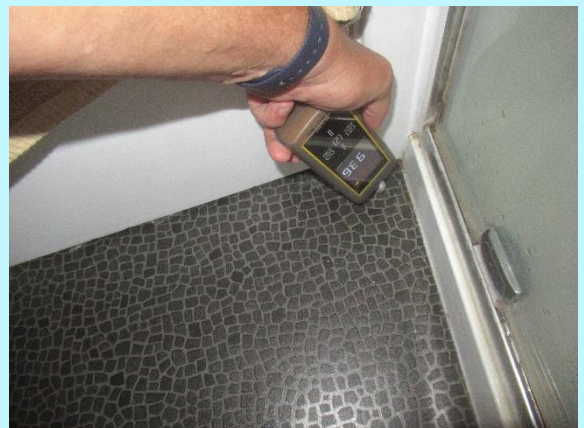
Elevated moisture at the shower to wall junction can indicate the liner is not correctly sealed here

| Feature | Attributes & Possible Defects | Comments |
|---|--|--|
| Showers | Leakage Adequacy of flow Wet wall linings Operation of taps and wastes Water hammer Screen material and operation | Acrylic showers with proprietary wet wall linings and glass surrounds. We recorded elevated moisture at the wall and floor junctions around the shower and this can indicate the liner is incorrectly sealed We cannot verify the condition of the framing or flooring in this area, and we recommend further investigation by an LBP or plumber |

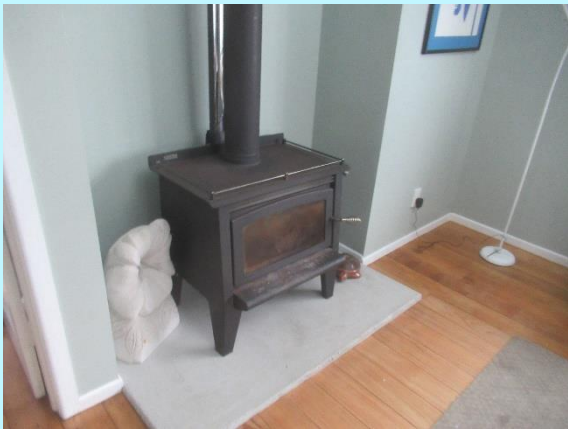
Wood fires must be checked and serviced annually by accredited installers

| Feature | Attributes & Possible Defects | Comments |
|---|---|--|
| Heating | Type: Wood fire Location: Lounge | We recommend the fire is checked by an accredited installer and then serviced annually. Further information can be found here https://www.nzhha.co.nz/find-a-service/ |

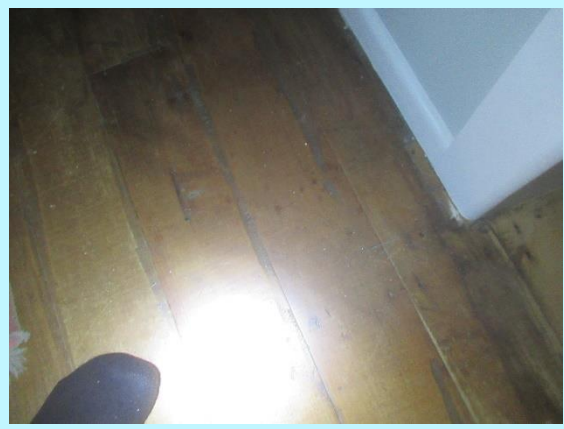
We did see old borer holes in the flooring, we did not see any live borer in the visible areas

| Feature | Description |
|--|---|
| Insect and Pest Infestation | <p>We did not see any obvious signs of borer in the visible areas however recommend that due to the amount of native timber in the dwelling it would be prudent to check for borer on a regular basis – we recommend DIY pest control is considered as a preventative measure</p> |
