Healthy Homes Evaluation

1/315 Southampton Street East
Akina Hastings 4122

2/315 Southampton Street East
Akina Hastings 4122

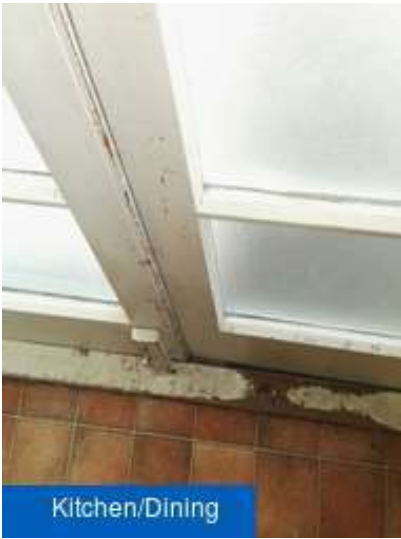
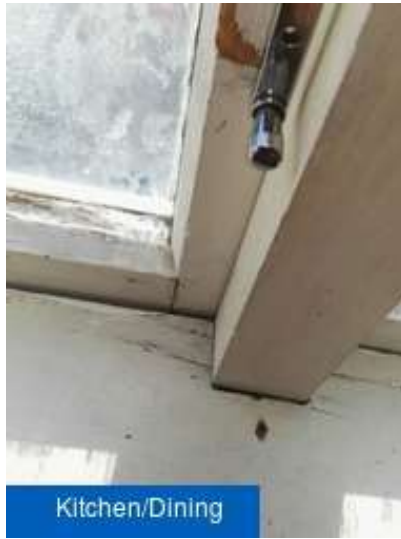
Kitchen/Dining	Non-Compliant	Non-compliant due to the door perimeter not being sealed adequately and the window perimeter not being sealed adequately.
-----------------------	----------------------	---

Additional Comment	Easing of the front doors and fitting of draft stop to these doors and the windows will resolve this issue.
---------------------------	---

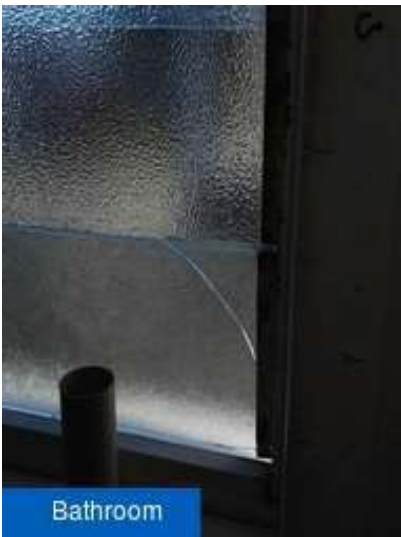
Location	Result	Statement
Bathroom	Non-Compliant	Non-compliant due to gaps in the louvre style inserts (requires draught stopping product or replacement).
	Additional Comment	Size 780mm wide x 750mm.

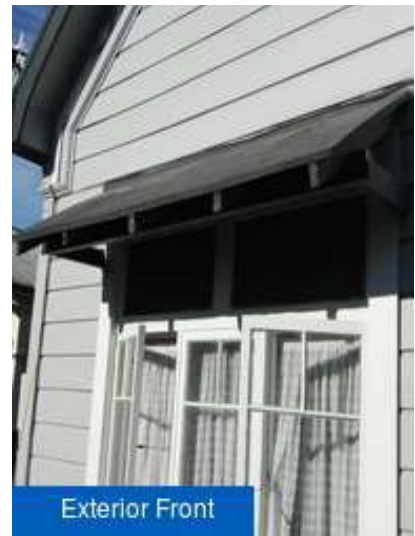
Non-compliant due to gutters blocked, gutters damaged and surface ground water not directed away from the property adequately.

Reclipping of one gutter clip and clearing of 5m of the lower gutter. In addition, fitting of a gutter and downpipe connected to the surface water drain for the small roof over the window will resolve this issue.

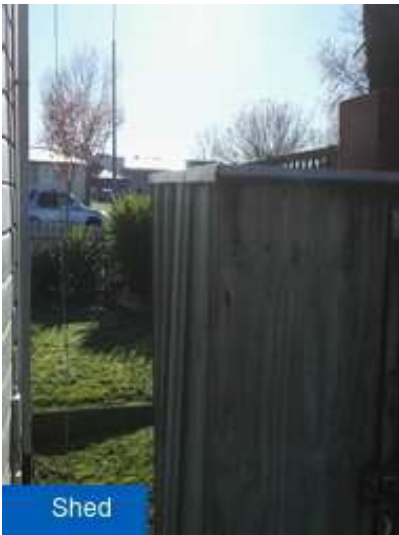
Shed	Non-Compliant	Non-compliant due to surface ground water not directed away from the property adequately.
------	----------------------	---

Additional Comment		Fitting of a gutter and downpipe connected to the surface water drain will resolve this issue.
---------------------------	--	--

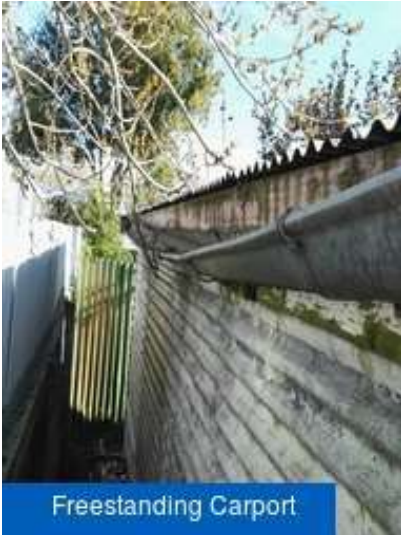
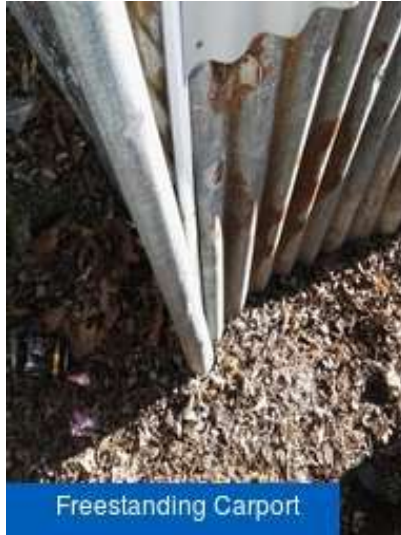
Freestanding Carport	Non-Compliant	Non-compliant due to gutters blocked, gutters damaged and surface ground water not directed away from the property adequately.
----------------------	----------------------	--

Additional Comment		Repair or replace the gutter and downpipe, plus make sure that the downpipe is cleared and connect it to a surface water drain to resolve this issue.
---------------------------	--	---

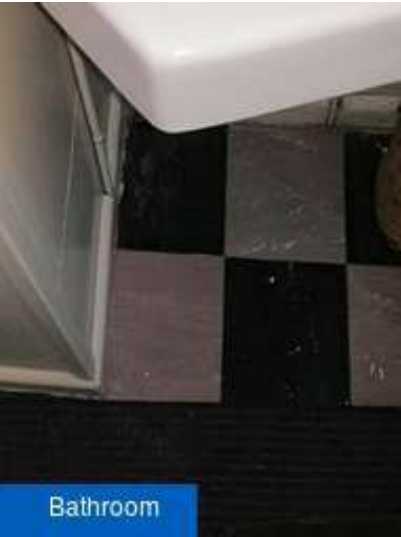
The presence of what we suspect to be undisturbed asbestos material has the potential to cause harm if disturbed and inhaled. Those at risk include any person in close proximity when disturbed. This is a Safety at Work Act 2016 required inclusion. Hazard Identified in the Bathroom.

Comments Suspected asbestos material in the floor tiles.

Current Risk	Actions	Potential Solutions	Resultant Risk
High	Eliminate	To eliminate the risk, we recommend the material remain undisturbed and engage an expert in the field of asbestos testing and identification and if confirmed as asbestos, follow their recommended mitigation management plan. E.g. "Be aware and do not disturb".	Moderate

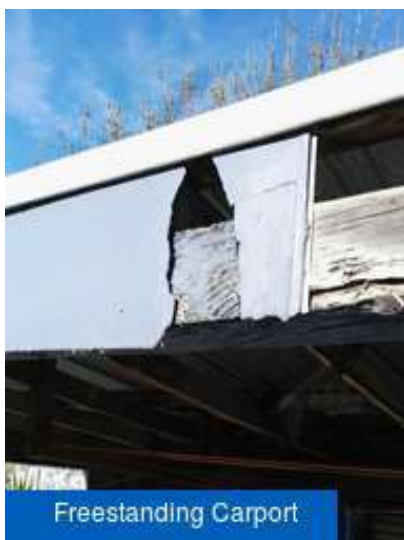
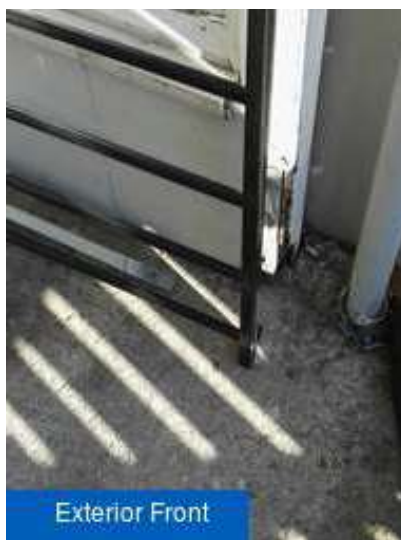
The presence of what we suspect to be previously disturbed asbestos material has the potential to cause harm if disturbed further and inhaled. Those at risk include any person in close proximity when disturbed. This is a Safety at Work Act 2016 required inclusion. Hazard Identified in the Freestanding Carport and Exterior Front.

Comments Freestanding Carport: Suspected asbestos material in the upper front fascia. Exterior Front: Suspected disturbed asbestos material in the lower, inner cladding to the porch.

Current Risk	Actions	Potential Solutions	Resultant Risk
High	Eliminate	To eliminate the risk, we recommend the material not be disturbed further and engage an expert in the field of asbestos testing and identification and if confirmed as asbestos, follow their recommended mitigation management plan. E.g. "Be aware and do not disturb".	Moderate
High	Isolate	To isolate the risk, if necessary and practicable, we recommend preventing access to this area until rectified.	Low

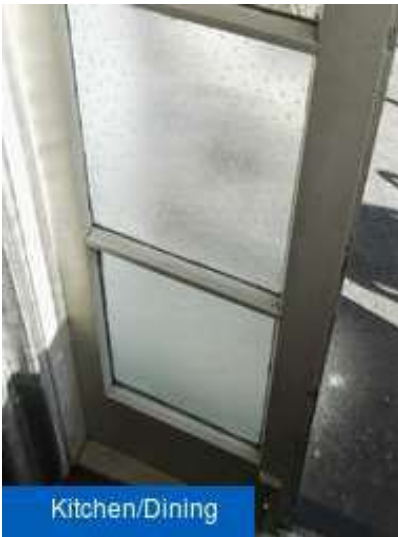
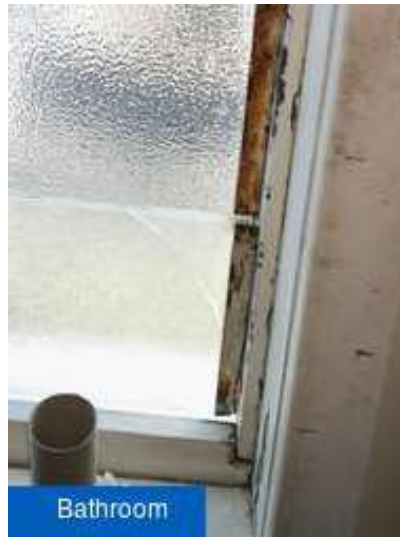
Location	Comment
Kitchen/Dining	Suspected lack of safety glass to the doors. If or when this glass needs replacing we recommend it is replaced with safety glass.
Bathroom	Broken pane of glass. If or when this glass needs replacing we recommend it is replaced with safety glass.

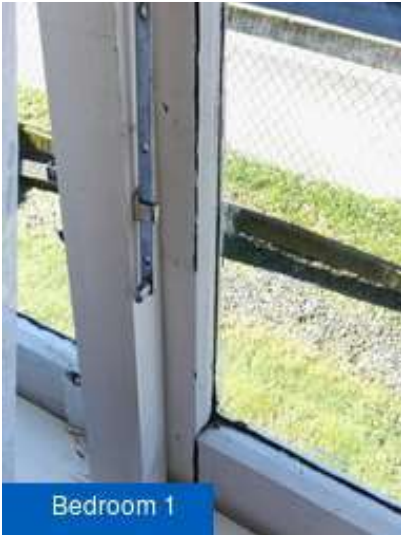
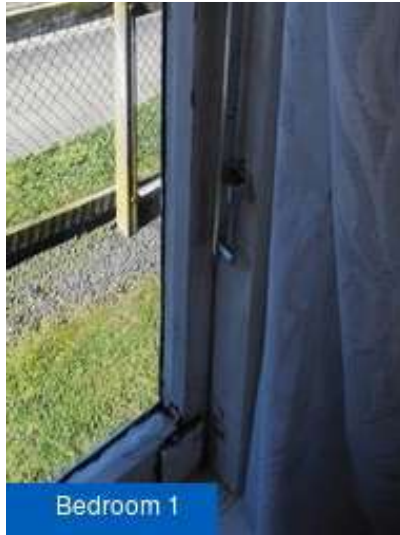
skylight that takes up at least 5% of the habitable space.

Additional Comment The windows need easing and possibly repair or replacement to resolve this issue.

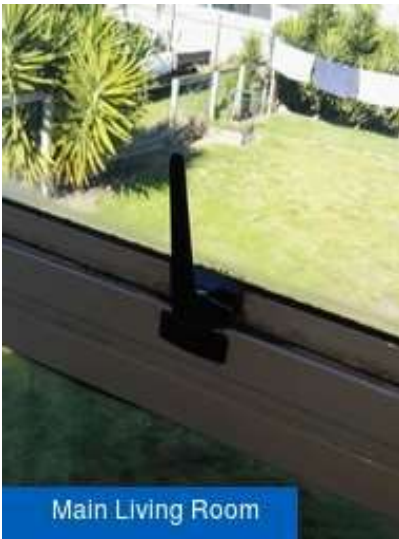
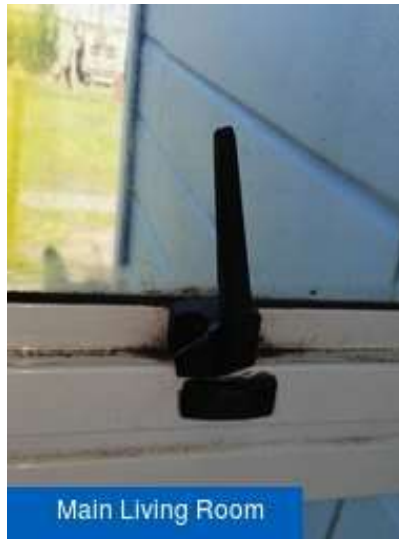
Location	Result	Statement
Main Living Room	Non-Compliant	Non-compliant due to the window perimeter not being sealed adequately and damage window latch.
	Additional Comment	Repair of both window latches will resolve this issue.

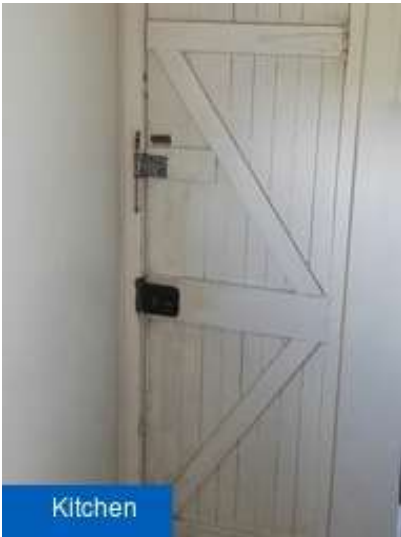
Location	Result	Statement
Kitchen	Non-Compliant	Non-compliant due to the door perimeter not being sealed adequately.
	Additional Comment	Fitting of draft stop to the door will resolve this issue.

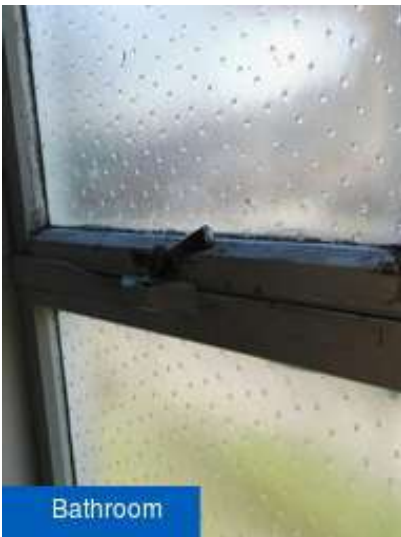
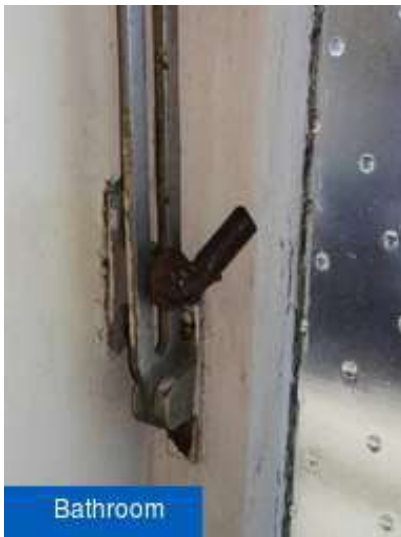
Location	Result	Statement
Bathroom	Non-Compliant	Non-compliant due to the window perimeter not being sealed adequately, absent window latch and other - see comments.
	Additional Comment	The window requires a new latch screw, repair of the central timber sealing strip and fitting of draft stop to resolve this issue.

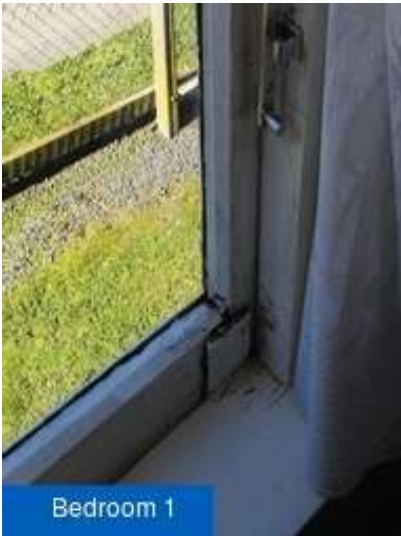
Location	Result	Statement
Bedroom 1	Non-Compliant	Non-compliant due to the window perimeter not being sealed adequately.
	Additional Comment	Once the windows are repaired they may need draft stop.

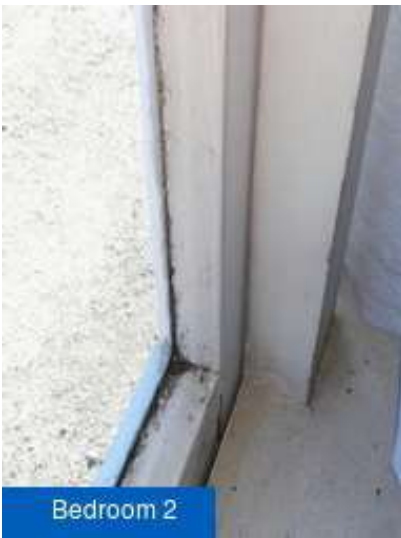
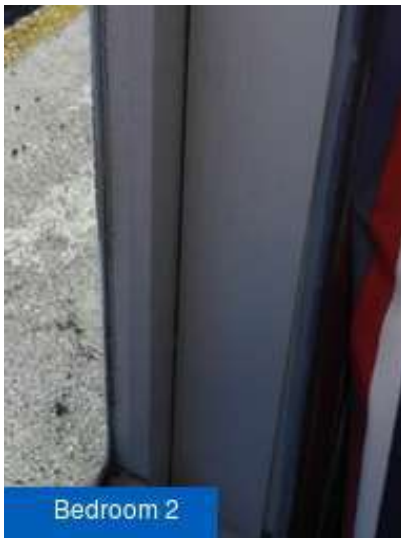
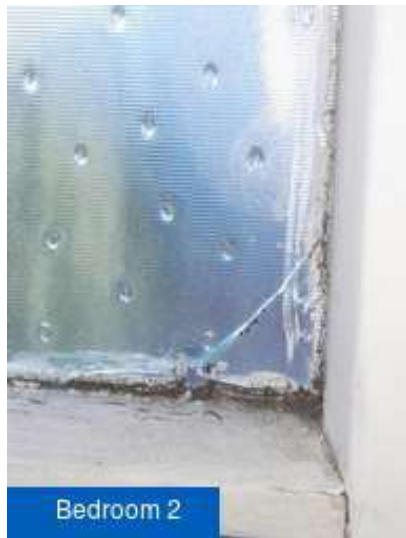
Location	Result	Statement
Bedroom 2	Non-Compliant	Non-compliant due to the window perimeter not being sealed adequately and other - see comments.
Additional Comment		Replacing the upper window, 500mm x 250mm, and fitting of draft stop to the opening light, plus sealing up the screwed shut opening light will resolve this issue.

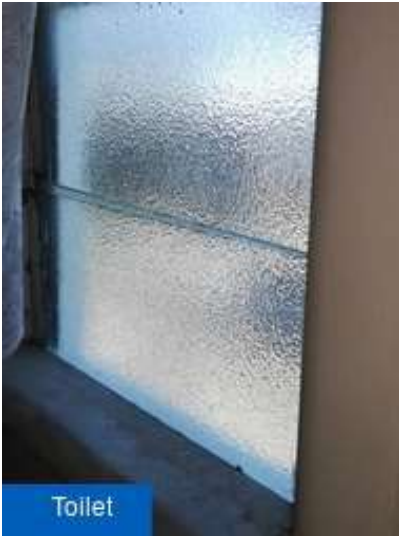
Location	Result	Statement
Toilet	Non-Compliant	Non-compliant due to gaps in the louvre style inserts (requires draught stopping product or replacement).

Additional Comment Size 450mm x 450mm.

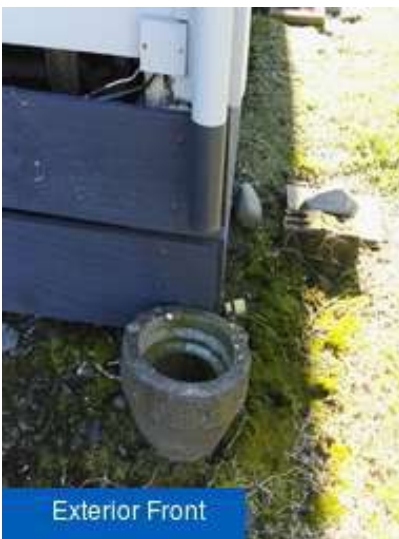
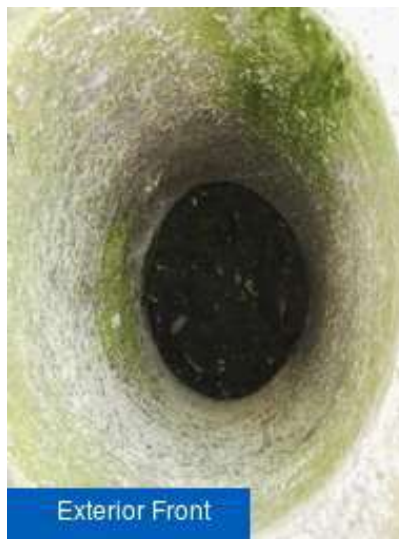
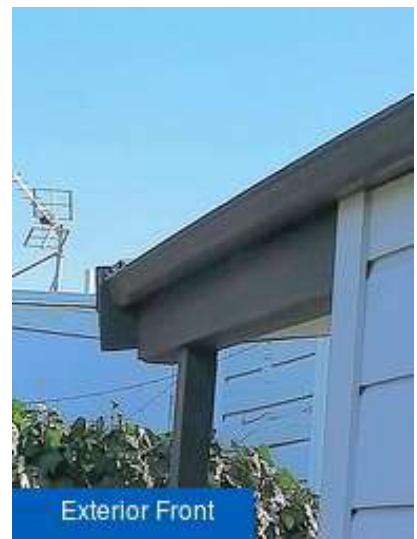
Location	Result	Statement
Exterior Front	Non-Compliant	Non-compliant due to downpipe not connected adequately, drain blocked, surface ground water not directed away from the property adequately and other - see comments.
	Additional Comment	Fitting 300mm of downpipe and connecting to the surface water drain, clearing of the drain, plus refitting of the lower gutter so that it drains towards the downpipe will resolve this issue.

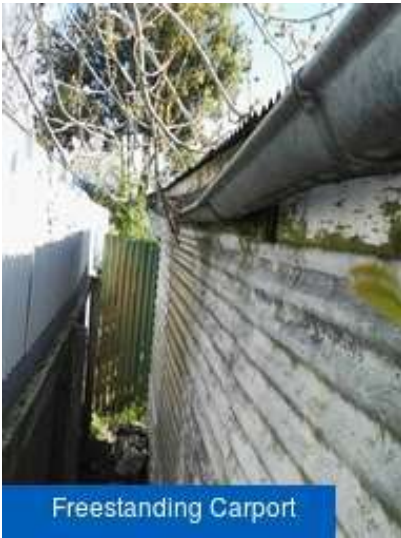
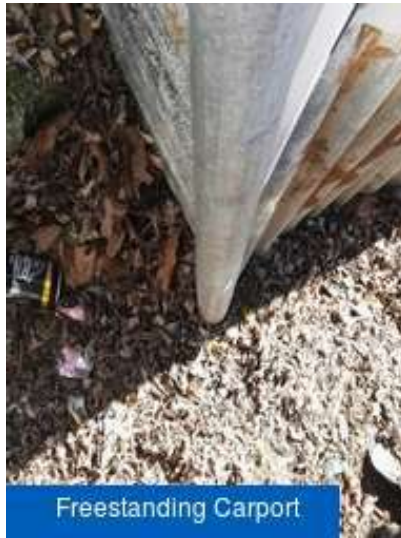
Location	Result	Statement
Freestanding Carport	Non-Compliant	Non-compliant due to gutters blocked, gutters damaged, drain blocked and surface ground water not directed away from the property adequately.
	Additional Comment	Repair or replace the gutter, clearing of the drain and make sure that the drain, if any, is connecting to a surface water drain will resolve this issue.

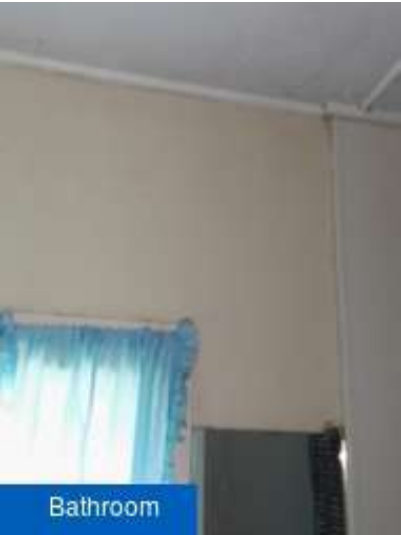
Comments Suspected asbestos material in the cladding to the walls.

Current Risk	Actions	Potential Solutions	Resultant Risk
High	Eliminate	To eliminate the risk, we recommend the material remain undisturbed and engage an expert in the field of asbestos testing and identification and if confirmed as asbestos, follow their recommended mitigation management plan. E.g. "Be aware and do not disturb".	Moderate

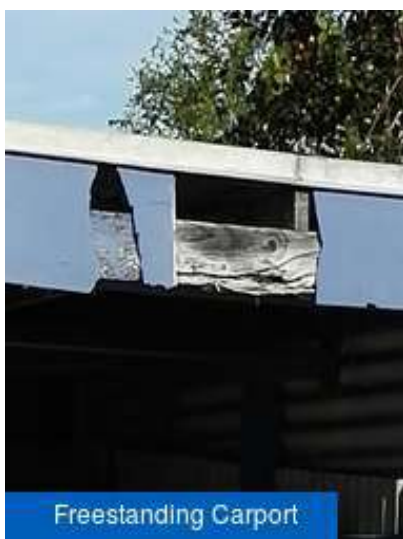
The presence of what we suspect to be previously disturbed asbestos material has the potential to cause harm if disturbed further and inhaled. Those at risk include any person in close proximity when disturbed. This is a Safety at Work Act 2016 required inclusion. Hazard Identified in the Freestanding Carport.

Comments Suspected asbestos material in the fascia to the front.

Current Risk	Actions	Potential Solutions	Resultant Risk
High	Eliminate	To eliminate the risk, we recommend the material not be disturbed further and engage an expert in the field of asbestos testing and identification and if confirmed as asbestos, follow their recommended mitigation management plan. E.g. "Be aware and do not disturb".	Moderate
High	Isolate	To isolate the risk, if necessary and practicable, we recommend preventing access to this area until rectified.	Low

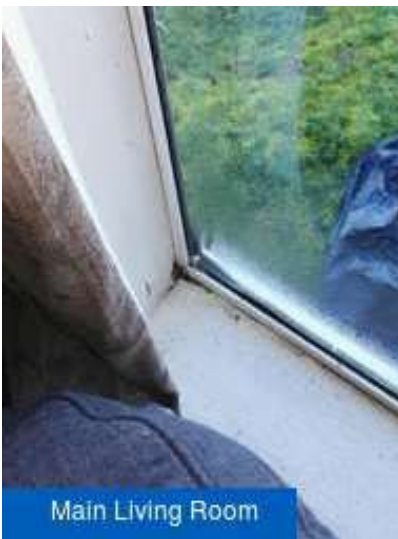
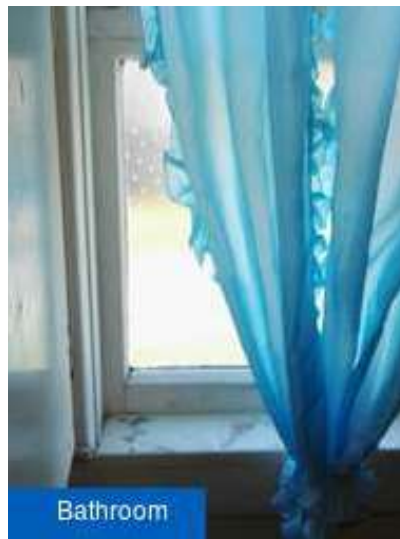
Location	Comment
Main Living Room	The main glazing seals are pulling out to the windows and need replacement.
Bathroom	Suspected lack of safety glass to the windows. If or when this glass needs replacing we recommend it is replaced with safety glass.
