# LONG TERM MAINTENANCE PLAN

Body Corporate 534969 – Avenue Apartments,  
Mangere Auckland

## **LONG TERM MAINTENANCE PLAN - AVENUE APARTMENTS – BODY CORPORATE 534969 - 69 HALL AVENUE, MANGERE**

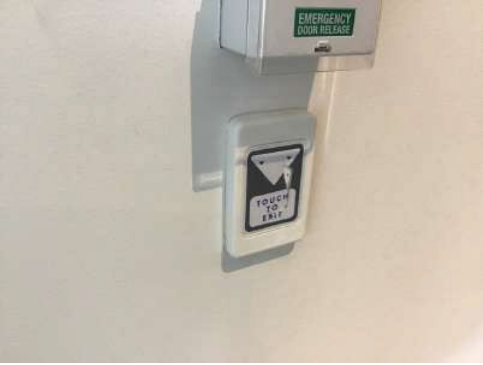
Location: Block 4

| Block 4<br>Internal<br>Stairway and<br>Landings | <div>Doors</div> <div>Personnel<br/>Electronic Door Entry<br/>System</div> <div>Door Exit Button Cracked<br/>And Requires Replacement</div> | Poor - Requires<br>replacement | Exit release button cracked and in need of<br>repair | No | 1 | \$350 | \$350 | \$350 | |

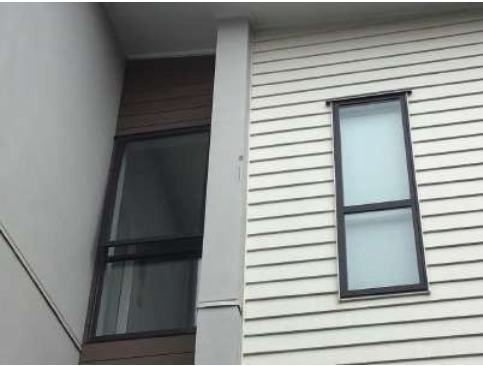
Location: Block 6

| Block 6<br>External<br>Building External | <div>Cladding</div> <div>Sheet Cladding<br/>Repairs - Wall Cladding<br/>Damage To Cladding At<br/>High Level</div> <div>Repair Cladding To North<br/>North Elevation</div> | Moderate - Some<br>wear and tear | Cladding damaged at external corner high<br>level. Repair as per manufacturers<br>instructions. | No | 1 | \$1,200 | \$1,200 | \$1,200 | |

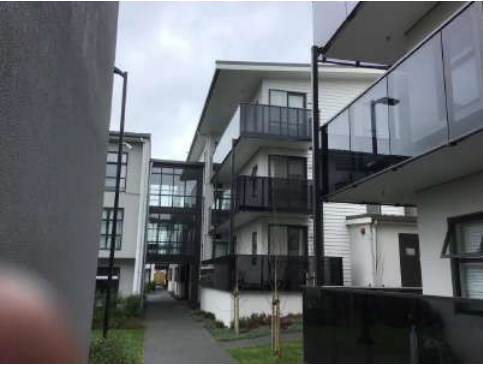
| Location | Building Element | Condition | Comments | Unit | Quantity | Unit Cost | Current cost | Future Cost | Photographs |
|---|---|---|---|---|---|---|---|---|---|
| Block 4<br>External<br>Building External | <div>Decoration</div> <div>External<br/>Paint - Walls, Soffits,<br/>Timber, Generally, Acrylic,<br/>Scaffolding</div> <div>Repaint External Walls And<br/>Soffits</div> | Very Good - As<br>New | External decoration presents in very good<br>condition | m2 | 520 | \$65 | \$33,800 | \$39,198 | |

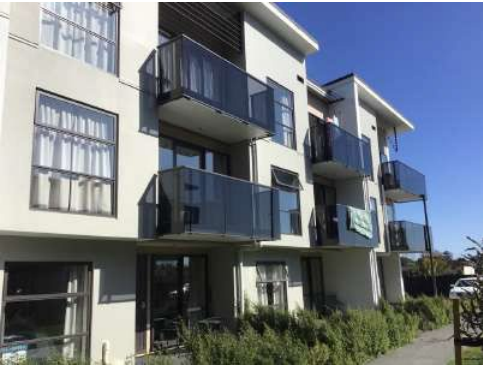
| Location | Building Element | Condition | Comments | Unit | Quantity | Unit Cost | Current cost | Future Cost | Photographs |
|---|---|---|---|---|---|---|---|---|---|
| Block 5<br>External<br>Building External | <div>Decoration</div> <div>External<br/>Paint - Walls, Soffits,<br/>Timber, Generally, Acrylic,<br/>Scaffolding</div> <div>Repaint External Walls And<br/>Soffits</div> | Very Good - As<br>New | External decoration presents in very good<br>condition | m2 | 540 | \$65 | \$35,100 | \$40,705 | |

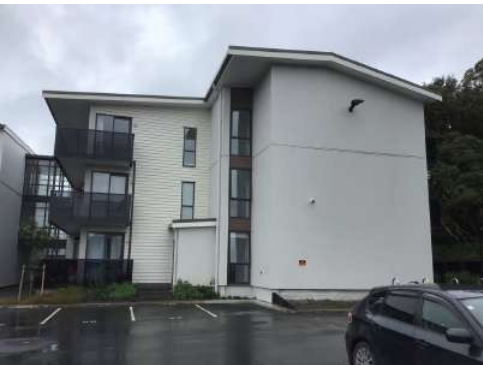
| Location | Building Element | Condition | Comments | Unit | Quantity | Unit Cost | Current cost | Future Cost | Photographs |
|---|---|---|---|---|---|---|---|---|---|
| Block 6<br>External<br>Building External | <div>Decoration</div> <div>External<br/>Paint - Walls, Soffits,<br/>Timber, Generally, Acrylic,<br/>Scaffolding</div> <div>Repaint External Walls And<br/>Soffits</div> | Very Good - As<br>New | External decoration presents in very good<br>condition | m2 | 712 | \$65 | \$46,280 | \$53,671 | |

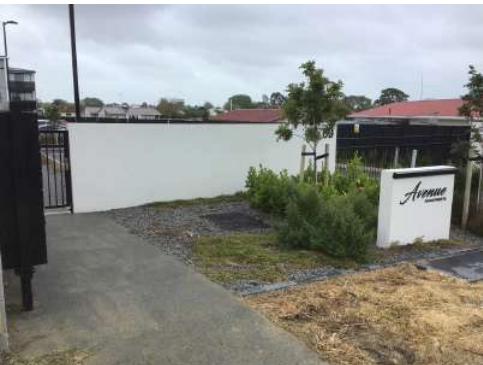
| Location | Building Element | Condition | Comments | Unit | Quantity | Unit Cost | Current cost | Future Cost | Photographs |
|---|---|---|---|---|---|---|---|---|---|
| External common<br>areas<br>External | <div>Decoration</div> <div>External<br/>Painting to concrete<br/>Repaint Walls At Entry</div> <div>Repaint Walls At Entry</div> | Very Good - As<br>New | External decoration presents in very good<br>condition | m2 | 30 | \$42 | \$1,257 | \$1,457 | |

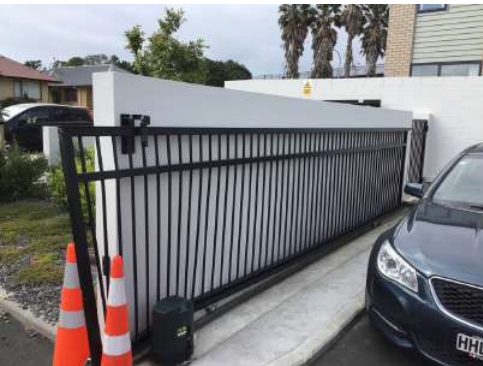
| External common<br>areas<br>External | <b>External Works</b><br><br>Gates<br>Vehicle, Steel, Manual<br>Electric Motor<br><br>Replace Gate Motor | Very Good - As<br>New | | No | 1 | \$2,500 | \$2,500 | \$2,972 | |
