## Visual Non-Invasive Property Inspection

21/05/2026

Phil Staunton

2 Chrystalwood Lane, Governors Bay

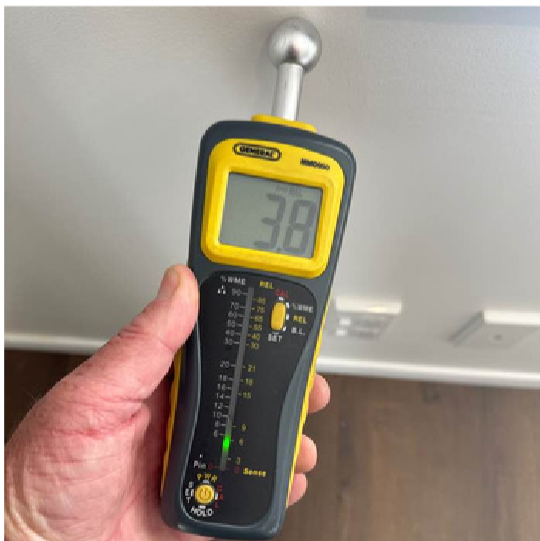
Low moisture reading,  
green = Good

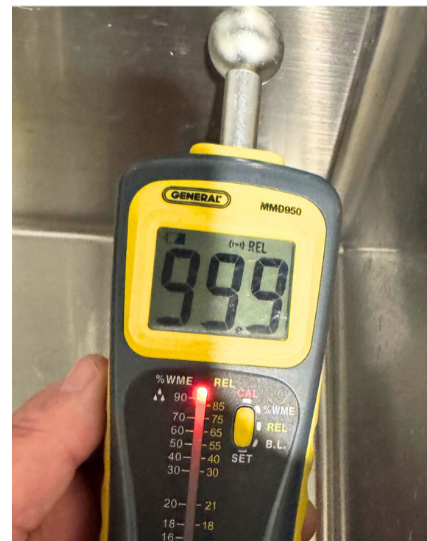
High moisture reading:  
Red:  
Damp = 20+  
Wet = 50+

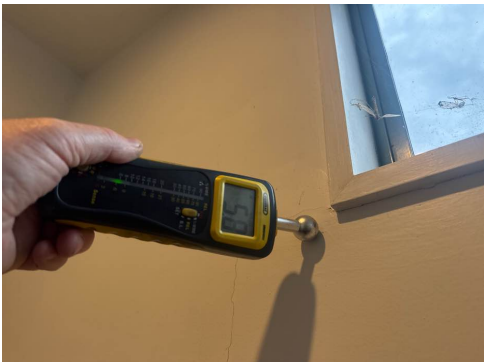
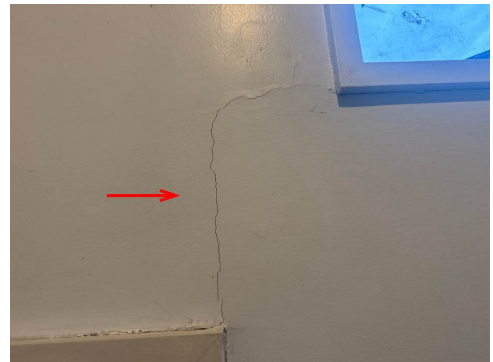
Very high moisture readings were detected to the lower wall tile areas on both sides of the toilet. The source of moisture could not be confirmed during this visual inspection and further investigation is recommended to determine whether leakage or concealed moisture ingress is present. Refer to photos.

Very high moisture content in these areas

- Investigate high moisture readings around toilet wall areas.
- Carry out repairs to any leaking plumbing, failed waterproofing, or moisture ingress issues identified.
- Repair cracking above door frame area.

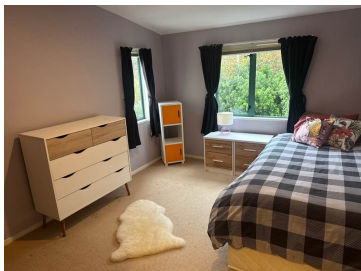
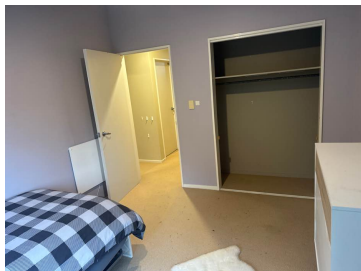
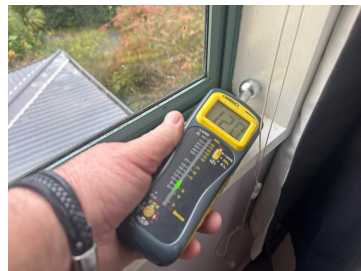
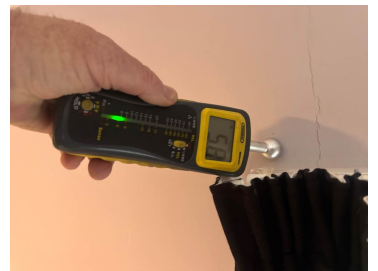
Elevated moisture readings were detected within the bunk room and also within the upper-level purple bedroom. The exact source of moisture could not be confirmed during this visual inspection and further investigation is recommended to determine whether moisture ingress or leaking is occurring. Refer to photos.

Very high moisture reading  
in this area bunk room

- Investigate elevated moisture readings in bunk room and upper-level purple bedroom.
- Repair any identified moisture ingress or leaking issues.
- Replace heavily worn carpet throughout bedrooms.
- Carry out general cosmetic wall and ceiling repairs and repainting as required.

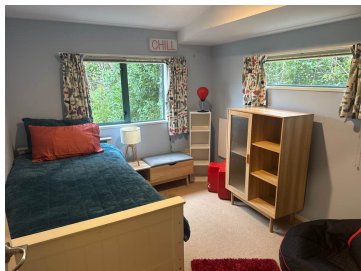
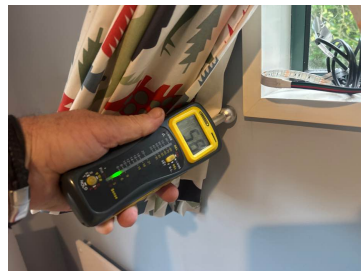
High moisture in this area  
purple bedroom

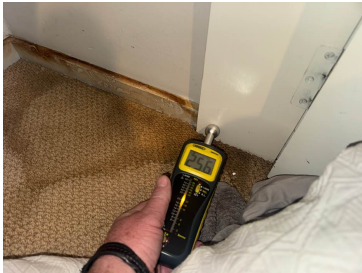
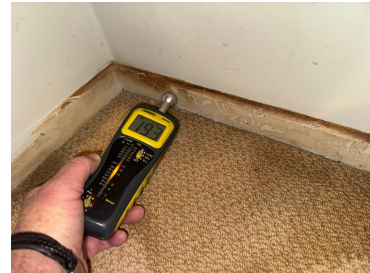
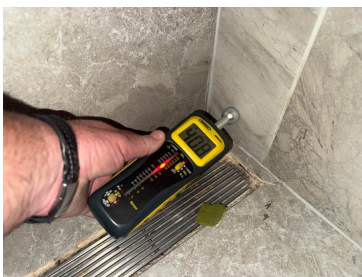
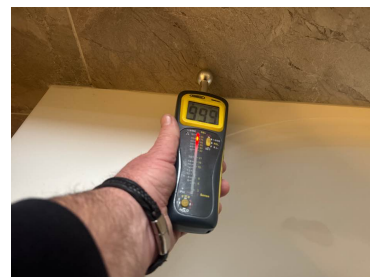
Elevated to very high moisture readings were detected around the lower shower wall tiles, particularly on the right-hand side adjoining the hallway cupboard wall. Inside the hallway cupboard, significant visible water damage is present to carpet and skirting areas; however, only low elevated moisture readings were recorded from the cupboard side at the time of inspection. Further investigation is required to determine the extent and source of moisture ingress. Refer photos.

Significant water damage backing onto the shower

- Investigate moisture ingress around shower wall and adjoining hallway cupboard areas.
- Repair any leaking plumbing, failed waterproofing, or exterior moisture ingress defects identified.
- Repair damaged carpet, skirting, and wall materials within hallway cupboard.
- Reseal and repair shower and tiled wall areas as required following investigation.

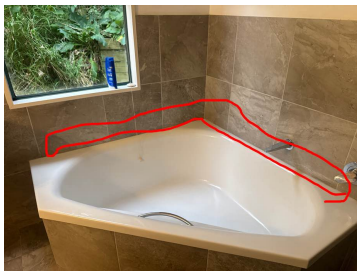
Very high moisture readings were also detected to tiled wall areas above the shower along the exterior wall.

This is opposite the significant water damage in the cupboard
