Earthquake/Insurance Documentation & Disclosure

The following EQC/NHC claim was made for the property at 9 Glenys Place, Broomfield in relation to the dwelling:

CLM/2010/032331

Statement of Claim Checklist / Repair Strategy

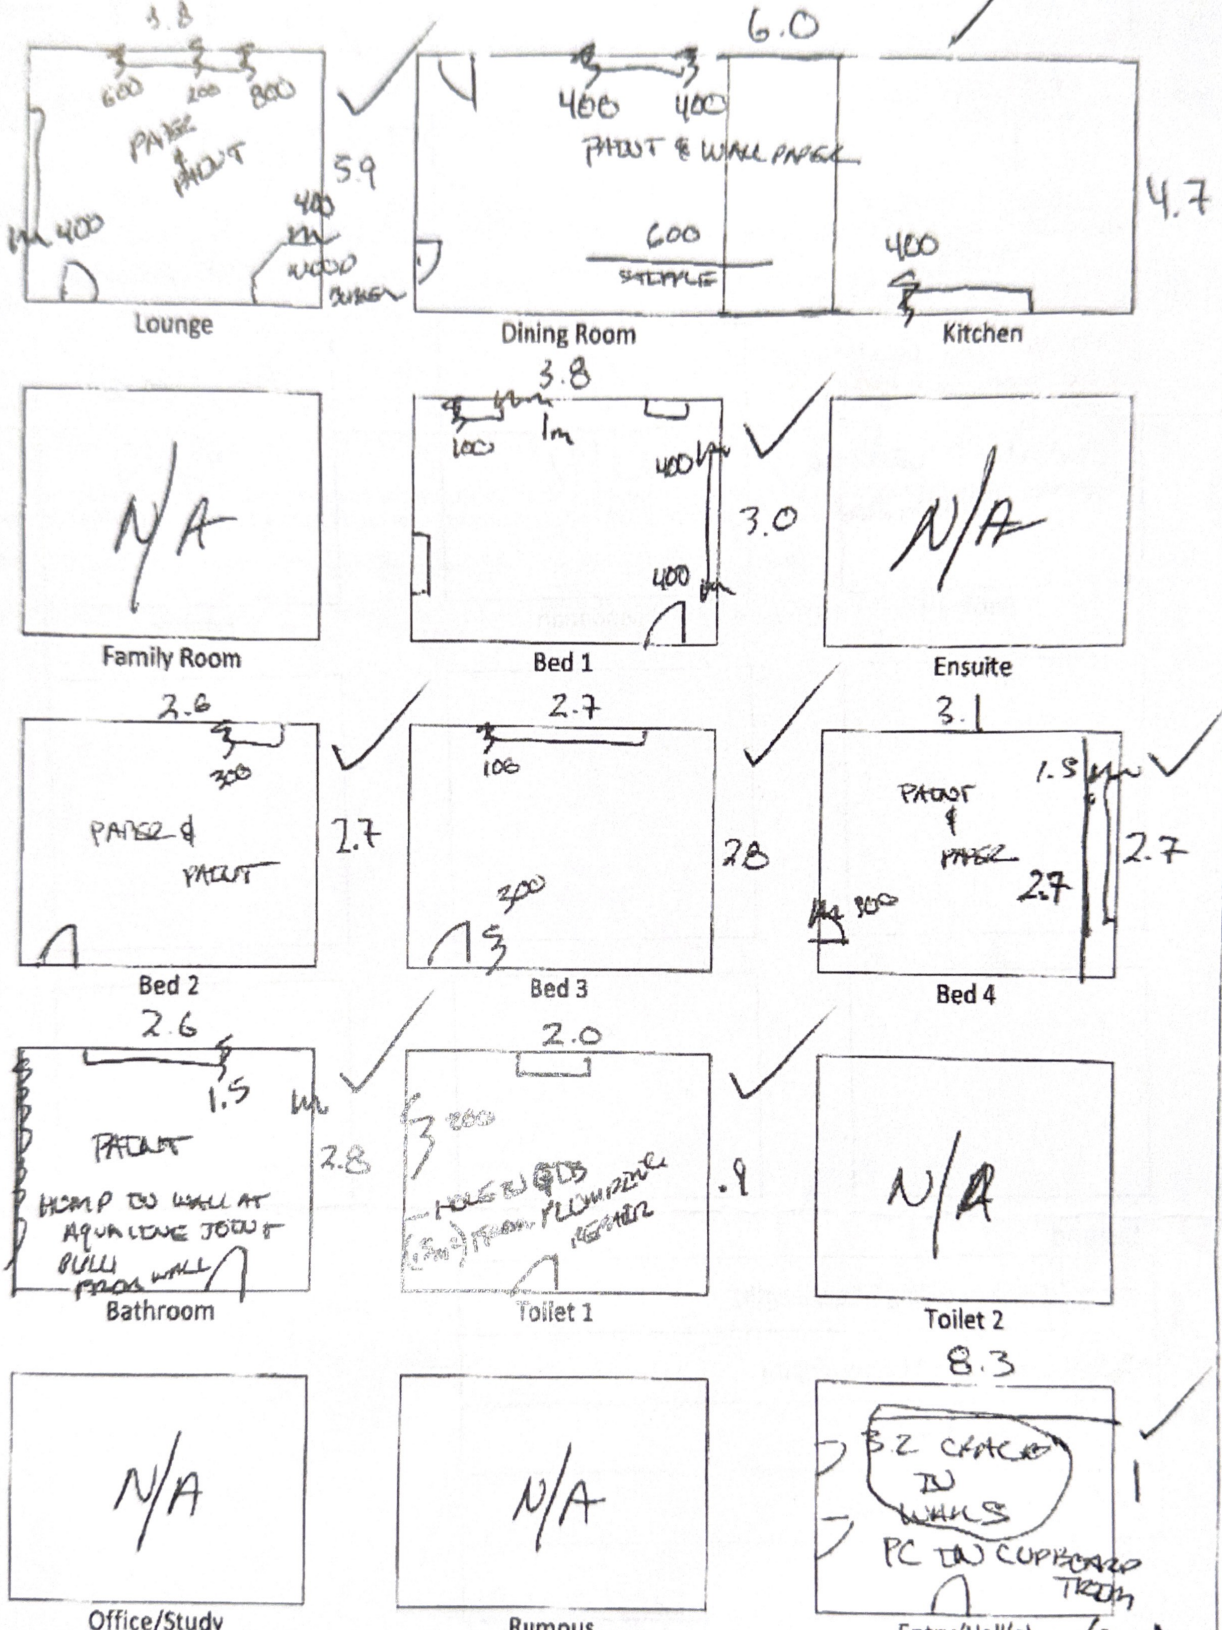
Dwelling Inspection Checklist: Show measurements indicate damage

Room	Earthquake Damage	Walls	Ceiling	Floor	Repair Strategy
	Y/N	✓	✓	✓	
3.8x5.9 Lounge	Y	✓			2-4 Cracks in Wall / Rock out, Fill, wallpaper & paint
6.0x4.7 Dining Room	Y	✓	✓		
Kitchen	Y	✓	✓		Cracks in Ceiling / Remove Stipple, Rock out & re-stipple. 600 Cracks in Wall 1-2m Remove Wallpaper, Rock out, Fill, Re-wallpaper & paint
Family Room	N/A				
3.8x3.0 Bedroom 1	Y	✓			Wall Cracking / Rock out, Fill & Reprint.
Ensuite	N/A				
2.6x2.7 Bedroom 2	Y	✓			Wall Cracking - Strip Paper, Fill, Repaper & Paint. Rock out.
2.7x2.9 Bedroom 3	Y	✓			Wall Crack. - Remove Wallpaper - Rock out Fill & Re-wallpaper.

Room	Cracks/Spalling	Walls	Ceiling	Floor	
	Y/N	✓	✓	✓	
3.1 x 2.7 Bedroom 4	Y	✓	✓		Cracks to Wall / Peck out, Fill & Re-paint (5) Seal Ceiling Crack - Stipple Ceiling - Remove & Re-paint (2.7)
2.6 x 2.0 Bathroom	Y	✓			Cracking to Walls - Peck out, Fill & Re-paint Hump in Wall (Furniture) Remove & Re-paint. 2.8 x 1.5m
2.0 x 1.9 Toilet 1	Y	✓			Holes in Wall (Plumbing leaks) Cracking in walls Peck out, Grout, Fill & Re-paint.
Toilet 2	WA				
Office / Study	WA				
Rumpus	WA				
8.3 x 1.0 Entry / Hall(s)	Y	✓	X	X	Strip wall paper Wall Cracks - Peck out, Fill & Re-paint. (3.2)m. & Re-wallpaper. 5.5m of Cupboard Join, Peck out, Fill & Re-paint
Stairwell	WA				
2.5 x 2.1 Laundry	Y	✓			Cracking to Walls - Strip Paper, Peck out, Fill & Re-paint (3.2)m.
5.6 x 5.9 Garage	Y	✓	✓		Wall Cracks - Peck out, Fill & Re-paint .11m Ceiling Cracks - Re-Coat, Stip & Re-paint Ceiling 12m
Other

Item	Event Damage		Repair Strategy
	Y	N	
Roof	Y		Refit Flashing around Metal Flue on Roof. Refit Roof Tiles. 22" m.
EXTERNAL WALLS	North	Y	7.9m Step Cracking - Block out, Repoint & Paint. Seal between Soffit & Bricks. (5m)
	South	Y	9m Step Cracking - Block out, Repoint & Paint. Seal between Soffit & Bricks. (5m)
	East	Y	11m Step Cracking - Block out, Repoint & Paint.
	West	Y	4m Step Cracking - Block out, Repoint & Paint. Seal between Soffit & Bricks. (5m) Refit Facia (5m) & Paint. (5m)
Decks	N		
CHIMNEY	Base	N	
	Ceiling Cavity	N	
	Above Roof	N	
	Fireplace	N

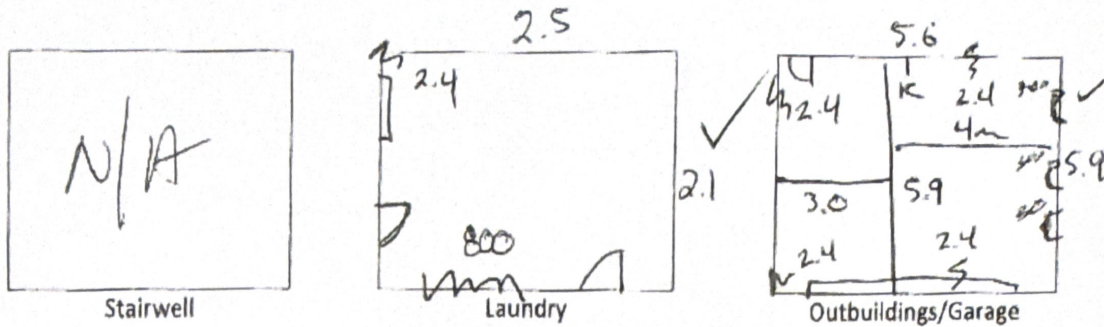
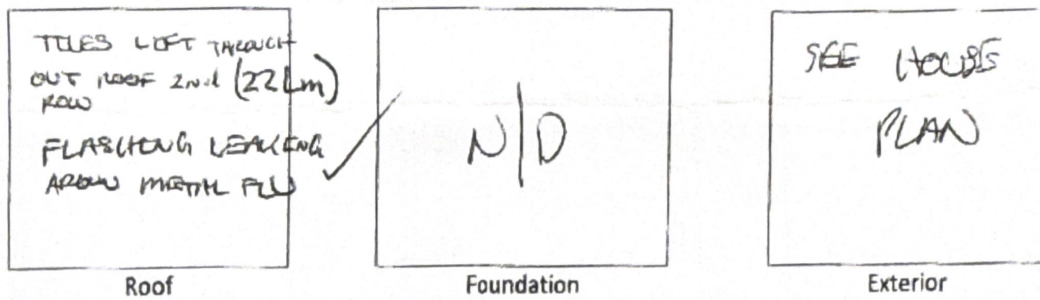
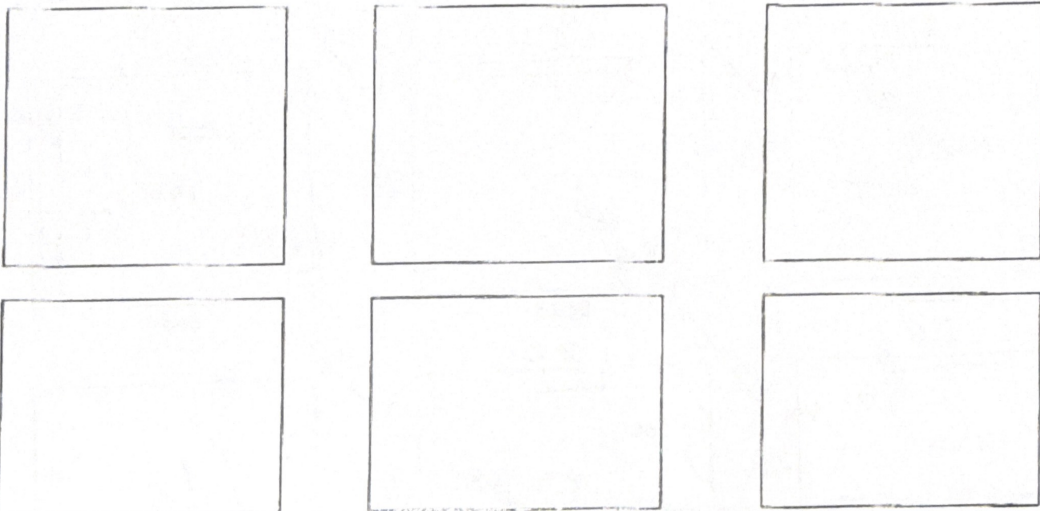
—	Crack to ceiling (show length)
W	Crack to wall (show length)
X	External damage
O	Foundation damage
+	Floor damage

PC - PAINT CRACKS
 R - REMOVABLE CRACK TO SEAMS

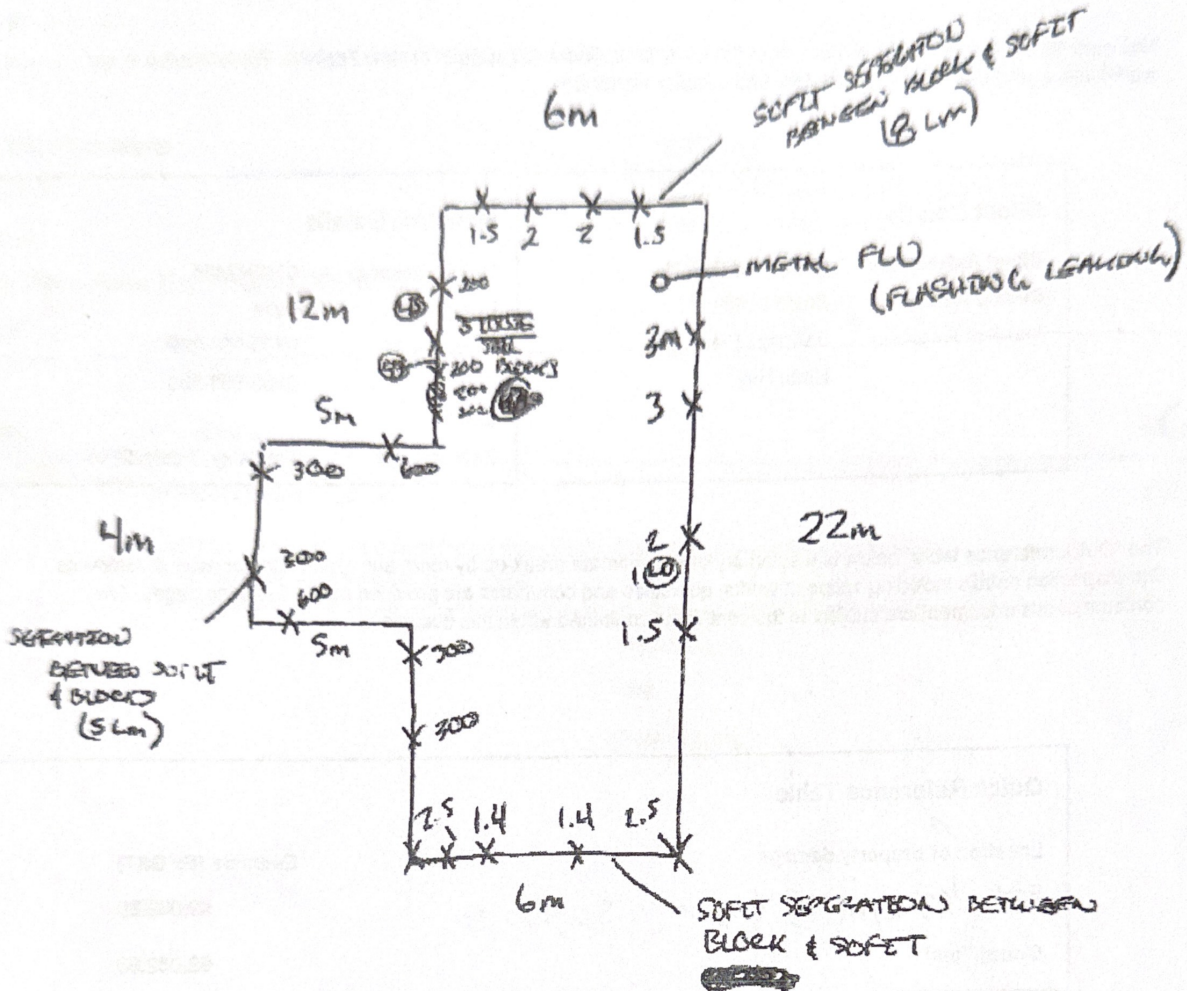
HOUSE FOOTPRINT

(L3) LOOSE BRICKS

X - MORTAR CRACKS
