Re: 18 Westbrook Place, Rotorua - Val. No. 06562/107.03.  
Legal Description: Lot 3 DPS 81300.

As Built Floor Plan – Amendments during construction.

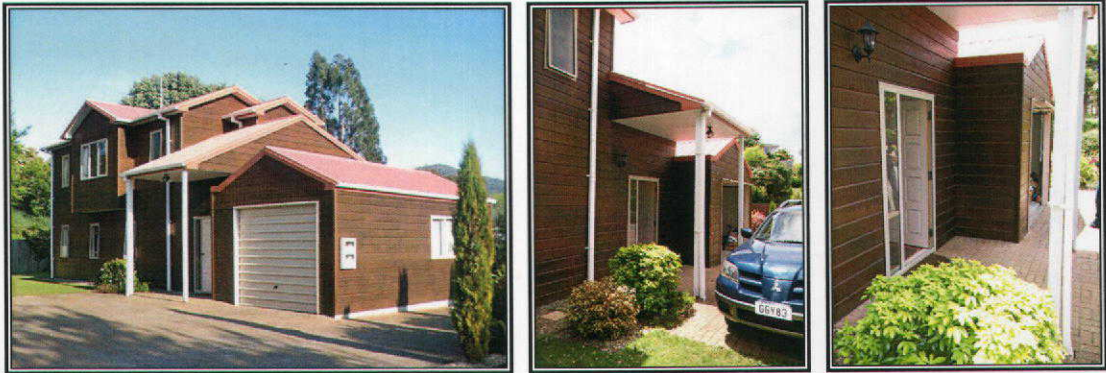
The original plans indicate the garage as a separate building, though was instead built attached to the house. The concrete floor has been in a single pour up against the house wall and is stable.

The original porch area beside the garage is enclosed to form an entry, which extends out approximately 1.8m from the wall. The roof line and roofing material matches the main dwelling in style, age and condition.

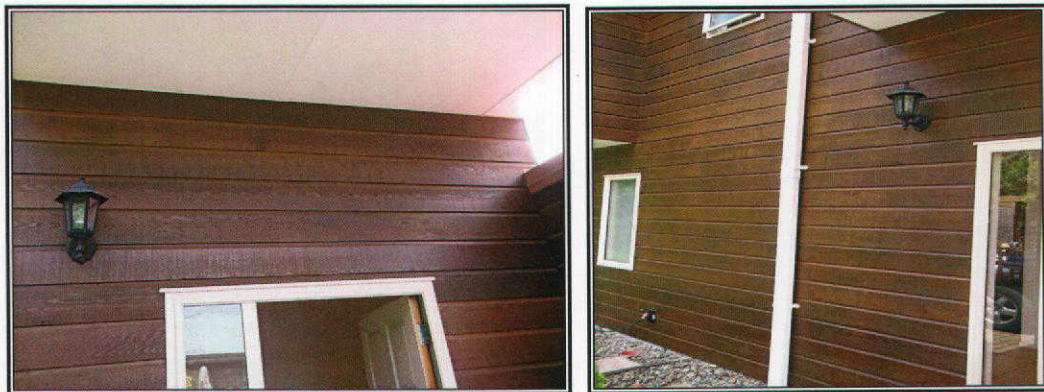
The weatherboards are an exact match with the remainder of the house, indicating they are from the same batch. The boards are staggered with full lengths across the front of the entry extending down across the bathroom and bedroom. The boards across the gable of the roof line over the stairwell and entry are also full lengths, again, as exact match to that of the adjoining garage and house. The entry door joinery installation is to the same joinery profile as the remainder of the house.

The floor tiles are also an exact match to those in the dining area where the conservatory window was installed, which was completed during construction. It is reasonable to conclude the linings and finishes were all completed at the same time.

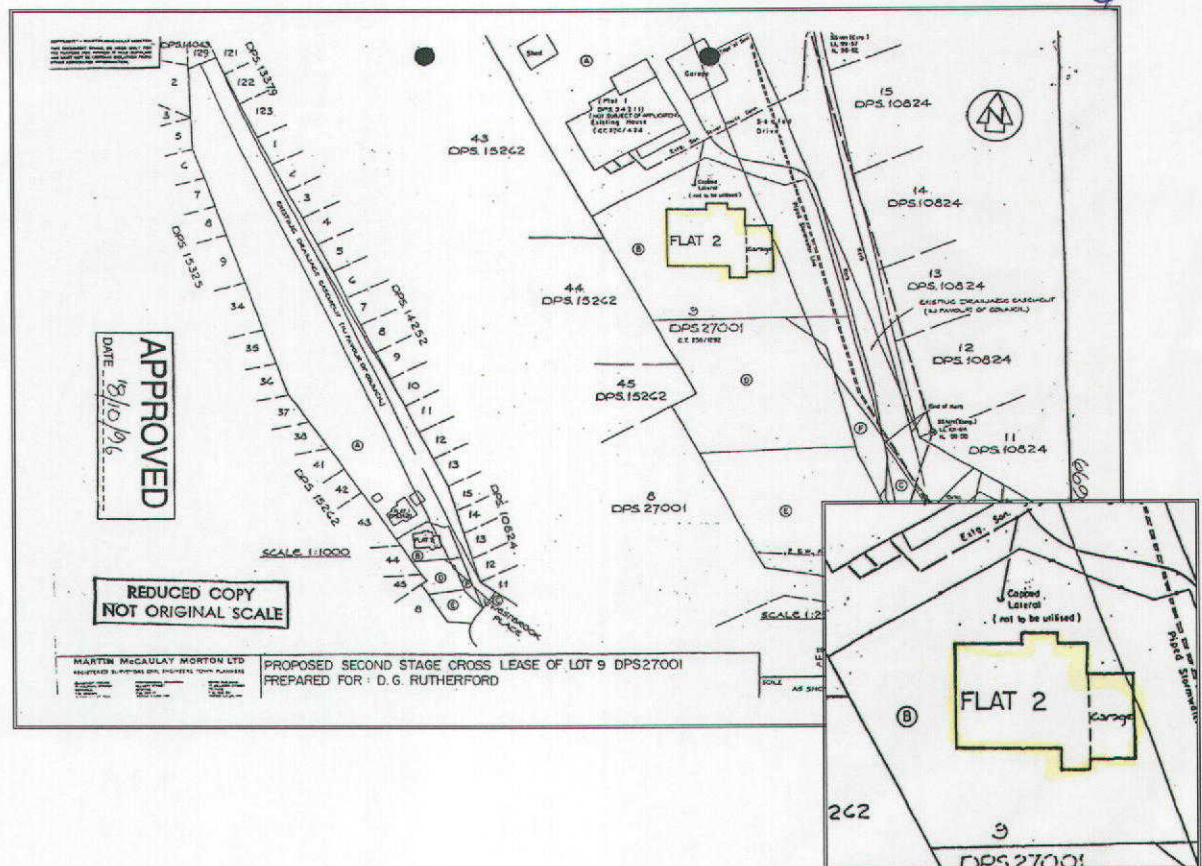
There was an application for cross-lease subdivision of the Subject property in 1996, at which time the building had progressed to pre-line stage with inspections having been carried out. The new cross-lease plan of the existing dwelling shows that in Sept 1996 when the plan was prepared and submitted, the footprint of the dwelling had the garage attached and the porch cover built. It is reasonable to conclude the garage and porch were existing at that time, prior to building work being completed and C.C.C being issued in 2001.

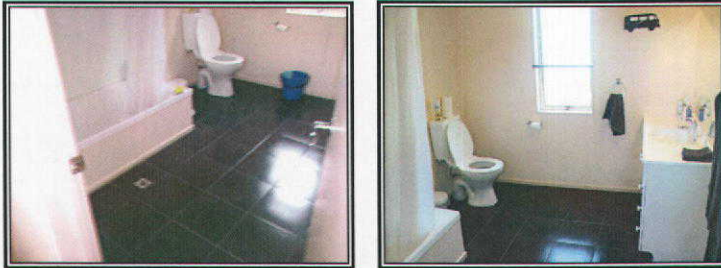
The upstairs bathroom toilet pan and vanity have been inverted. Fittings are modest and match those of the ground floor bathroom. There is no benefit from inverting the fittings had they already been installed as indicated on the plan, given the significant work and resultant repairs necessary had the WC been relocated subsequent to original installation. N.B: With excess space within the room for installation to either wall the change would simply have been a personal decision during construction.

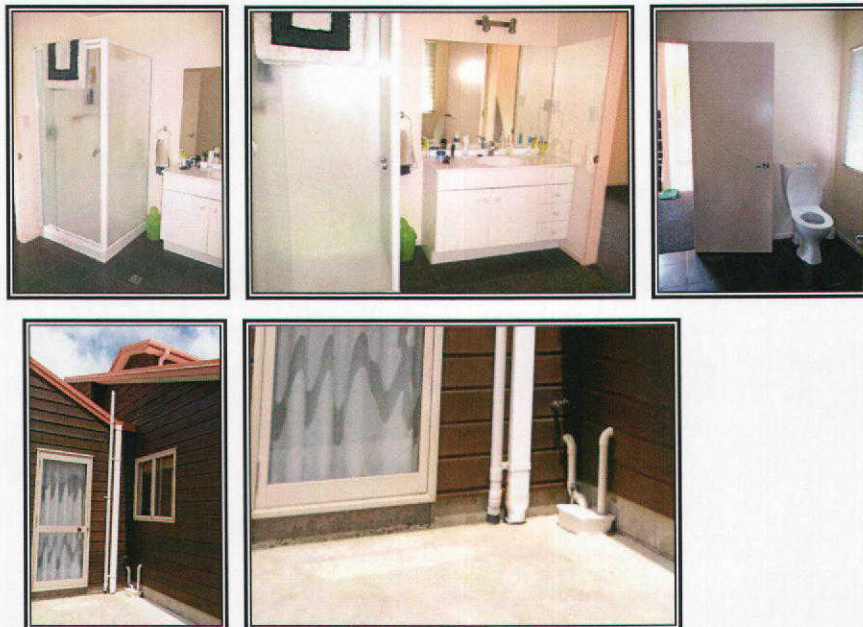
The alteration to the ground floor bathroom consists of the vanity being relocated beside the shower. The toilet pan, shower and floor wastes are installed as originally indicated. The laundry is relocated in the garage, a logical change following the decision to attach the garage to the house. Instead of being located in the centre of the house, the laundry is now beside the exterior P.A door which is more convenient to the washing line. Plumbing and drainage discharges into the gully trap which also serves the kitchen. The fittings to the ground floor bathroom match those of the upstairs, with floor wastes installed where originally intended.
