EARTHQUAKE RECOVERY (EQR) DOCUMENTATION

Released Under the Official Information Act 1982
EQR Property Overview Report

Assessment of Property at 258A-D BREEZES ROAD, ARANUI, CHRISTCHURCH 8061 on 15/11/2011

Address	A-D/258 BREEZES ROAD, ARANUI, CHRISTCHURCH, 8061	EQC Claim Number	CLM/2011/057426
Hazards	Nil	EQC Assessor (L,F)	Bennett, Paul
Inspection Date	15-Nov-2011	Placard	No Sticker
		EQC Estimator (L,F)	Graham, Jonathen

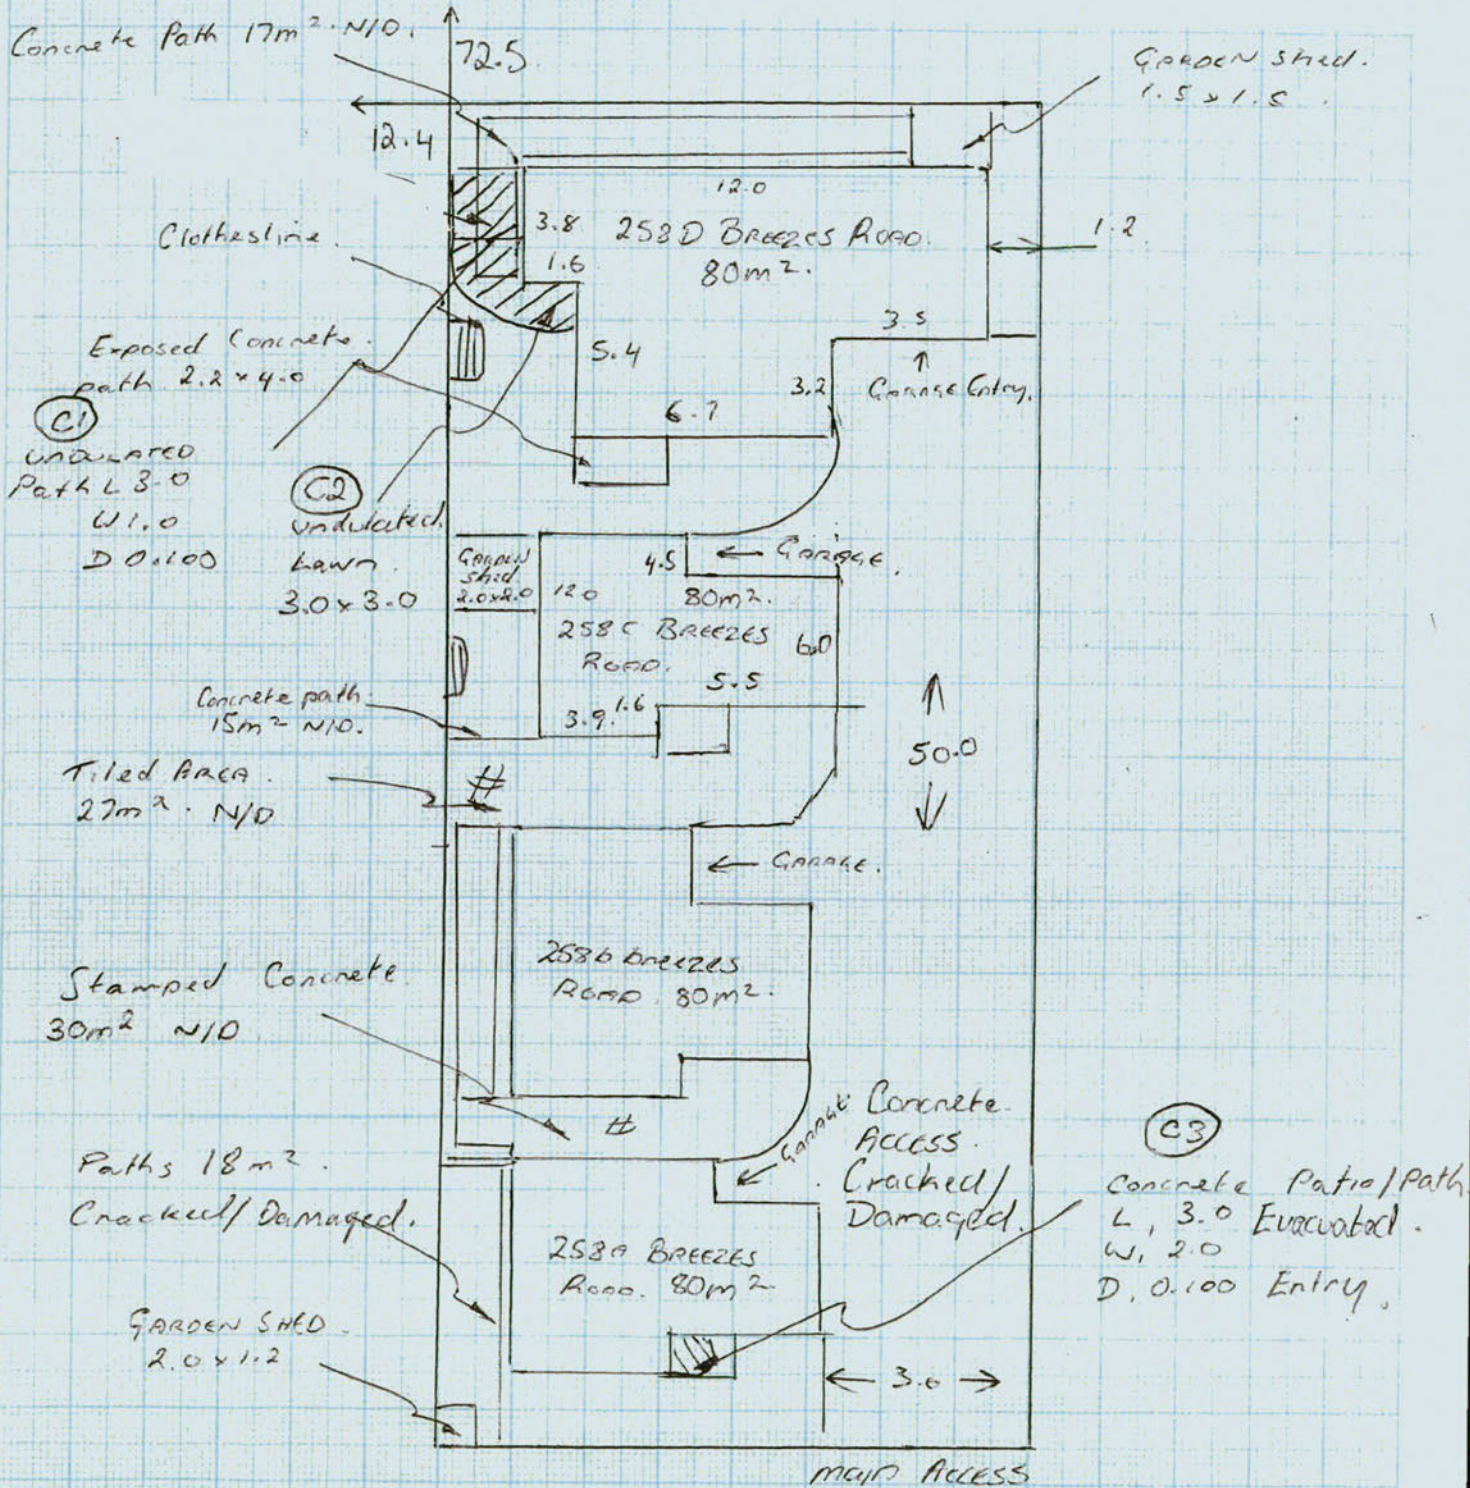
Item N°	Description/Construction	Length	Height/Width	Depth	Damage	Damaged Area	Evacuated m ²	Inundated m ²	Debris m ³	Access	
										E	D
C1	258 D UNDULATED. Below Path.	3.0	1.0	0.100	Undulated.	3.0.	3.0	-	-	E	
C2	258 D Undulated. Below LAWN.	3.0	3.0	0.100	Undulated.	9.0	9.0	-	-	E	
C3.	258A Evacuated. Below Concrete entry	3.0	2.0	0.100	EVALUATED	6.0	6.0	-	-	E

900m²
All LAND Within EQC Cover.

Repair Strategy: Removal and/or import materials and labour to repair land 18.0m²
