# EARTHQUAKE RECOVERY (EQR) DOCUMENTATION

# EQR Property Overview Report

| EQC Property ID | Property Address | Vulnerable? | Property F Status | Property Finalisation Indicator | | |
|---|---|---|---|---|---|---|
| 2010092719 | 133 SUMNERVALE DRIVE, SUMNER | | F3 - Complete & Finalised | Some Finalisation has taken place | | |

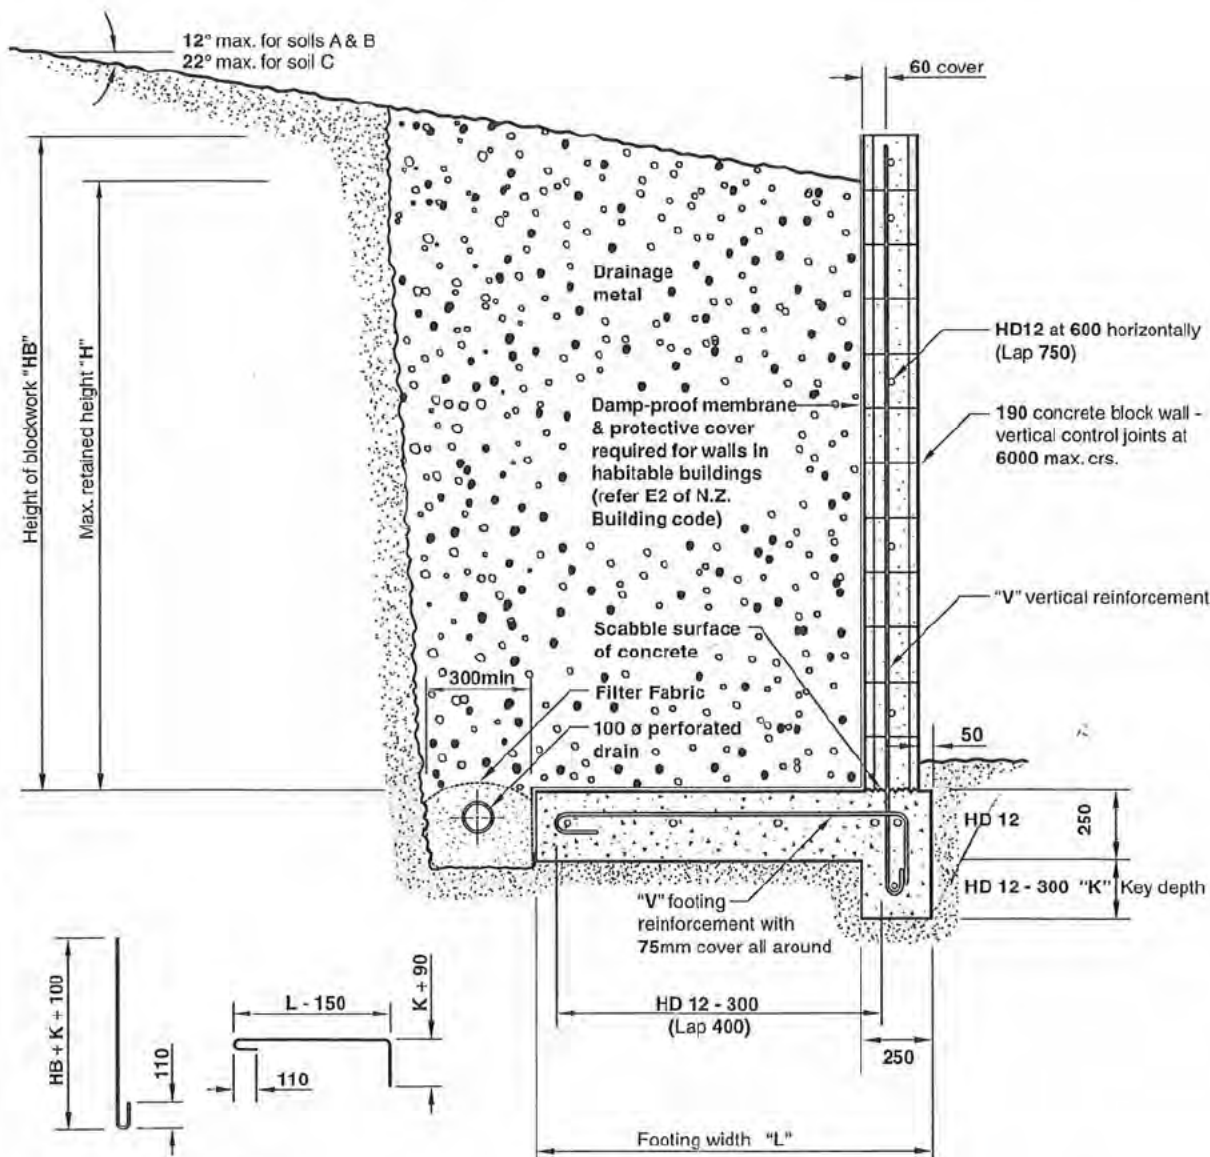
## TYPE II. 190mm RETAINING WALL – WITH BACKSLOPE

*Remedial solution for retaining wall RWC*

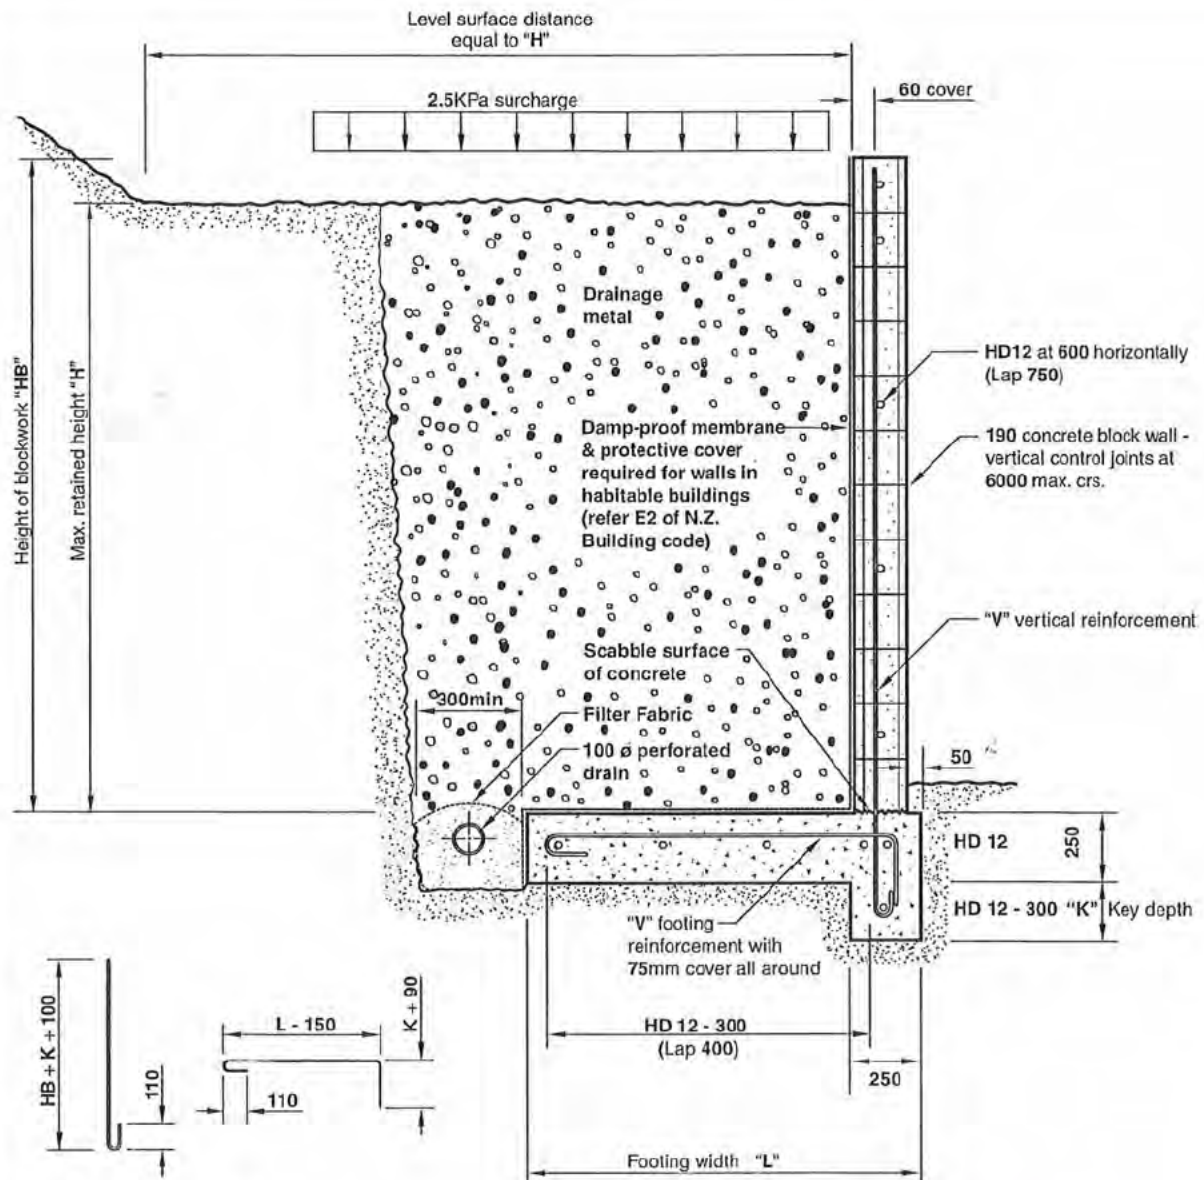
## TYPE II. 190mm RETAINING WALL – WITH SURCHARGE

*Remedial solution for RW2 and RW3/RW4 joint solution*
