**Information request - CLM/2011/252094 and CLM/2011/118363 – 30 and 30A Coronation Street, Rangiora 7400.**

## Assessment of Property at 30 CORONATION STREET, RANGIORA 7400 on 24/09/2011

# EQC Full Assessment Report

**Claim Number:** CLM/2011/118363  
**Claimant:** [REDACTED]  
**Property Address:** 30 CORONATION STREET  
 RANGIORA 7400

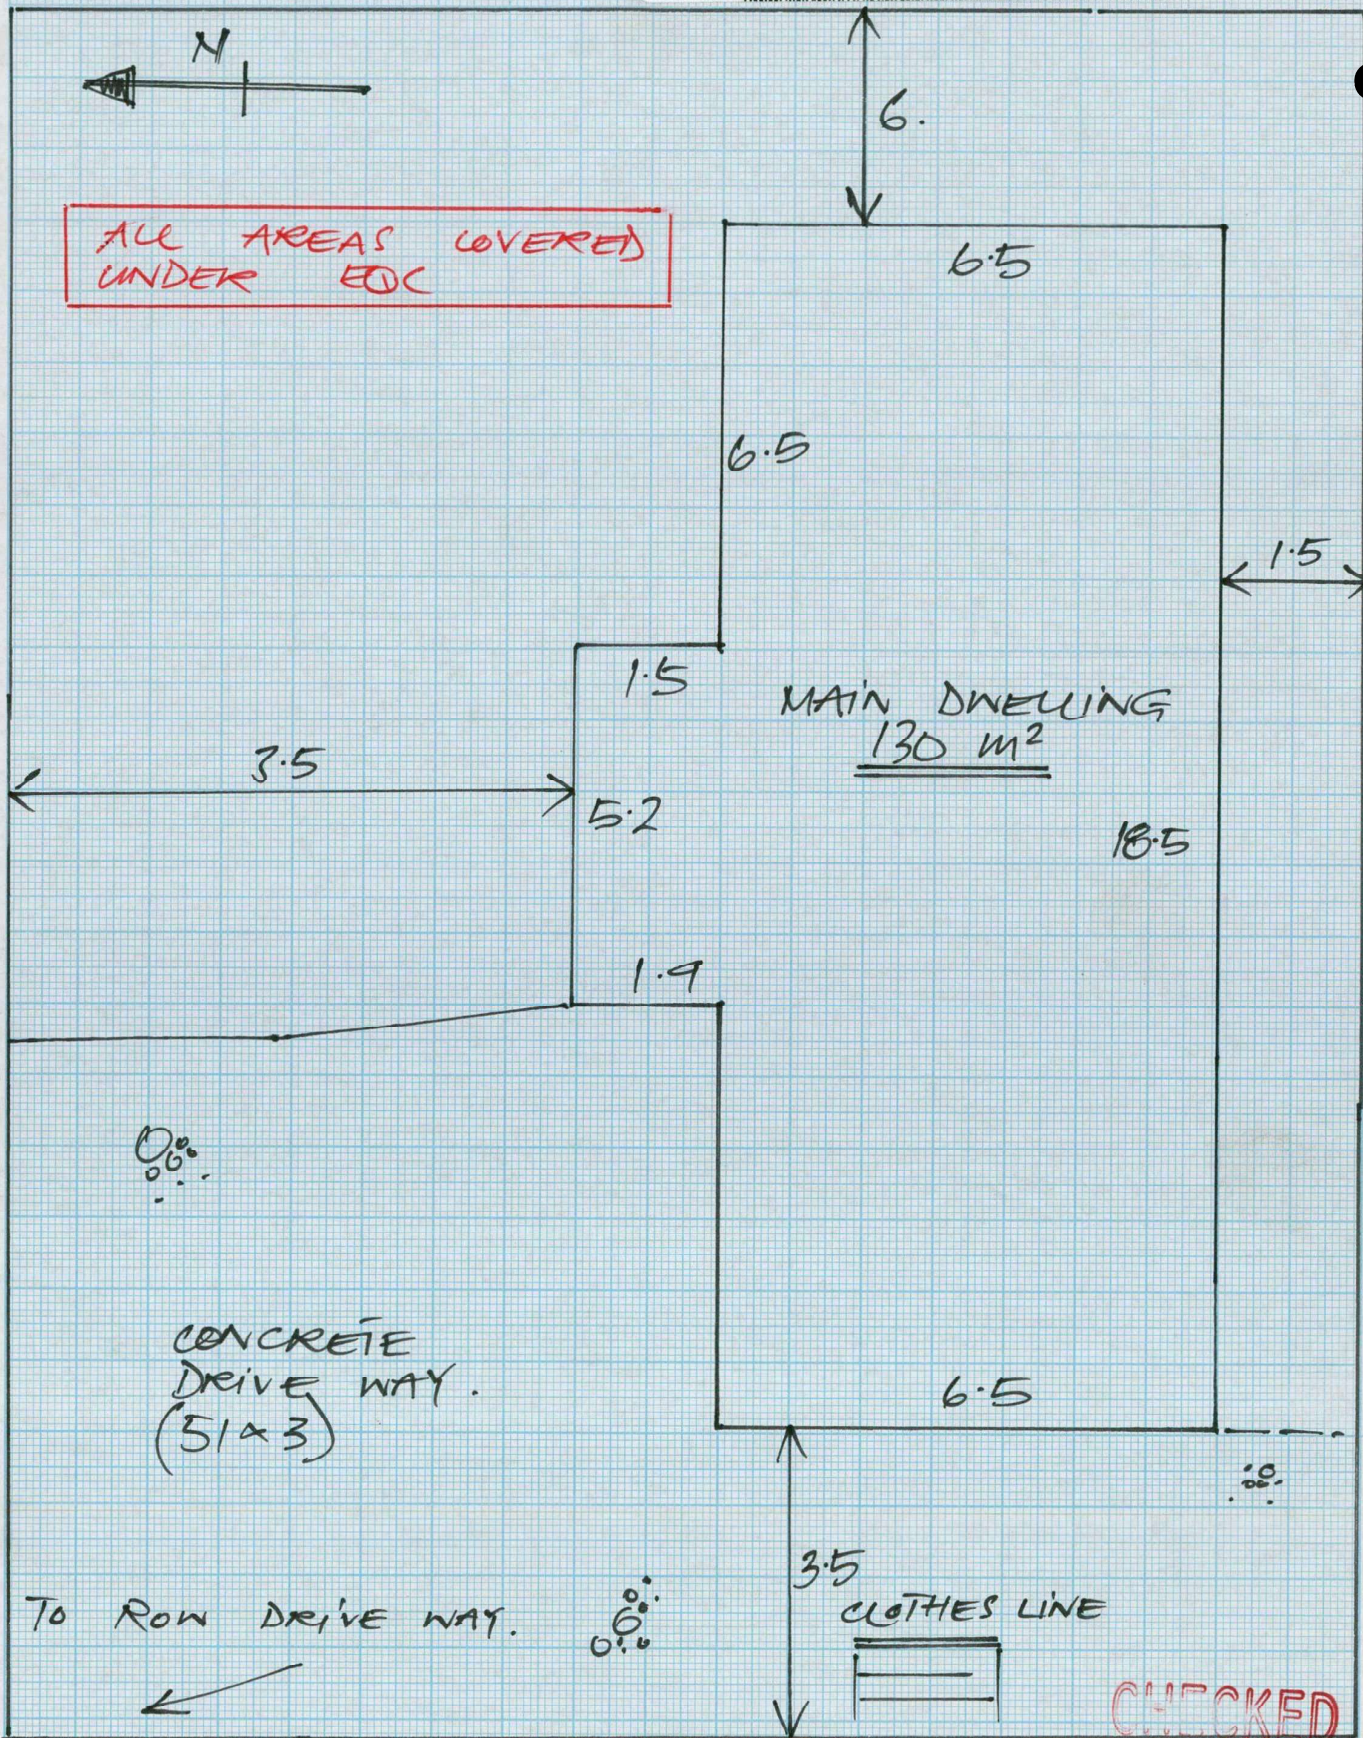
ALL AREAS COVERED UNDER EDC
