CASH SETTLED CLAIM(S)

Date: 17 Sept 2010Author: BRYAN STAPLESClaim No.: 2010 1062485Claimant: KAIAPOI WORKING men's ClubSituation of Loss: 101 Raven Quay
KAIAPOILA: BRYAN STAPLESEstimator: DOUG TREDUNICK

Increased Flooding Vulnerability (IFV) Engineering Assessment

Property address	101 RAVEN QUAY, KAIAPOI 7630
Property ID (QPID)	1143960
Master claim number	CLM/2010/055441
Date	11 May 2017
Claim issue number	1

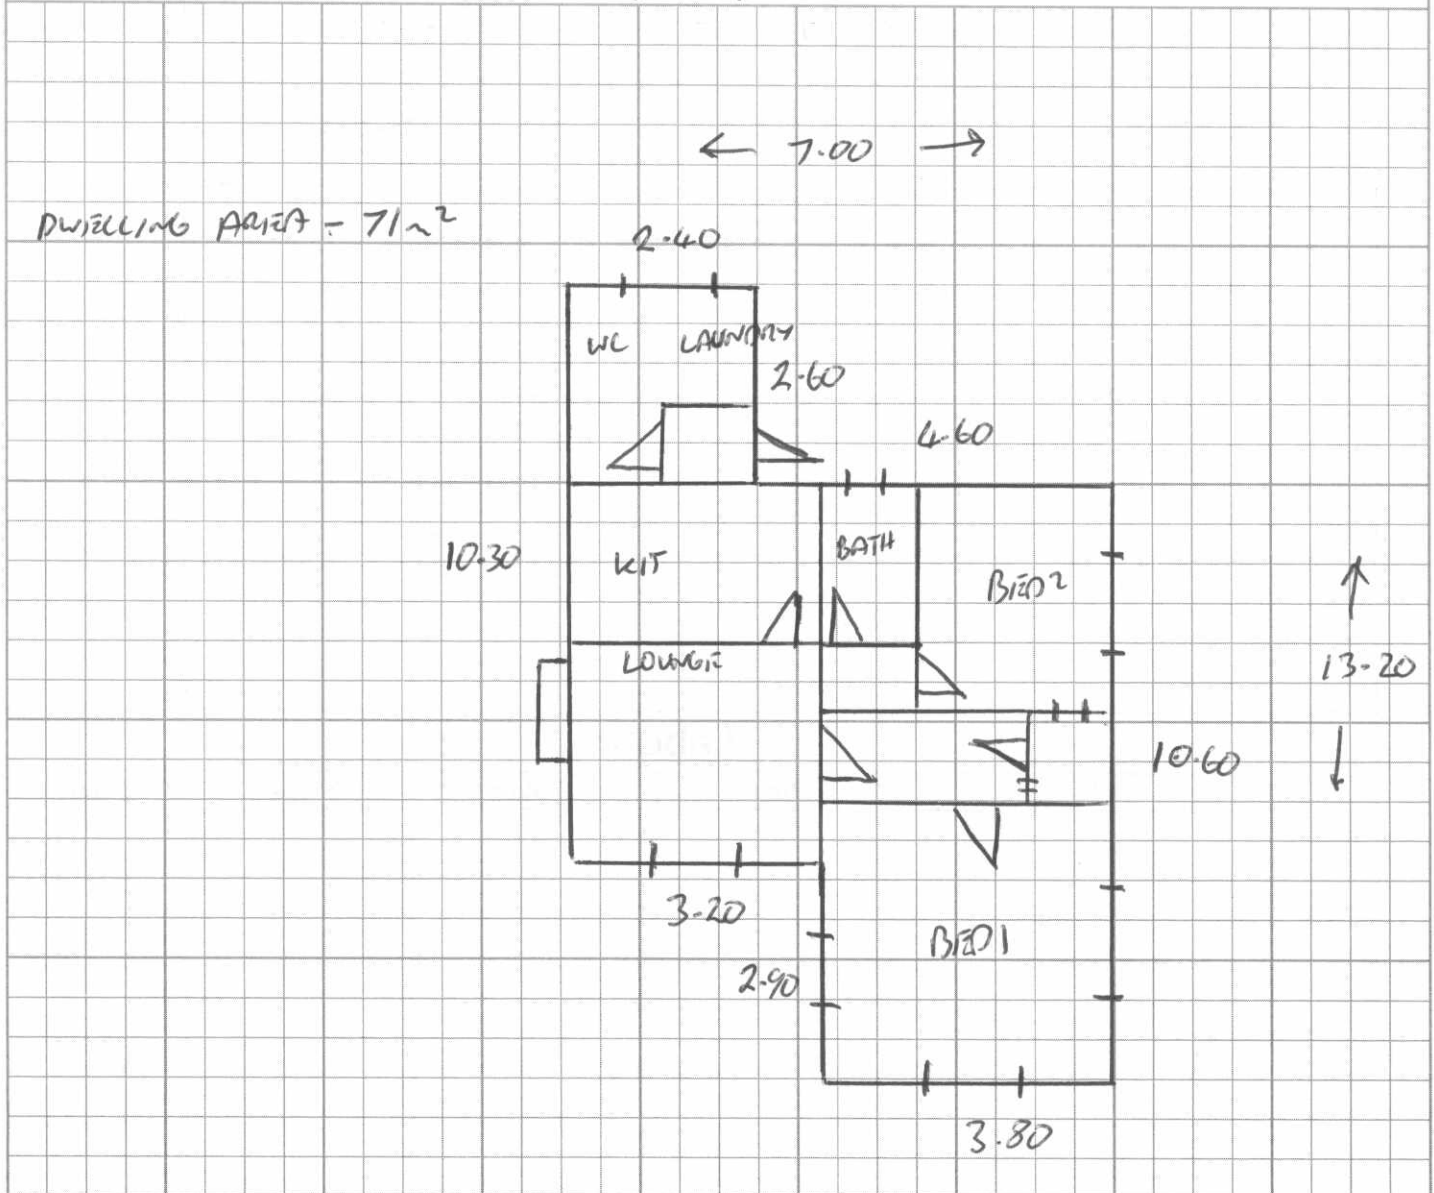
Sketch Plan of Property

NO VISABLE INTERNAL DAMAGE VISABLE.
 INTERNAL LINING HARDBOARD & SOFTBOARD.

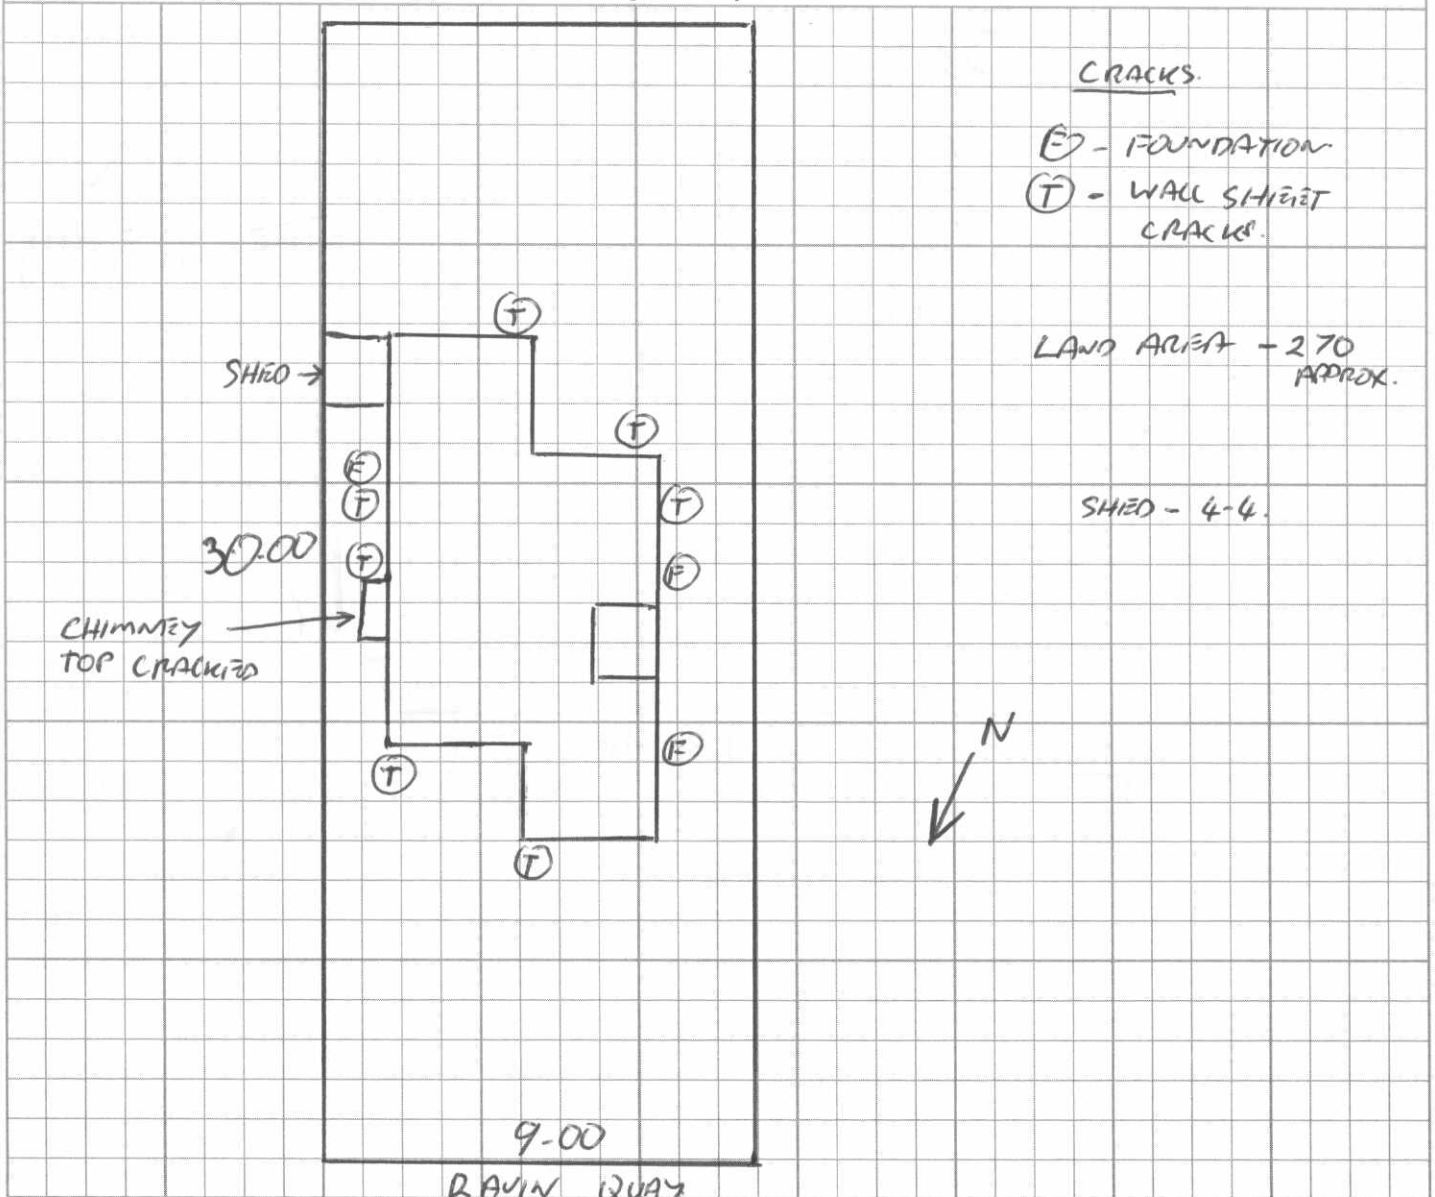
Sketch Plan of Property

NO VISABLE LAND DAMAGE.

FLAT ROOF

HARDIES SLAT EXTERIOR.

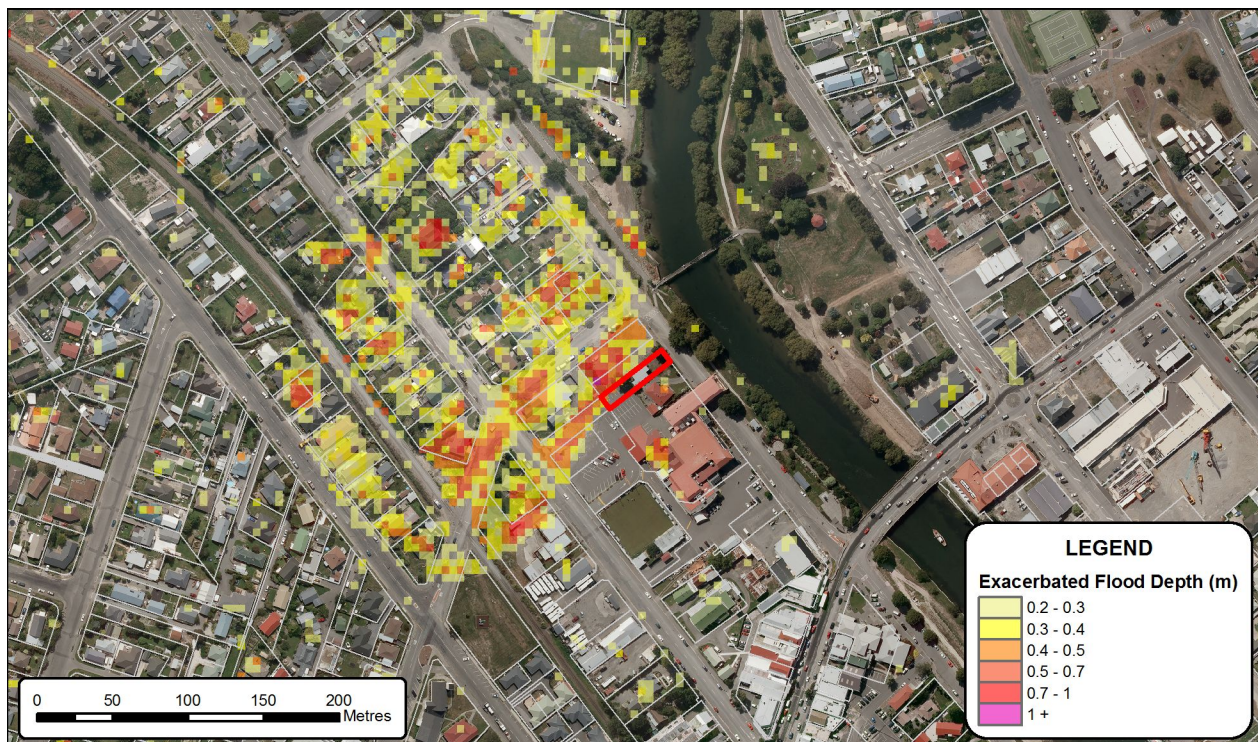
Map 1: Exacerbated flood depth 1 in 100 year flood event

Map 1 shows exacerbated flood depth caused by the Canterbury earthquake sequence. The exacerbated flood depth is used as a measure of IFV. The exacerbated flood depth is defined as the increase in flood depth due to onsite land subsidence.

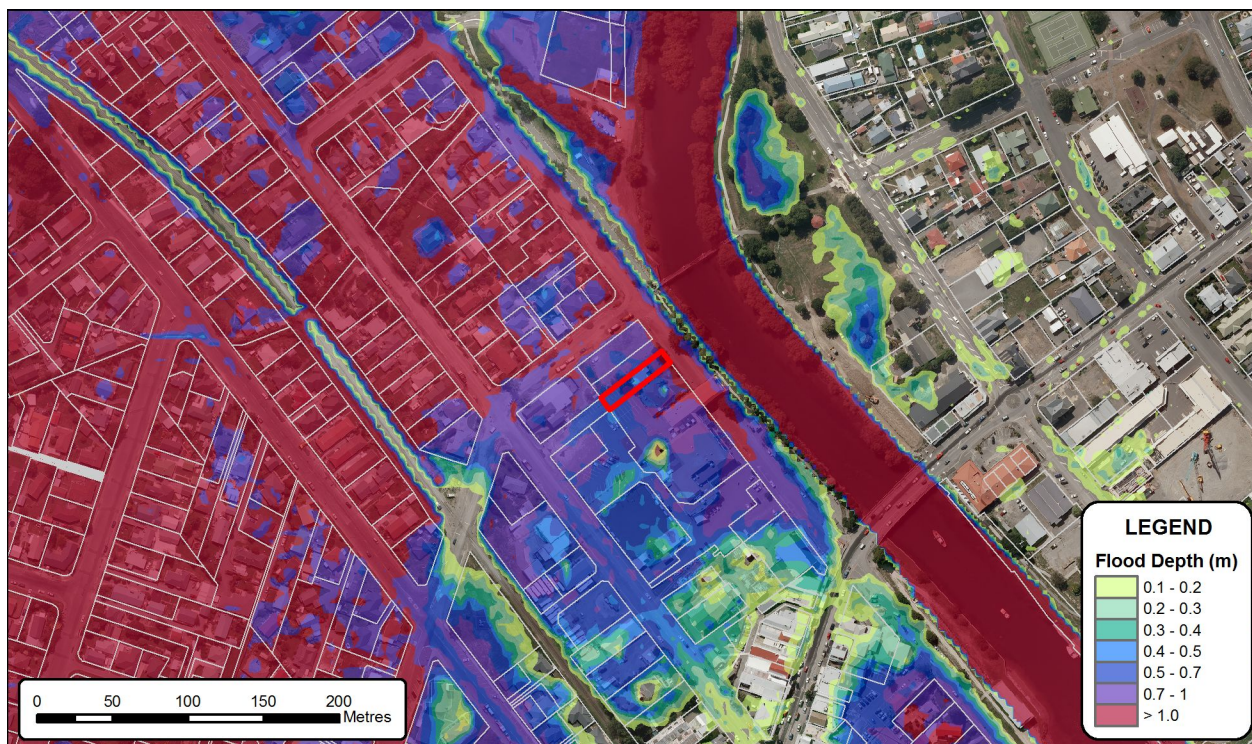
Map 2: Modelled flood depths for a 1 in 100 year flood event before Canterbury earthquake sequence

Map 2 shows flooding for the 1 in 100 year flood event before the Canterbury earthquake sequence.

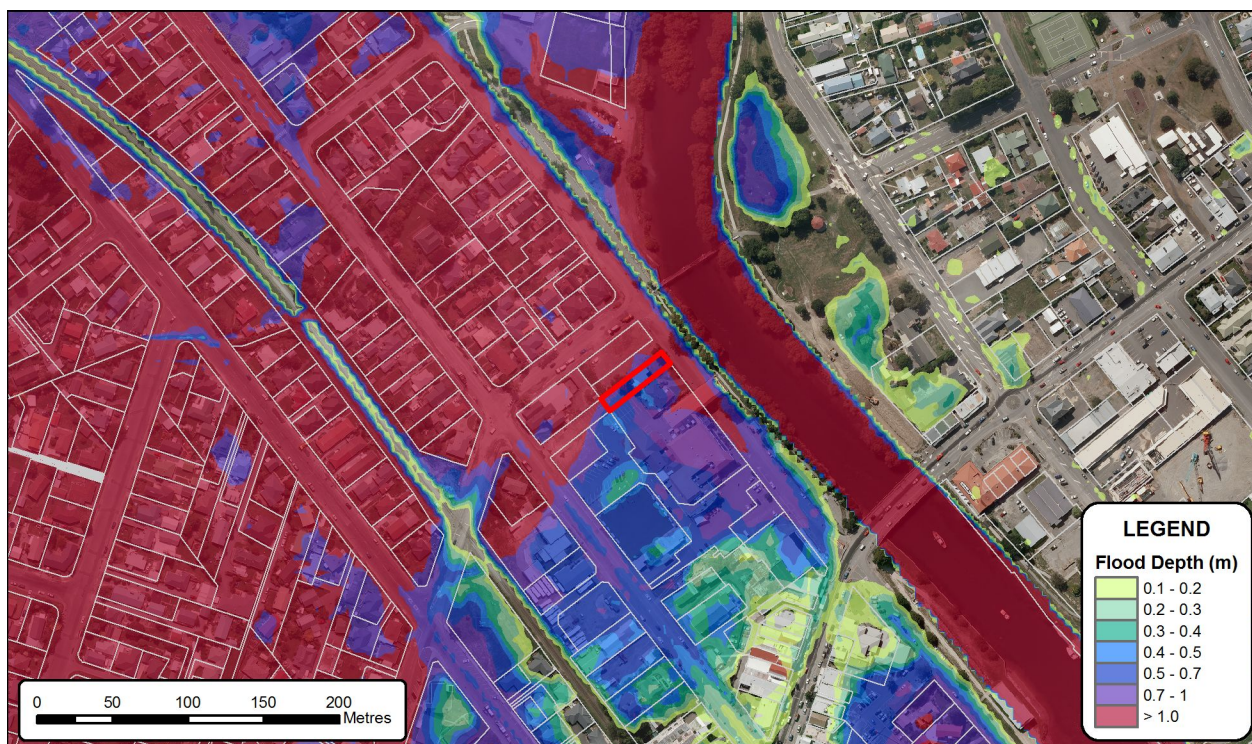
Map 3: Modelled flood depths for a 1 in 100 year flood event after the Canterbury earthquake sequence

Map 3 shows flooding for the 1 in 100 year flood event after the Canterbury earthquake sequence.

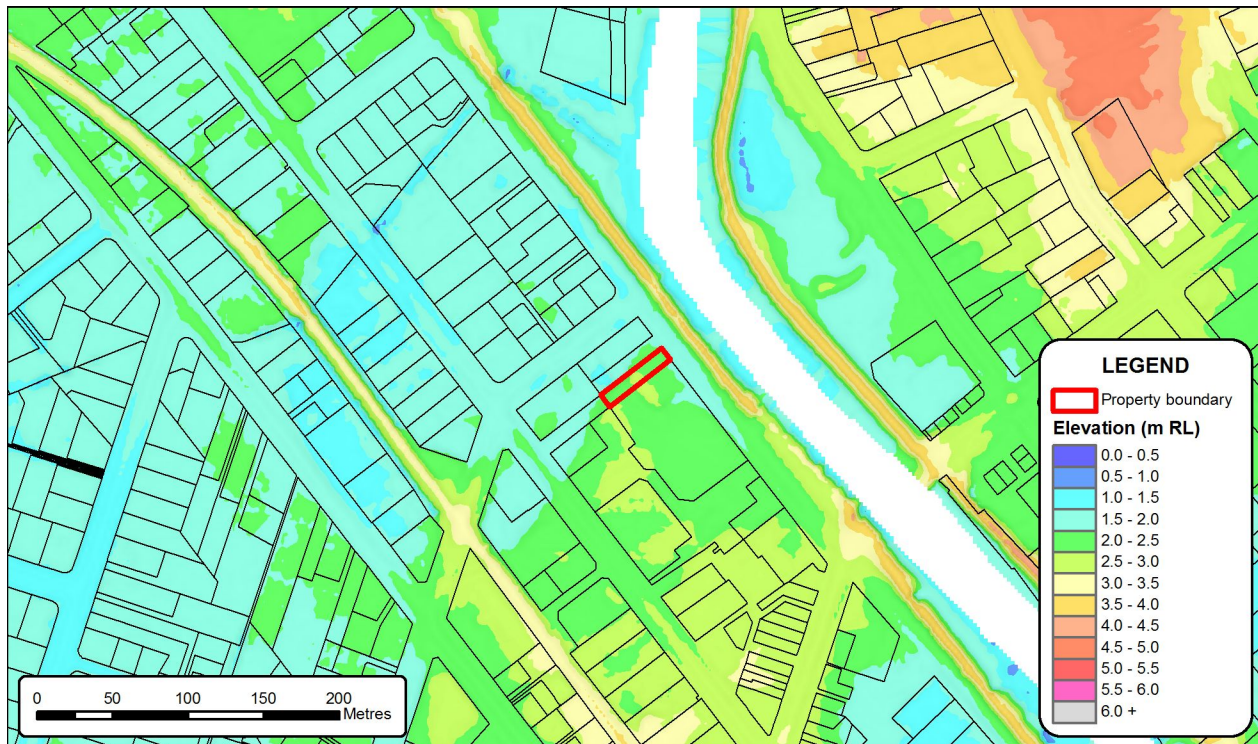
Map 4: Ground surface elevation post December 2011

Map 4 shows the ground elevation (i.e. the height of the land) following the Canterbury earthquake sequence. The ground surface elevation was measured using an aerial LiDAR survey (which involved scanning the ground surface
