**From:** Authority@goredc.govt.nz  
**Sent:** Friday, 18 March 2016 3:06 p.m.  
**To:** Ian Lowe  
**Subject:** Updated CRM - 3 Waters - Locate Asset-2016/6906

## Customer Request (CRM) Summary

**Request Number:** 6906\2016  
**Logged by:** Gillian Bedwell  
**Category:** 3 Waters - Locate Asset  
**Description:** Bruce Heslip has been unable to isolate the water supply to the Gore Bowling Club rooms on the corner of Ardwick and Irk Street. He turned the toby tap off but the water was still on in the building. They wish to repair a leaking inside tap in the near future. Could you please take a look at toby tap and also contact Ivan Bagrie (208 8434) Green Keeper or Bruce Heslip (208 4252) so they can be on site to ensure water is turned off to the building.

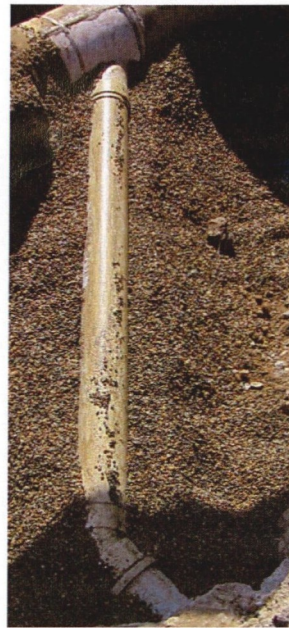
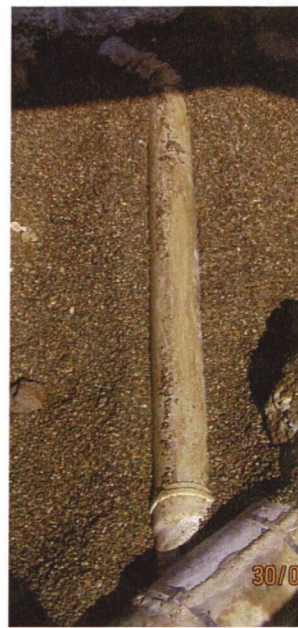
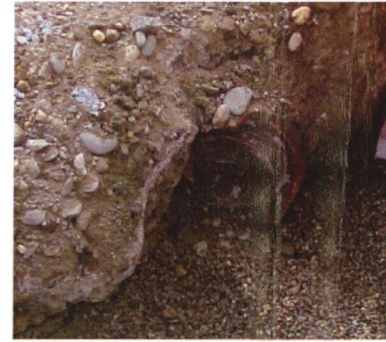
Lateral Capped

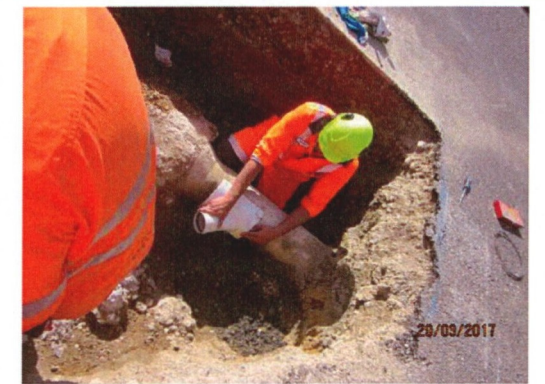
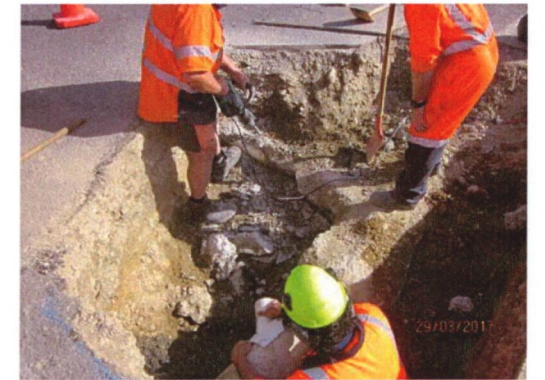
225mm Concrete Saddle installation

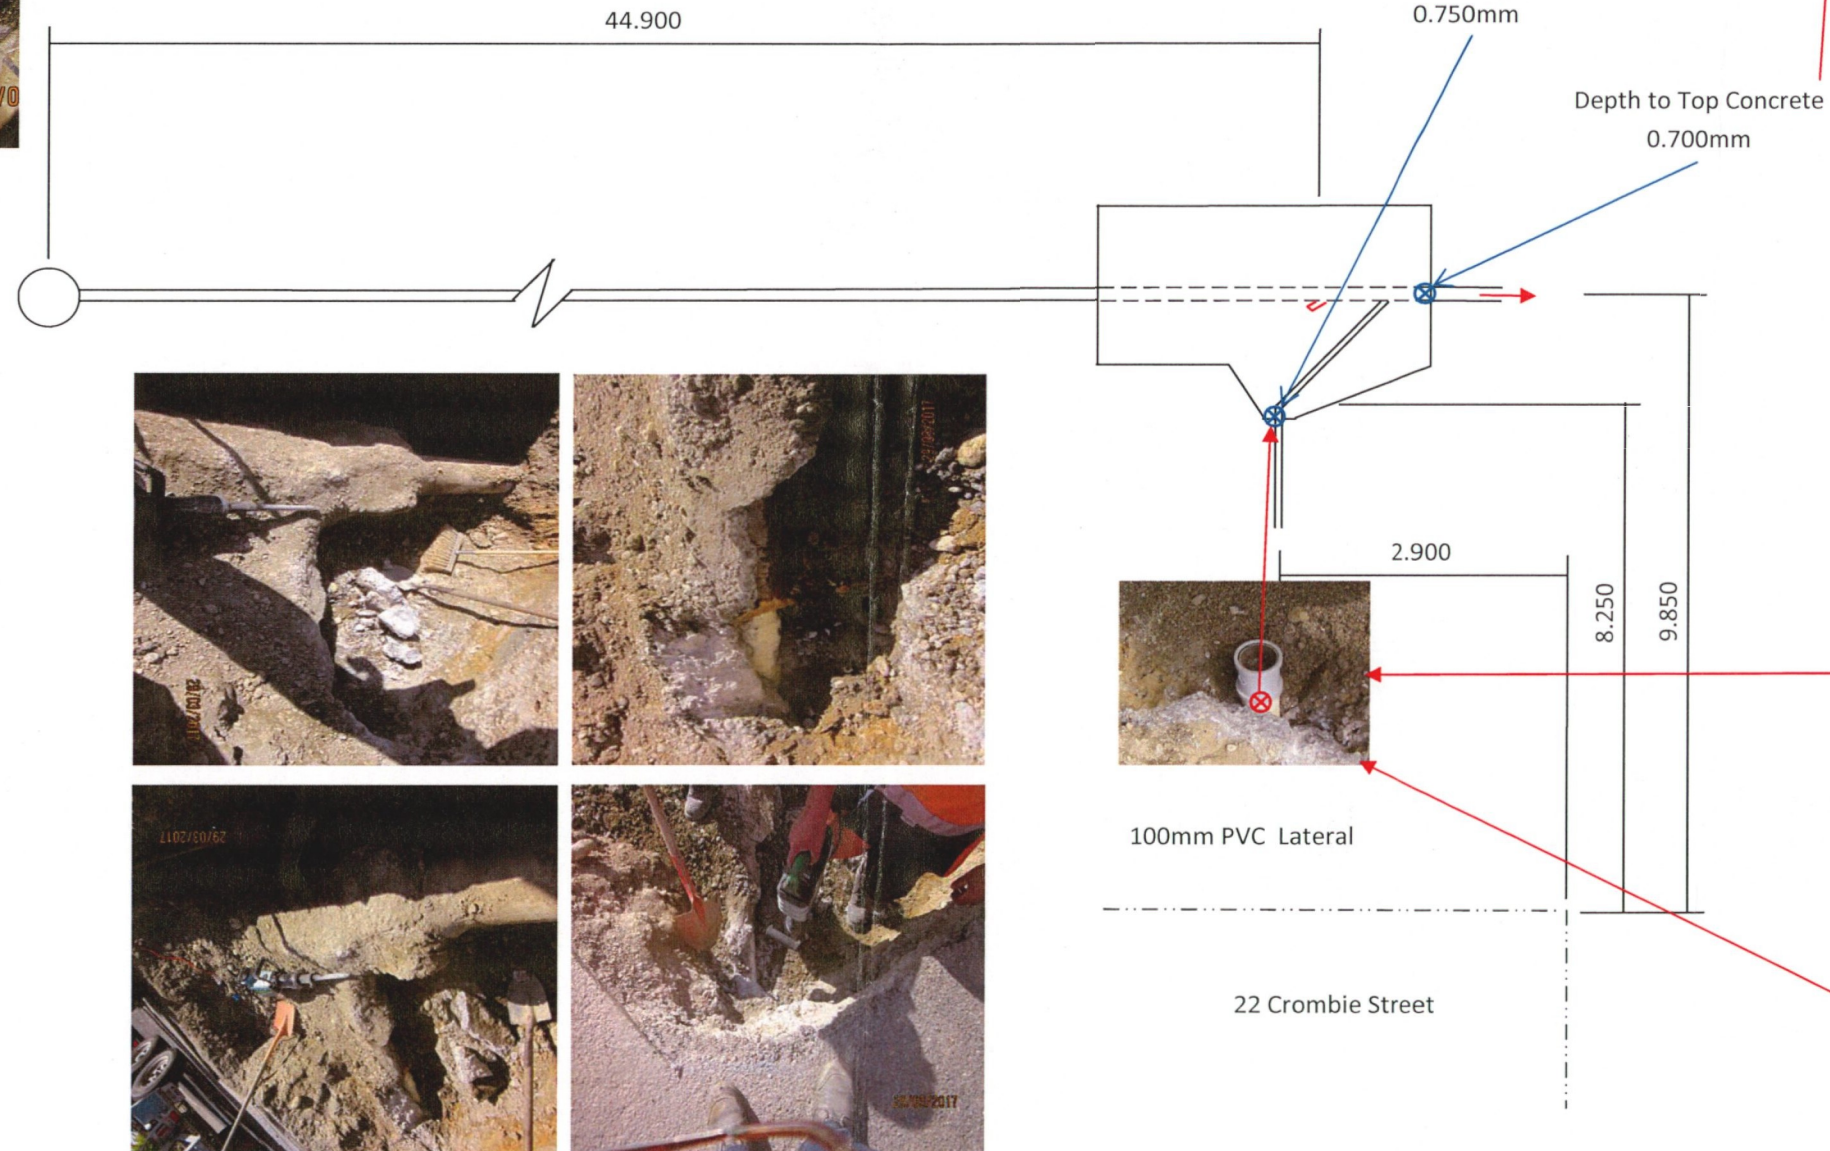
100mm PVC Lateral connection  
to 225mm Concrete Main

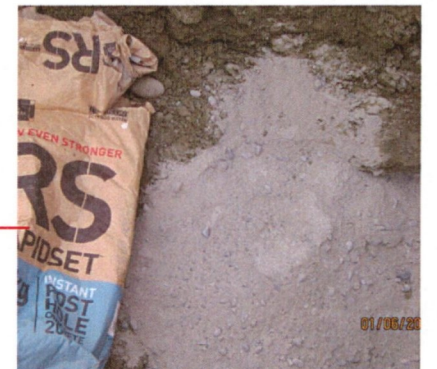
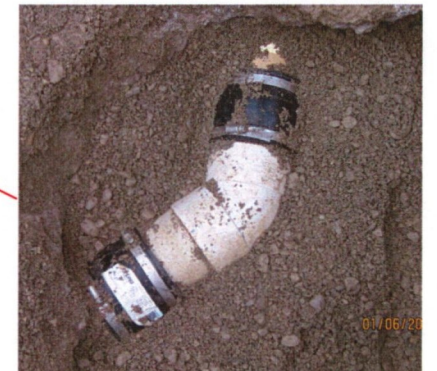
100mm PVC Lateral

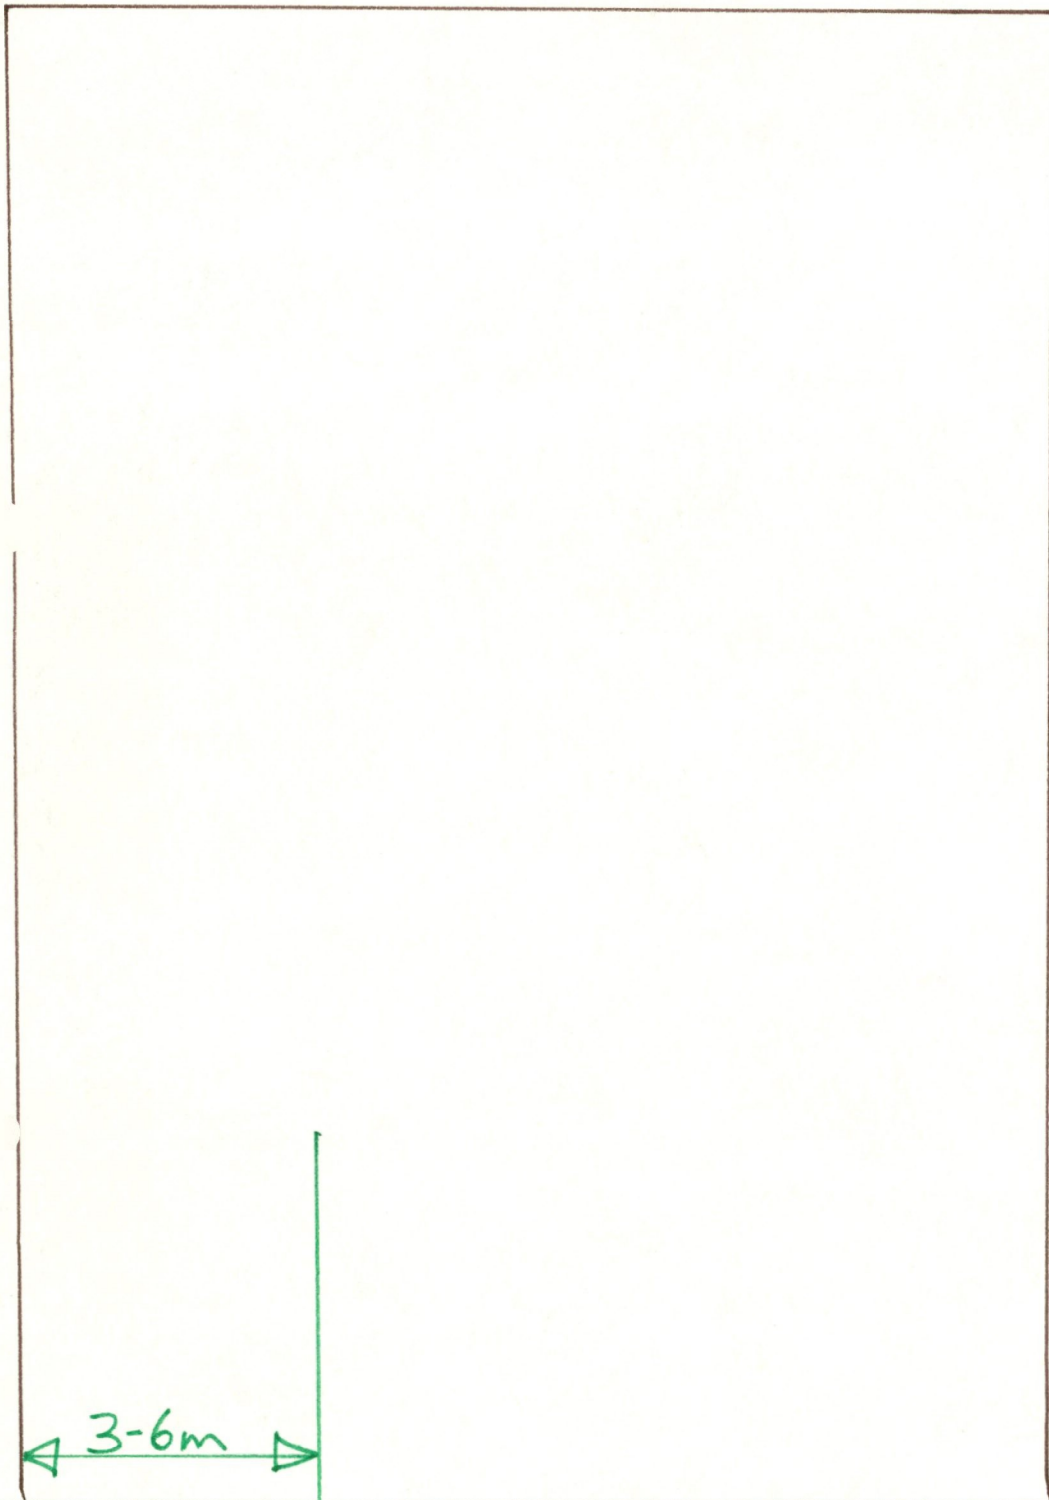
22 Crombie Street

Front Boundary

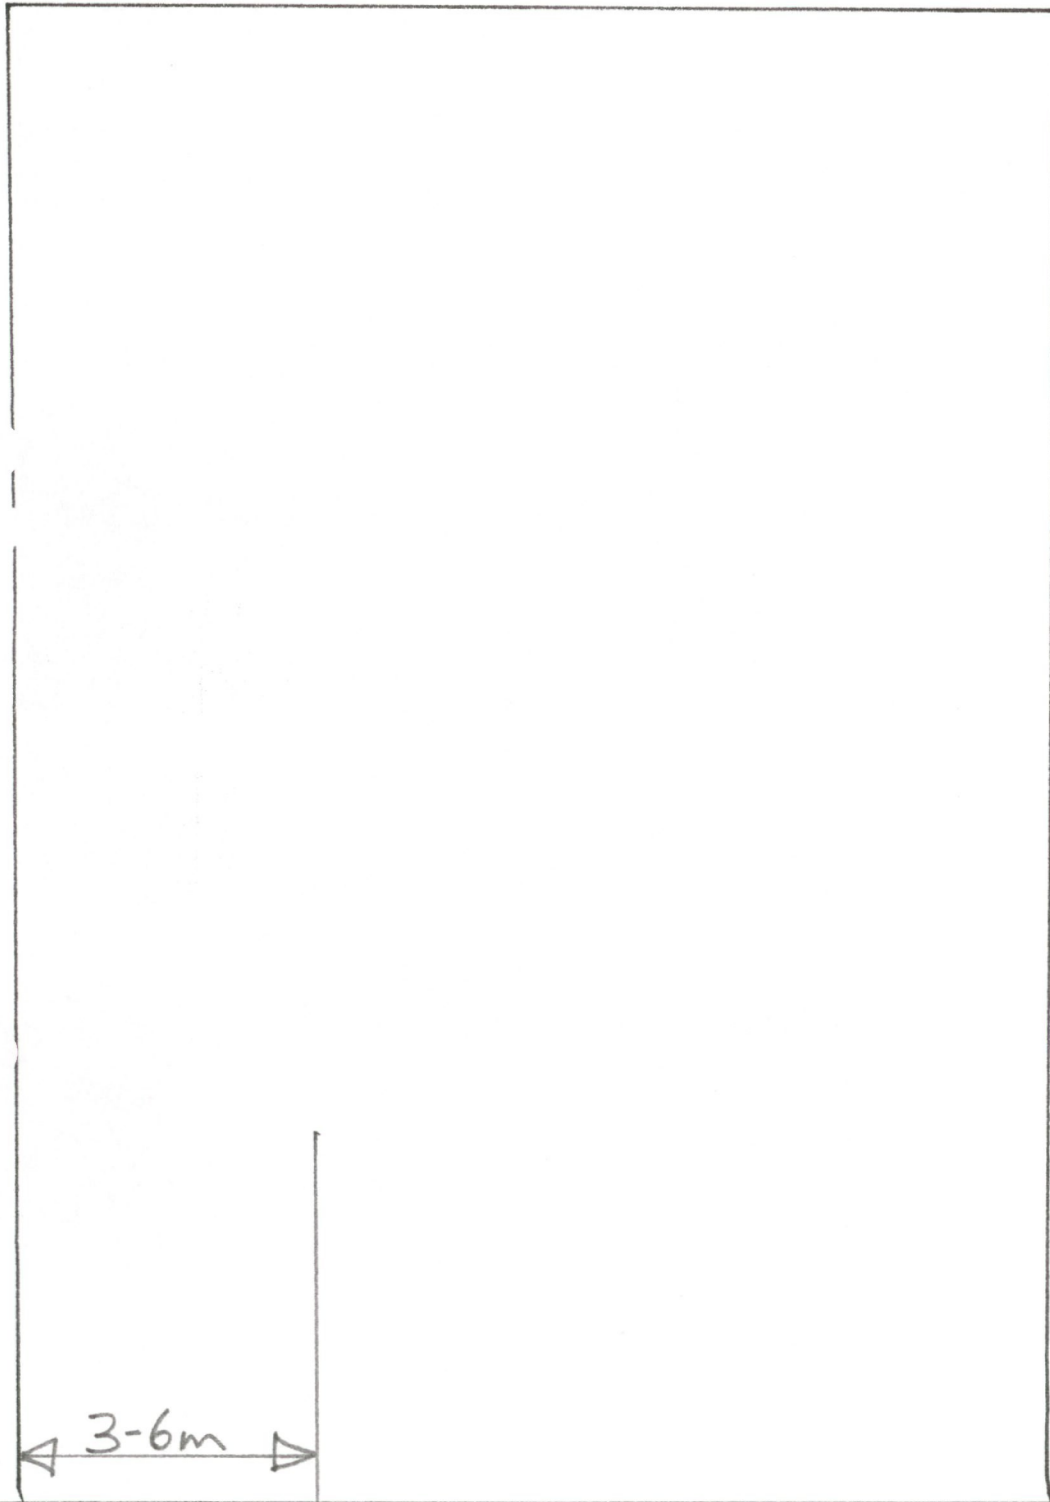
22 Crombie Street

Water Supply
