Unauthorised building work report for  
**Certificate of Acceptance application.**

Address 113 King Edward Street  
94/141 Pt Sec 3 Sec 177 Motueka DIST  
1956041600

Inspector Keith Langham, ASAP Building Inspections Ltd.

Date of inspection: 13 October 2021

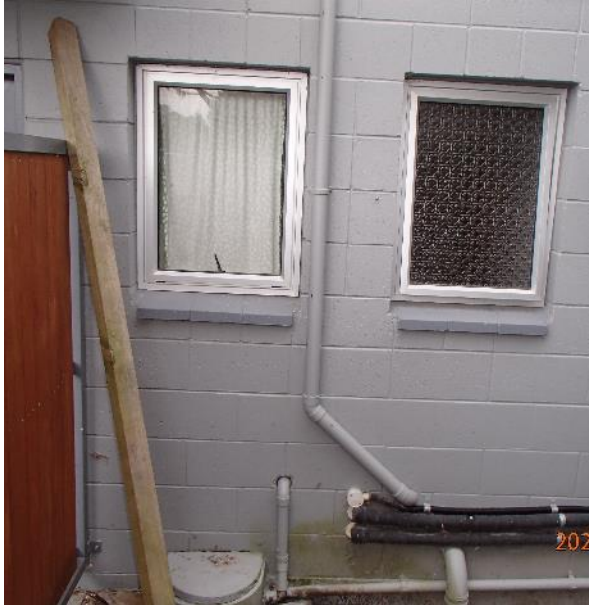
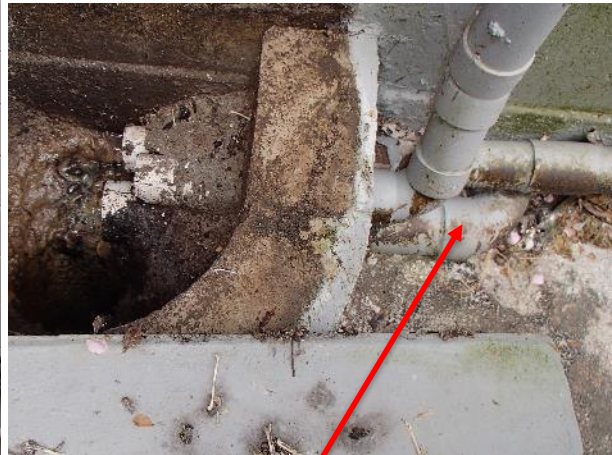
Waste from the laundry tub goes to gully on the outside wall.

This gully now receives the waste from the shower and basin.

*Basin waste through the wall, shower direct to gully. shower waste into side of gully*

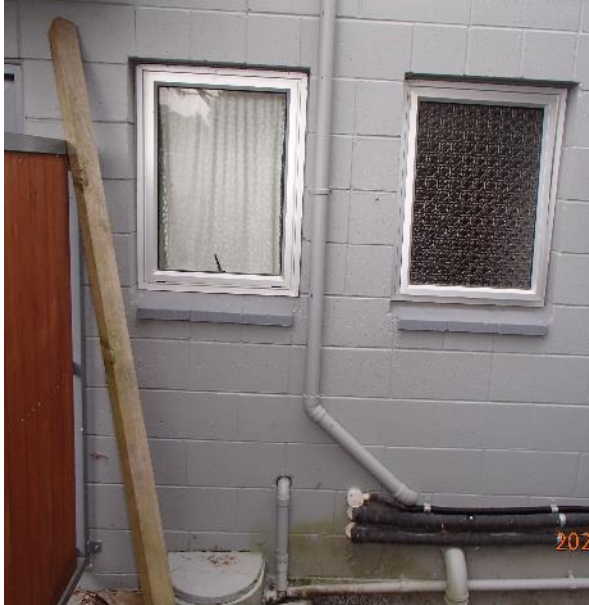
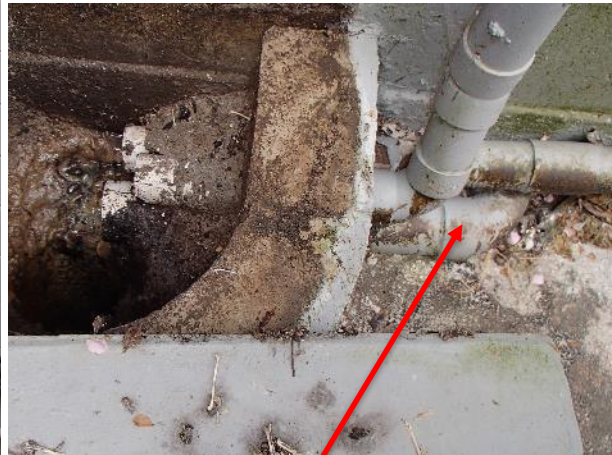
Waste from the laundry tub goes to gully on the outside wall.

This gully now receives the waste from the shower and basin.

*Basin waste through the wall, shower direct to gully. shower waste into side of gully*
