# Lot 15, 220 Withy Road, Awakaponga

## Geotechnical report

Project 50721 - Rev.0 - 28/03/2023

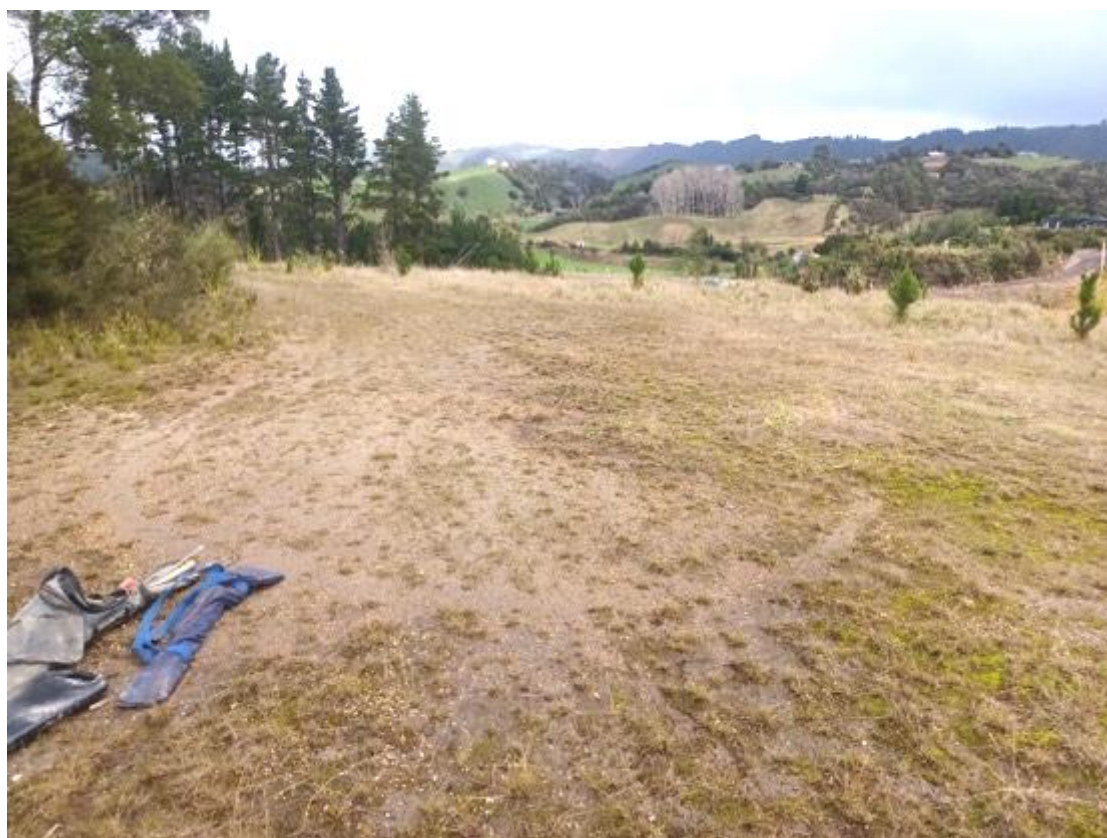
**Figure 4: View on the proposed building platform looking southwest**

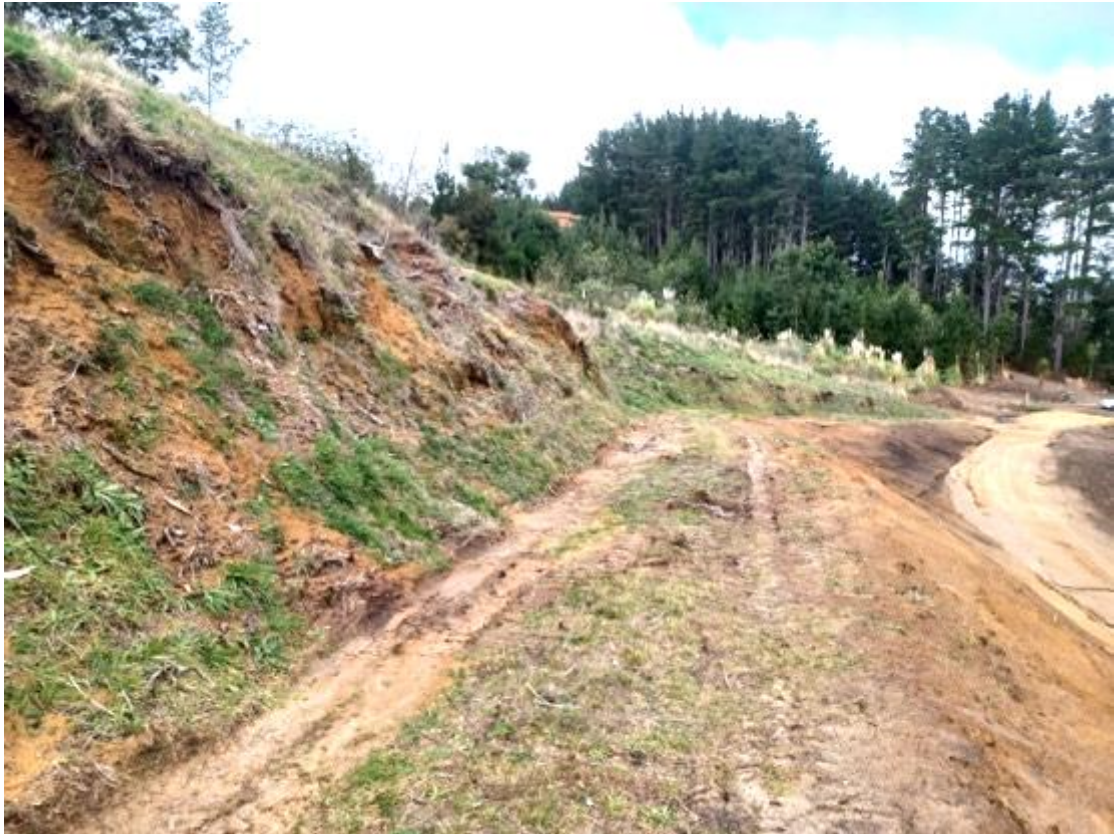
The western slope is approximately 15-20m high, with the angle varying between 25-30°. The slope leads down to Lot 20 to the west. Approximately 5m west of the building platform is a cut at approximately 60-70° for the driveway leading up to the site. On the cut surface, shallow slips were noted and the pumiceous subsoil was exposed.

**Figure 5: View of the shallow slip on the western slope**

A visual site assessment of the slopes adjacent to the proposed building platform was undertaken during the site walkover. It is understood that the eastern slope exhibited signs of failure during MCE's investigation in 2004. During EDC's site visit, we noted shallow failure on the cut surface of the western slope.

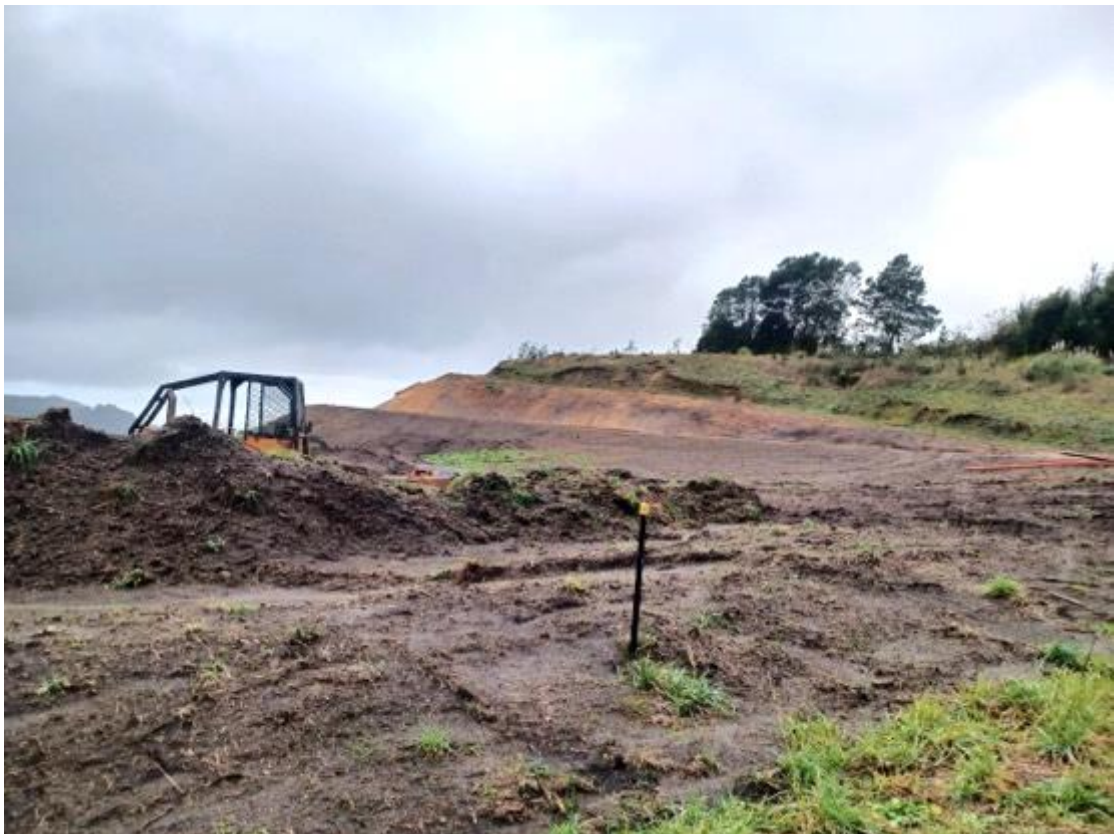
**Figure 6: View on the proposed building platform and eastern slope**

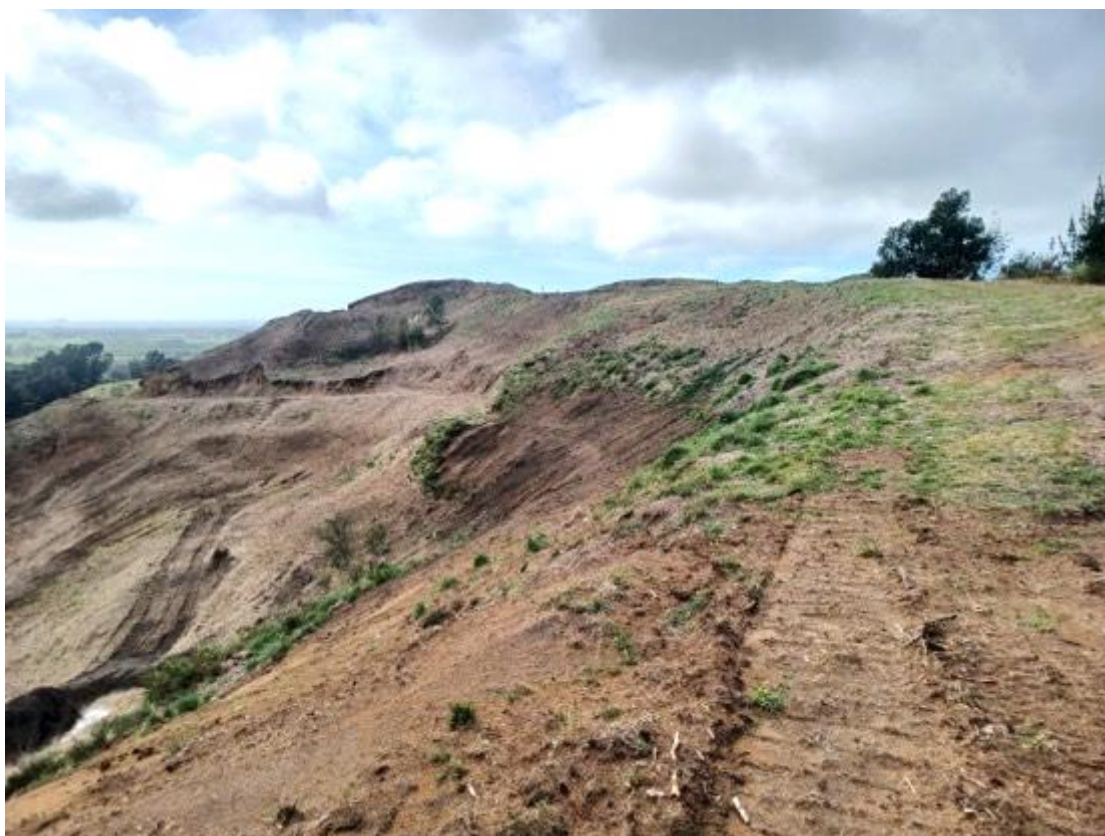
The northern slope is approximately 50m high, with a slope of approximately 35°. At the time of EDC's visit, we noted an access track leading to Lot 14 to the north that was cut off in the middle. This was likely part of the earthworks for the subdivision.

**Figure 7: View on the northern slope**

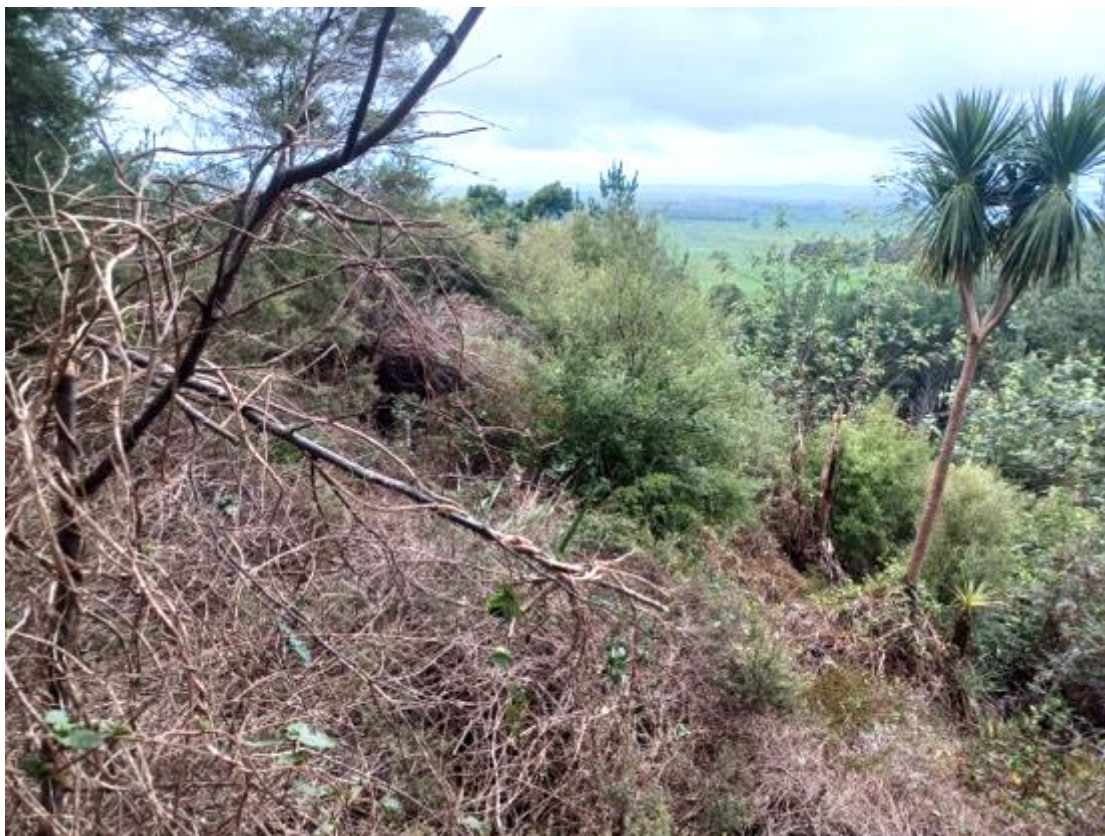
Based on the report produced by MCE in 2004, we understand that the eastern slope had failed previously. During EDC's visit, the eastern slope was overgrown with vegetation and thus was not possible to assess the slope conditions. Based on the BOPRC contours, the slope is approximately 36m high at 30°.

**Figure 8: View of the eastern slope**

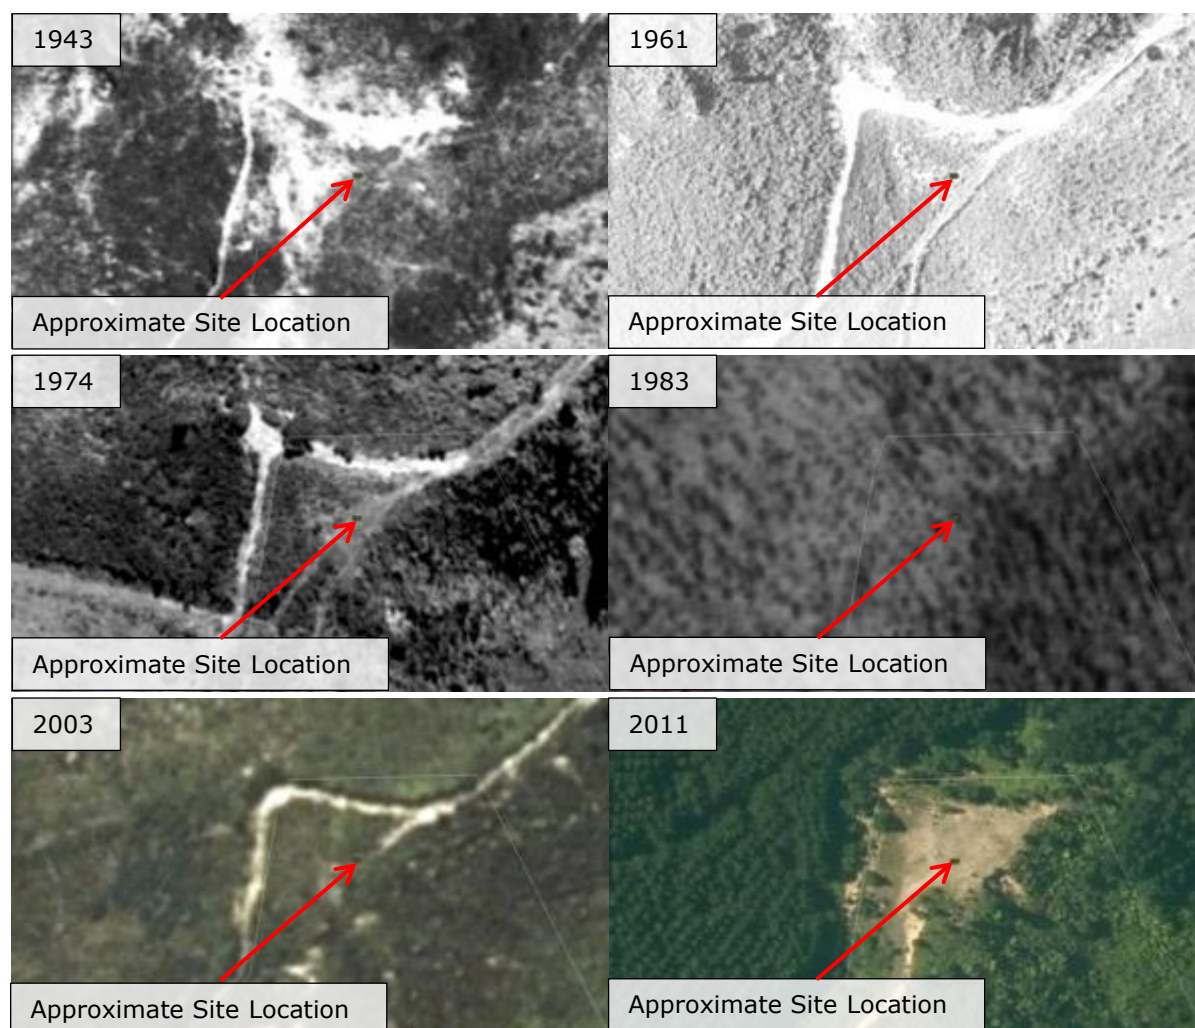
In the 1974 and 2003 photos, there appear to be potential signs of slope failure southeast of the building platform.

**Figure 11: Historical Aerial Photographs**

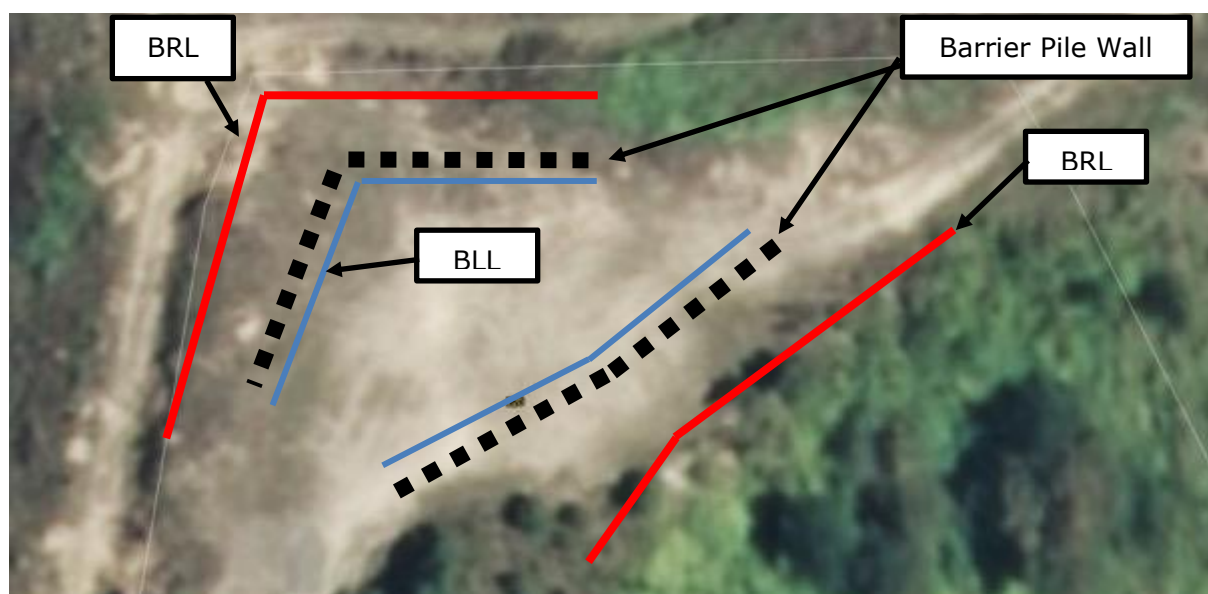
**Figure 14: Approximate Building Setbacks and Barrier Pile Wall Locations**

Based on the outcome of the analysis, without additional work to stabilise the slopes around the building platform, the required factor of safety cannot be achieved. We therefore recommend in-ground retaining wall be constructed 5m from each of the slope crests. The in-ground barrier pile wall or equivalent should be designed to have a minimum shear capacity of 600kN per meter length, and 12m in depth; the barrier pile wall should be designed by a chartered structural engineer.

Following the construction of the barrier pile wall, we consider a BLL of 1m as measured from the edge of the retaining structure is considered acceptable. Additionally, it is permissible for the barrier pile wall to be constructed further than 5m away from the slope crest if a smaller building platform is preferred, however, a BLL of 1m from the retaining structure still remains.

We also recommend a BRL at the crest of each slope, if the proposed building platform is to extend beyond BLL, additional investigation deep testing such as CPT deep borehole or similar should be conducted at the crest of each slope.
