**MAINTENANCE AND REPLACEMENT PLAN**  
**FOR**  
**PRIVATE STORMWATER AND WATER SUPPLY**  
**FOR**  
**PARKLAND ESTATES**  
**PUKEHANGI RD, ROTORUA**  
**REVISION A**

## PUBLIC HEALTH RISK MANAGEMENT PLAN

Supply Name:  
Parkland Estates, Pukehangi Road, Rotorua

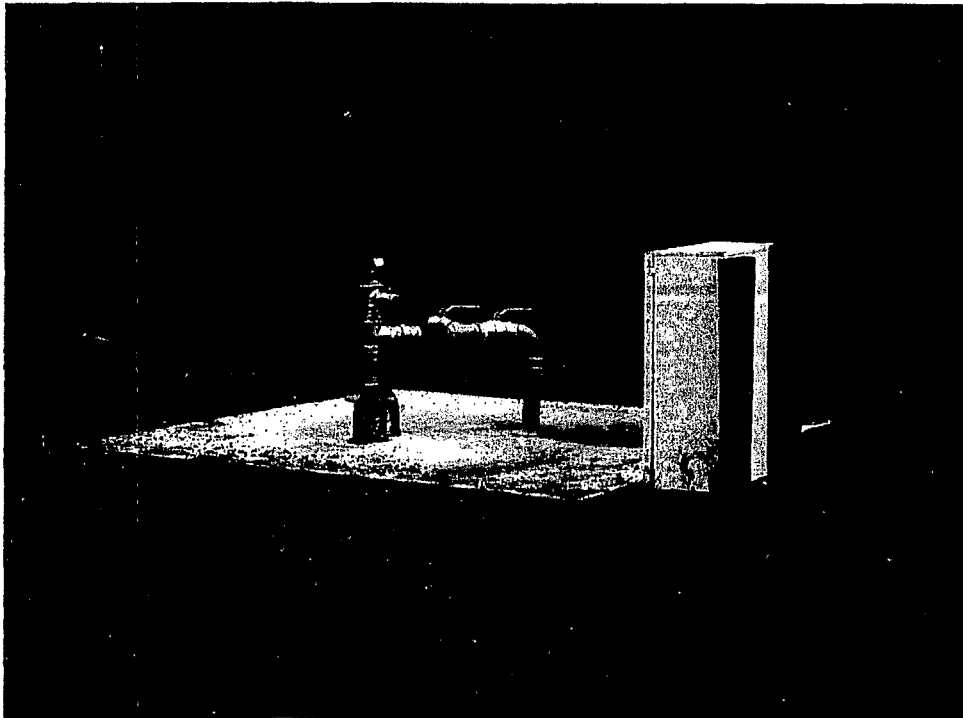
*Photograph 1: Bore head and surrounds*

Photograph 1 shows the bore head and power box. The bore head and piping are new. There are plans to improve the power supply enclosure in the near future.

A concrete pad has been laid around the bore head to secure it and prevent runoff pooling around the top of the well. The casing also extends above the ground for further protection. It is understood that there are plans to fence the bore area off.

| List what could happen that may cause drinking-water to become unsafe (deterioration in water quality) | Is this under control? | If not, judge whether this needs urgent attention. Urgent attention is needed for something that happens a lot and/or could cause significant illness. |
|---|---|---|
| 1. Contamination of bore water through bore head and casing. | No. The existing bore head has some of the recommended protective elements, but it is not fenced off to prevent vandalism or access. | Yes. |
| 2. Contamination of bore water from nearby surface activities. | No. The condition of the casing and joints is unknown but there is an obstruction 20m deep that prevents level sensors being lowered into the bore. | Yes. |

| Copy the 'Needs Urgent Attention' from the worksheets. Expect no more than 3–5 in each worksheet. | IMPROVEMENT SCHEDULE: How can you remove or reduce or remedy the cause and by when? Indicate clearly where additional resources are required. | Until remedied, how will you know when this is actually causing deterioration towards unsafe drinking-water? | What contingency management plan is in place until the cause is removed or reduced or remedied? Who needs to know and how quickly? Who can help? |
|---|---|---|---|
| Contamination of bore water through bore head and casing. | The bore head needs to be protected in the following manner: <ul style="list-style-type: none"> <li>Construct a secure lockable shed around the bore head.</li> </ul> | Bacteriological monitoring ( <i>E.coli</i> )<br>Possibly chemical determinands present at shallower depths | If <i>E.coli</i> is present carry out the procedure outlined in the NZDWS 2005 (Figure 4.1 pg 37). |
| Contamination of bore water from nearby surface activities. | The bore head needs to be protected as above.<br>Check casing and repair any damage. | Bacteriological monitoring ( <i>E.coli</i> )<br>Possibly chemical determinands present at shallower depths | If <i>E.coli</i> is present carry out the procedure outlined in the NZDWS 2005 (Figure 4.1 pg 37). |

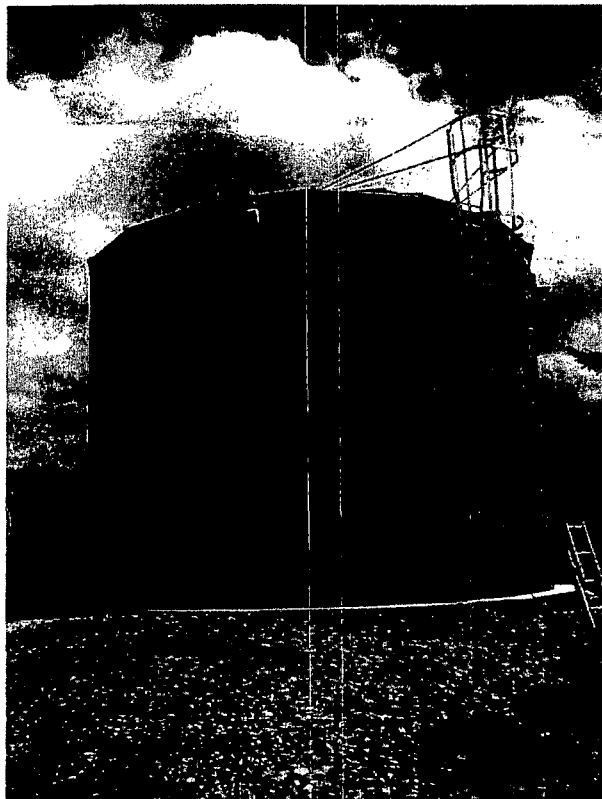
The overflow pipes have a 90 degree bend and water falls onto a board so that it will splash. This is to make the overflowing water more visible from the lifestyle blocks. There is also a visual water level indicator on the side of the reservoir. There are mesh barriers in the overflow pipes to prevent birds entering the reservoir.

*Photograph 3: Parkland Estates Reservoir*

| List what could happen that may cause drinking-water to become unsafe (deterioration in water quality) | Is this under control? | If not, judge whether this needs urgent attention. Urgent attention is needed for something that happens a lot and/or could cause significant illness. |
|---|---|---|
| 6. Not enough water in storage to meet demand. | Yes. There is plenty of storage available and the reservoir is in good condition. | |
| 7. Contaminating material enters reservoir | Yes. There is a padlocked lid to prevent access and the overflows are protected so birds cannot enter the reservoir. | |
