SUBDIVISION ASSESSMENT

332 KOMOKORIKI HILL ROAD

AHUROA

For: Muriwai Valley Farm Enterprises Ltd

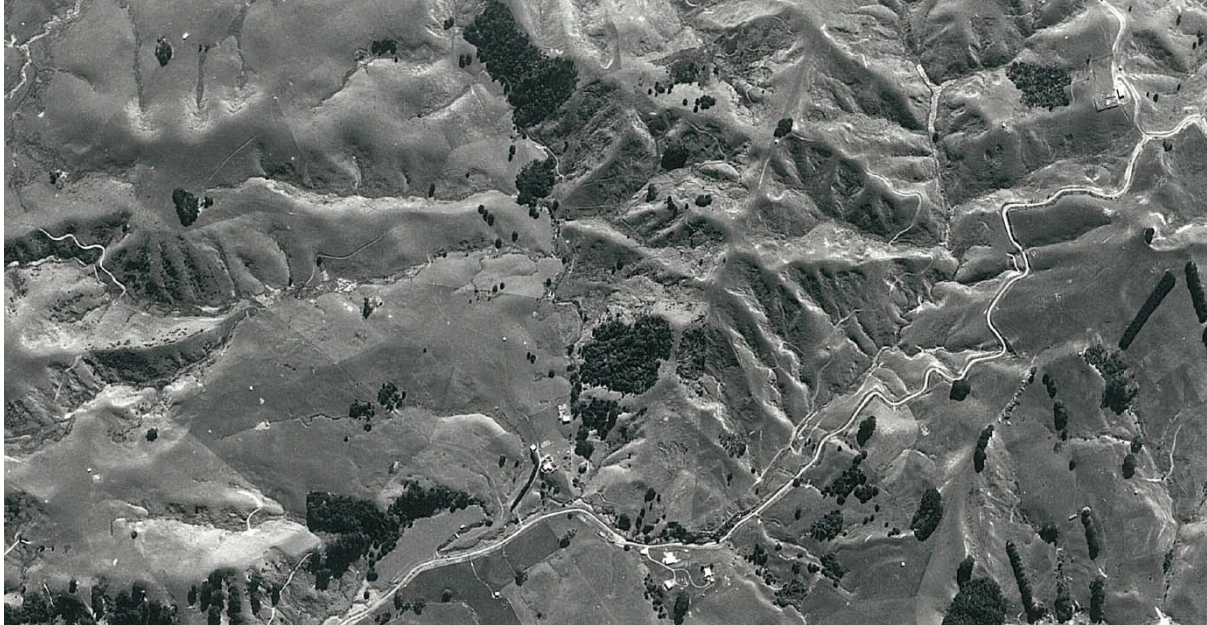
Figure 2: 1976 aerial image

visible in Figure 2 below from 1976. The west of the property containing the proposed development site and residential building sites has more rolling terrain and the observed land instabilities is largely related to surface creep and shallow regolith slippage associated with saturated surface soils. A number of recent instabilities with associated head scarps were observed at the site, however the nominated building platforms within proposed Lots 5-9 do not show signs of recent instability.

The historic images indicate that the proposed building sites have remained stable over the past 40 years with no obvious signs of large scale instability over this period. However evidence of past land movement reinforces the stability sensitive nature of the development.
