Engineering Assessment: Geotechnical Assessment
for 5 new Lots within a Proposed Subdivision

Report Prepared for: Beegee Trust

Site Location: 124 Maioro Road, Otatau

Reference: R2020/793

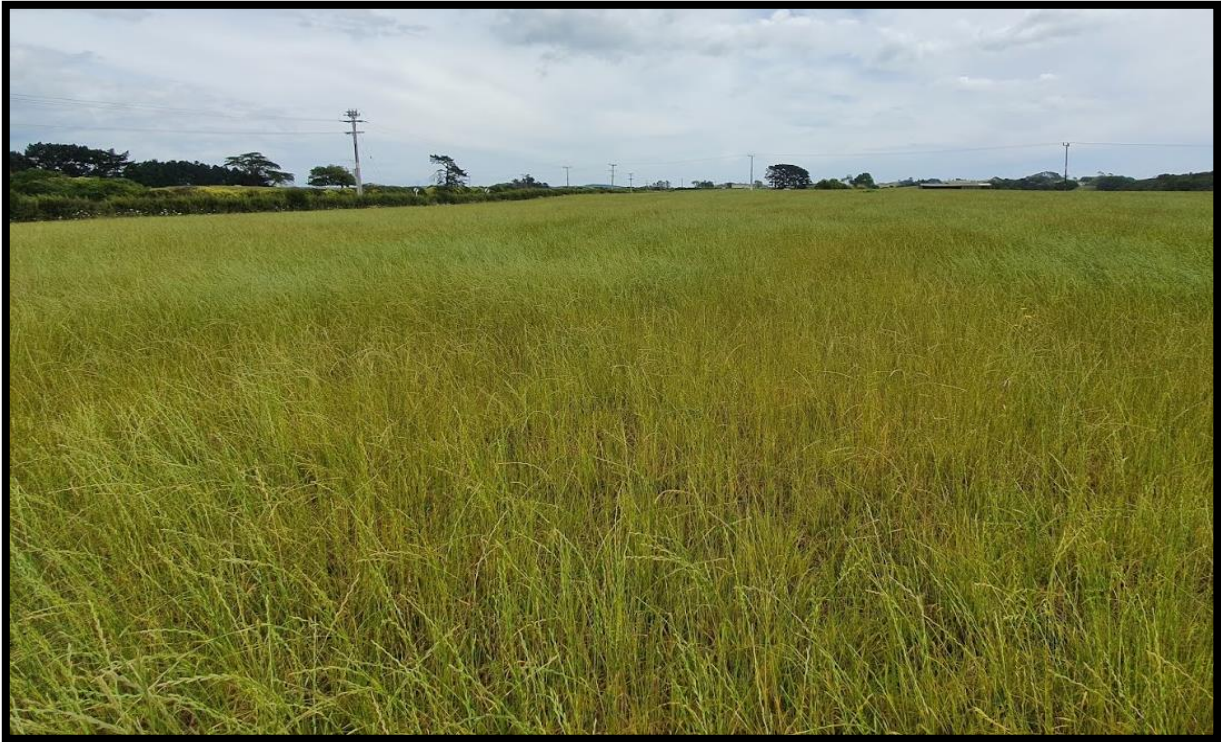
Proposed Lots 1 and 2 are on flat to gently sloping ground with slopes less than 4 degrees towards the north-east. No overland flow paths or potential flood areas were identified on these Lots. There are no steep slopes directly bordering the proposed Lots.

Figure 3: View south-west across proposed Lot 1 & 2.

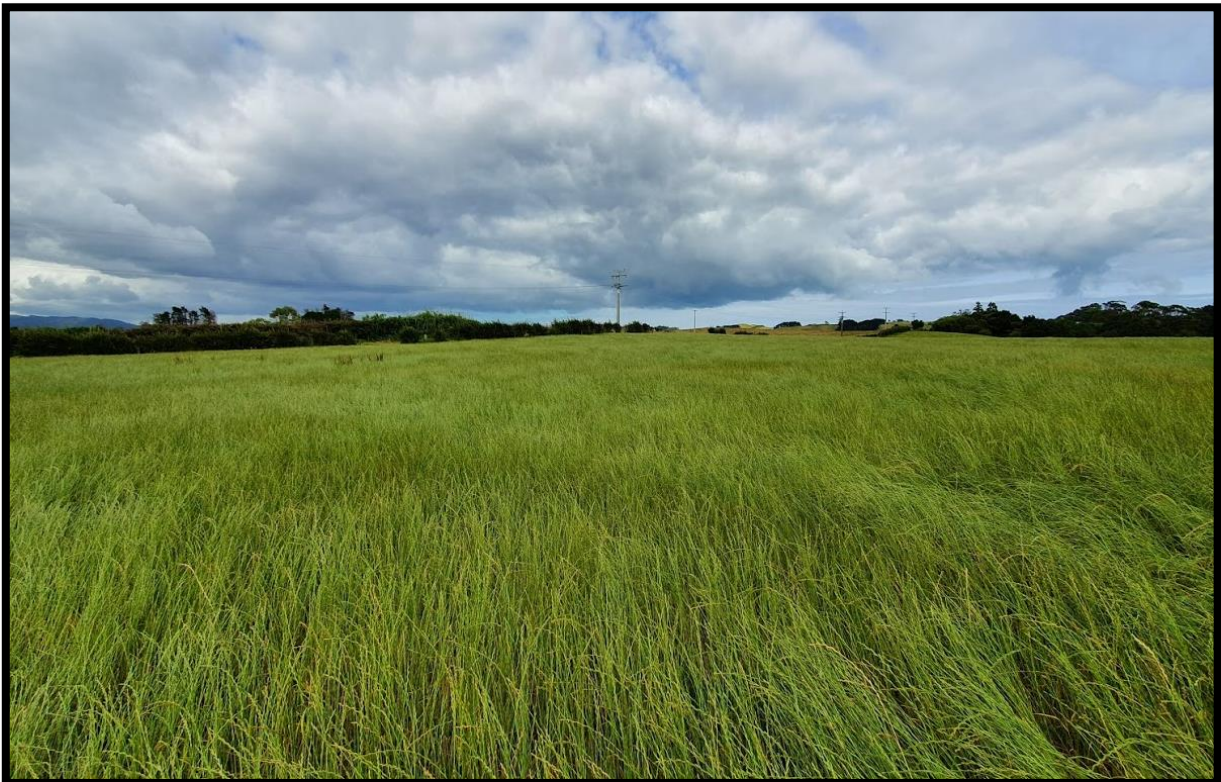
The proposed building platforms for Lots 3 and 4 are flat to gently sloping with slope angles of less than 5 degrees. Across the building platform areas (1000m²) there is some undulation in the topography. There is a steep bowl-shaped feature with associated flow path located to the east of Lot 3. This steeply sloping area shows signs of erosion and soil creep. The topographical feature is located approximately 20m from the edge of the building platform on Lot 3 and will not adversely impact any building platform on the Lot. There is also steeply sloping ground along the northern boundary of Lot 4. The ground along the boundary slopes

Figure 4: View south-west across the building platform for Lot 3.

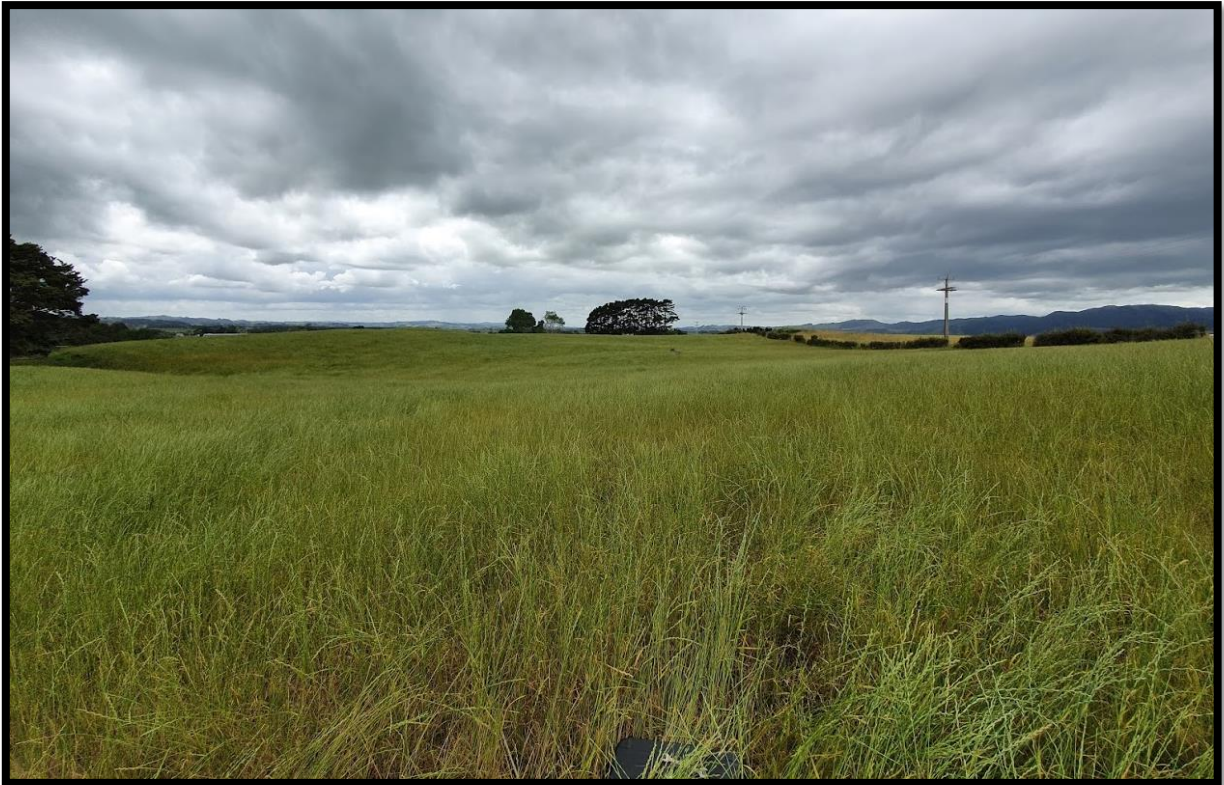
Figure 5: View north-east towards Lot 4.

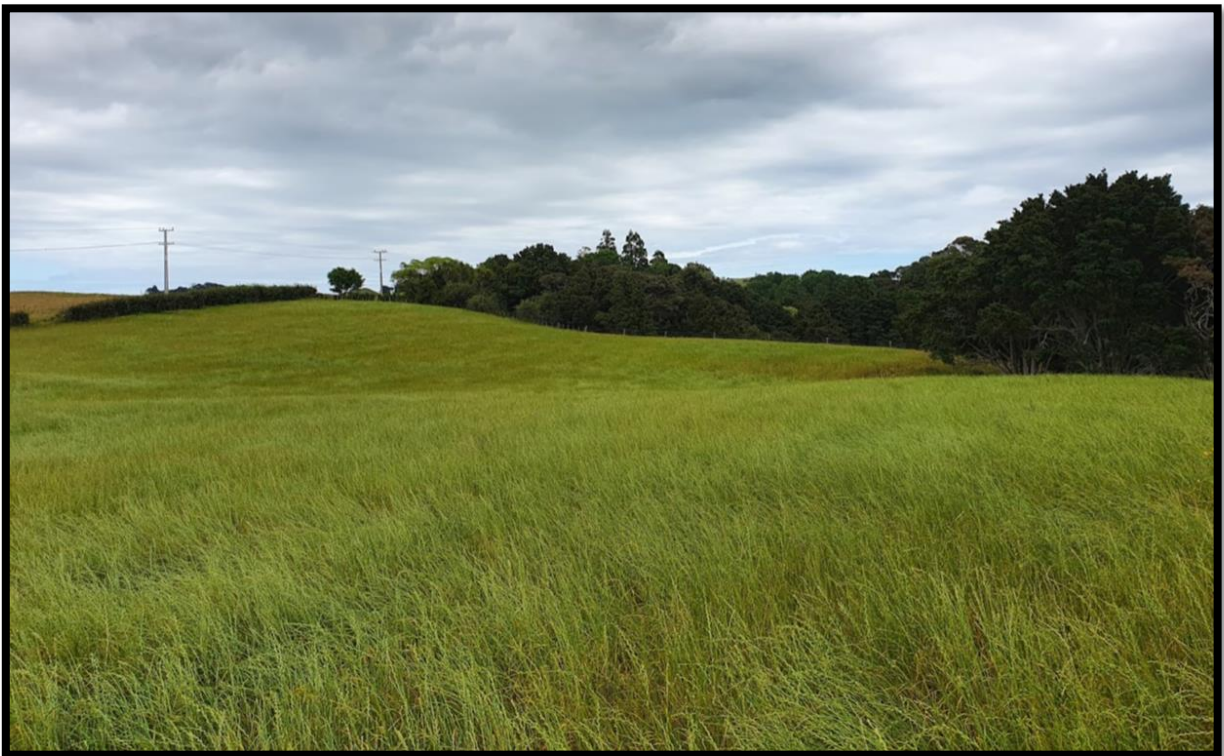
The building platform area on Lot 5 slopes towards the north to east at a maximum angle of 12 degrees. Directly north-west of the building platform area there is steeply sloping ground >30 degrees into an area of bush. The ground at this location has soil creep and erosion present. No large scale or deep-seated instabilities were noted at this location. There is an overland flow path running towards the north. The flow path is located near the eastern boundary of the Lot. The wastewater disposal areas for Lots 4 and 5 are setback from this overland flow path.

Figure 6: View south-west towards the building platform for Lot 5.
