GEOTECHNICAL INVESTIGATION REPORT

PROPOSED SUBDIVISION

**LOT 2 DP 349782
KOMOKORIKI HILL ROAD
KOMOKORIKI**

Reference: GL225.1

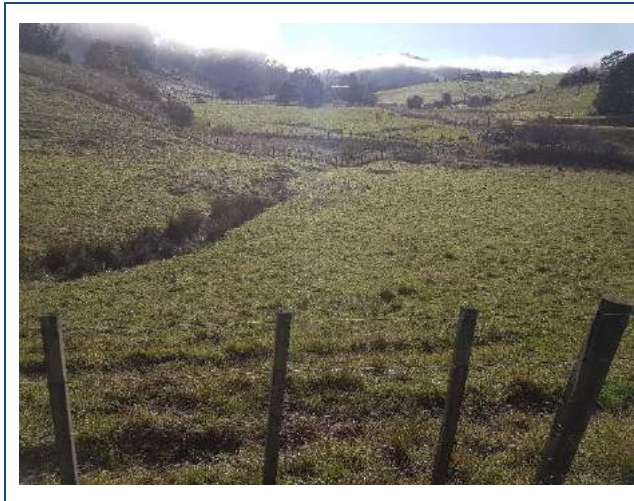
Photograph 1:

Looking from the existing accessway that runs through the middle of the proposed lot subdivision towards the north east at the low laying regions of Lot 1. The Auckland Council GIS indicates that this area is mapped within the flood prone area, as it is adjacent to Kotorengaru Stream. Foundations designed within this area need to take this into consideration.

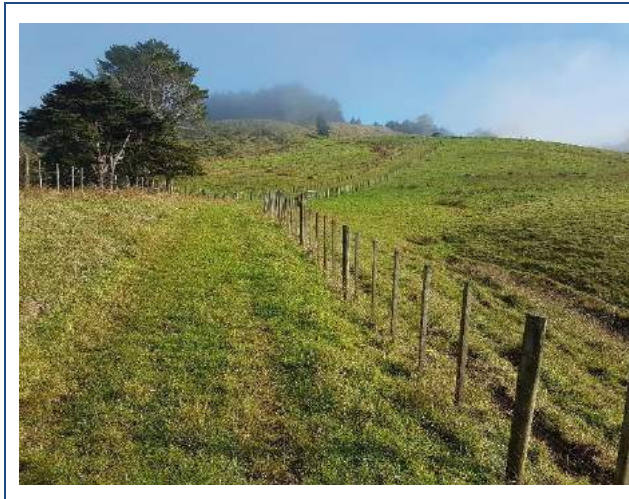
Photograph 2:

Looking from the accessway towards the north west with Lot 1 and Lot 3 to the right of the photograph and Lot 2 and Lot 4 in the centre and top of the image. The photo shows numerous visual signs indicating historical and/or presently active instability. The ground surface is steep across some of the site and shows evidence of a number of slump scarps. Furthermore, the steep nature of the property makes the land prone to longer term near surface soil creep and/or shallow seated slope failure within the upper soil layers.

Due to the moderately steep nature of parts of the site and indications of shallow soil movement, we recommend that the foundations be piled if the dwelling is to be located within 10m upslope of moderately steep ground (steeper than 1v:4h, or 14°).

Due to the moderately steep nature of parts of the site and indications of shallow soil movement piles will be required to safeguard against the effects of potential longer-term soil creep or shallow seated slope failure.

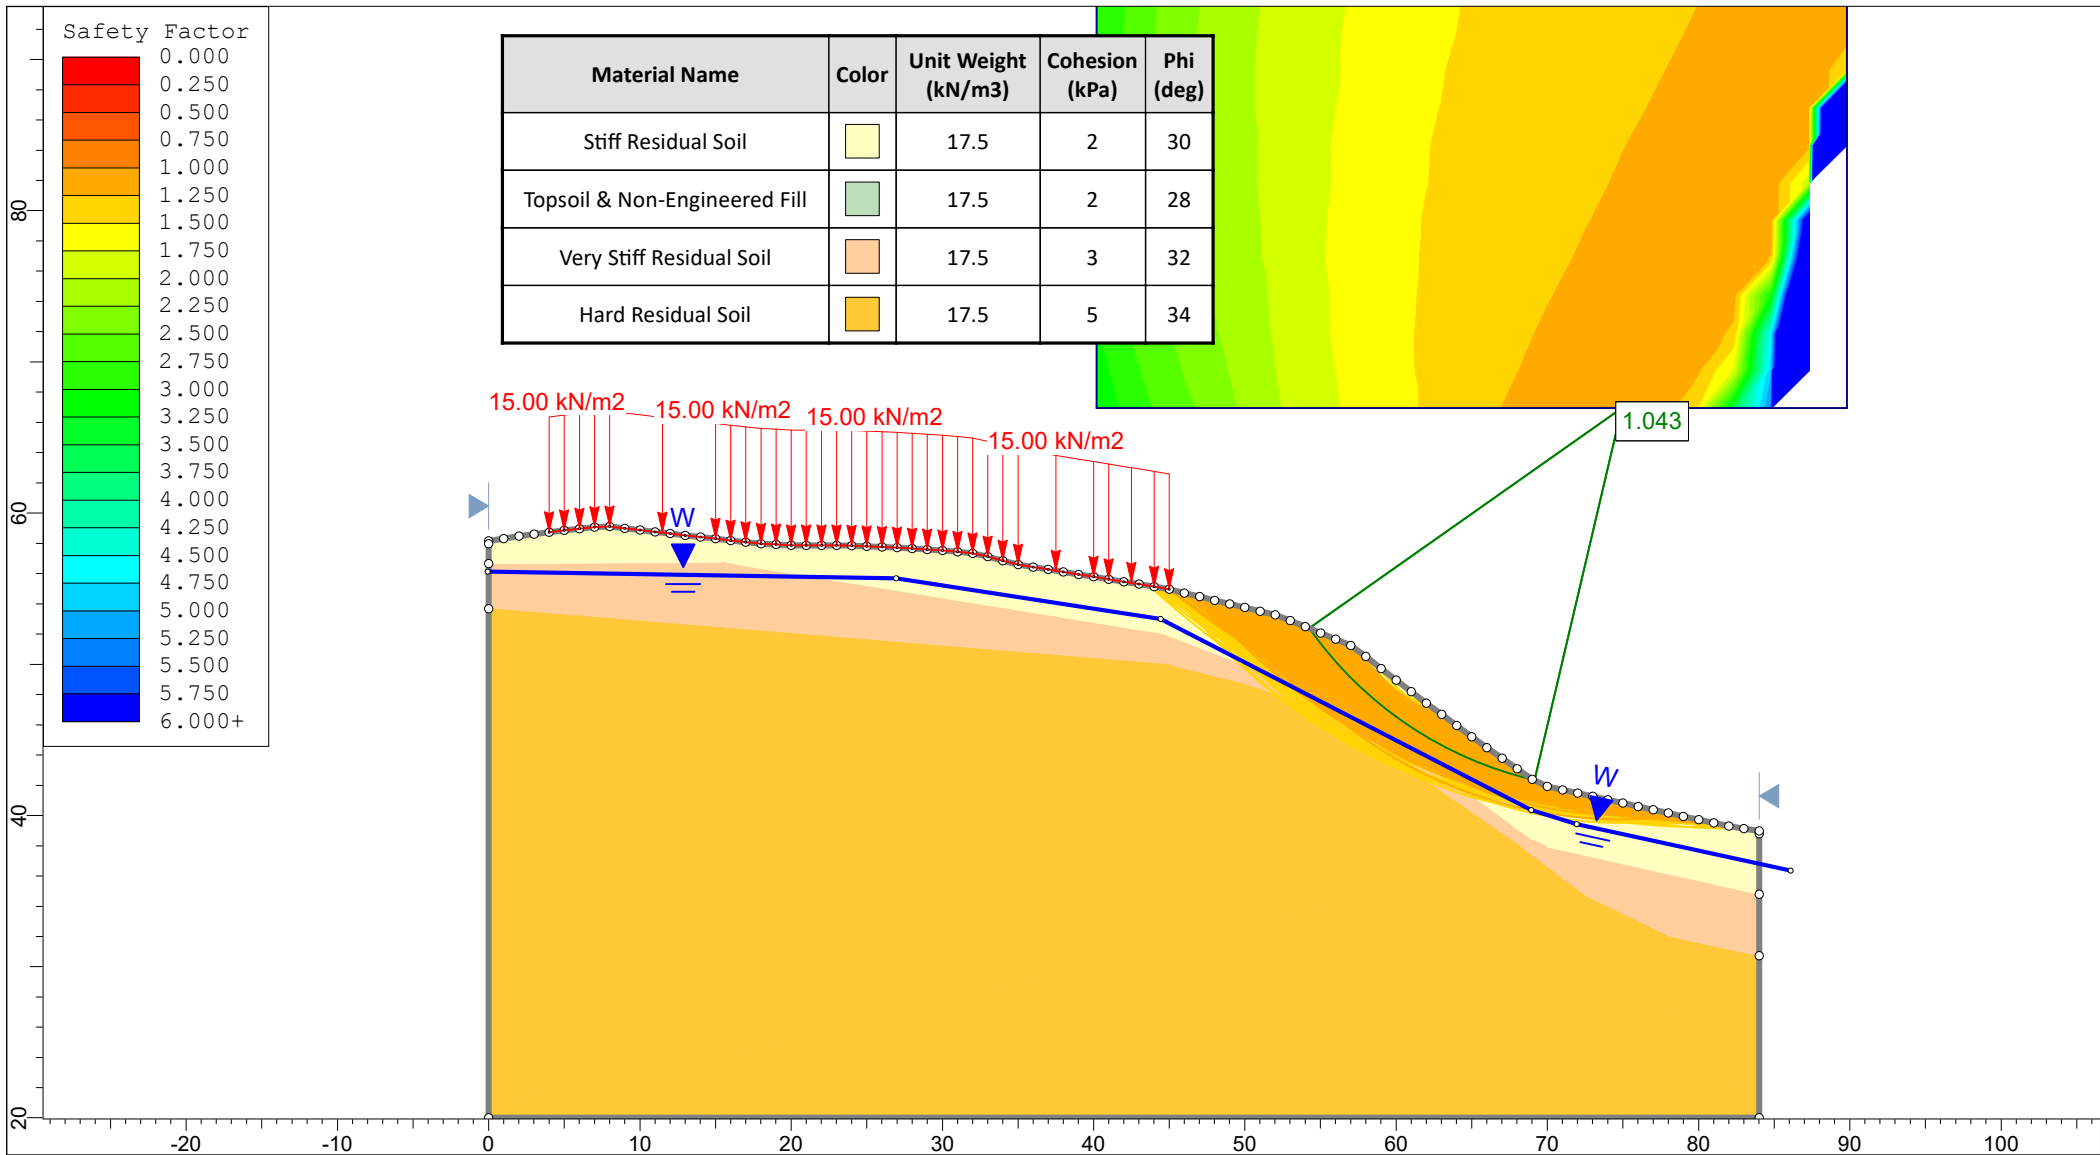
Project		GL225: Proposed Rural Subdivision	
Analysis Description		Section 1: Extreme Groundwater Conditions	
Drawn By	MA	Scale	1:500
Date	26/06/2019, 3:22:03 PM	Company	Geoconsult
		File Name	SEC 1 Extreme.slim

Condition	Sections					
	1	2	3	4	5	6
Normal groundwater conditions	1.04**	1.83	1.23*	1.82	1.29*	1.69
Extreme groundwater conditions	1.04**	1.60	1.23*	1.45	1.25*	1.44
Seismic conditions	2.23	1.97	3.75	5.25	1.66	1.34

** Foundations within this lot need to be specifically designed to address global stability issues.

Material Name	Color	Unit Weight (kN/m ³)	Cohesion (kPa)	Phi (deg)
Stiff Residual Soil		17.5	2	30
Topsoil & Non-Engineered Fill		17.5	2	28
Very Stiff Residual Soil		17.5	3	32
Hard Residual Soil		17.5	5	34

1.043

It should be noted that some of the results shown in Table 2 indicate that a lower FOS than that required by Auckland Council, however, the majority of these slopes were calculated beyond the proposed building footprint. The only calculated global slopes with a predicted FOS lower than the council requirement encroaching into the proposed building footprint were the ones calculated in section 1. We recommend that foundations are specifically designed within Lot 5 to address global stability issues.
