# Geotechnical Report

Lots 9 & 10, Block 3/DP 28  
60 Kauri Street  
Ravensbourne, Dunedin

**GeoSolve Ref: 180239**

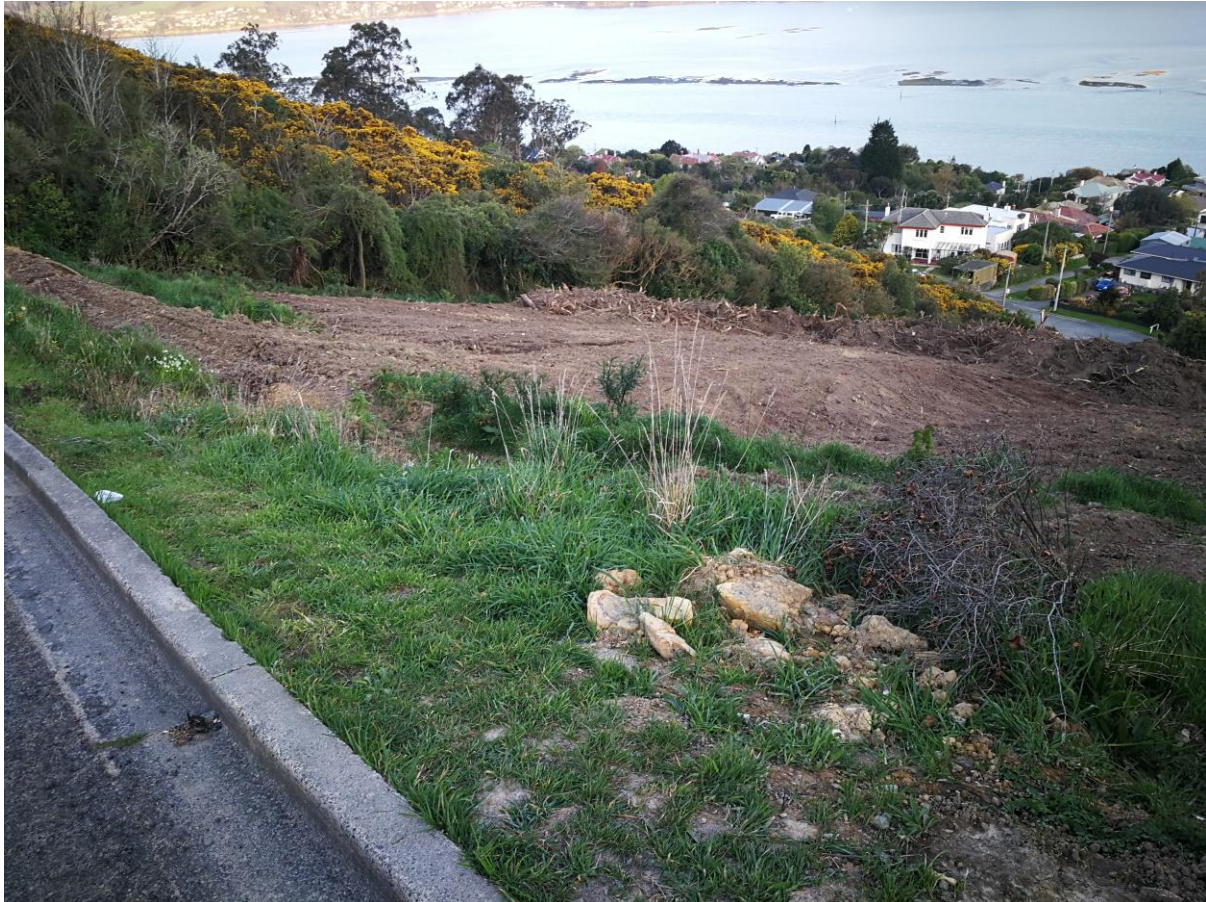
**Photo 1 – Proposed development site, 60 Kauri Street**
