# Land Information Memorandum

Property address:  
1/32 Ryan Street

**Property address** 1/32 Ryan Street, Linwood, Christchurch  
**Valuation roll number** 22442 01702  
**Valuation information** Capital Value: \$0  
Land Value: \$0  
Improvements Value: \$0  
*Please note: these values are intended for Rating purposes*  
**Legal description** Lot 1 DP 585857  
**Existing owner** A K Residential Limited  
228 Stone Street  
WANAKA 9305

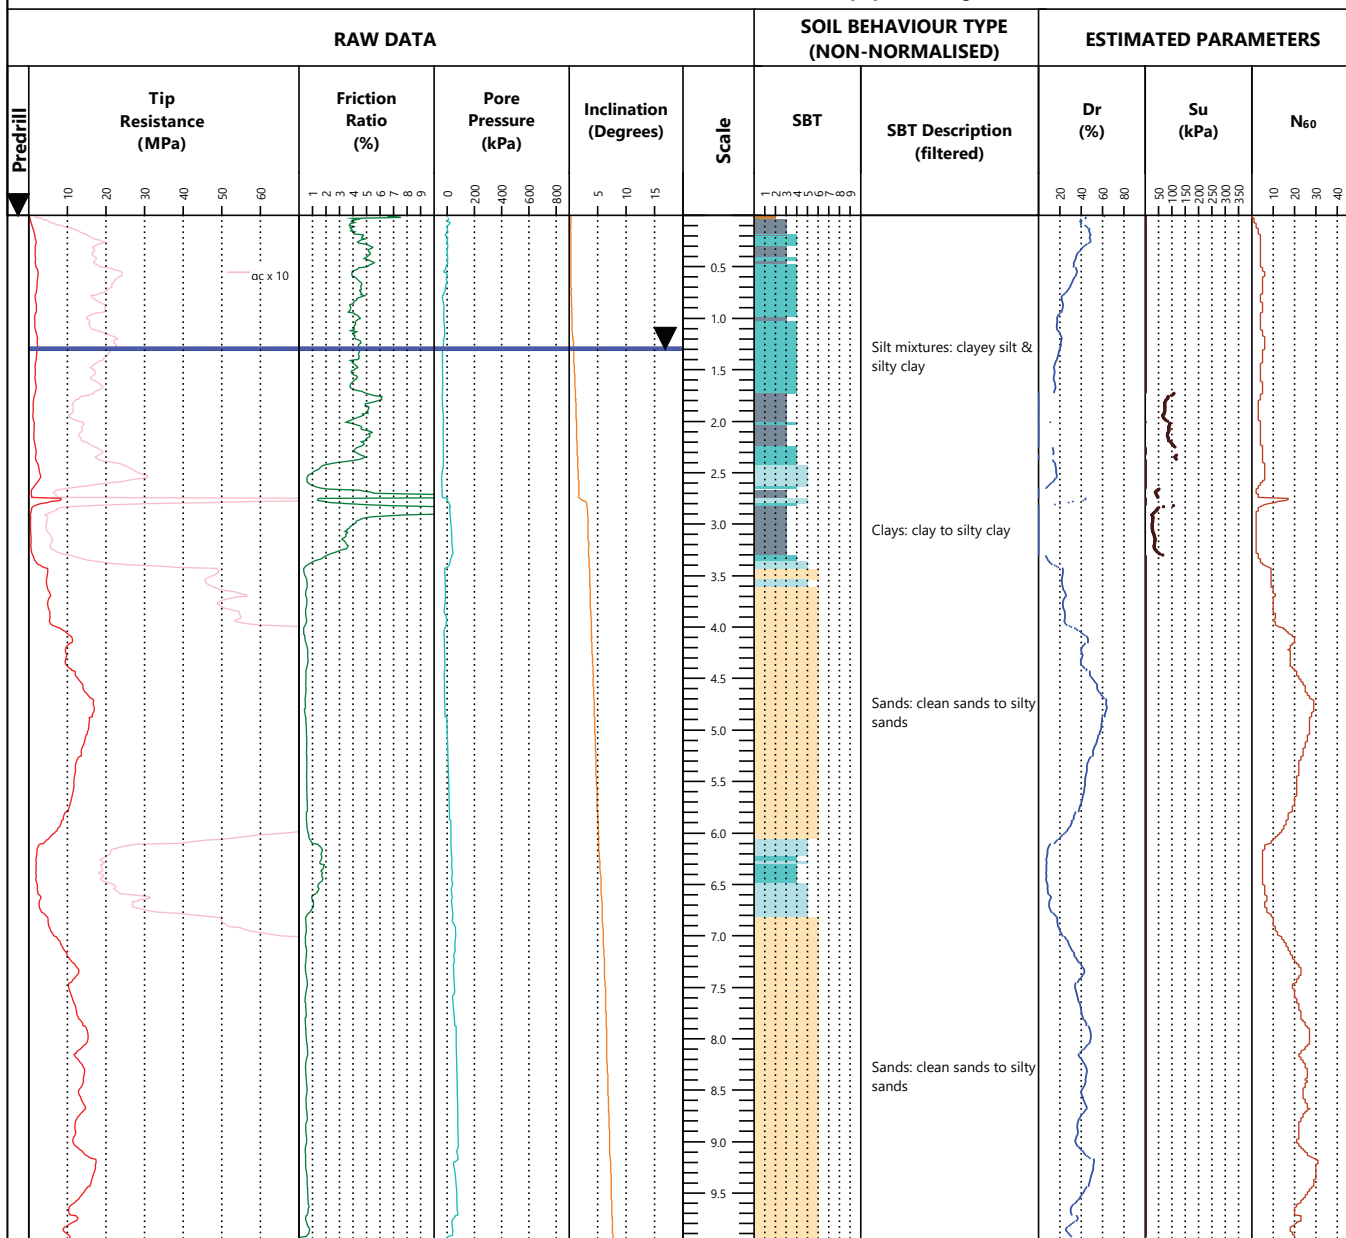
**Equipment:** Pagani TG63-150

**Cone Type:** Pagani Piezocone - Compression

Deep ground testing was carried out on the 14<sup>th</sup> of September 2021 by McMillan Drilling Ltd and comprised two Cone Penetrometer Test (CPT01- CPT03) pushed to a target depth of 10 m complete with excess pore pressure measurements. A historical onsite CPT was found which was tested by Pro-Drill Limited on the 26<sup>th</sup> of March 2013. In addition, two Scala penetrometer tests (SP01 – SP02) were performed by Tetrad on the 14<sup>th</sup> of October. The Scala penetrometer and CPT test locations and results are shown in Appendix A and summarized in Table 1 below.

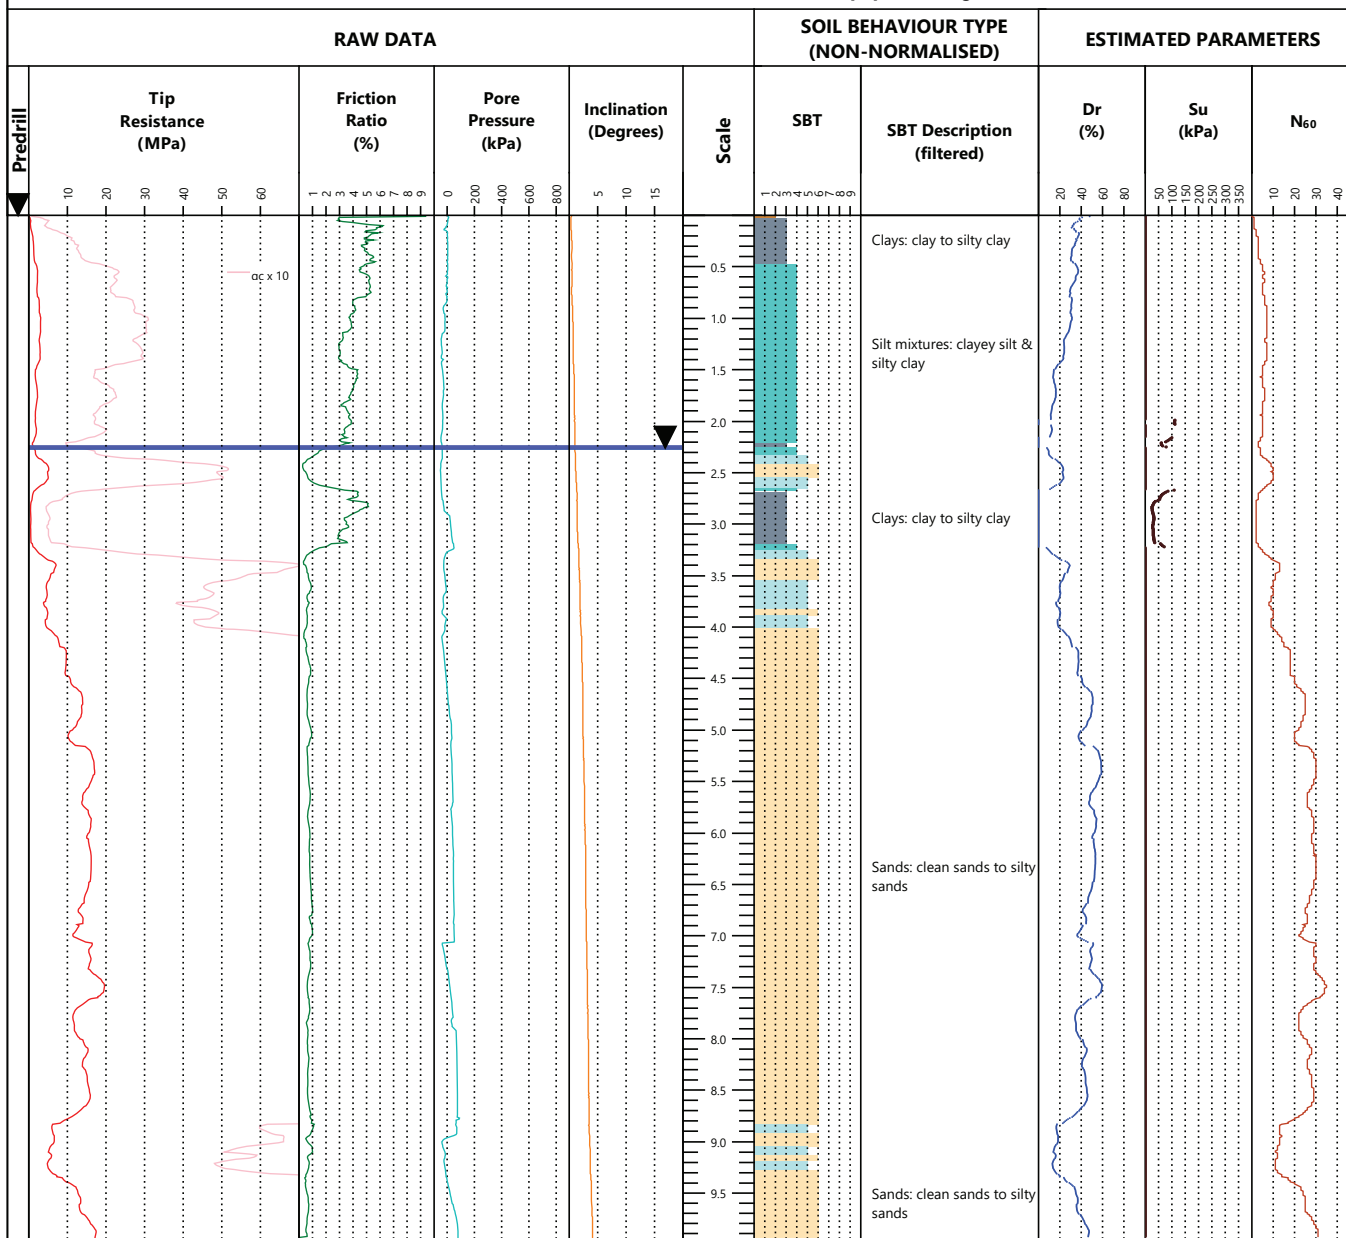
Sheet 1 of 1

<b>Cone Type:</b> Pagani Piezocone - Compression		<b>Predrill:</b> -	<b>Termination</b>	<b>Soil Behaviour Type (SBT) - Robertson et al. 1986</b>	
<b>Cone Reference:</b> MKS332		<b>Water Level:</b> 2.26m	<b>Target Depth</b> <input checked="" type="checkbox"/>	<b>0</b> Undefined	<b>5</b> Sand mixtures: silty sand to sandy silt
<b>Cone Area Ratio:</b> 0.79		<b>Collapse:</b> 2.96m		<b>1</b> Sensitive fine-grained	<b>6</b> Sands: clean sands to silty sands
<b>Standards:</b> ISO 22476-1:2012			<b>Effective Refusal</b>	<b>2</b> Clay - organic soil	<b>7</b> Dense sand to gravelly sand
<b>Zero load outputs (MPa)</b>	<b>Before test</b>	<b>After test</b>		<b>3</b> Clays: clay to silty clay	<b>8</b> Stiff sand to clayey sand
<b>Tip Resistance</b>	22.1903	22.1331		<b>4</b> Silt mixtures: clayey silt & silty clay	<b>9</b> Stiff fine-grained
<b>Local Friction</b>	0.2715	0.2703			
<b>Pore Pressure</b>	3.0082	3.0071

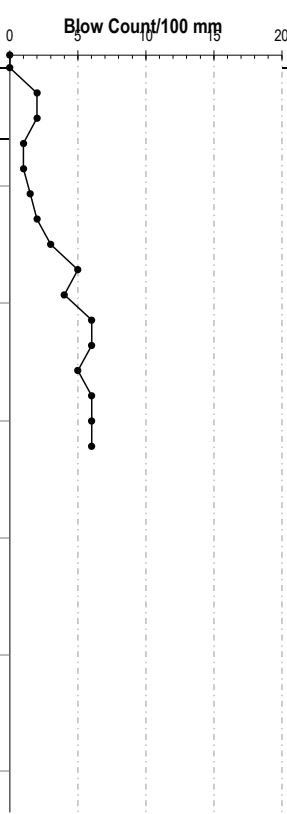
Drill Type: Scala Driller: Callum Nish		<b>SCALA No.</b>		<b>SP01</b>	
<b>Client:</b> A K Property Limited <b>Site Address:</b> 32 - 36 Ryan Street, Phillipstown <b>Town/City:</b> Christchurch				<b>Date:</b> 15/10/2021 <b>Weather:</b> Fine <b>Project No:</b> 21341			
Geological Formation:	Depth (m)	Sample Description:	Graphic Log	USCS	Water Table	Blow Count

0.0						
	-0.5						
	-1.0						
	-1.5						
	-2.0						
	-2.5						
	-3.0						
	-3.5						
	-4.0						
	-4.5						
<b>Note:</b> Scala Penetrometer and hand auger log tests give an indication of the ground condition at the test location only. While they are representative of typical conditions across the site, they do not identify variations in the ground away from the test location.

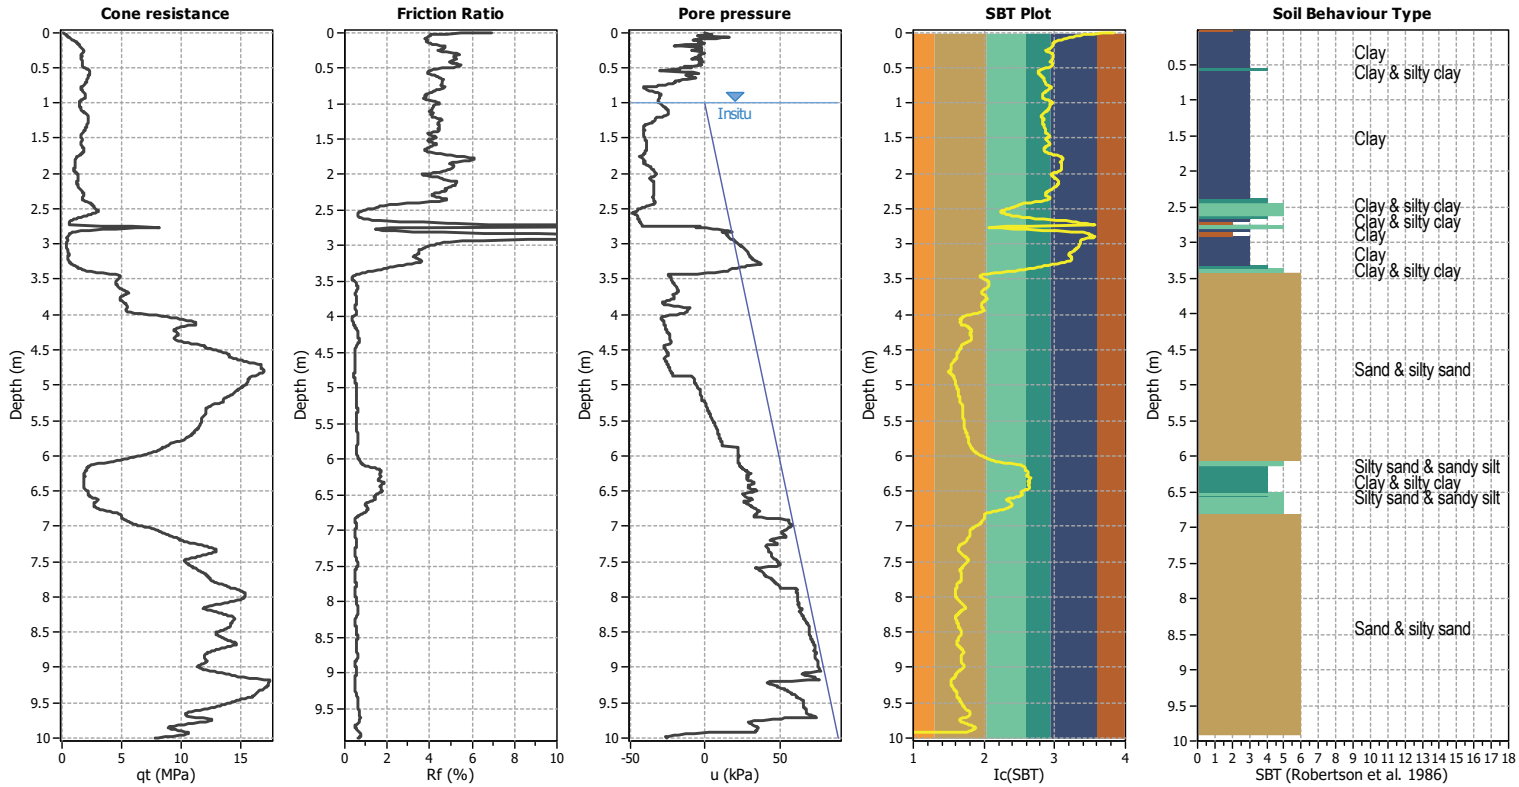
CPT basic interpretation plots

Analysis method:	B&I (2014)	Depth to GWT (erthq.):	0.50 m	Fill weight:	N/A
Fines correction method:	B&I (2014)	Average results interval:	3	Transition detect. applied:	No
Points to test:	Based on Ic value	Ic cut-off value:	2.60	K <sub>0</sub> applied:	Yes
Earthquake magnitude M <sub>w</sub> :	7.50	Unit weight calculation:	Based on SBT	Clay like behavior applied:	Sands only
Peak ground acceleration:	0.13	Use fill:	No	Limit depth applied:	Yes
Depth to water table (insitu):	1.00 m	Fill height:	N/A	Limit depth:	10.00 m

Liquefaction assessment of the CPT tests has been completed by the method of Idriss and Boulanger (2014).

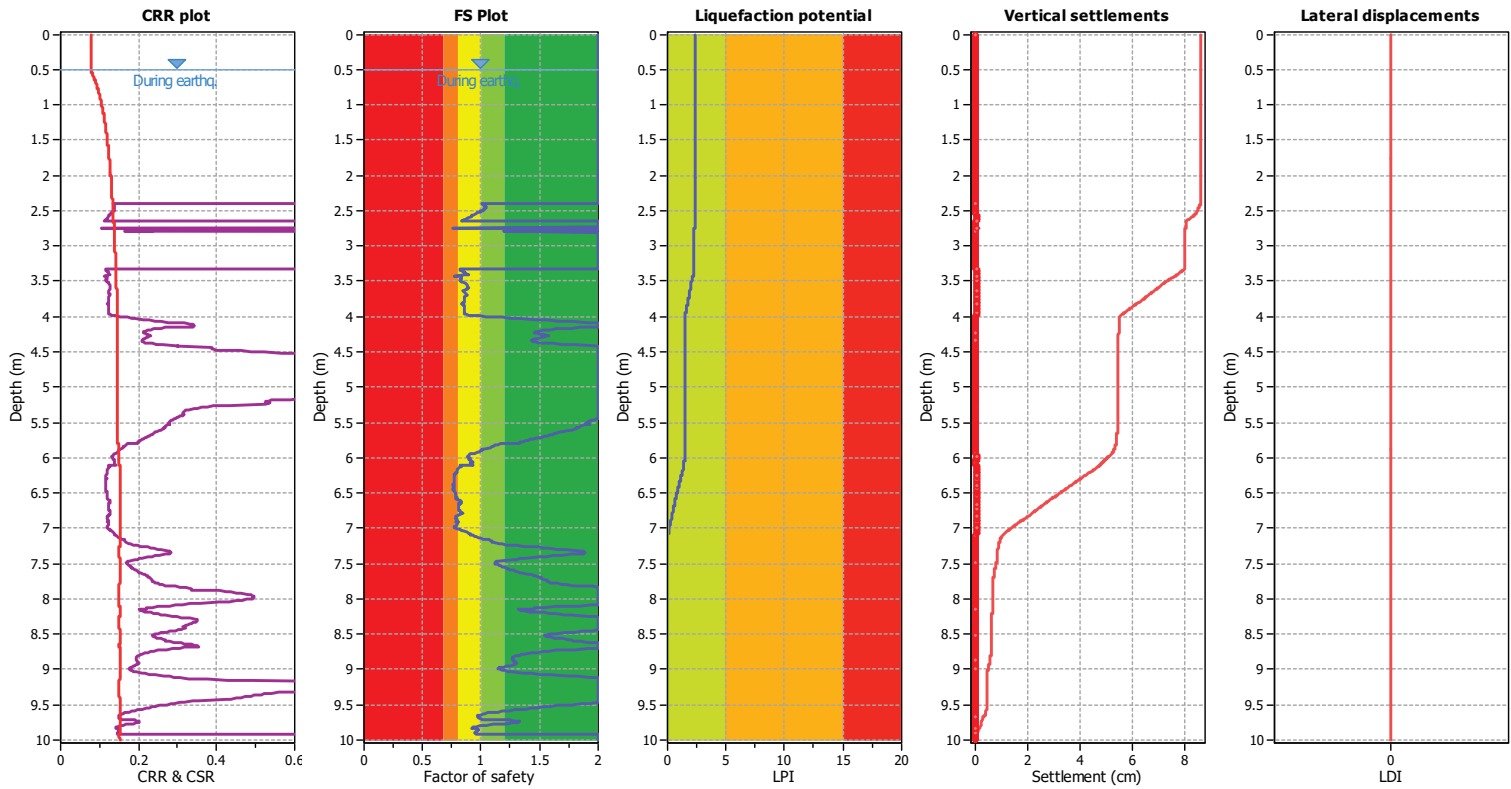
Liquefaction analysis overall plots

Analysis method: B&I (2014)  
Fines correction method: B&I (2014)  
Points to test: Based on Ic value  
Earthquake magnitude  $M_w$ : 7.50  
Peak ground acceleration: 0.13  
Depth to water table (insitu): 1.00 m

Liquefaction analysis confirmed liquefaction potential Indices (LPI) values of 3 and 5 for a SLS1 and SLS2 event respectively and increasing to 20 for a ULS event. These values translate to *Moderate* ground surface damage for a SLS1 and *Severe* for a ULS event.

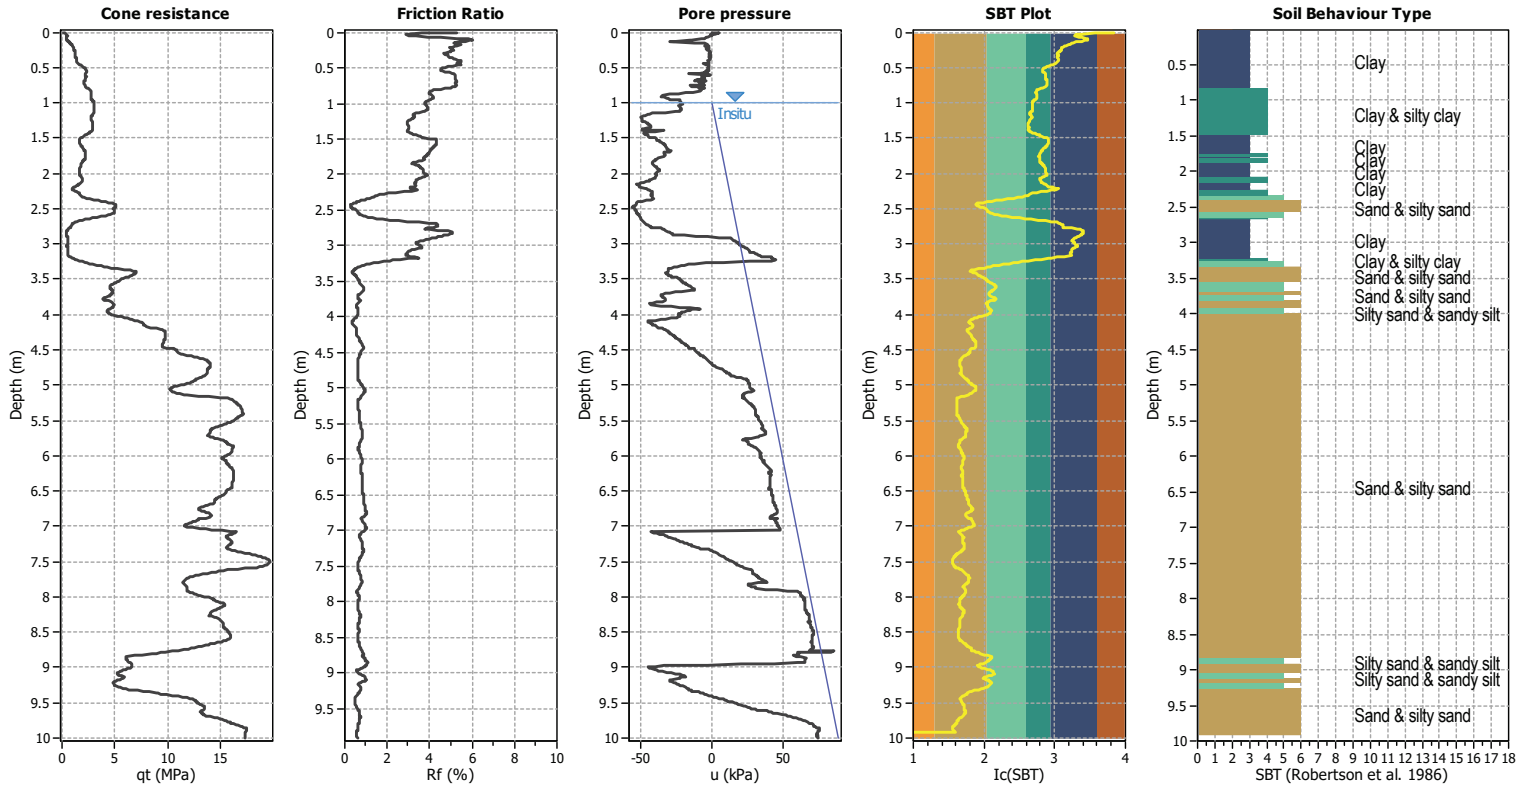
CPT basic interpretation plots

Analysis method:	B&I (2014)	Depth to GWT (erthq.):	0.50 m	Fill weight:	N/A
Fines correction method:	B&I (2014)	Average results interval:	3	Transition detect. applied:	No
Points to test:	Based on Ic value	Ic cut-off value:	2.60	K <sub>o</sub> applied:	Yes
Earthquake magnitude M <sub>w</sub> :	7.50	Unit weight calculation:	Based on SBT	Clay like behavior applied:	Sands only
Peak ground acceleration:	0.13	Use fill:	No	Limit depth applied:	Yes
Depth to water table (insitu):	1.00 m	Fill height:	N/A	Limit depth:	10.00 m

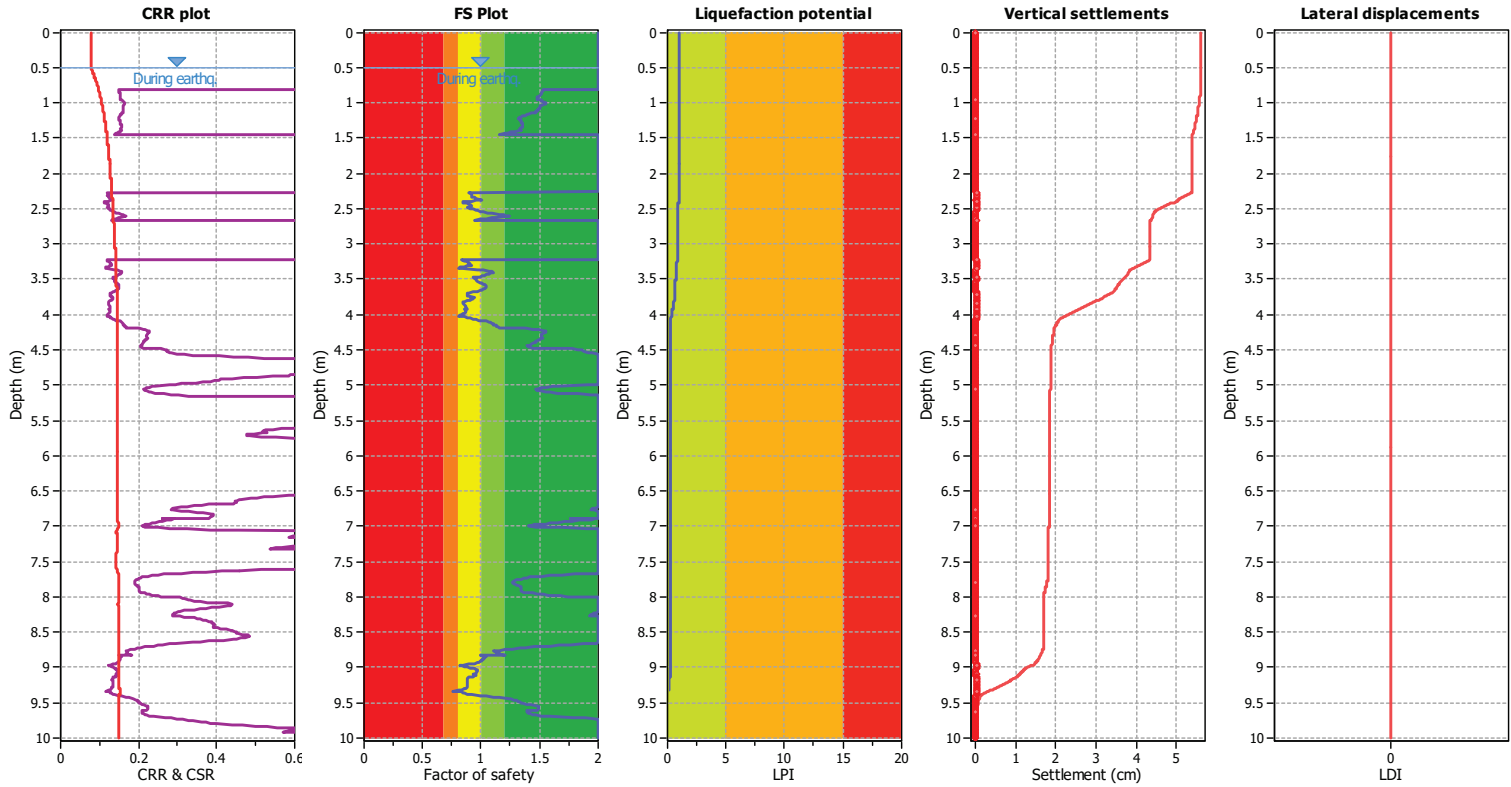
Liquefaction analysis overall plots

Analysis method: B&I (2014)  
Fines correction method: B&I (2014)  
Points to test: Based on Ic value  
Earthquake magnitude  $M_w$ : 7.50  
Peak ground acceleration: 0.13  
Depth to water table (insitu): 1.00 m
