HUNUA PROPERTY DEVELOPMENT LIMITED

WHITE ROAD, HUNUA, AUCKLAND

GEOTECHNICAL ASSESSMENT FOR PROPOSED HOUSE SITES: LOTS 1 - 5

REF: R6120-1A
DATE: 30 APRIL 2020

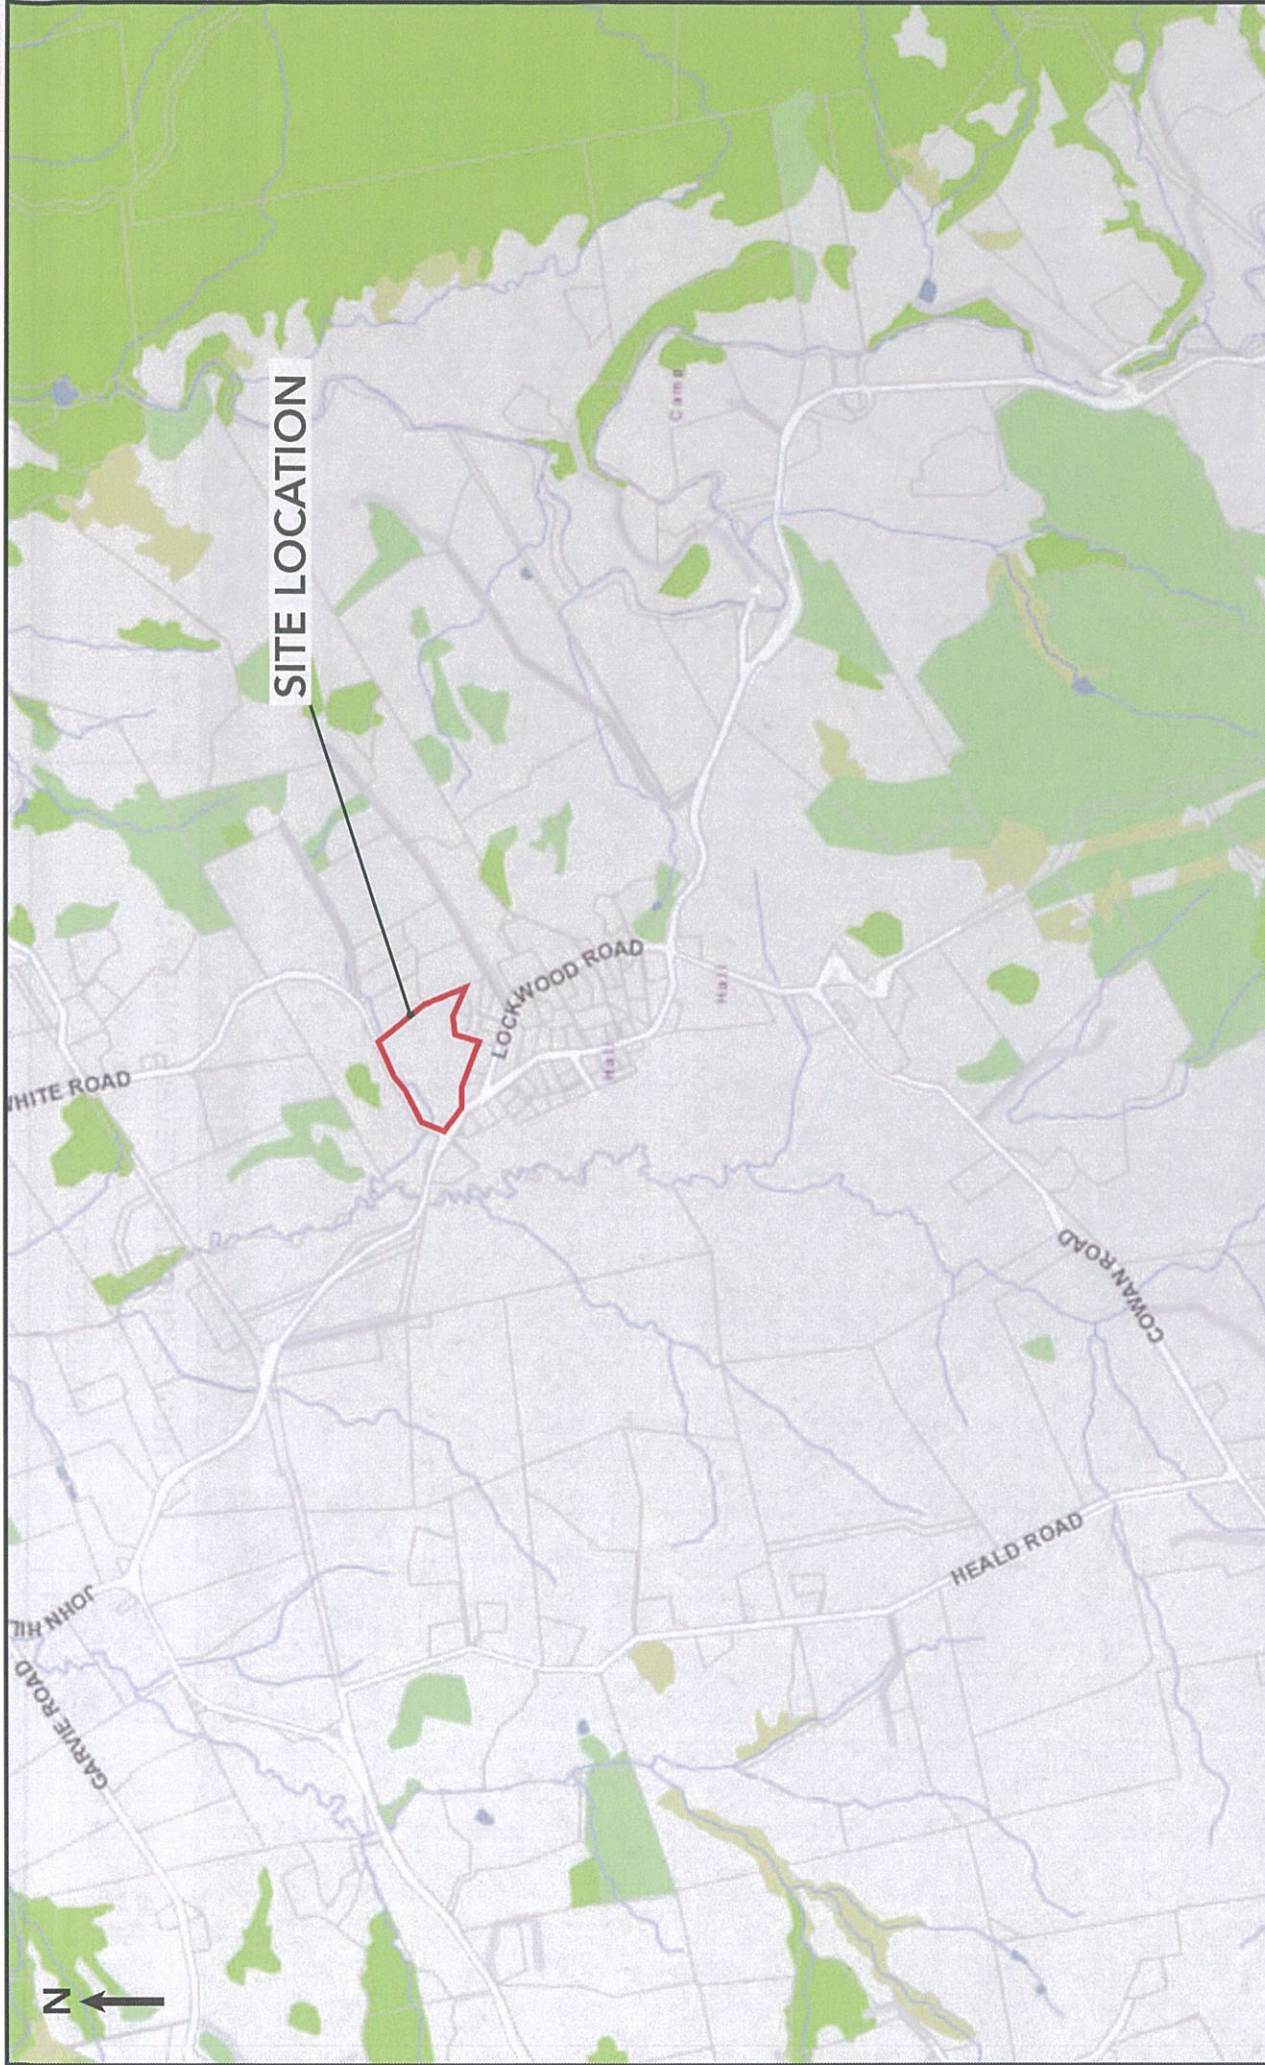
Drawing No.
001

HUNUA PROPERTY DEVELOPMENT LTD
WHITE ROAD, HUNUA, AUCKLAND
SITE LOCATION PLAN

A geotechnical assessment has been undertaken by GCL for a proposed house site within each of the Lots 1 - 5 at White Road, Hunua at the request of the client Hunua Property Development Limited. The site location is presented in Drawing 001.

A site location map is presented on Drawing 001.

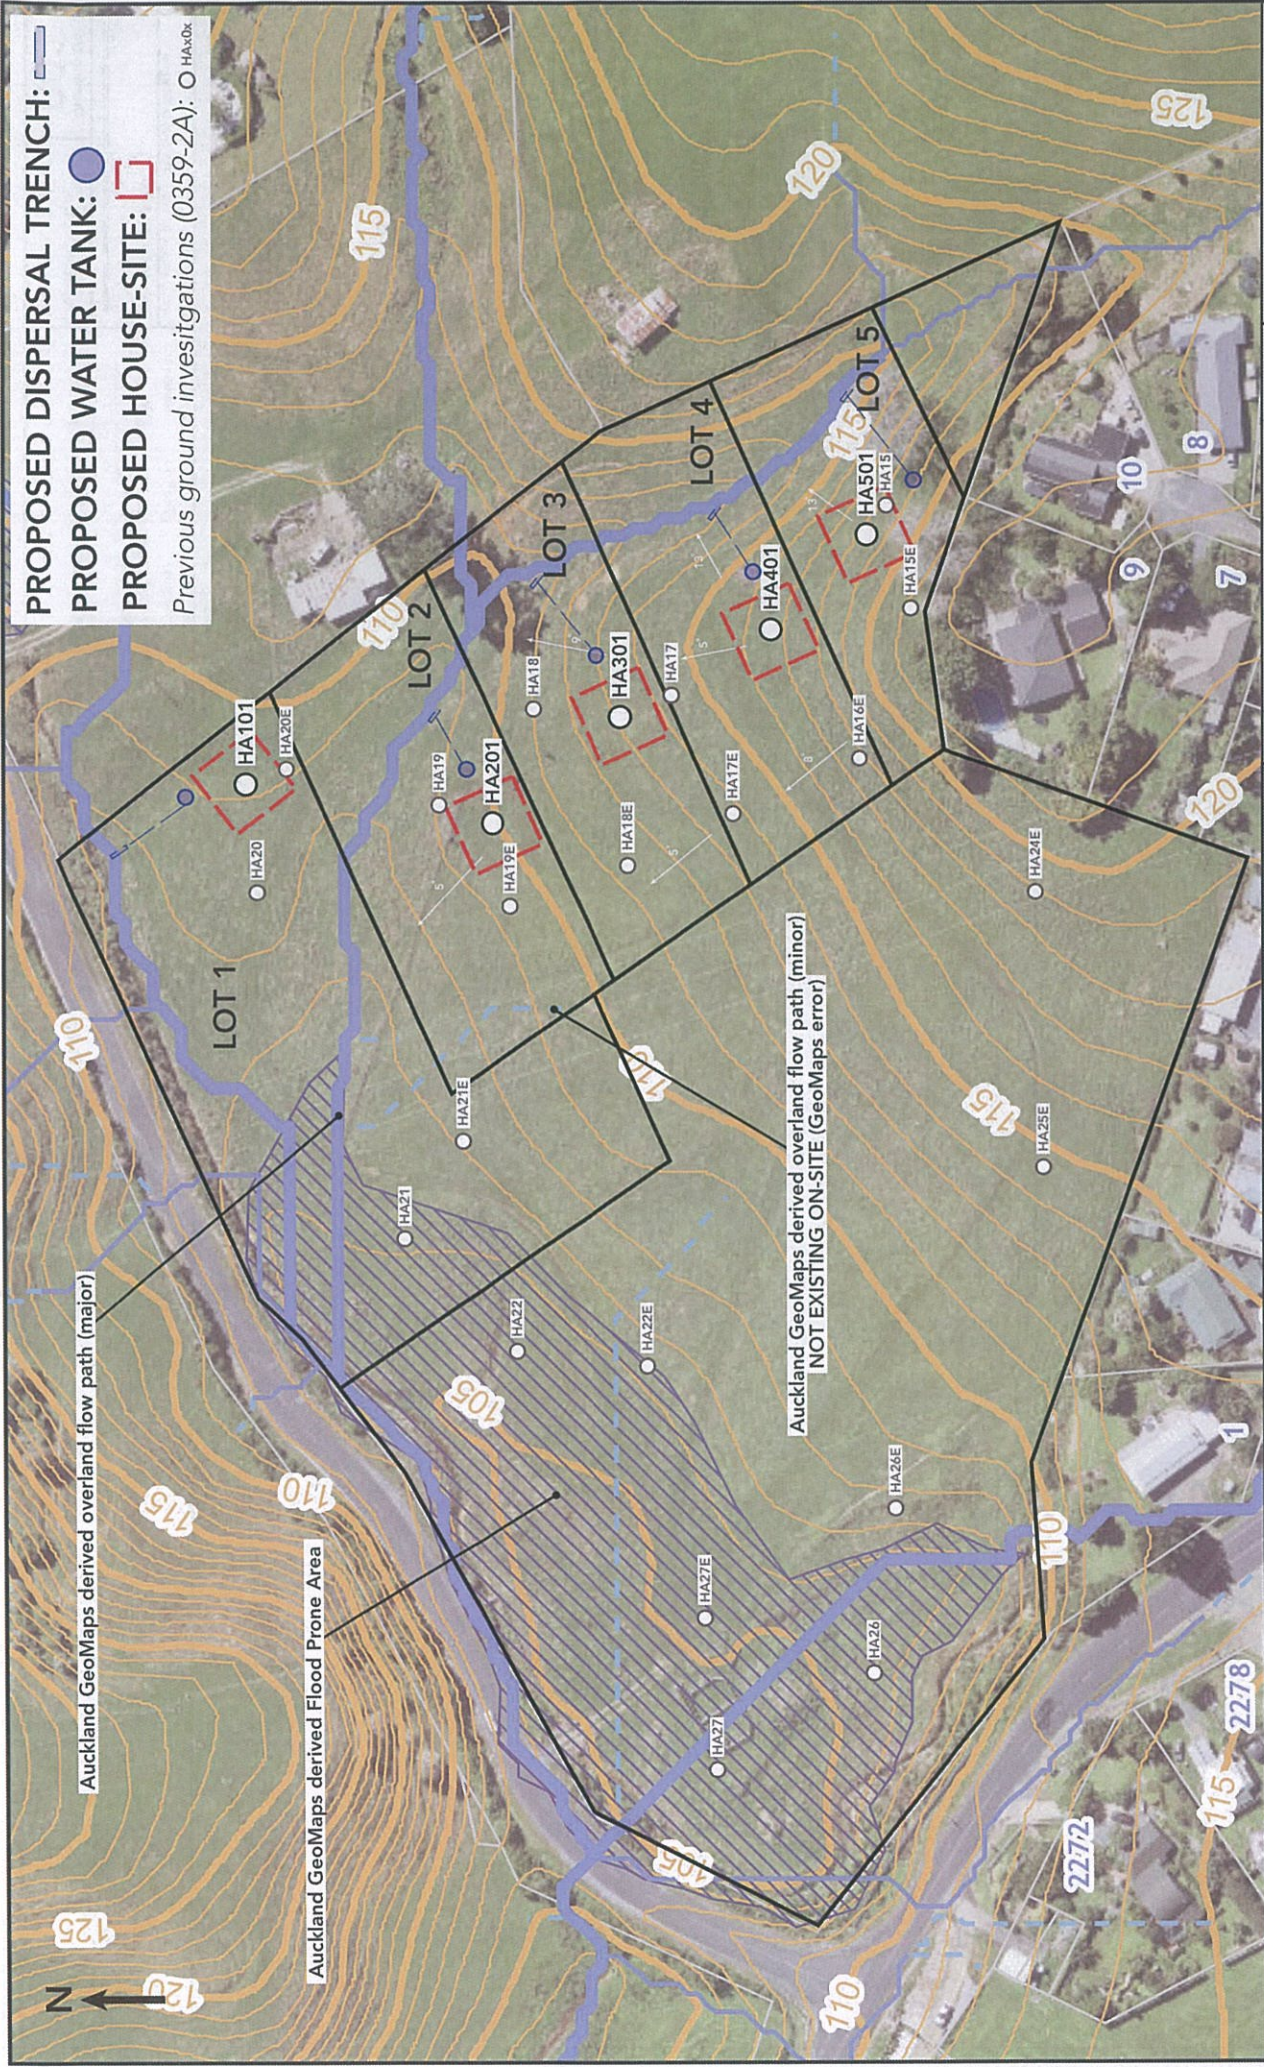
HUNUA PROPERTY DEVELOPMENT LTD
WHITE ROAD, HUNUA, AUCKLAND
INVESTIGATION LOCATION PLAN

The investigations have been carried out in accordance with NZS3604:2011 and the Building Code. The investigation locations are shown on Drawing 002.

Stormwater disposal is proposed to be located within the eastern portions of each Lot, as shown on Drawing 002. The details of stormwater control and management is provided within Section 7 of this report.

The assessed house sites are shown on Drawing 002. The proposed house sites are located on broad gently sloping topography which is underlain by competent ground conditions and is remote from steeper slopes and/or slopes prone to the development of slope instability features.
