Geotechnical Report

19 Woodside Terrace
Andersons Bay, Dunedin

GeoSolve Ref: 180505

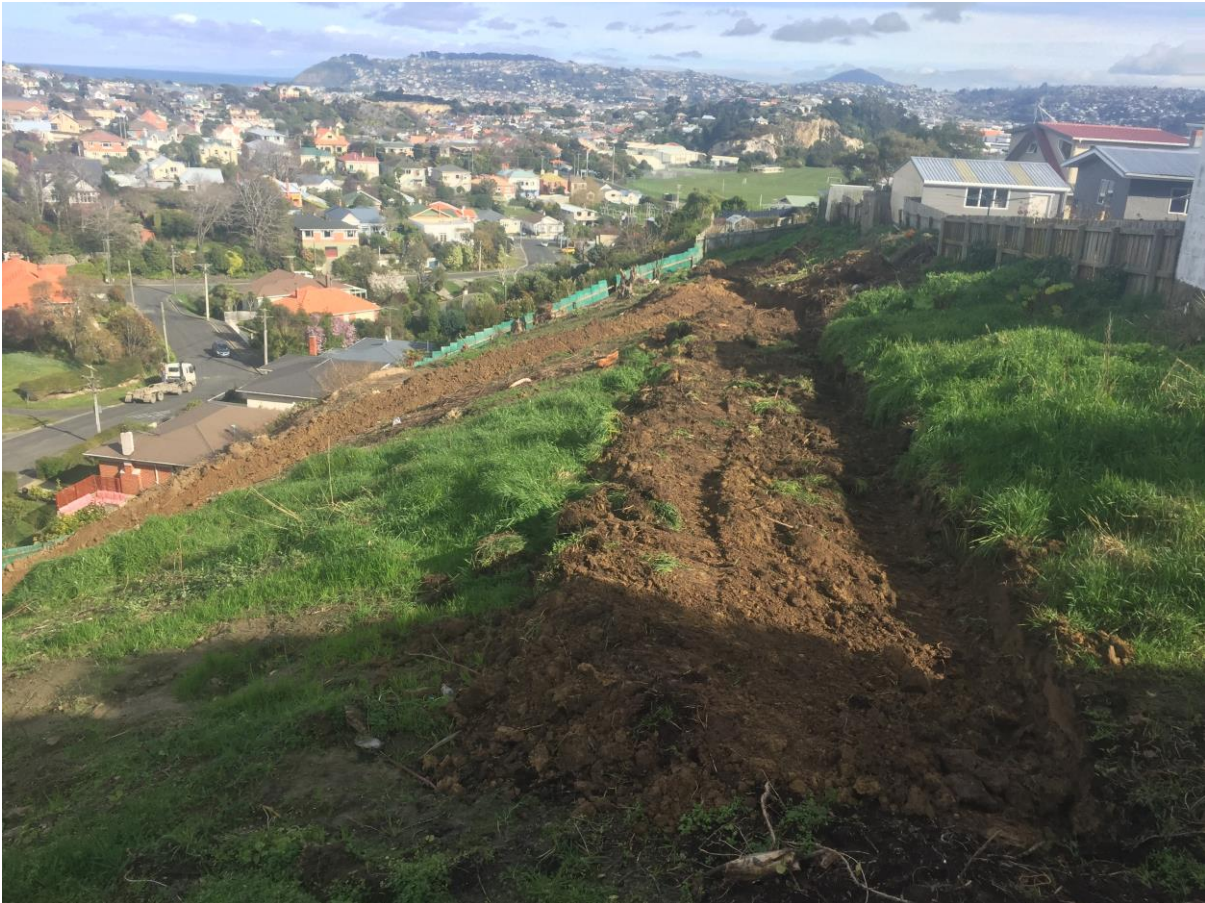
Figure 1.1 – Proposed building platform, 19 Woodside Terrace

We understand that the current proposal is to establish a series of level building platforms along the elevated extent of the site to support the garage, with two levels of each apartment above. The intent is to cut into the slope to allow foundations to be constructed

on cut material below the garage. Cuts to establish the building platforms are estimated to be approximately 2-4 m.

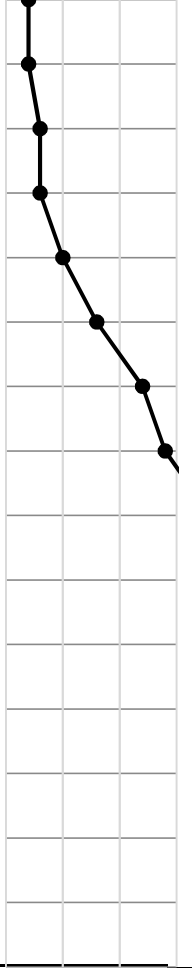
Brown, organic SILT. Soft. Moist.

Grey mottled orange, SILT with minor clay, sand and gravel. Sand is fine to coarse. Gravel is fine to medium, subrounded to subangular. Non-plastic to low plasticity. Firm to stiff. Becomes very stiff from 1.0 m and hard from 1.5 m. Moist to dry.		NO SEEPAGE

Total Depth = 1.8 m

COMMENT: Excavation terminated at 1.8 m as unable to penetrate hard silts.	Logged By: MB
	Checked Date: 5-Sep-18
	Sheet: 1 of 1

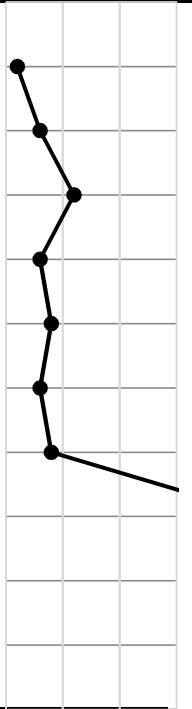
Brown, organic SILT. Soft. Moist.		NO SEEPAGE

0.45	COLLUVIUM

Orange brown, SILT with minor clay and sand. Sand is fine. Non-plastic to low plasticity. Firm. Moist.			
1.1	WEATHERED DUNEDIN VOLCANIC GROUP

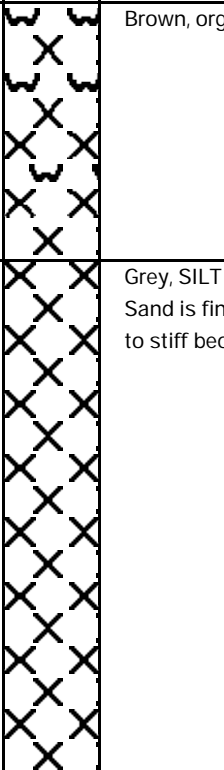
Brown, organic SILT. Soft. Moist.						
1.55	COLLUVIUM

Grey, SILT with a trace of sand and gravel. Mottled orange brown. Sand is fine to coarse. Gravel is fine to medium, subangular. Firm to stiff becoming very stiff. Moist.						
1.6	WEATHERED DUNEDIN VOLCANIC GROUP

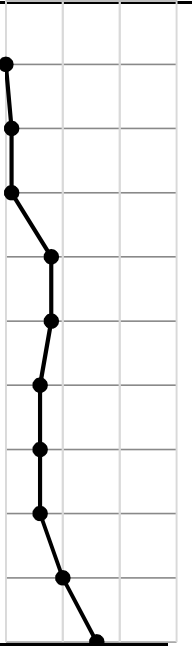
Brown, organic SILT with a trace of roots. Non-plastic. Soft. Moist to wet.		Seepage @ 0.3 m

0.55	LOESS/ COLLUVIUM

Orange brown, SILT with some clay and a trace of gravel. Non-plastic to low plasticity. Soft to firm. Moist. Saturated at 0.3 m.			
1.0	WEATHERED DUNEDIN VOLCANIC GROUP

Groundwater seepage was observed at 0.3 m below ground level at AH 7. Other than AH 7, soils were observed to be in moist condition. Seepage is evident at the base of the slope immediately above the stream.

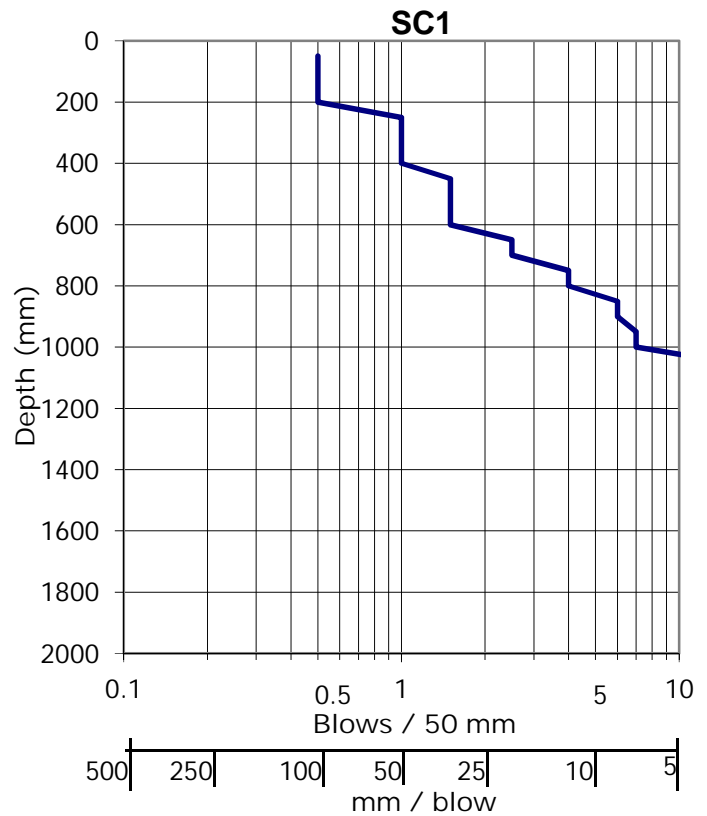
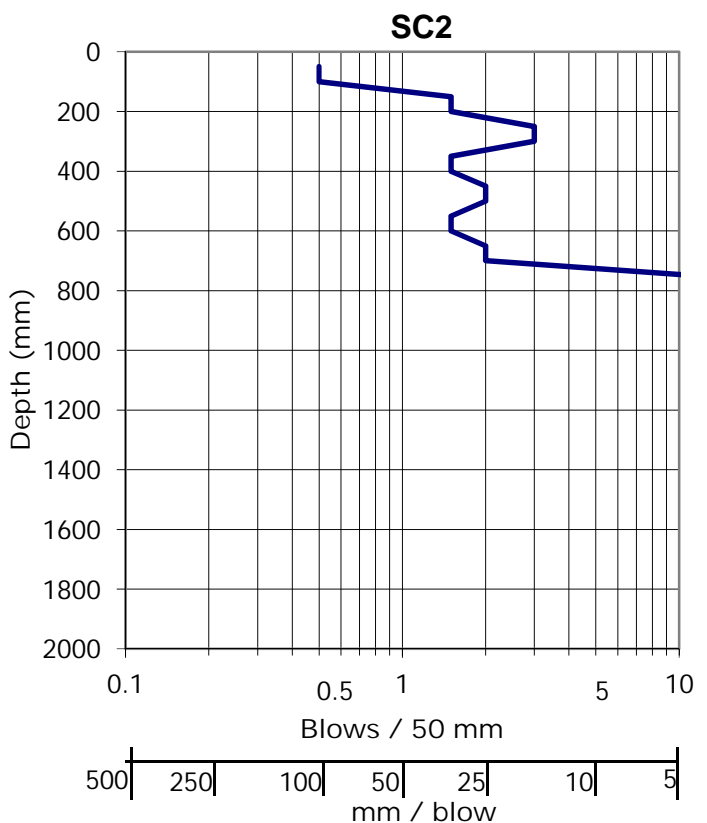
Test Number	SC1 & SC2
Sheet of	1 of 5

SC1		SC2	
Location: TP1 RL: 0 m		Location: TP2 RL: 0 m	
mm Driven	No. of Blows	mm Driven	No. of Blows
50	0.5	50	0.5
100	0.5	100	0.5
150	0.5	150	1.5
200	0.5	200	1.5
250	1	250	3
300	1	300	3
350	1	350	1.5
400	1	400	1.5
450	1.5	450	2
500	1.5	500	2
550	1.5	550	1.5
600	1.5	600	1.5
650	2.5	650	2
700	2.5	700	2
750	4	750	11.5
800	4	800	11.5
850	6	850	
900	6	900	
950	7	950	
1000	7	1000	
1050	15	1050	
1100		1100	
1150		1150	
1200		1200	
1250		1250	
1300		1300	
1350		1350	
1400		1400	
1450		1450	
1500		1500	
1550		1550	
1600		1600	
1650		1650	
1700		1700	
1750		1750	
1800		1800	
1850		1850	
1900		1900	
1950		1950	
2000		2000	
Inferred Soil Type		Inferred Soil Type	
Watertable Depth		Watertable Depth

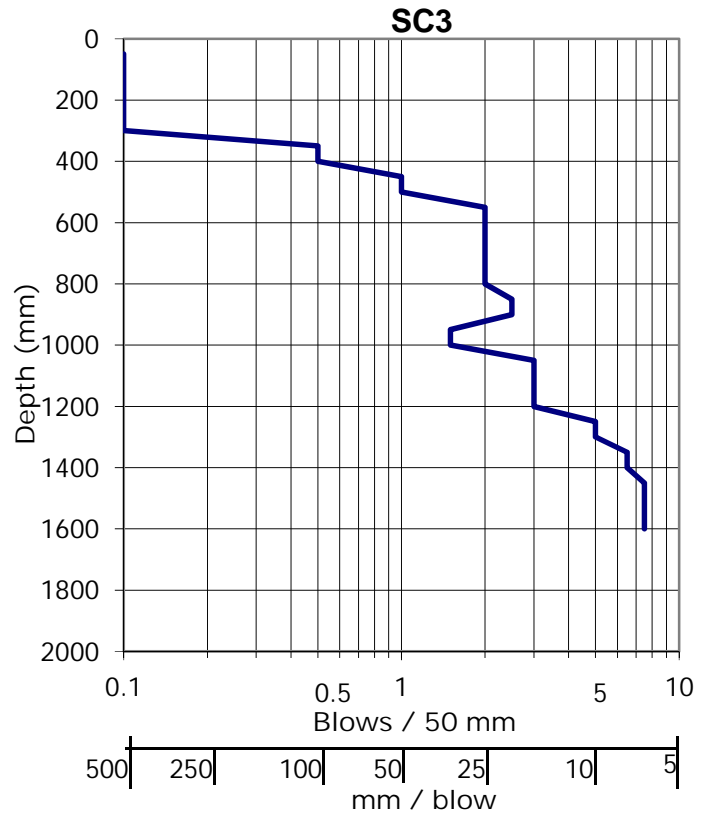
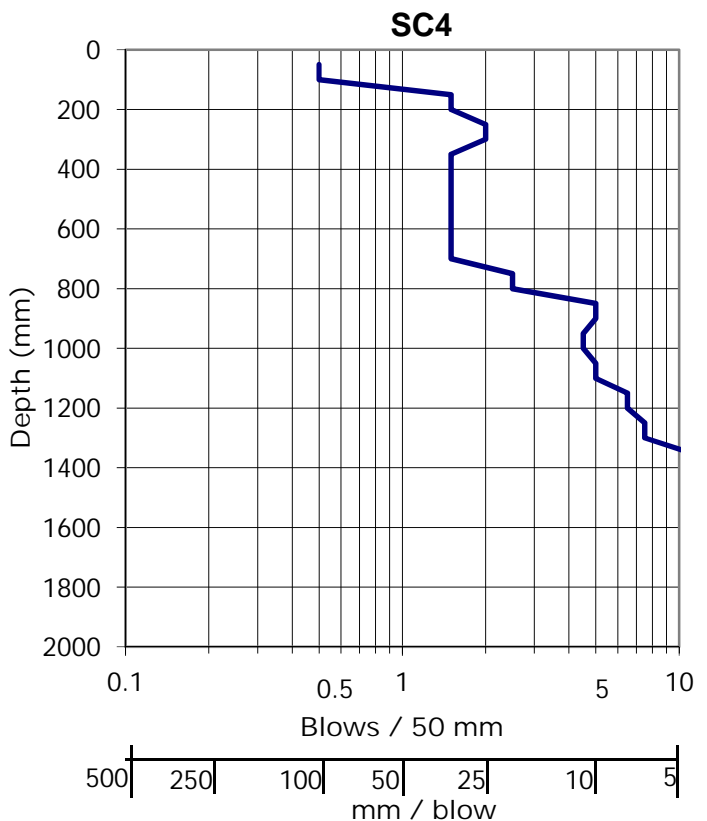
Test Number	SC3 & SC4
Sheet of	2 of 5

SC3		SC4	
Location: TP3 RL: 0 m		Location: TP4 RL: 0 m	
mm Driven	No. of Blows	mm Driven	No. of Blows
50	0.1	50	0.5
100	0.1	100	0.5
150	0.1	150	1.5
200	0.1	200	1.5
250	0.1	250	2
300	0.1	300	2
350	0.5	350	1.5
400	0.5	400	1.5
450	1	450	1.5
500	1	500	1.5
550	2	550	1.5
600	2	600	1.5
650	2	650	1.5
700	2	700	1.5
750	2	750	2.5
800	2	800	2.5
850	2.5	850	5
900	2.5	900	5
950	1.5	950	4.5
1000	1.5	1000	4.5
1050	3	1050	5
1100	3	1100	5
1150	3	1150	6.5
1200	3	1200	6.5
1250	5	1250	7.5
1300	5	1300	7.5
1350	6.5	1350	11
1400	6.5	1400	
1450	7.5	1450	
1500	7.5	1500	
1550	7.5	1550	
1600	7.5	1600	
1650		1650	
1700		1700	
1750		1750	
1800		1800	
1850		1850	
1900		1900	
1950		1950	
2000		2000	
Inferred Soil Type		Inferred Soil Type	
Watertable Depth		Watertable Depth

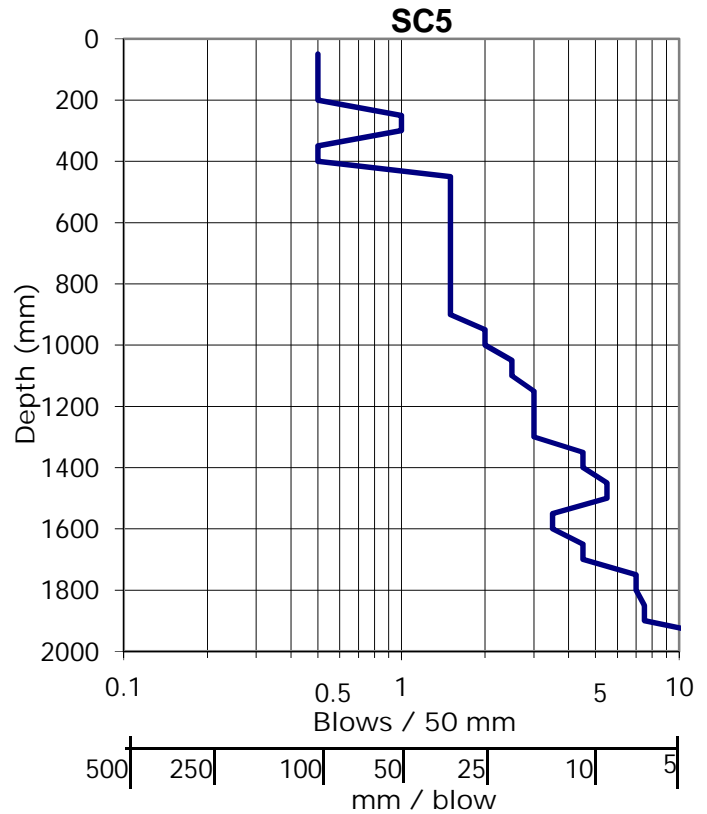
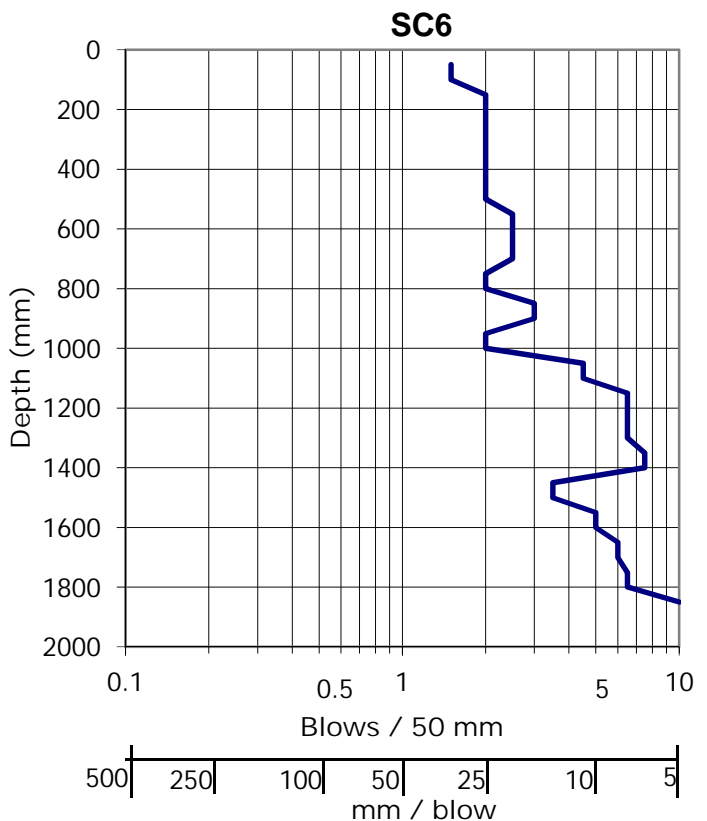
Test Number	SC5 & SC6
Sheet of	3 of 5

SC5		SC6	
Location: TP5 RL: 0 m		Location: AH6 RL: 0 m	
mm Driven	No. of Blows	mm Driven	No. of Blows
50	0.5	50	1.5
100	0.5	100	1.5
150	0.5	150	2
200	0.5	200	2
250	1	250	2
300	1	300	2
350	0.5	350	2
400	0.5	400	2
450	1.5	450	2
500	1.5	500	2
550	1.5	550	2.5
600	1.5	600	2.5
650	1.5	650	2.5
700	1.5	700	2.5
750	1.5	750	2
800	1.5	800	2
850	1.5	850	3
900	1.5	900	3
950	2	950	2
1000	2	1000	2
1050	2.5	1050	4.5
1100	2.5	1100	4.5
1150	3	1150	6.5
1200	3	1200	6.5
1250	3	1250	6.5
1300	3	1300	6.5
1350	4.5	1350	7.5
1400	4.5	1400	7.5
1450	5.5	1450	3.5
1500	5.5	1500	3.5
1550	3.5	1550	5
1600	3.5	1600	5
1650	4.5	1650	6
1700	4.5	1700	6
1750	7	1750	6.5
1800	7	1800	6.5
1850	7.5	1850	10
1900	7.5	1900	
1950	14	1950	
2000		2000	
Inferred Soil Type		Inferred Soil Type	
Watertable Depth		Watertable Depth

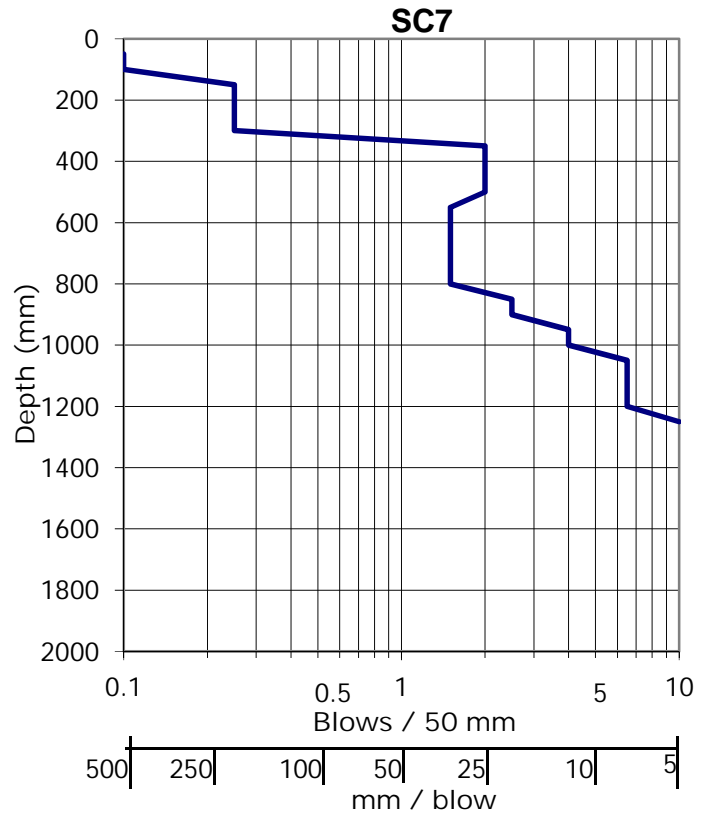
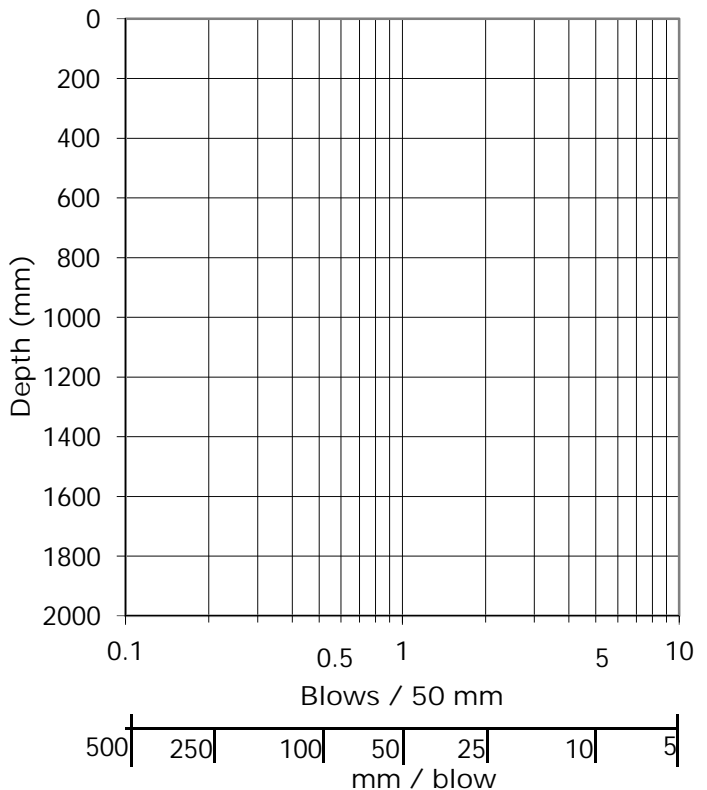
Test Number	SC7
Sheet of	4 of 5

SC7		Location:	
Location: AH7		RL:	
RL: 0 m		RL:	
mm Driven	No. of Blows	mm Driven	No. of Blows
50	0.1	50	
100	0.1	100	
150	0.25	150	
200	0.25	200	
250	0.25	250	
300	0.25	300	
350	2	350	
400	2	400	
450	2	450	
500	2	500	
550	1.5	550	
600	1.5	600	
650	1.5	650	
700	1.5	700	
750	1.5	750	
800	1.5	800	
850	2.5	850	
900	2.5	900	
950	4	950	
1000	4	1000	
1050	6.5	1050	
1100	6.5	1100	
1150	6.5	1150	
1200	6.5	1200	
1250	10	1250	
1300		1300	
1350		1350	
1400		1400	
1450		1450	
1500		1500	
1550		1550	
1600		1600	
1650		1650	
1700		1700	
1750		1750	
1800		1800	
1850		1850	
1900		1900	
1950		1950	
2000		2000	
Inferred Soil Type		Inferred Soil Type	
Watertable Depth		Watertable Depth

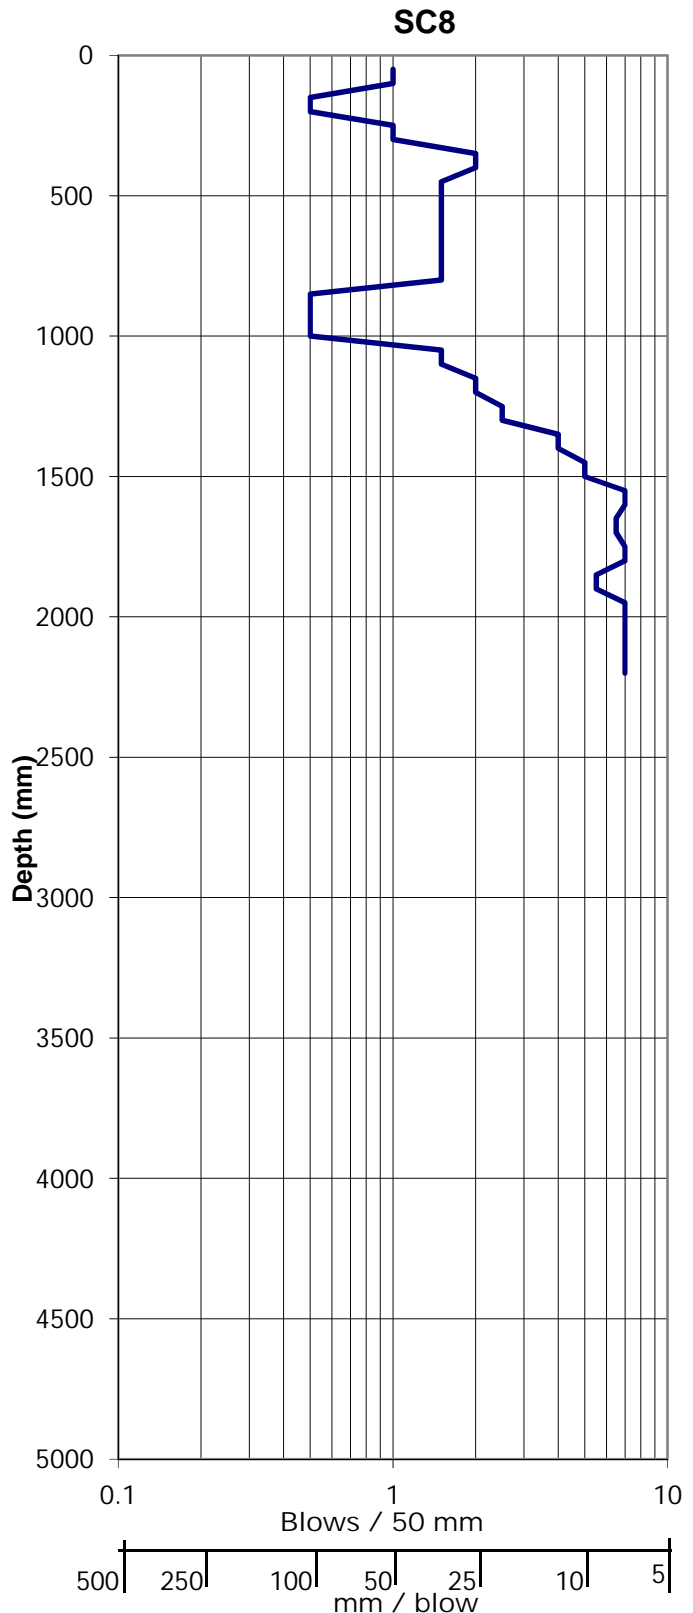
SC8	
mm Driven	No. of Blows
50	1
100	1
150	0.5
200	0.5
250	1
300	1
350	2
400	2
450	1.5
500	1.5
550	1.5
600	1.5
650	1.5
700	1.5
750	1.5
800	1.5
850	0.5
900	0.5
950	0.5
1000	0.5
1050	1.5
1100	1.5
1150	2
1200	2
1250	2.5
1300	2.5
1350	4
1400	4
1450	5
1500	5
1550	7
1600	7
1650	6.5
1700	6.5
1750	7
1800	7
1850	5.5
1900	5.5
1950	7
2000	7
2050	7
2100	7
2150	7
2200	7
2250	
2300	
2350	
2400	
2450	
2500

SC8 cont...	
mm Driven	No. of Blows
2550	
2600	
2650	
2700	
2750	
2800	
2850	
2900	
2950	
3000	
3050	
3100	
3150	
3200	
3250	
3300	
3350	
3400	
3450	
3500	
3550	
3600	
3650	
3700	
3750	
3800	
3850	
3900	
3950	
4000	
4050	
4100	
4150	
4200	
4250	
4300	
4350	
4400	
4450	
4500	
4550	
4600	
4650	
4700	
4750	
4800	
4850	
4900	
4950	
5000

Test Method Used: NZS 4402:1988 Test 6.5.2 Dynamic Cone Penetrometer
