**Fran Muraahi**  
**21 Island View Road, Rotorua**  
**Proposed Dwelling**  
**Geotechnical Assessment Report (V2)**

**14 April 2021**

Stratum Consultants Ltd (Stratum) has been engaged by Fran Muraahi to carry out a geotechnical assessment for the proposed subdivision at 21 Island View Road, Rotorua (the site).

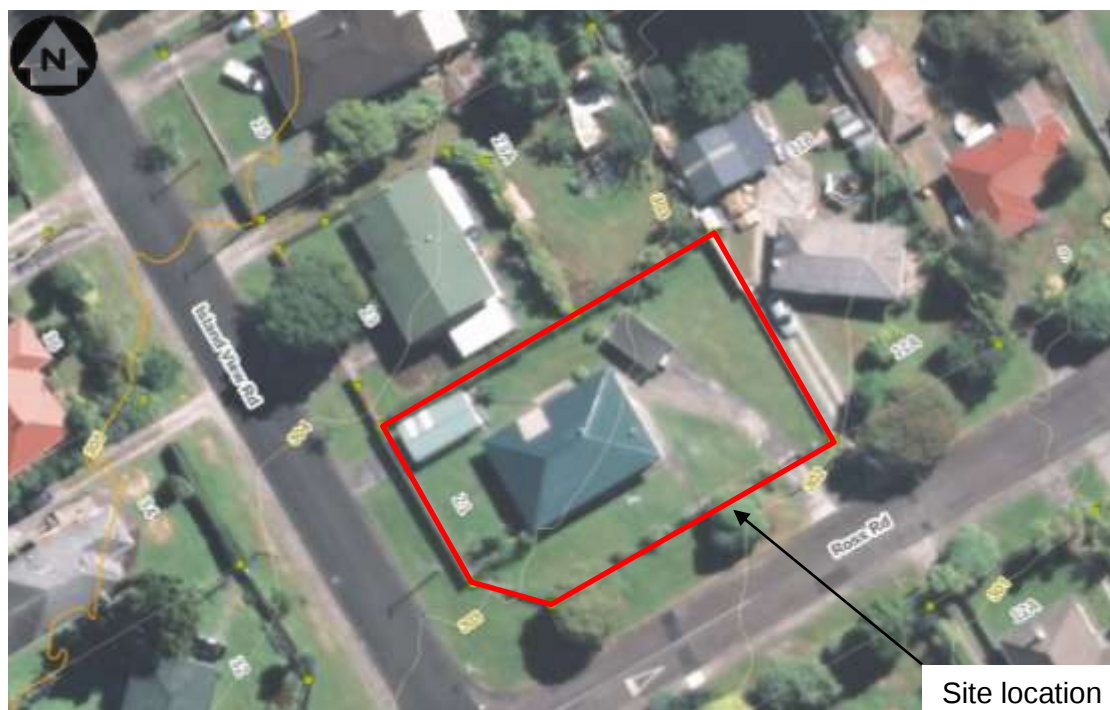
Figure 1: Site Setting

The topography of the site and surrounding area (one metre contours) is shown below on Figure 1.

The site is within residential area of Rotorua, located on the corner of Ross Road and Island View Road, approximately 2.2km south-west of Lake Rotorua. The site is approximately 995m<sup>2</sup> and contains an existing dwelling and two detached single garages. The topography of the site gently slopes to the south-east, ranging between approximately RL 302m to 304m above the Moturiki Datum

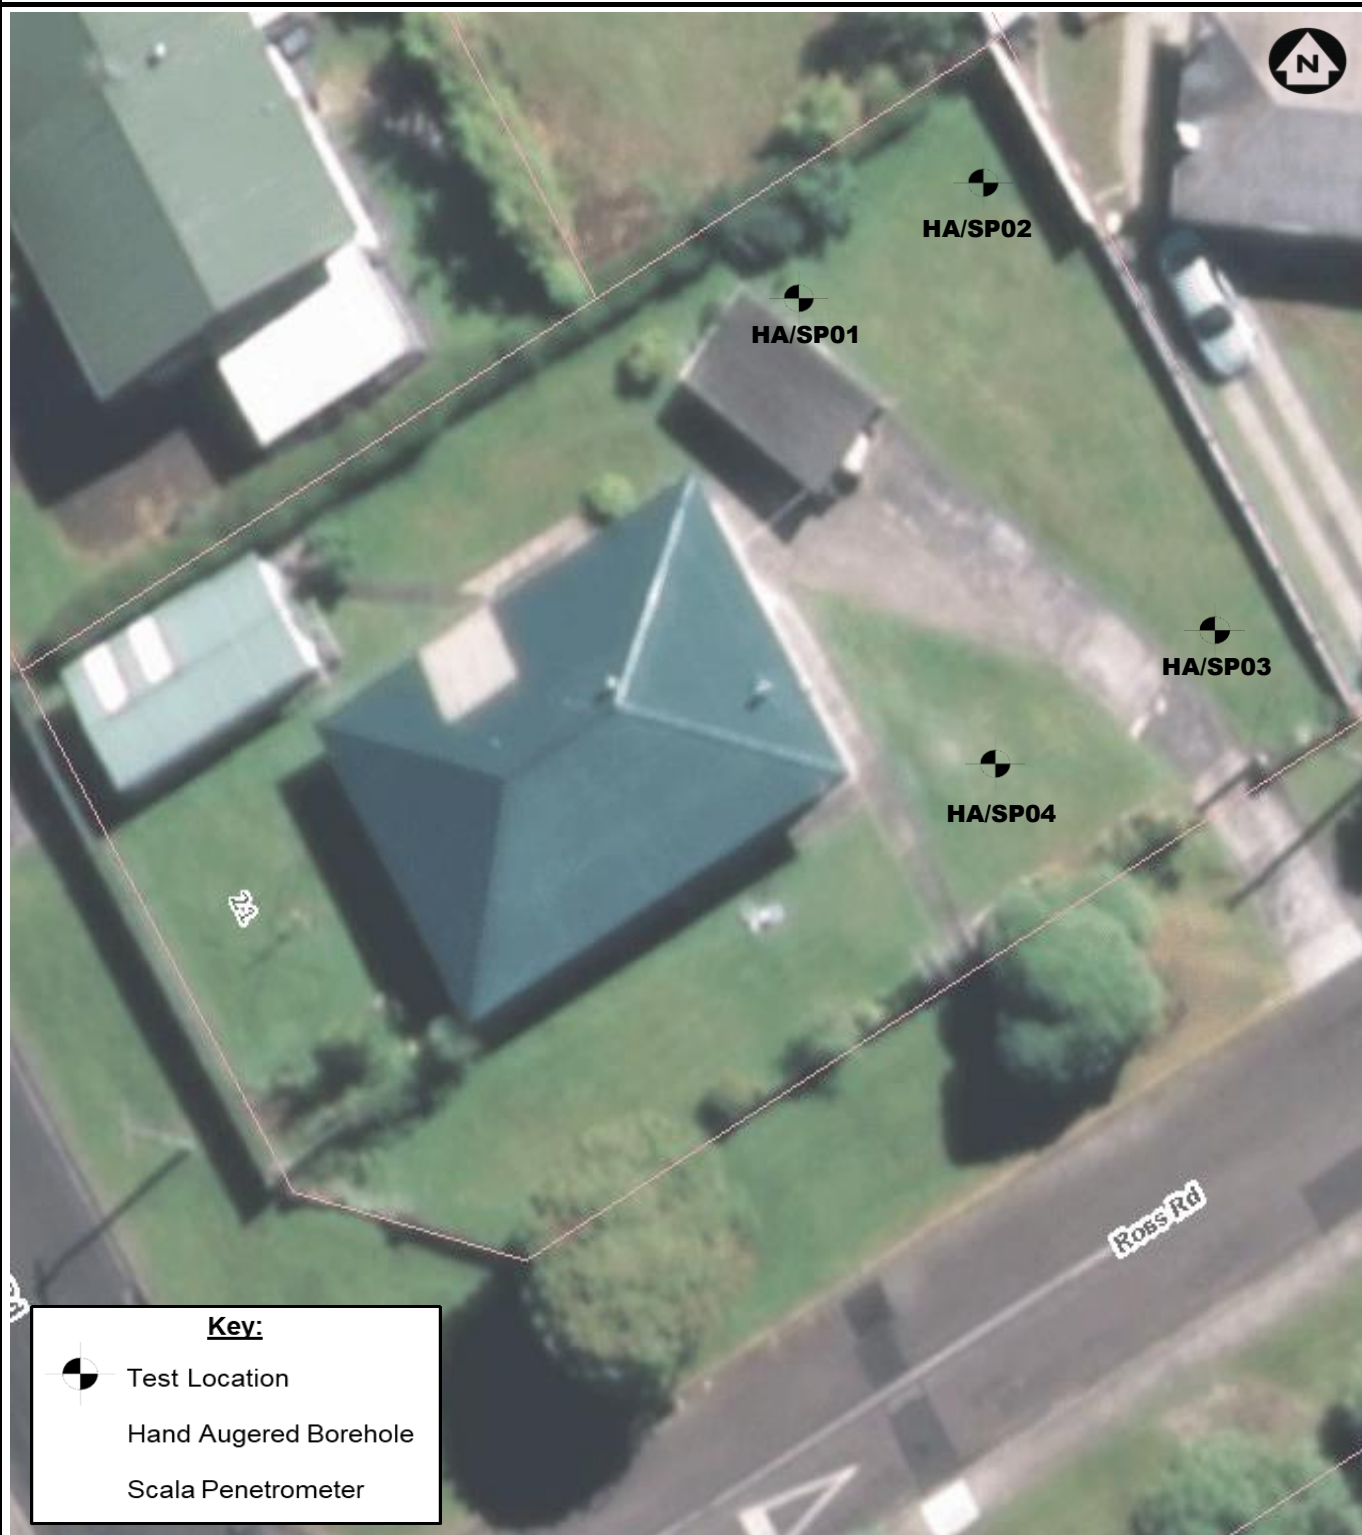
### Test Location Sketch

The hand augered boreholes, Scala penetrometer and shear vane tests were conducted at the locations shown on the test location plan presented in Appendix C. Borehole logs and test results are also included in Appendix C.

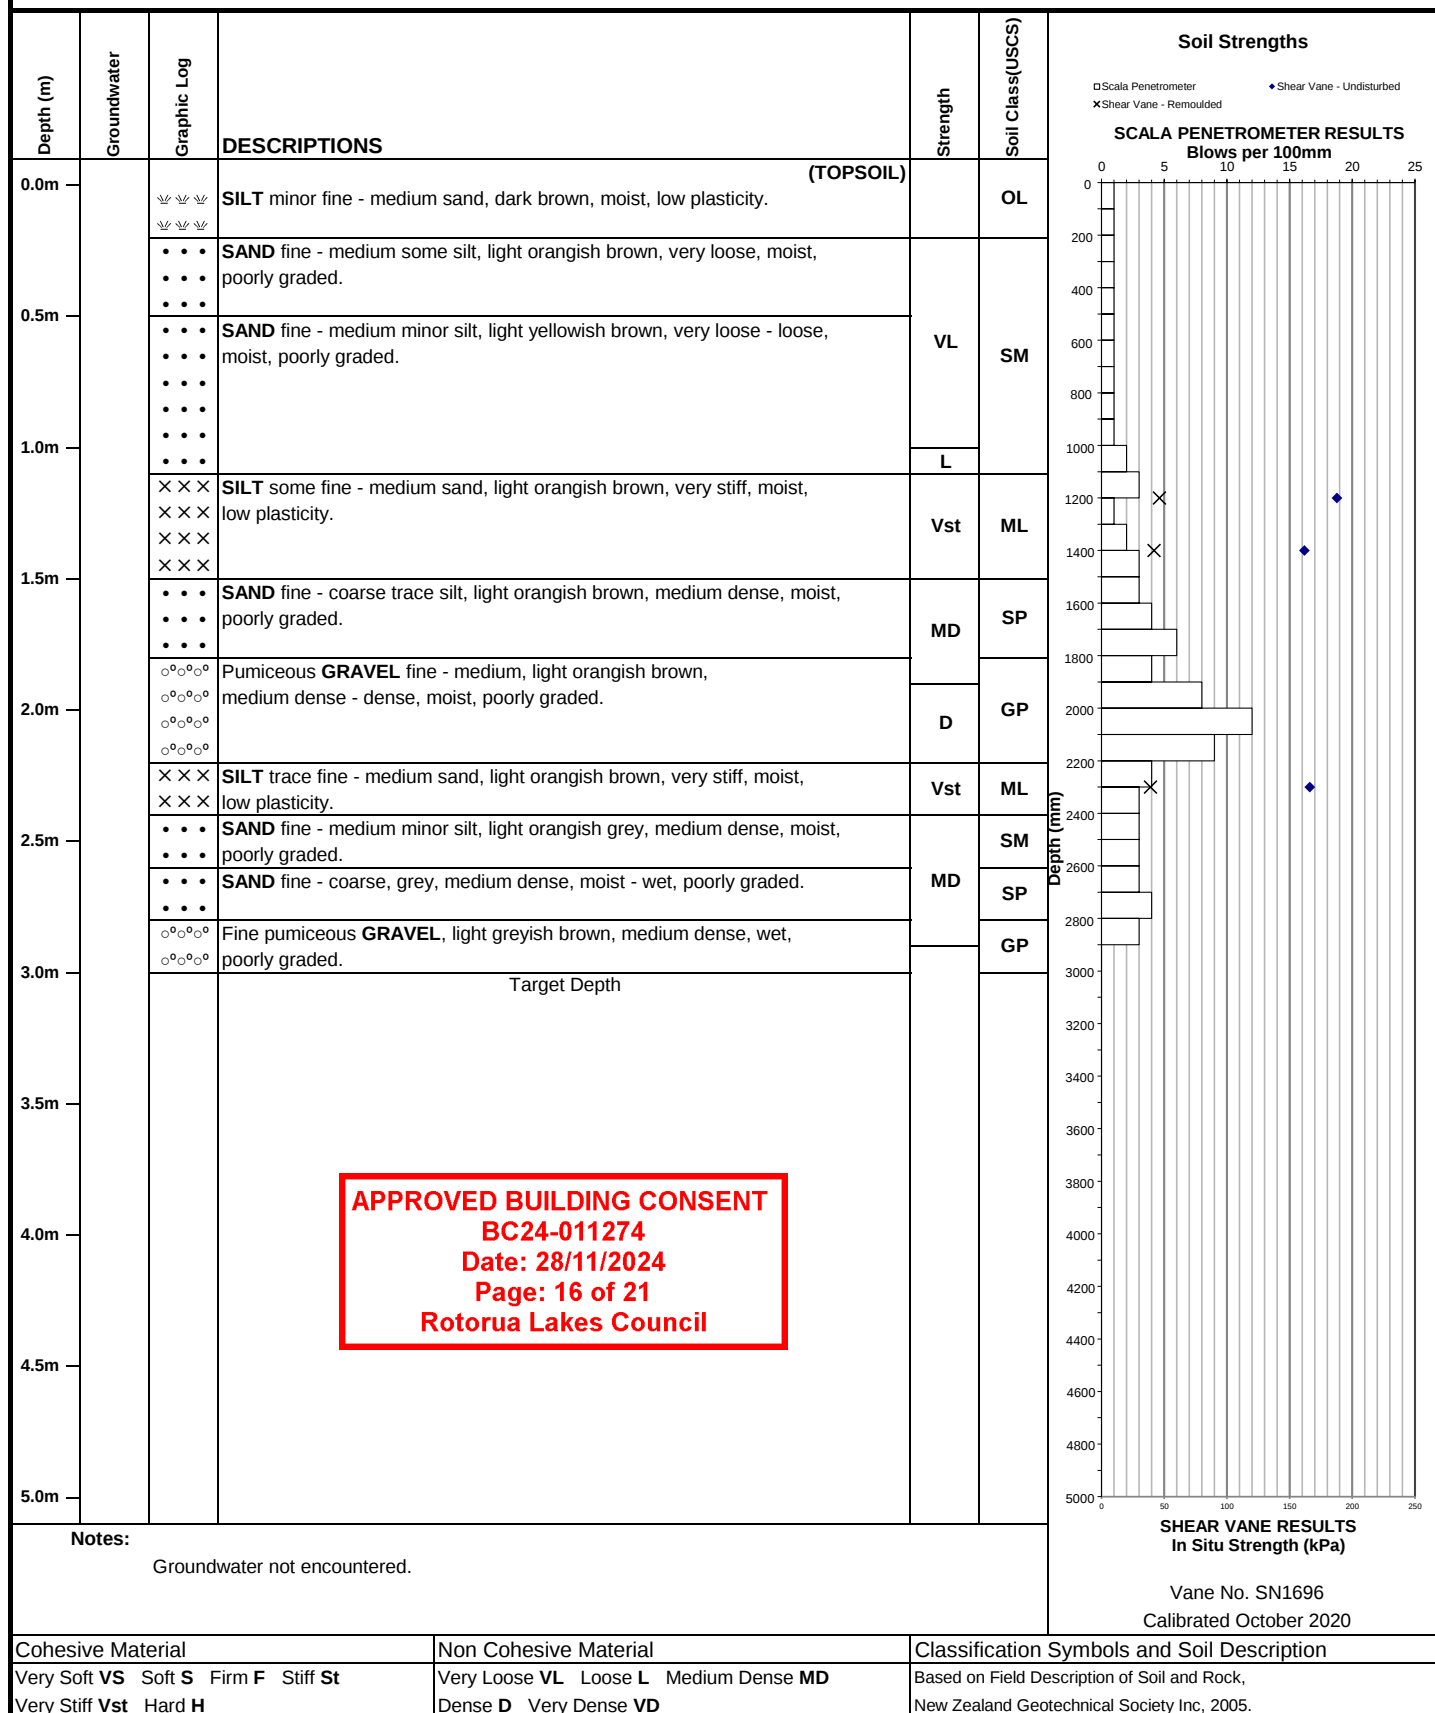
**Borehole No :** HA01

Groundwater not encountered.

The ground conditions encountered in the hand auger boreholes generally comprised topsoil ranging between 0.2m to 0.3m bgl, underlain by very loose to medium dense sands down to a maximum depth of 1.3m bgl. Beneath this, two 0.2 to 0.6m thick layers of very stiff to hard silt were encountered within medium dense to dense sand and pumice gravel. The pumiceous gravel extended to the base of the boreholes (up to 4.4m depth).

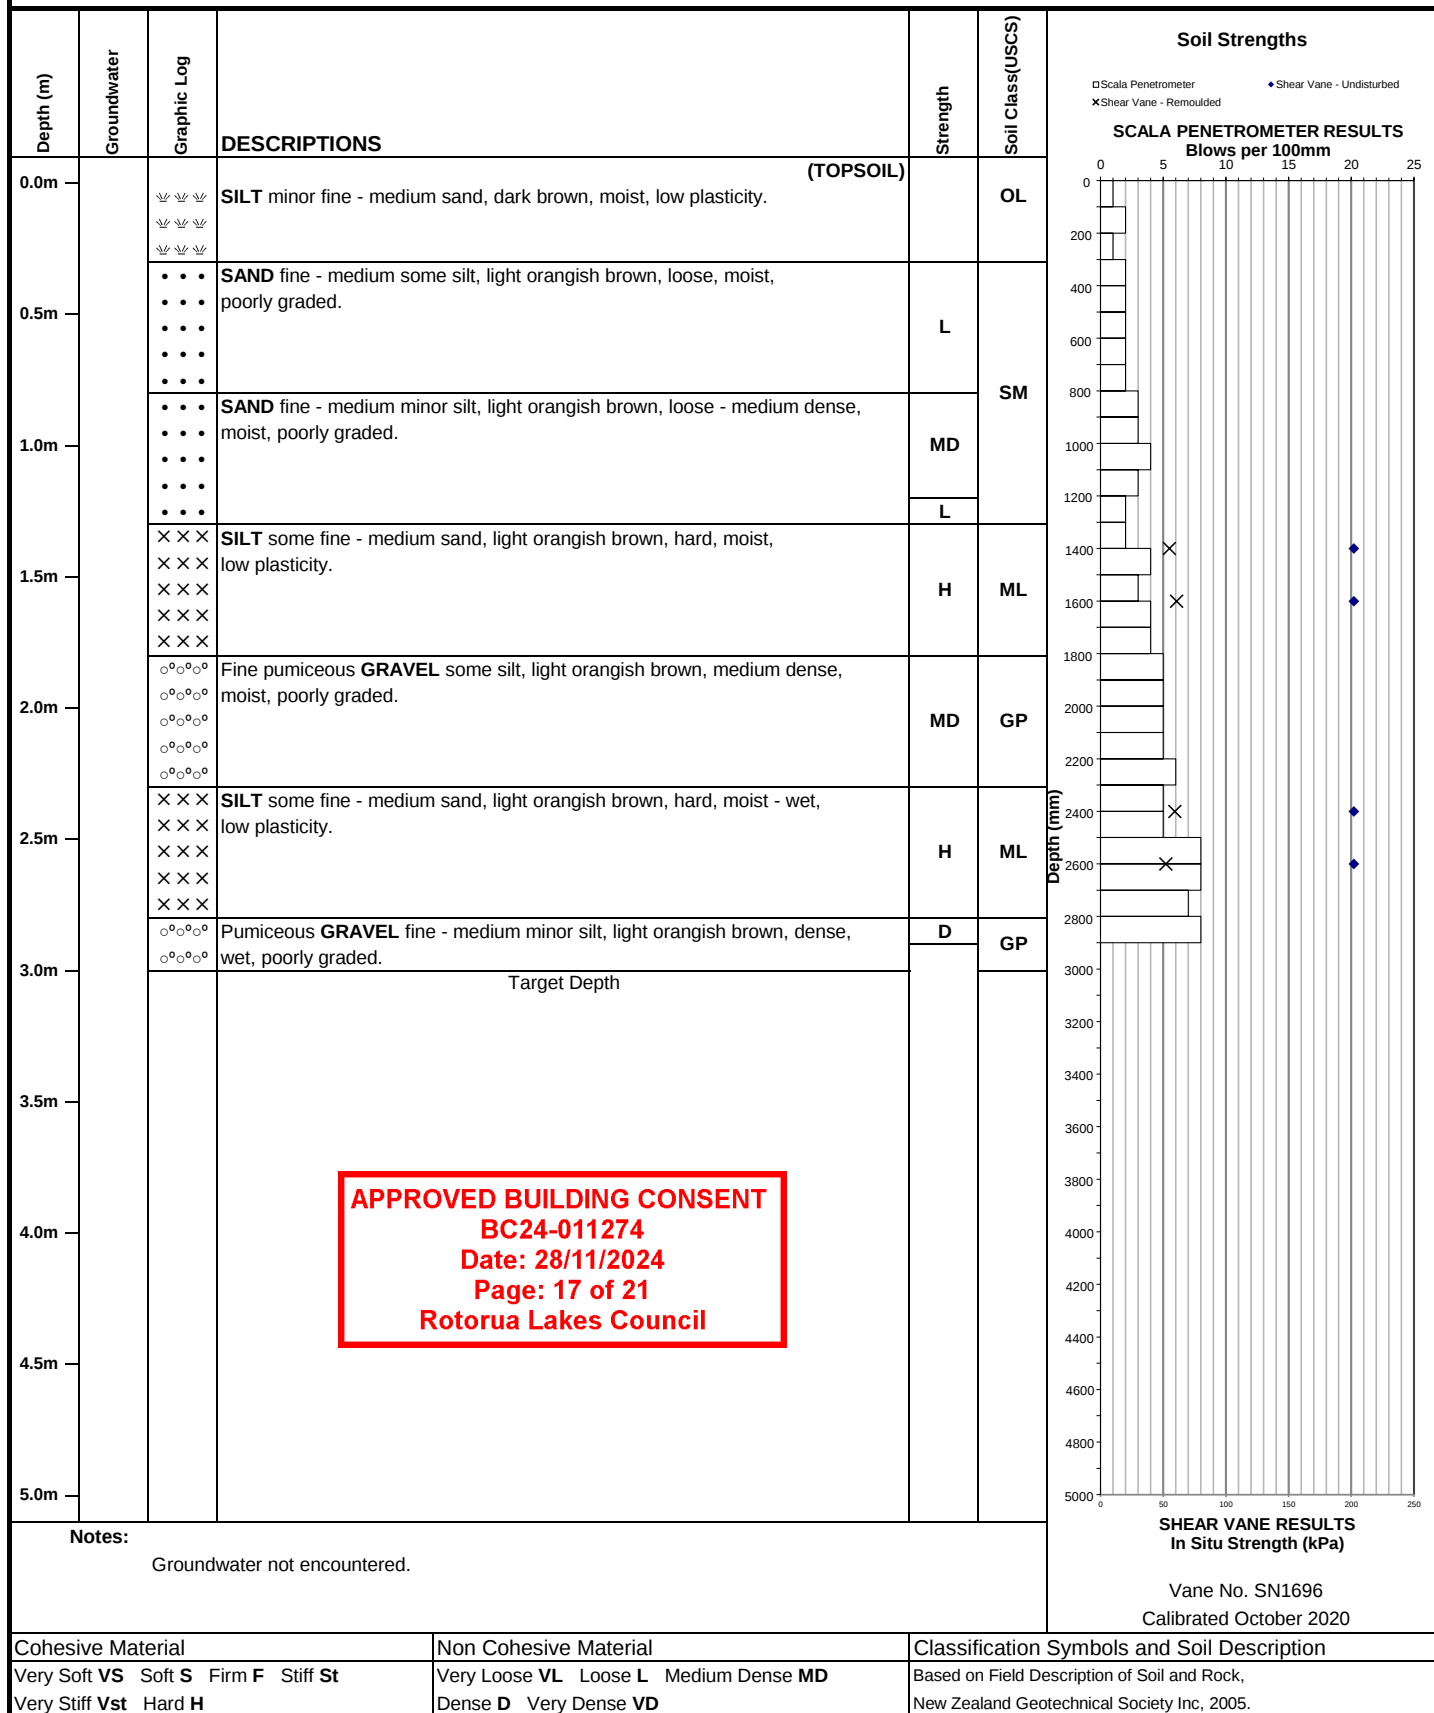
**Borehole No :** HA02

Groundwater not encountered.
