## GoGet Audit Report

Consent No: **24009002**  
Applicant: **Shannon Marie Burgess**  
Site Address: **7 Whitehaven Street, Weston**  
Work Type: **Construction of a 4 bedroom, 2 bathroom dwelling with media room and attached garage.**

Inspection Type: **Wall and Roof Framing**  
Inspection Status: **Fail**  
Inspected By: **Gordon Innes**  
Inspection Date: **9 September 2024 9:52 AM**  
Duration: **60 minutes**

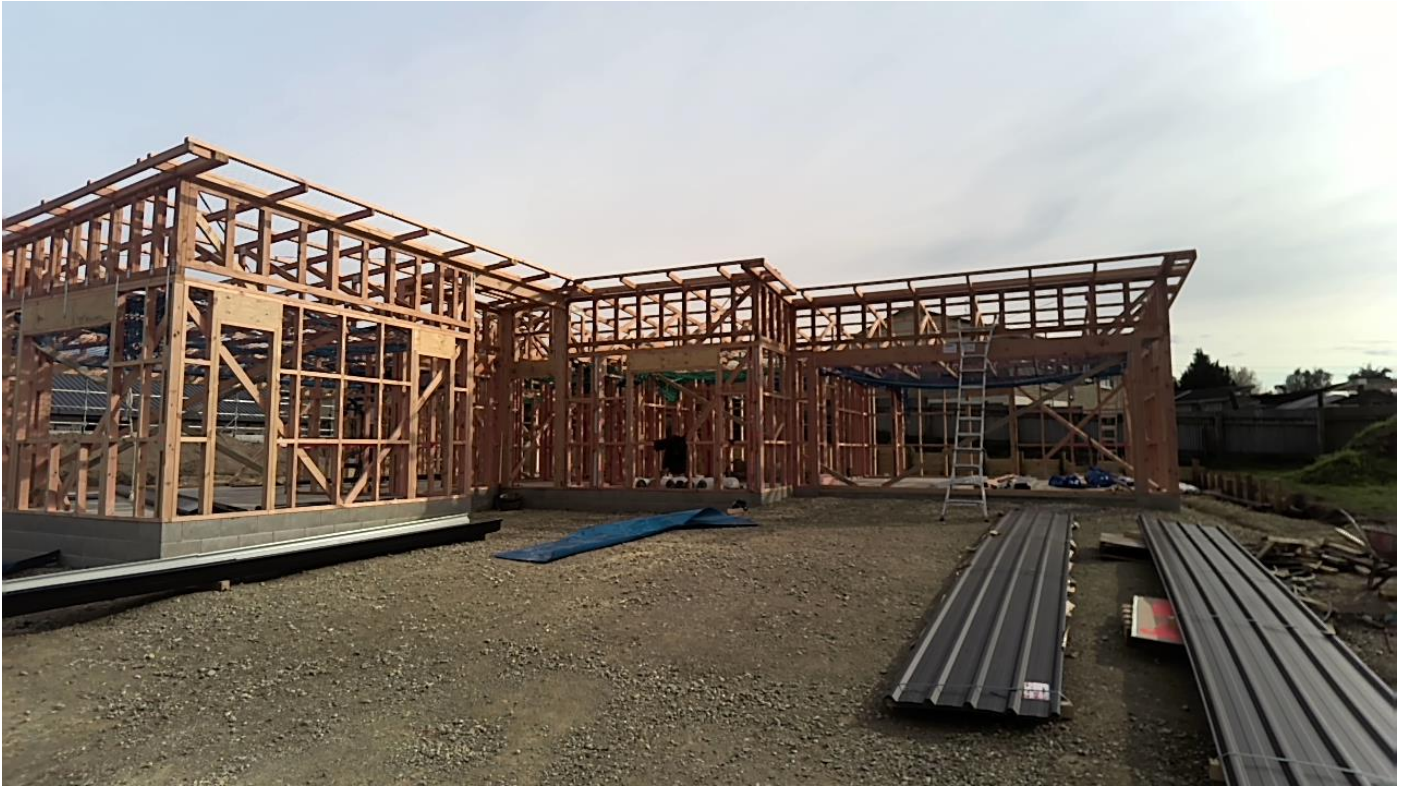
**Framing overview garage area**  
Taken at 9:54 AM on Monday 9/09/2024

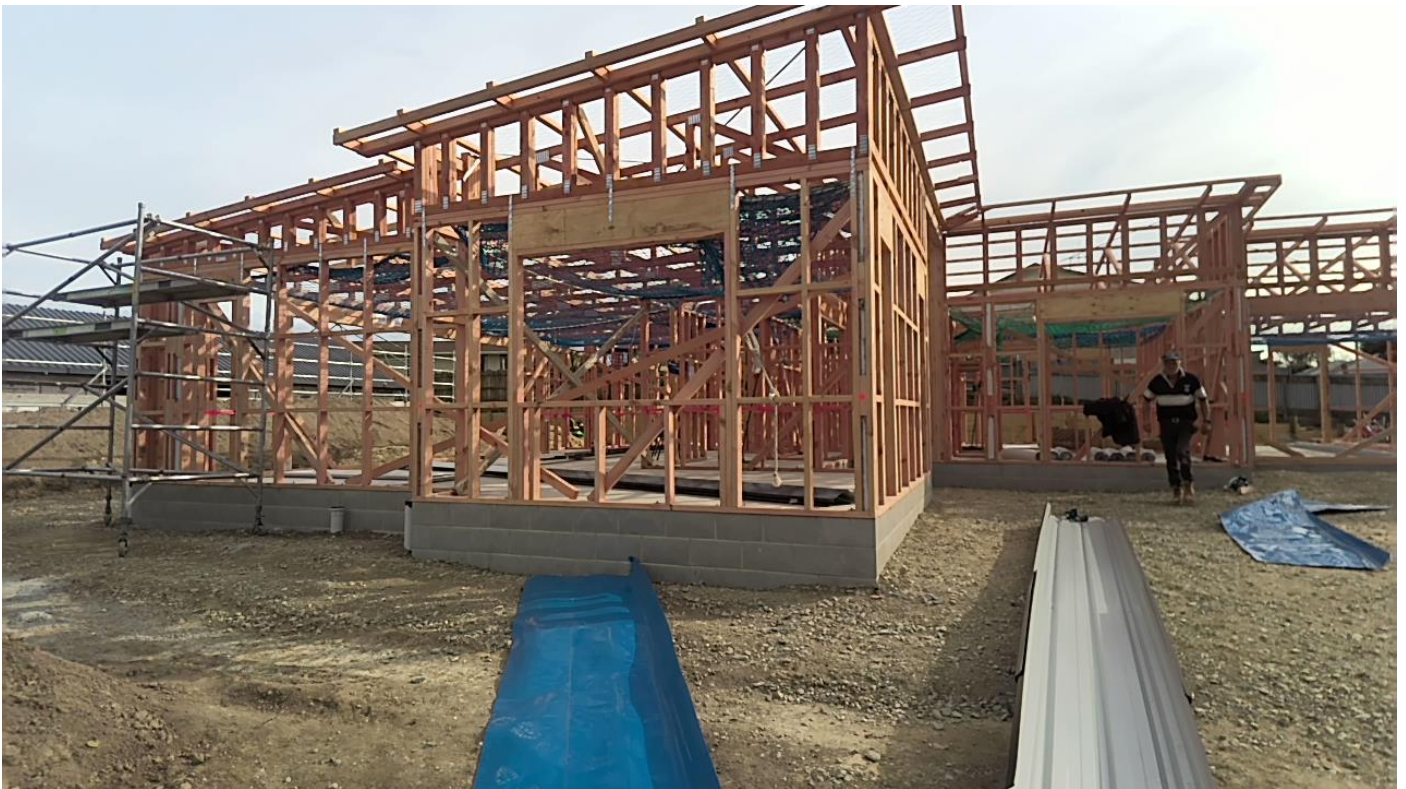
**South elevation**  
Taken at 9:55 AM on Monday 9/09/2024

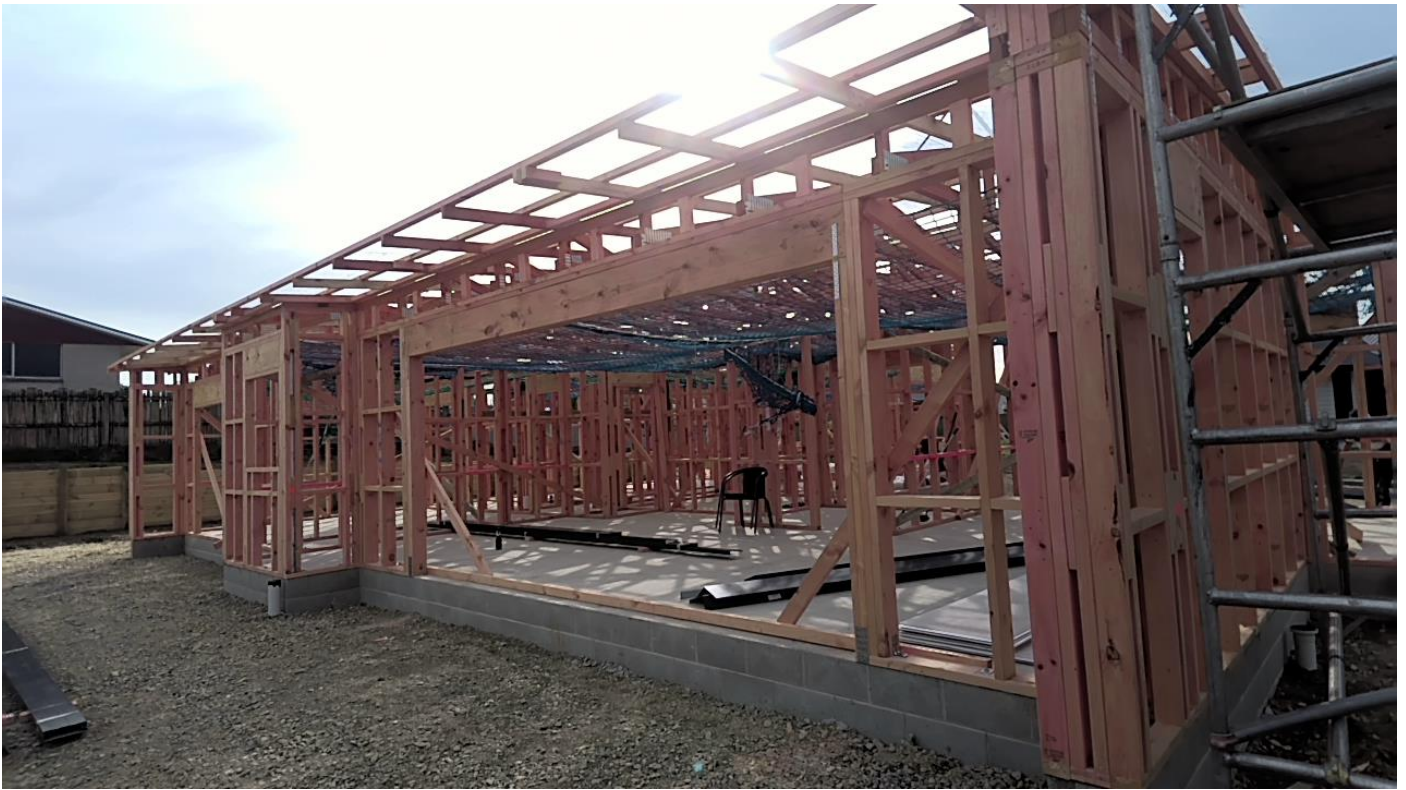
**West elevation**  
Taken at 9:55 AM on Monday 9/09/2024

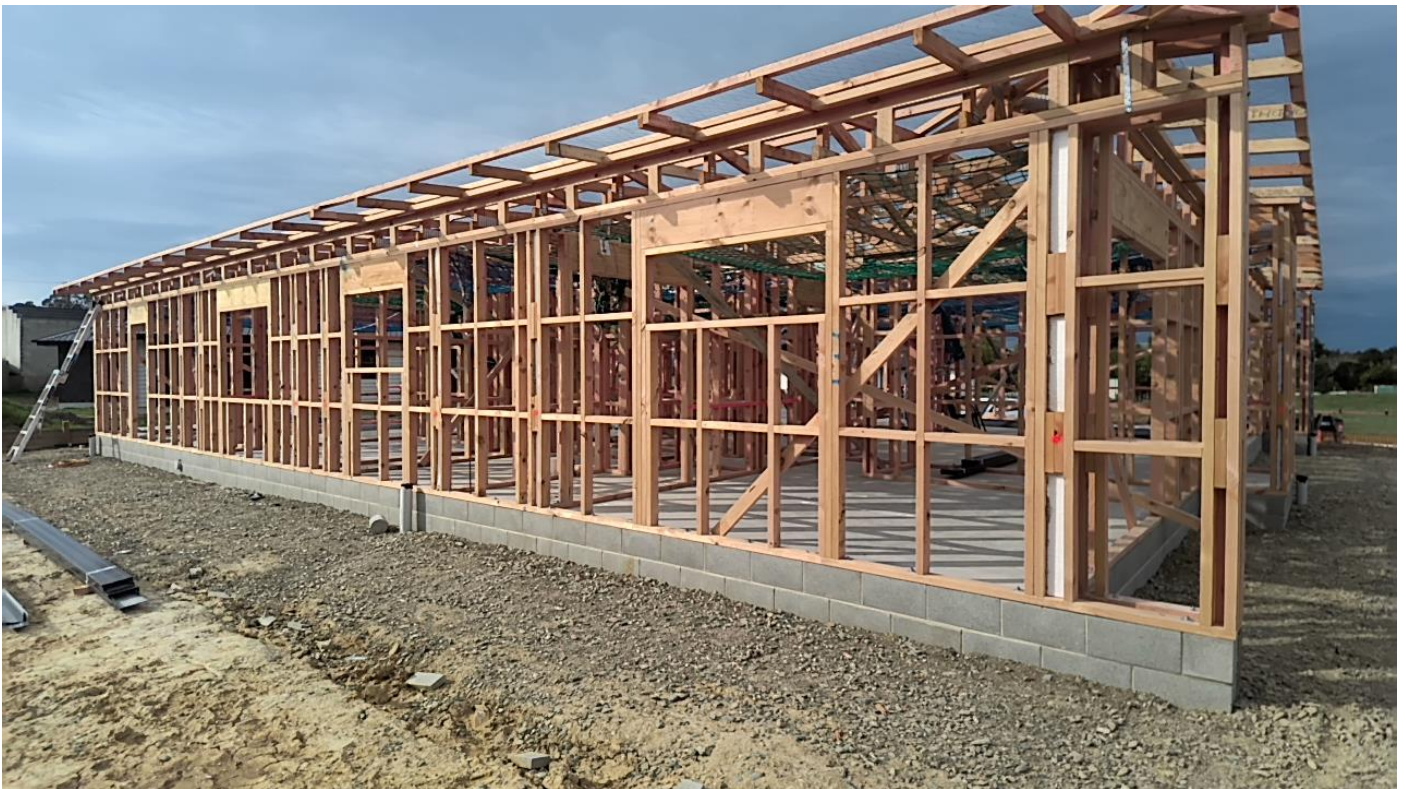
**North elevation framing**  
Taken at 9:56 AM on Monday 9/09/2024

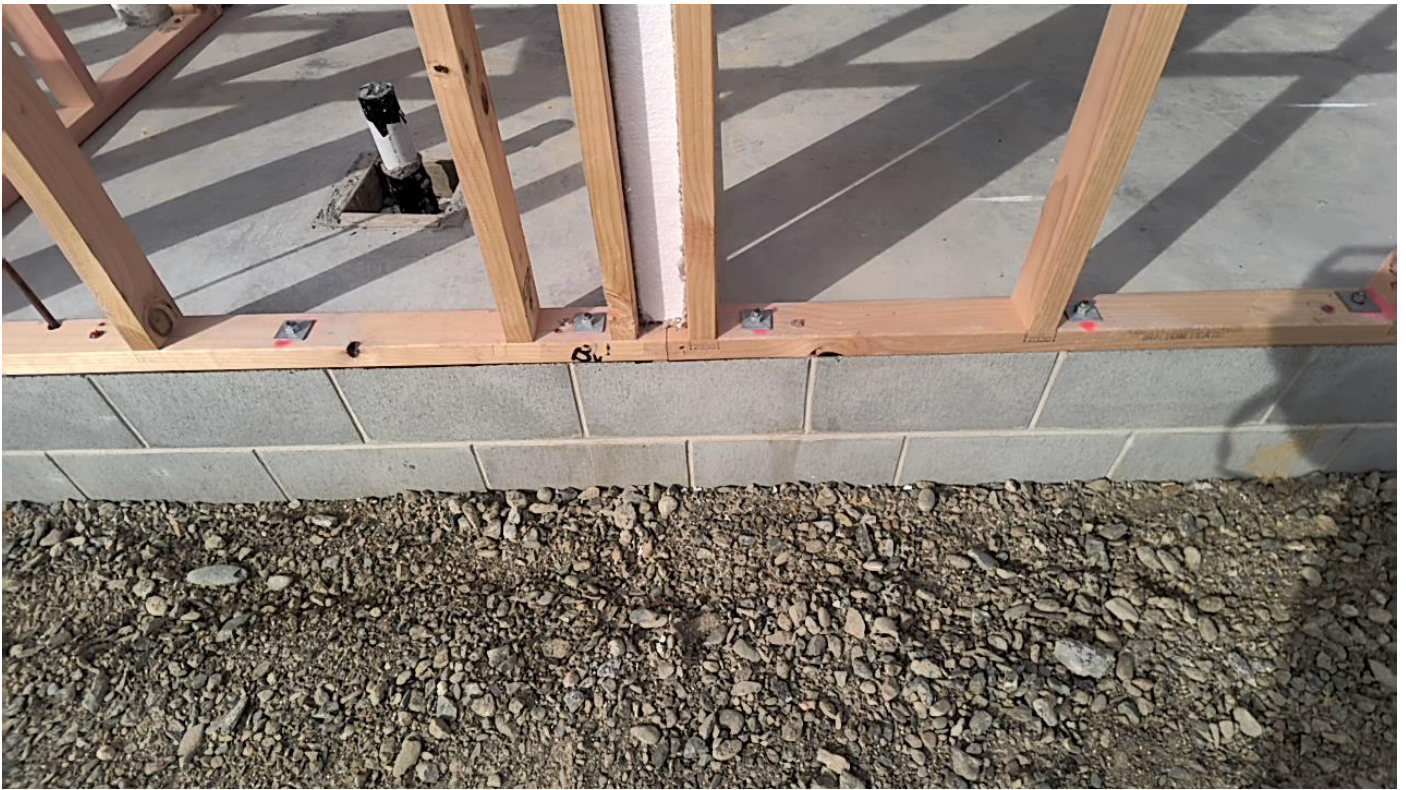
| <b>Bottom plate fixings in place as detailed in the consent documents, correct centres and at plate joins and junctions as required.</b> | |

**Fixing either side of join in bottom plate**  
Taken at 9:56 AM on Monday 9/09/2024

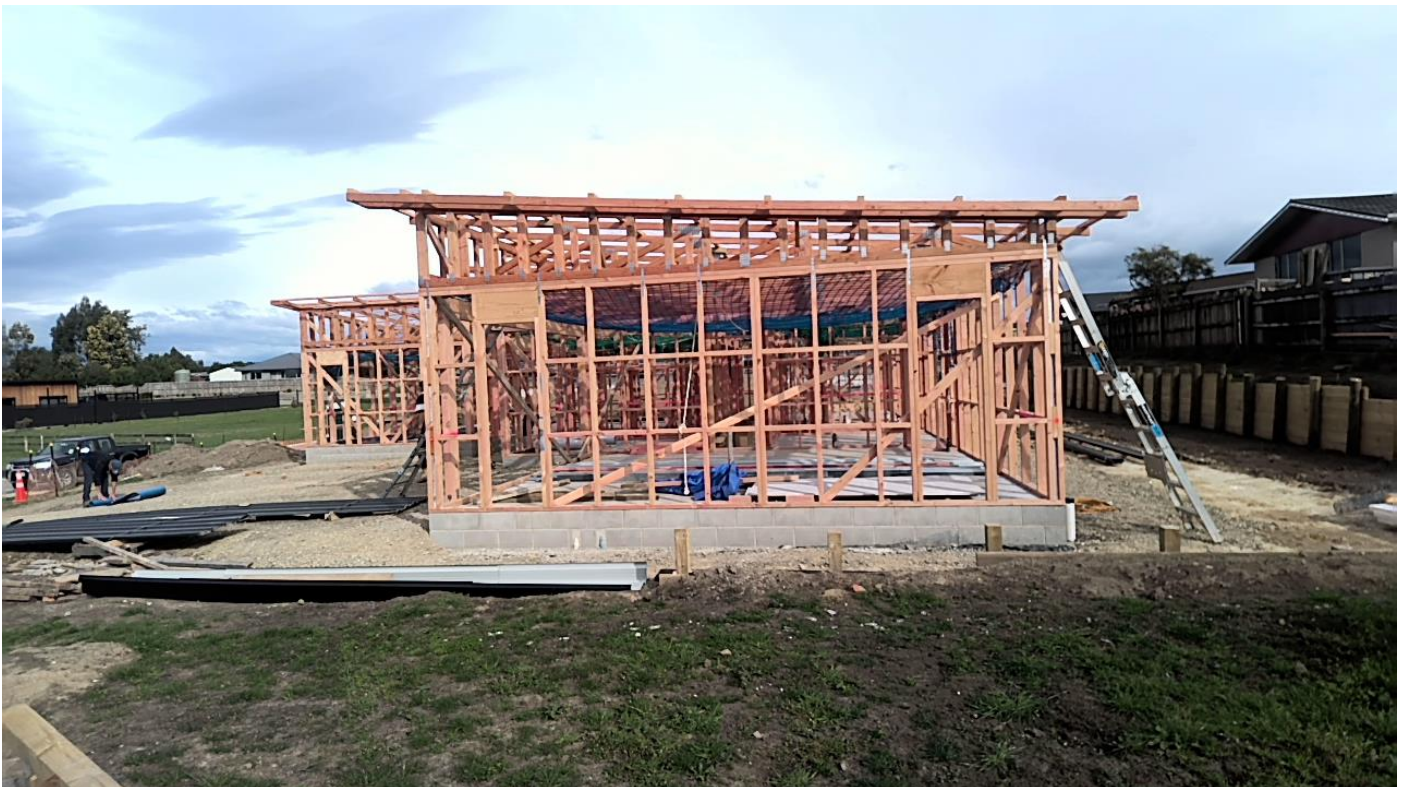
**East elevation**  
Taken at 9:57 AM on Monday 9/09/2024

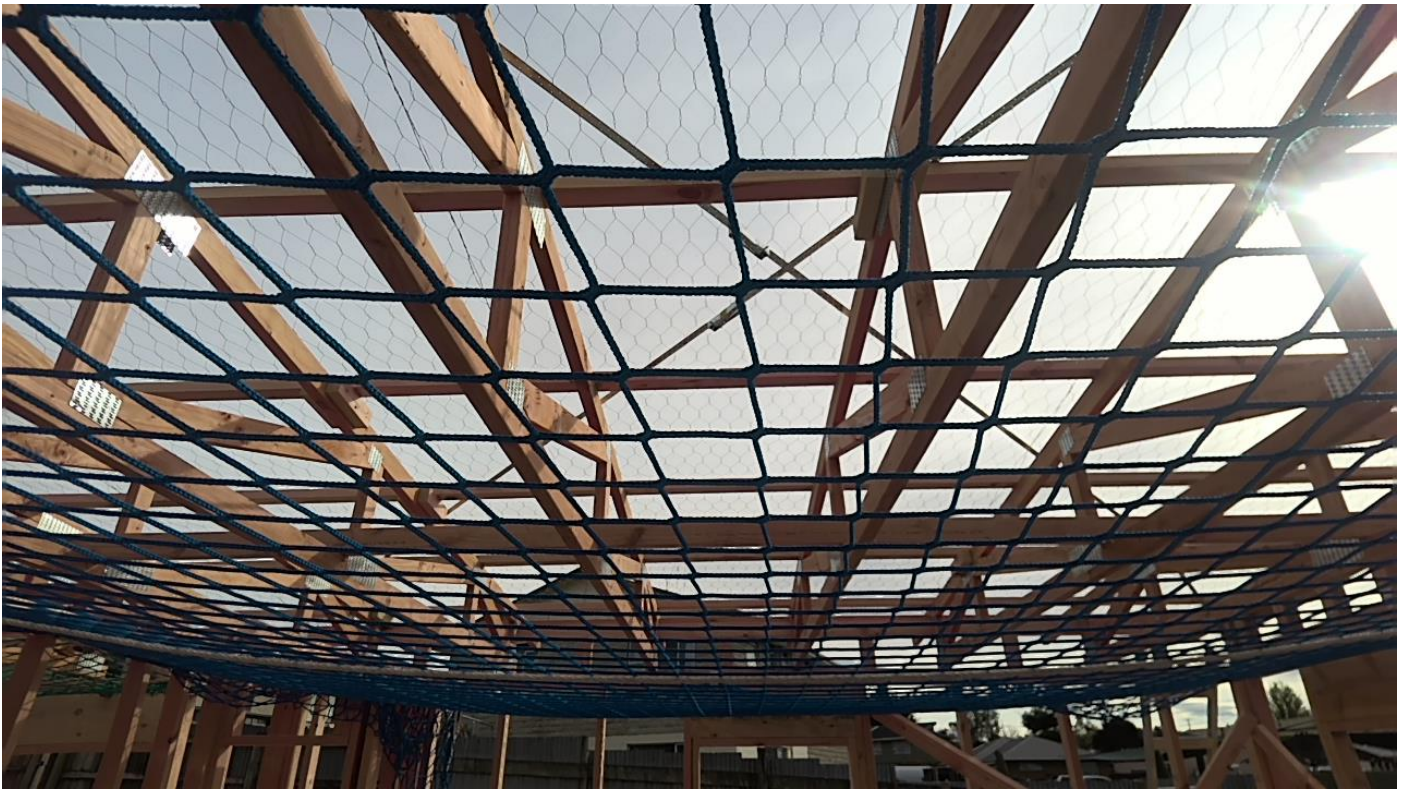
| Inspection Element | Status |
|---|---|
| <b>Roof plane bracing has been installed as detailed on the roof plan.</b> | |

**Roof plane bracing over garage**  
Taken at 9:57 AM on Monday 9/09/2024

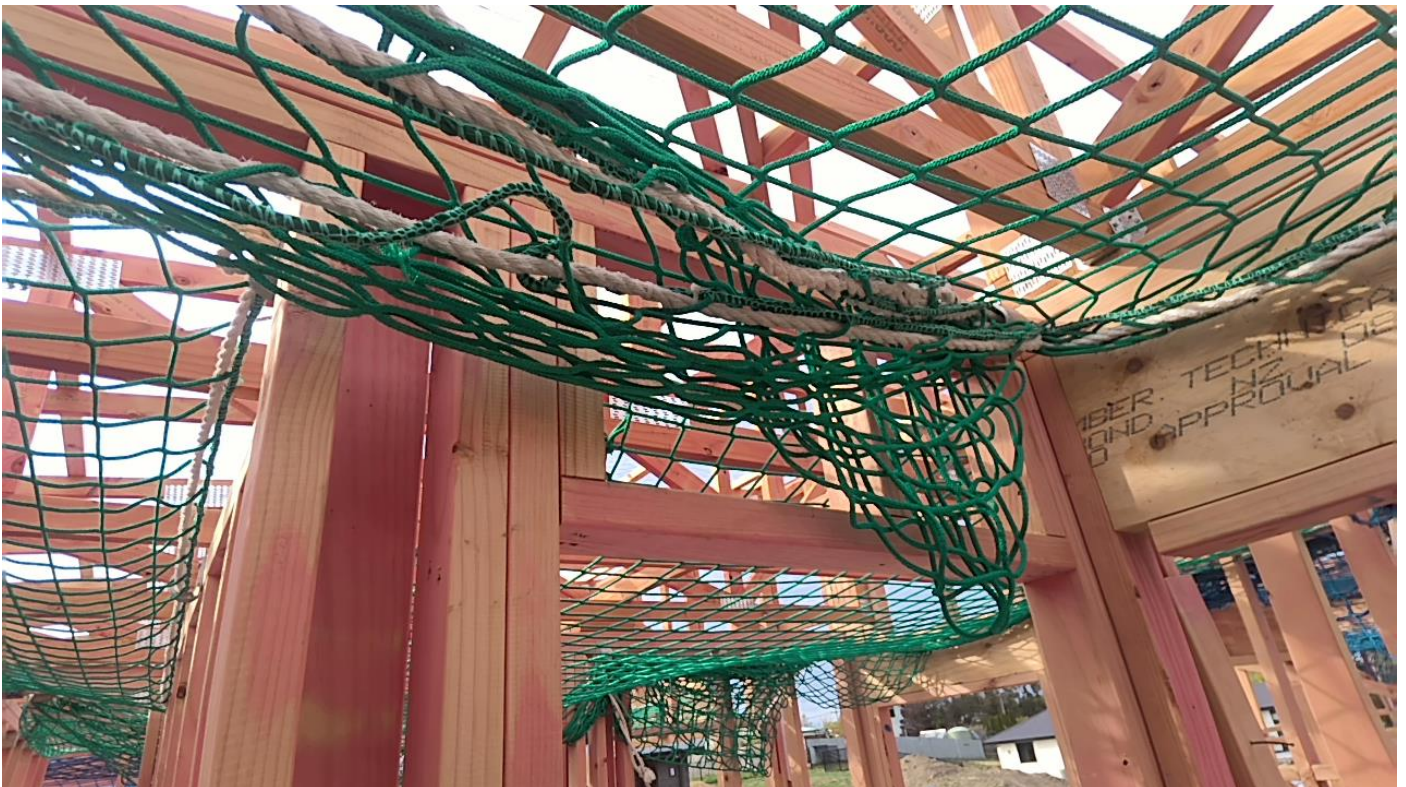
| <b>The lintel at the door into bed4/study from the hall is shown on plan 15 as a 2x140 lintel in the LBW, the pre nail plan has it as a 90x45 on flat timber opening, it does show this wall as a LBW, please confirm the requirements and install either to the consented plan or to the pre nail with commentary on the lintel fixing/size requirement.</b> | |

**Lintel in LBW to study may be required**  
Taken at 9:58 AM on Monday 9/09/2024

| <b>This can be viewed at next on site building inspection.</b> | |

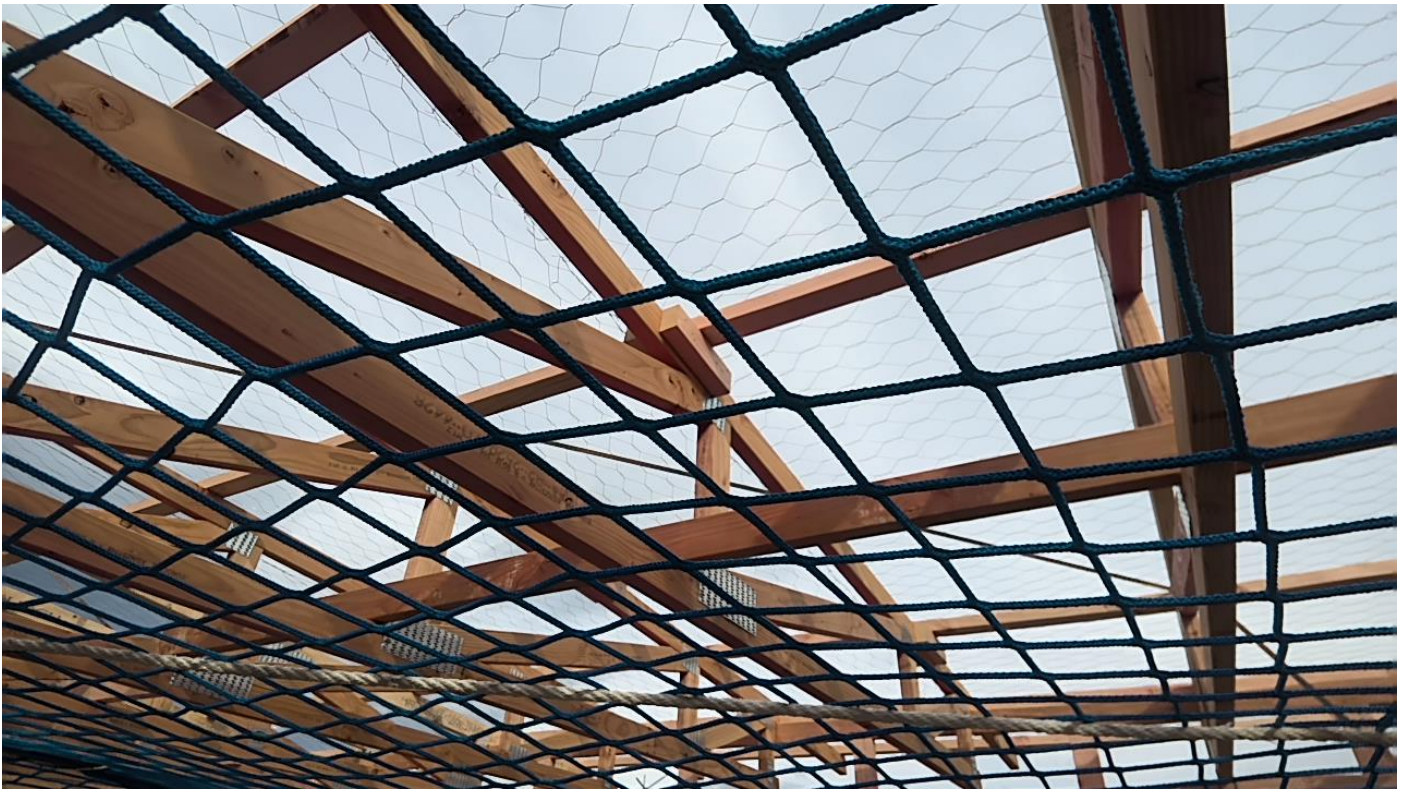
| Inspection Element | Status |
|---|---|
| <b>Purlin size, spacing and fixing is as per consented documents</b> | |

**Block to purlin joins**  
Taken at 9:59 AM on Monday 9/09/2024

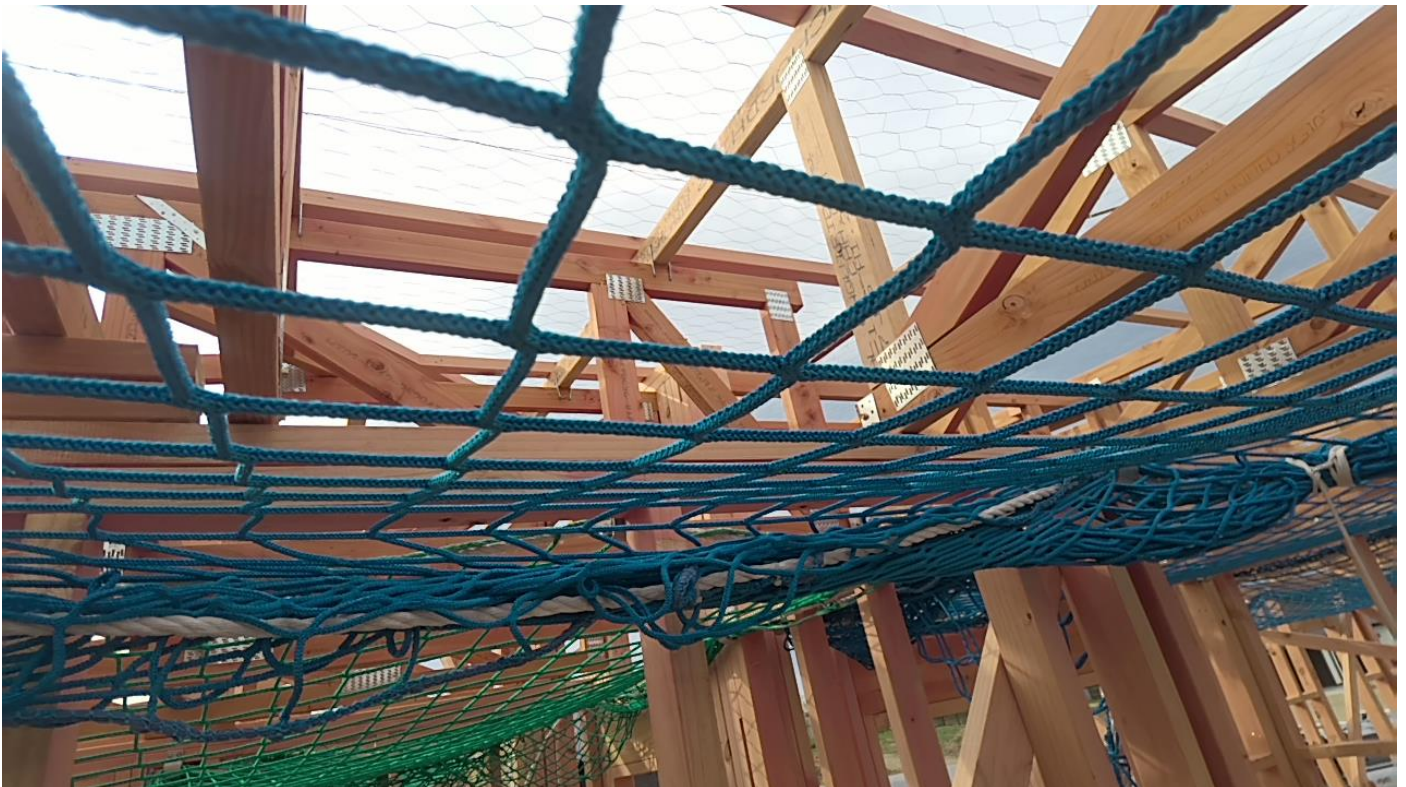
| Inspection Element | Status |
|---|---|
| <b>Trusses fixed to top plate as detailed in the truss layout, adequate support provided for point loads.</b> | |

**1 side of 9kn truss to top plate fixing**  
Taken at 10:00 AM on Monday 9/09/2024

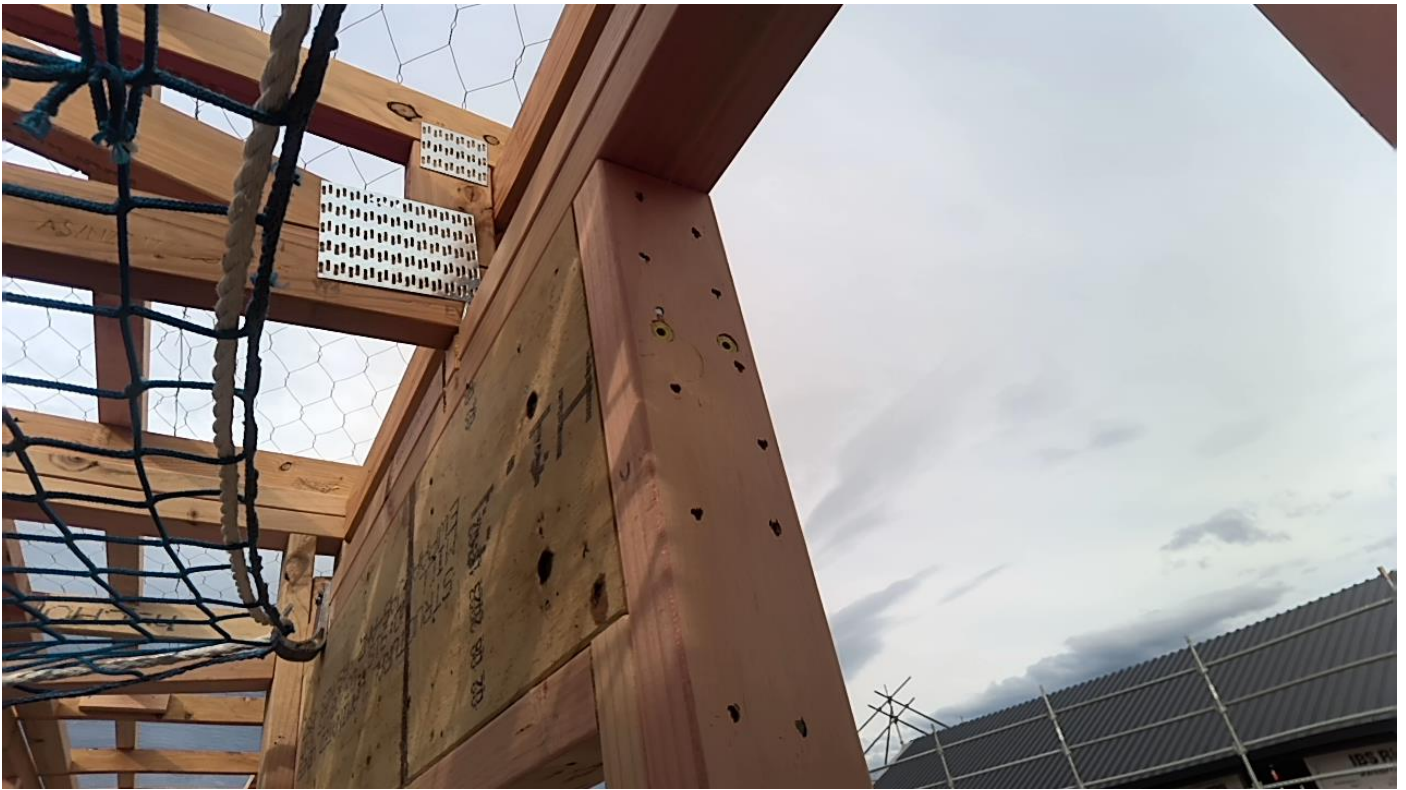
| <b>Top plate to stud stud connections and top plate to top plate connections completed in accordance with the consented documents. Stud lock system used.</b> | |

**Stud lock used for lintel and top plate fixings**  
Taken at 10:00 AM on Monday 9/09/2024
