## GoGet Audit Report

Consent No: **24009002**

Site Address: **7 Whitehaven Street, Weston**

Inspection Type: **Foul and Stormwater Drainage**

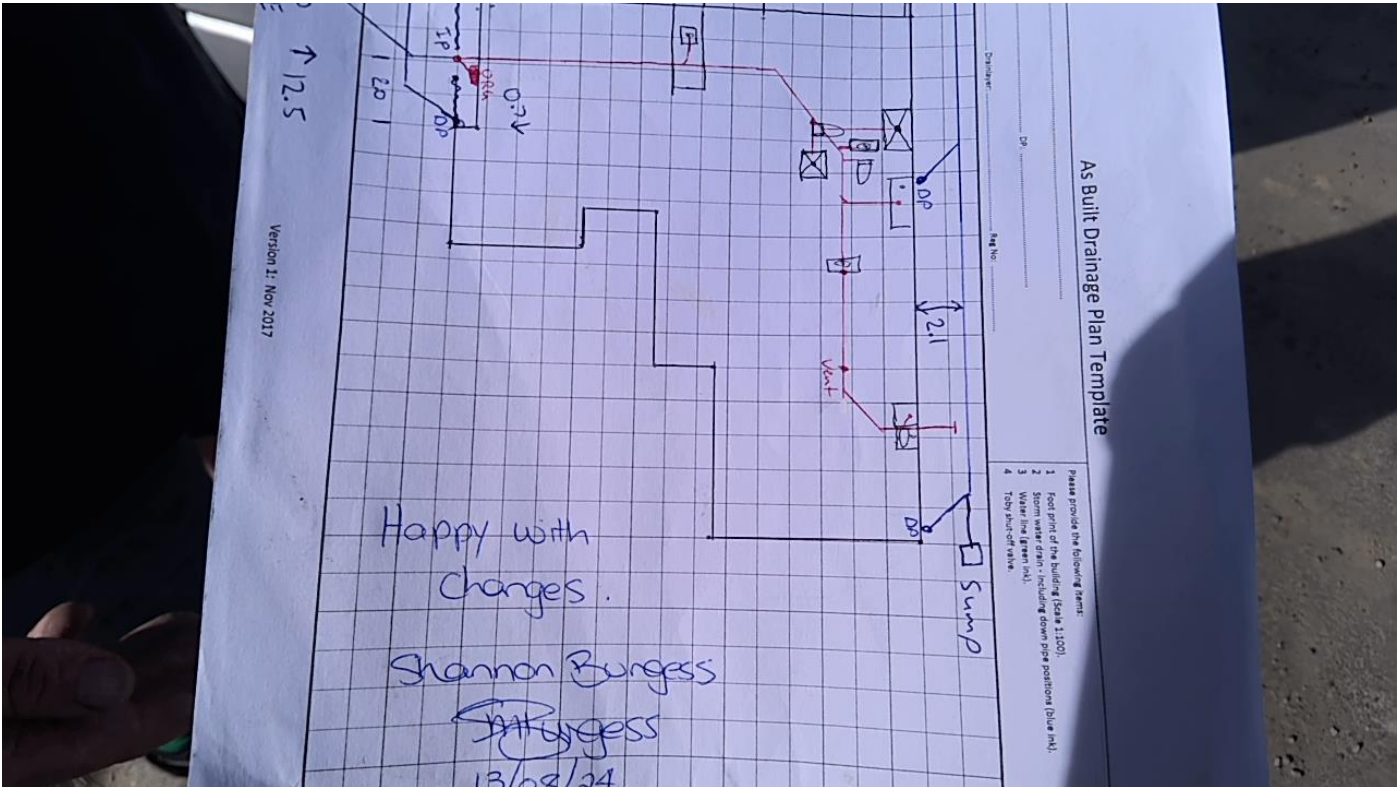
| Inspection Element | Status |
|---|---|
| <b>The owner has signed the drainage plan as it has changed from the consent</b> | |

**OWNER HAS SIGNED THE PLAN**  
Taken at 2:26 PM on Tuesday 13/08/2024
